# **LIDAR Inspection Report of Box Culvert ch.984+805**

**Bridge Chainage:** 984+805

- **Bridge No:** -
- **Chainage:** 984+805
- **Structure type:** Box Culvert

- **CKRP:** Chittorgarh to kota
- **State:** Rajasthan NH 27
- **Zone:** RJ-20

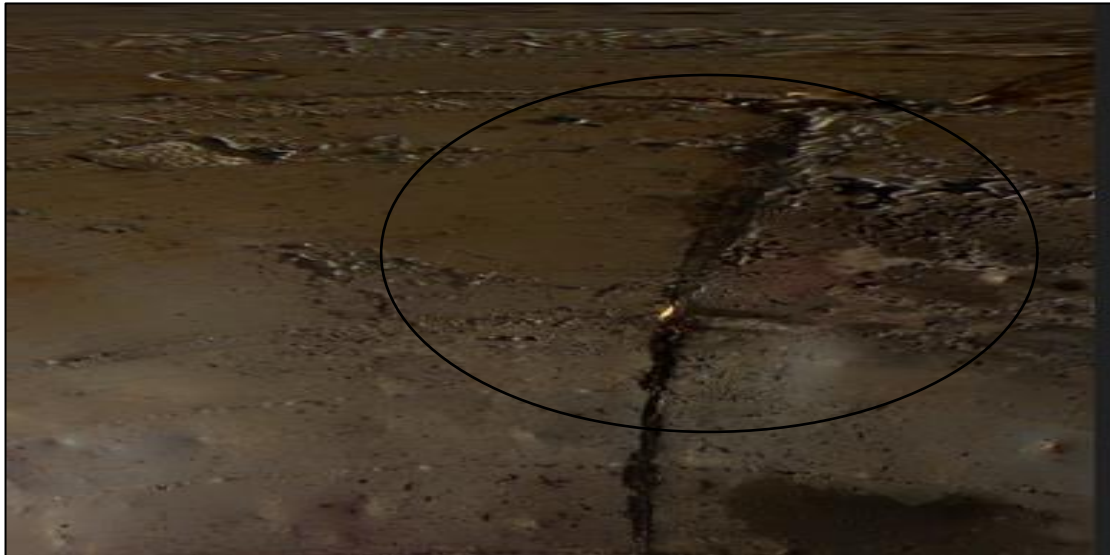
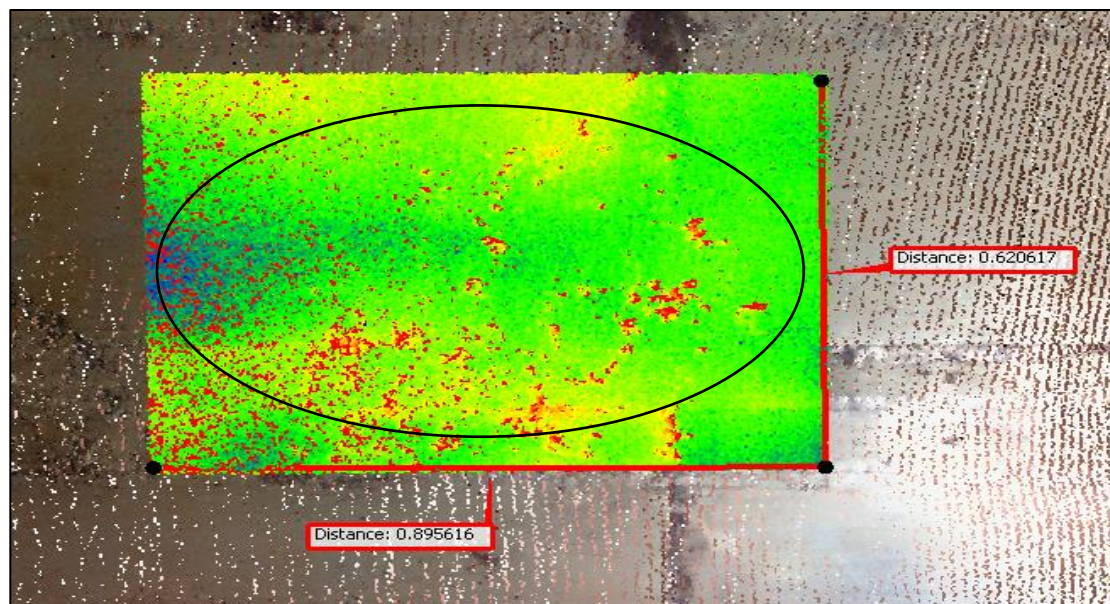
| Element Name | Observation | Location of Distress | Photo No. | Units | Distress Details | | | Area of Repair<br>(Sq.m/R MT/m3) |
|---|---|---|---|---|---|---|---|---|
| Slab Bottom | Scalling | | 1 | Sq m | 0.89 | 0.62 | | 0.5518 |

1. Scaling (SCL) observed on the slab bottom, measuring 0.89 m in length and 0.62 m in width, covering an area of 0.551 m<sup>2</sup>.

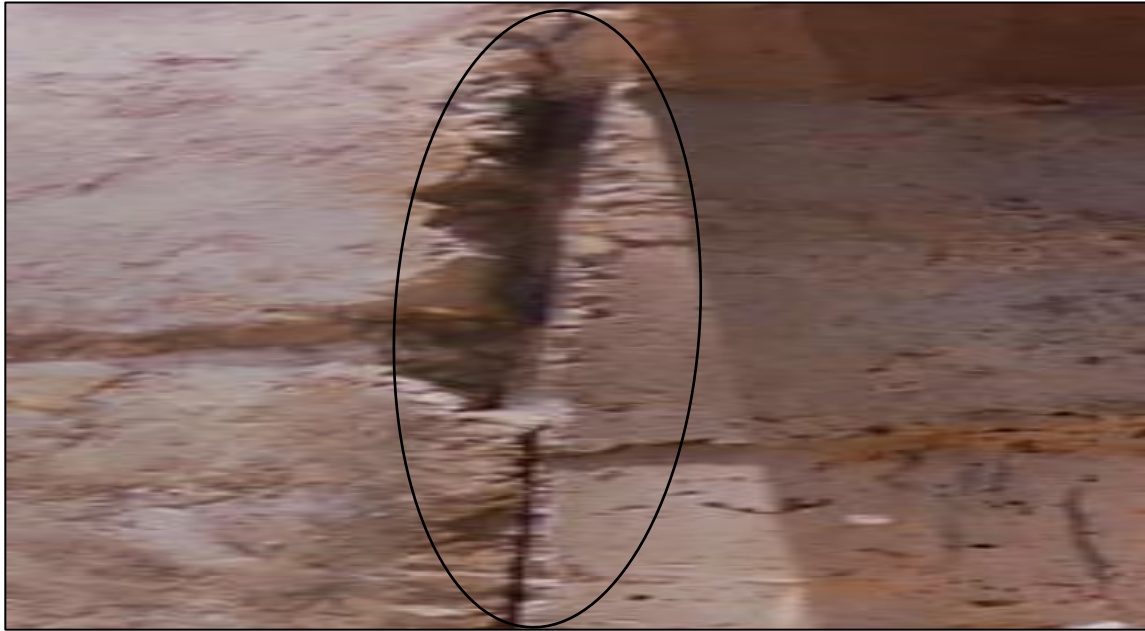
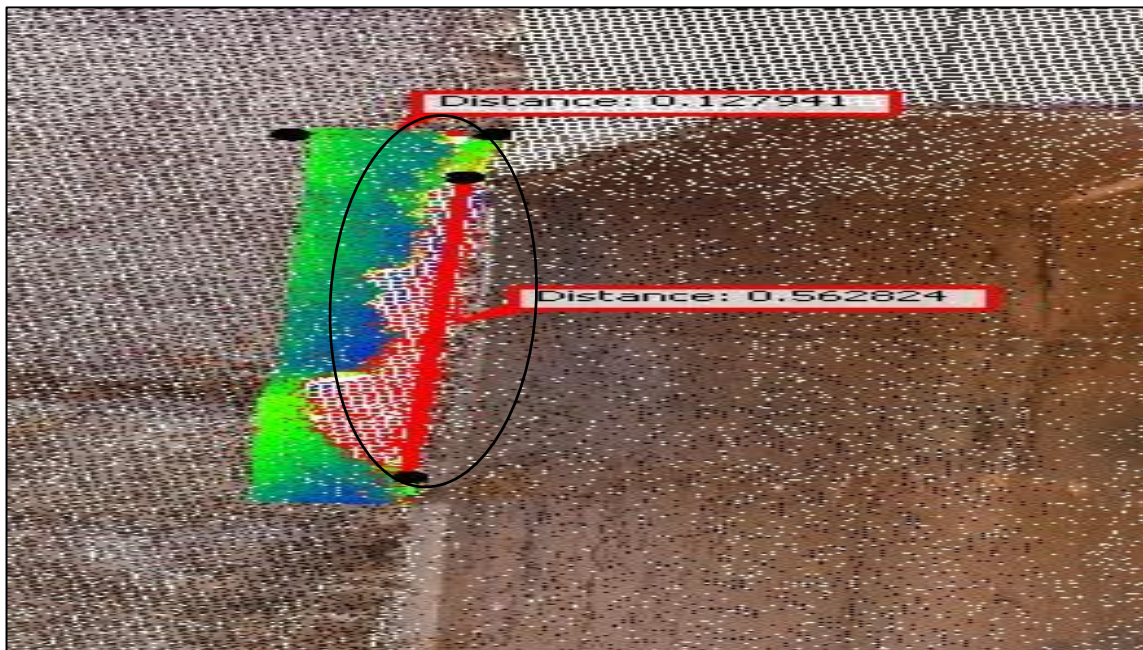
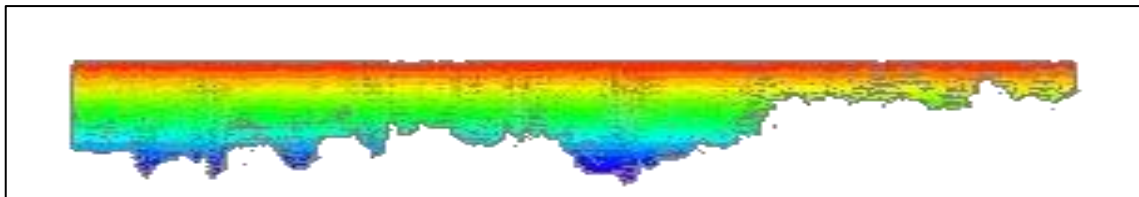
| Element Name | Observation | Location of Distress | Photo No. | Units | Distress Details | | | Area of Repair<br>(Sq.m/R MT/m3) |
|---|---|---|---|---|---|---|---|---|
| Wing Wall | Damage | | 2 | Sq m | 0.562 | 0.127 | | 0.071374 |

- 2. Wing Wall Damage observed on A1 (RHS), measuring 0.562 m in length and 0.127 m in width, covering an area of 0.0713 m<sup>2</sup>.**
