# LIDAR Inspection Report of **Box Culvert** ch.984+865

**Bridge Chainage:** 984+865 (CKRP)

- **CKRP:** Chittorgarh to kota
- **State:** Rajasthan NH 27
- **Zone:** RJ-06

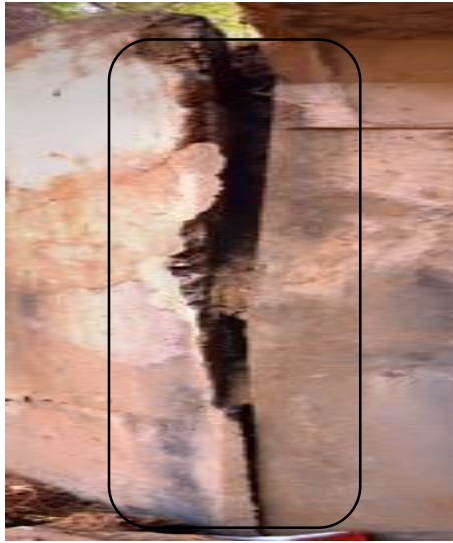
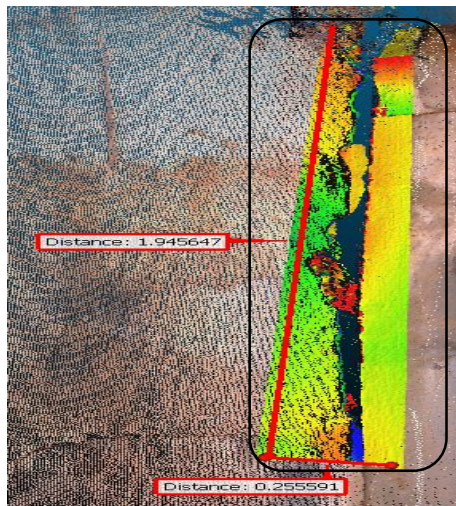
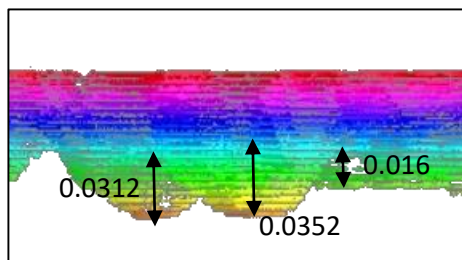
| Element Name | Observation | Location of Distress | Photo No. | Units | Distress Details | | | Area of Repair (Sq.m/RMT/m <sup>3</sup> ) |
|---|---|---|---|---|---|---|---|---|
| Abutment 2 | Damage | - | 1 | M | 1.94 | 0.25 | 0.031 | 0.015 |

**1. Damage observed on LHS A2 HP 7, measuring 1.94 m in length and 0.25 m in width. Depth ranges from 0.016 m (min) to 0.035 m (max), with an average depth of 0.031 m. The calculated volume of the distress is 0.0150 m<sup>3</sup>.**

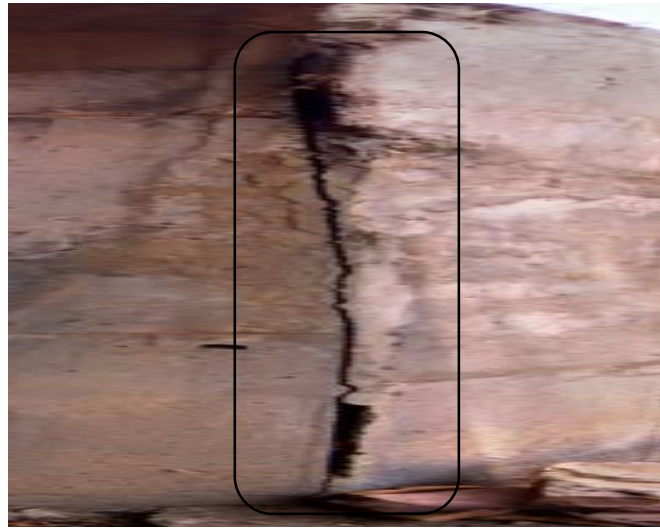
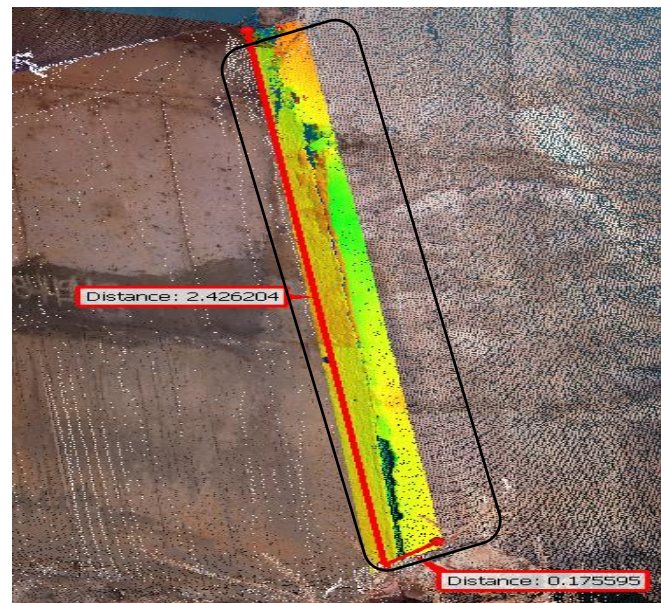
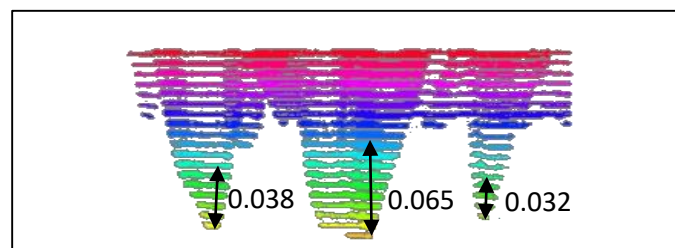
| Element Name | Observation | Location of Distress | Photo No. | Units | Distress Details | | | Area of Repair (Sq.m/RMT/m <sup>3</sup> ) |
|---|---|---|---|---|---|---|---|---|
| Abutment 1 | Damage | - | 2 | M | 2.24 | 0.17 | 0.038 | 0.014 |

**2.Damage observed on LHS A2 HP 7, measuring 2.24 m in length and 0.17 in width. Depth ranges from 0.032m (min) to 0.065 m (max), with an average depth of 0.038 m. The calculated volume of the distress is 0.0144 m<sup>3</sup>.**

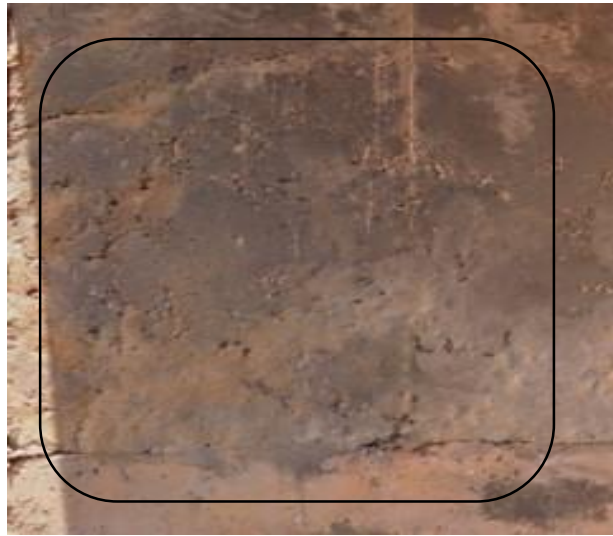
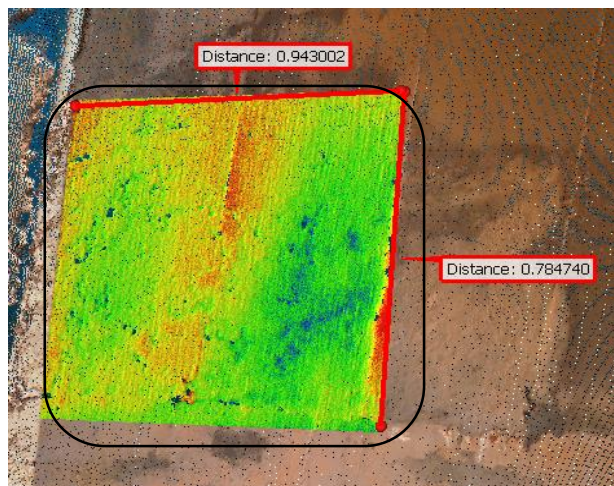
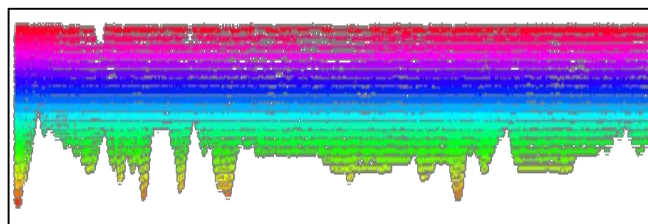
| Element Name | Observation | Location of Distress | Photo No. | Units | Distress Details | | | Area of Repair (Sq.m/R MT/m <sup>3</sup> ) |
|---|---|---|---|---|---|---|---|---|
| Abutment 1 | Scaling | - | 3 | M | 0.94 | 0.78 | | 0.733 |

**3. Scaling observed on RHS A1 SCL, measuring 0.94 m in length and 0.78 m in width, covering an area of 0.733 m<sup>2</sup>**

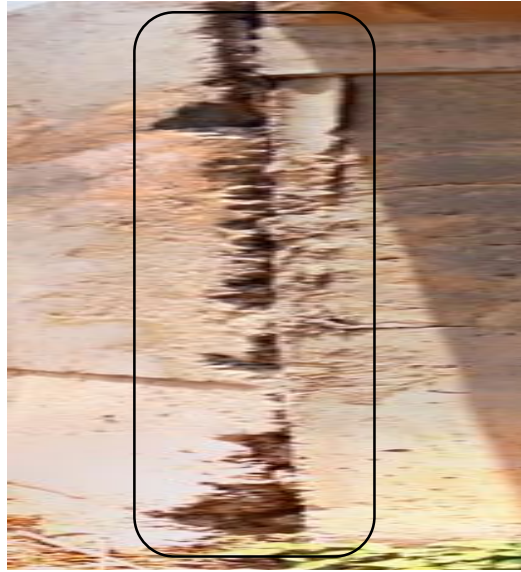
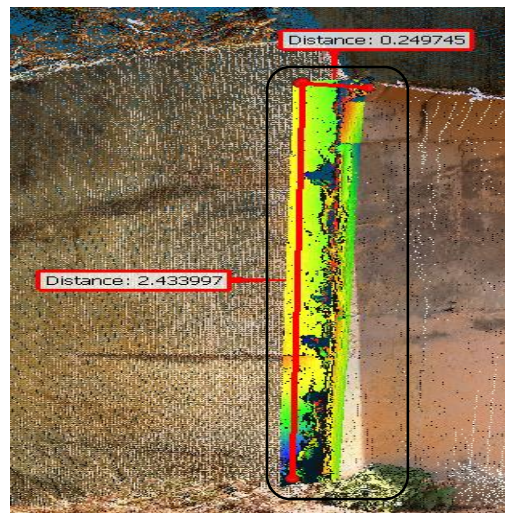
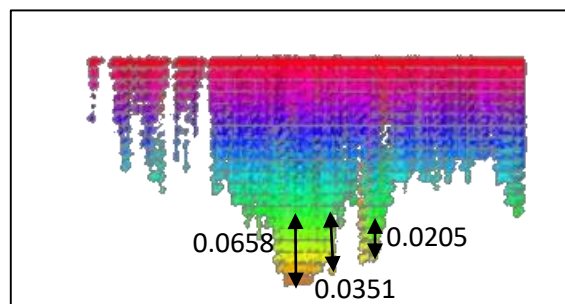
| Element Name | Observation | Location of Distress | Photo No. | Units | Distress Details | | | Area of Repair (Sq.m/R MT/m <sup>3</sup> ) |
|---|---|---|---|---|---|---|---|---|
| Abutment 1 | Damage | - | 4 | M | 2.24 | 0.24 | 0.035 | 0.018 |

**4. Damage observed on RHS A1 HP 7, measuring 2.24 m in length and 0.24 m in width. Depth ranges from 0.0205 m (min) to 0.0658 m (max), with an average depth of 0.0351 m. The calculated volume of the distress is 0.0188 m<sup>3</sup>.**

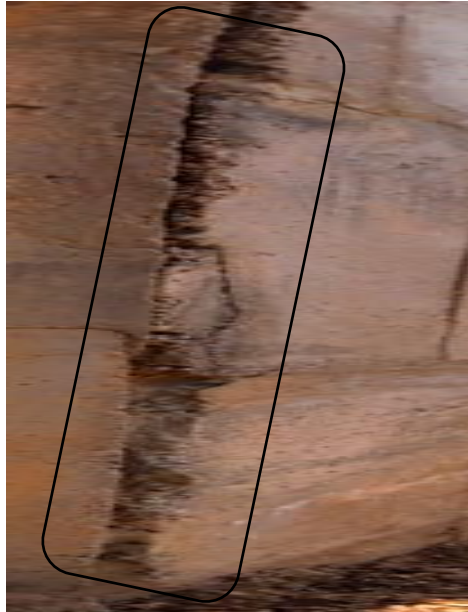
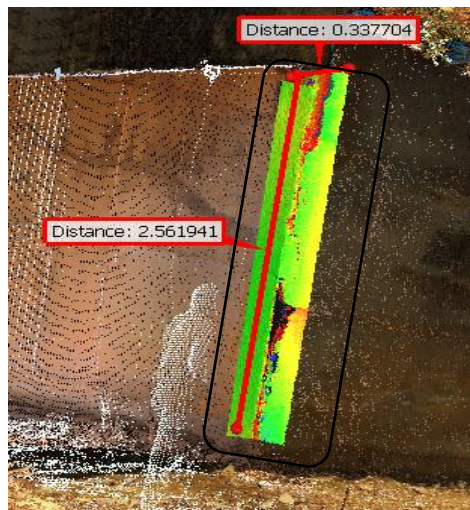
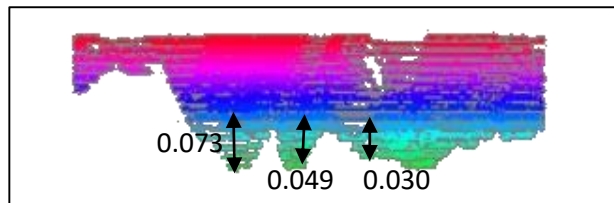
| Element Name | Observation | Location of Distress | Photo No. | Units | Distress Details | | | Area of Repair (Sq.m/R MT/m <sup>3</sup> ) |
|---|---|---|---|---|---|---|---|---|
| Abutment 2 | Damage | | 5 | M | 2.56 | 0.33 | 0.049 | 0.041 |

**5. Damage observed on RHS A2 HP, measuring 2.56 m in length and 0.33 m in width. Depth ranges from 0.030 m (min) to 0.073 m (max), with an average depth of 0.049 m. The calculated volume of the distress is 0.041 m<sup>3</sup>.**
