# LIDAR Inspection Report of **Box Culvert** ch.985+050

**Bridge Chainage:** 985+050 (CKRP)

- **CKRP:** Chittorgarh to kota
- **State:** Rajasthan NH 27
- **Zone:** RJ-06

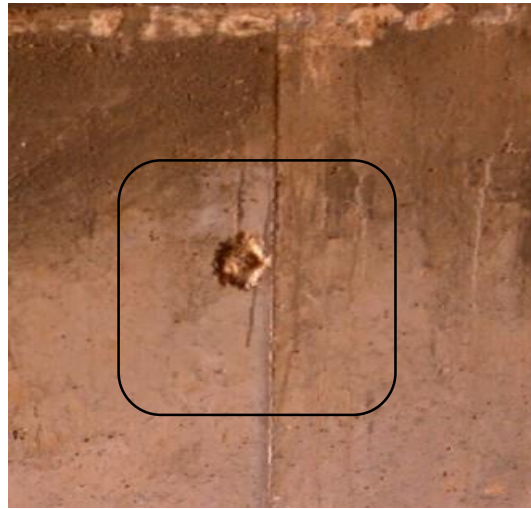
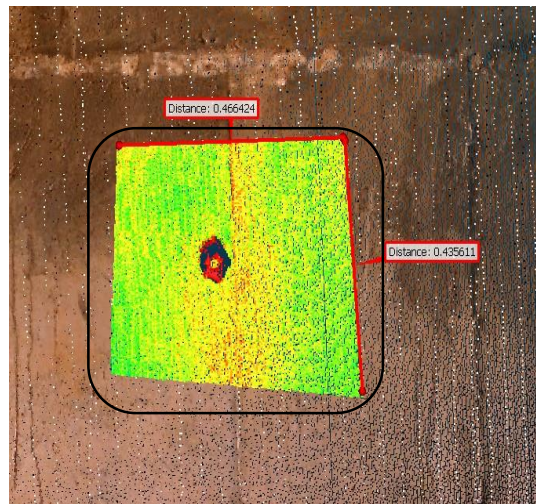
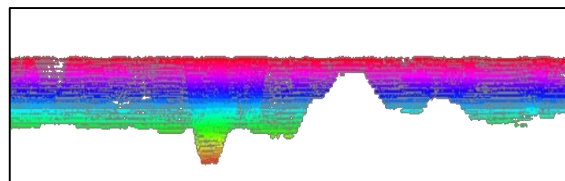
| Element Name | Observation | Location of Distress | Photo No. | Units | Distress Details | | | Area of Repair (Sq.m /RMT/ m3) |
|---|---|---|---|---|---|---|---|---|
| Abutment | Damage | - | 1 | M | 0.46 | 0.43 | | 0.197 |

**1. Damage observed on LHS Abutment Wall, measuring 0.46 m in length and 0.43 m in width, covering an area of 0.197 m<sup>2</sup>.**

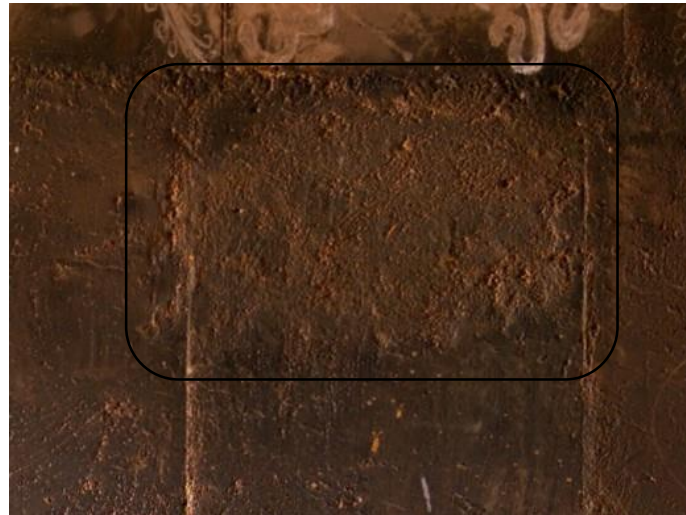
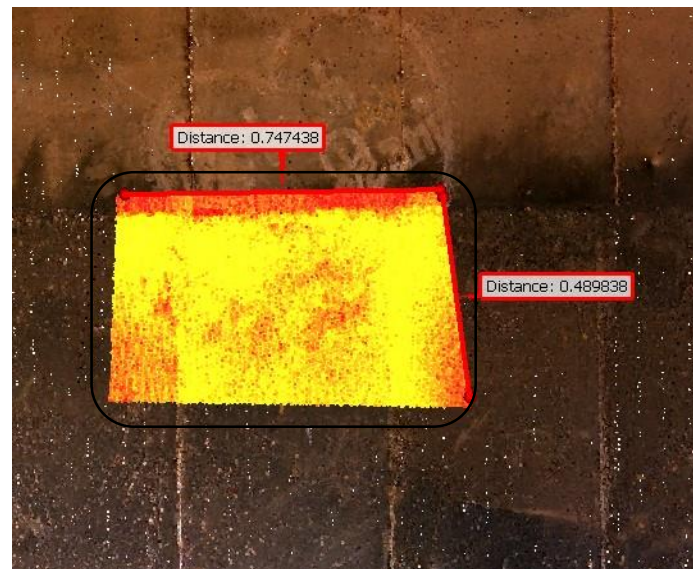
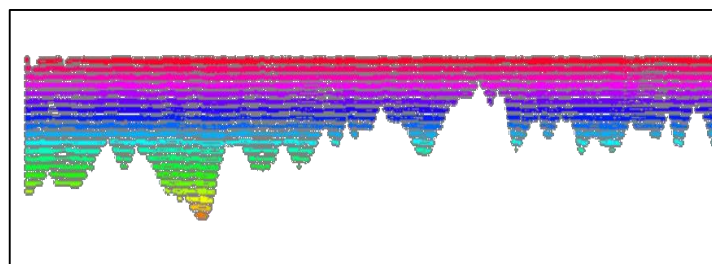
| Element Name | Observation | Location of Distress | Photo No. | Units | Distress Details | | | Area of Repair (Sq.m /RMT/ m3) |
|---|---|---|---|---|---|---|---|---|
| Wall | Scaling | - | 2 | M | 0.74 | 0.48 | | 0.355 |

**2. Scaling observed on LHS Wall SCL, measuring 0.74 m in length and 0.48 m in width, covering an area of 0.355 m<sup>2</sup>.**

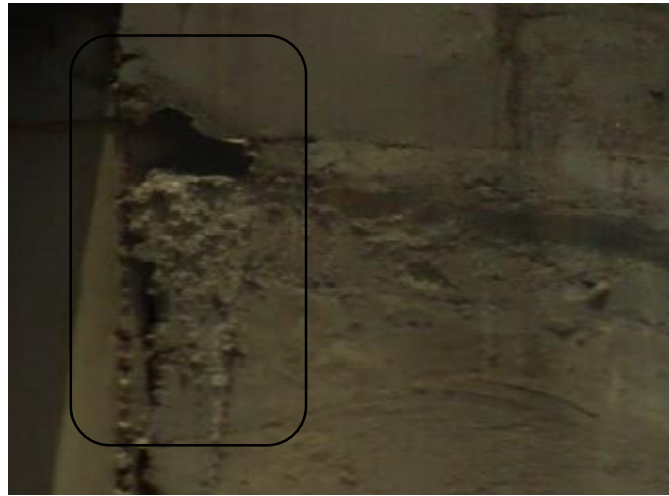
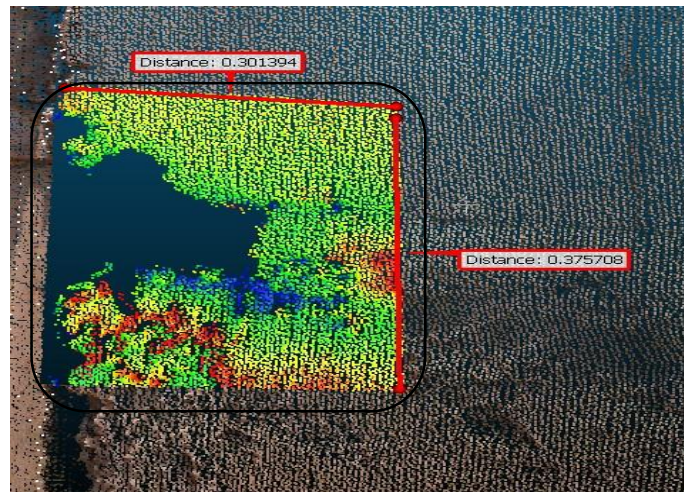
| Element Name | Observation | Location of Distress | Photo No. | Units | Distress Details | | | Area of Repair (Sq.m /RMT/ m3) |
|---|---|---|---|---|---|---|---|---|
| Abutment | Damage | - | 3 | M | 0.30 | 0.37 | | 0.111 |

**3. Damage observed on RHS Abutment Wall, measuring 0.30 m in length and 0.37 m in width, covering an area of 0.111 m<sup>2</sup>.**

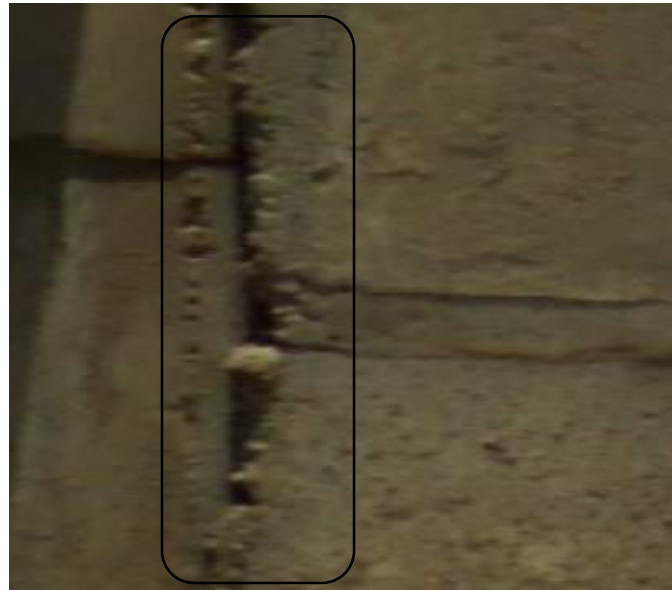
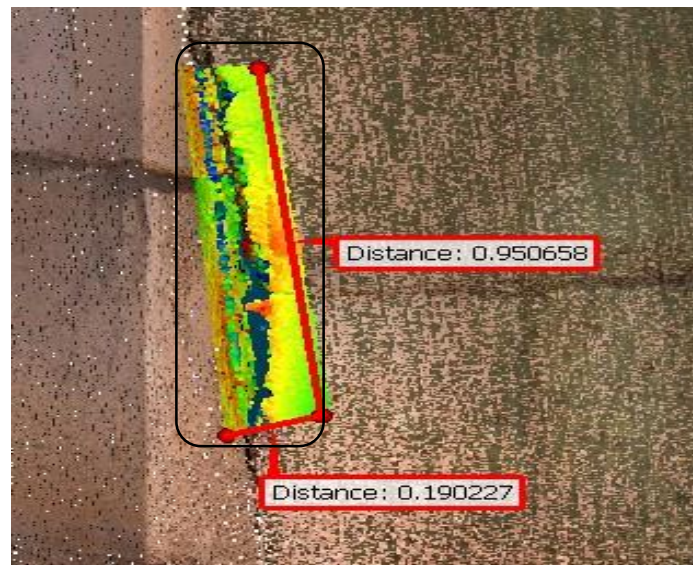
| Element Name | Observation | Location of Distress | Photo No. | Units | Distress Details | | | Area of Repair (Sq.m /RMT/ m3) |
|---|---|---|---|---|---|---|---|---|
| Abutment | Damage | - | 4 | M | 0.95 | 0.19 | | 0.180 |

**4. Damage observed on RHS Abutment Wall (Damage 2), measuring 0.95 m in length and 0.19 m in width, covering an area of 0.180 m<sup>2</sup>**
