# LIDAR Inspection Report of **Box Culvert** ch.985+700

**Bridge Chainage:** 985+700(CKRP)

- **Bridge No:** -
- **Chainage:** 985+700
- **Structure type:** Box Culvert

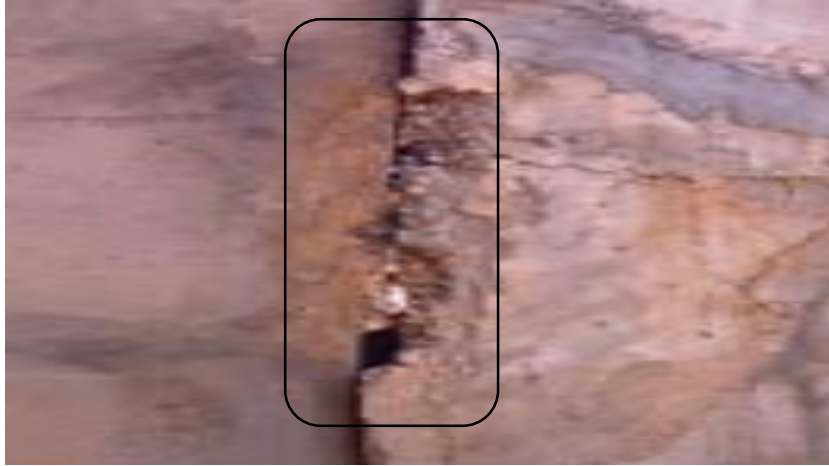
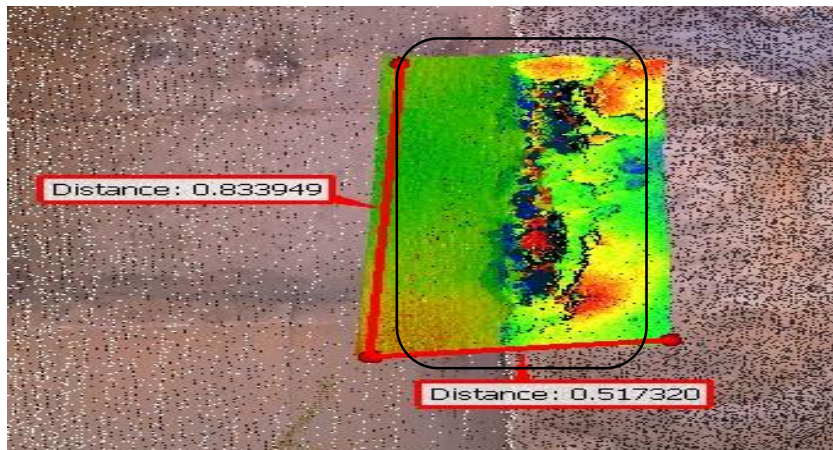
| Element Name | Observation | Location of Distress | Photo No. | Units | Distress Details | | | Area of Repair (Sq.m/R MT/m3) |
|---|---|---|---|---|---|---|---|---|
| Abutment | Damage | - | 1 | M | 0.83 | 0.51 | | 0.423 |

**1. Damage observed on LHS Abutment Wall, measuring 0.83 m in length and 0.51 m in width, covering an area of 0.423 m<sup>2</sup>.**

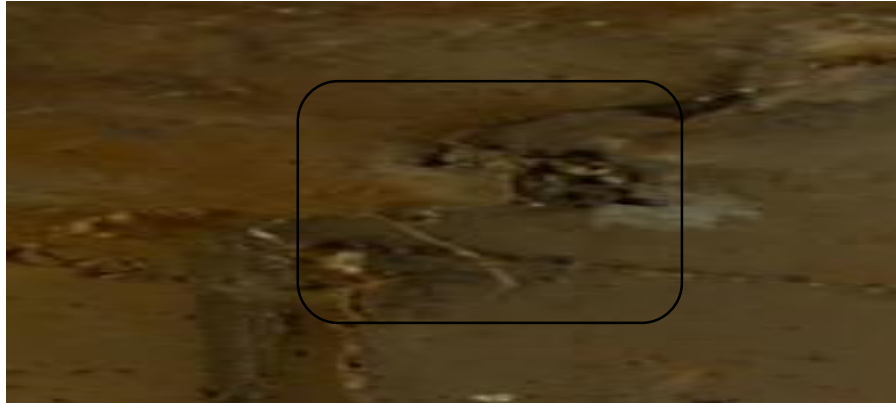
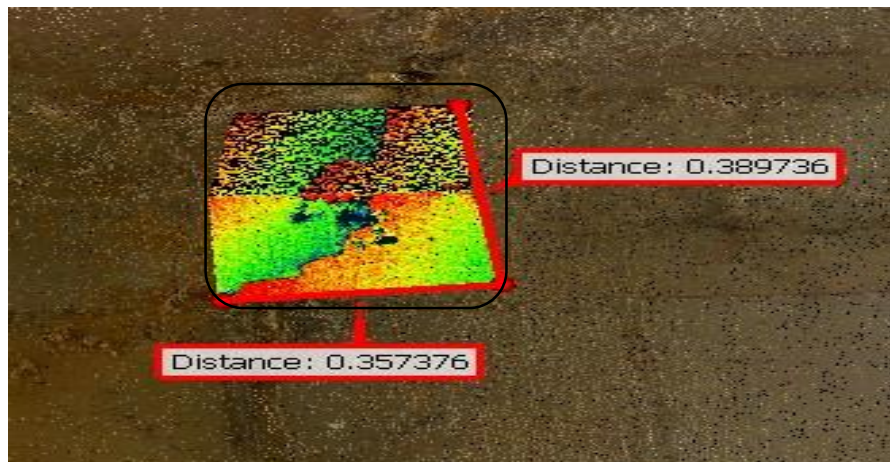
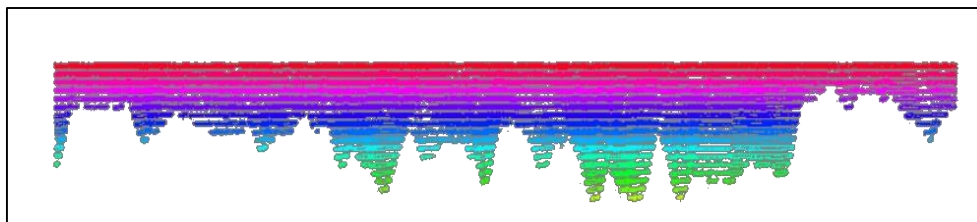
| Element Name | Observation | Location of Distress | Photo No. | Units | Distress Details | | | Area of Repair (Sq.m/R MT/m3) |
|---|---|---|---|---|---|---|---|---|
| Abutment | Honeycombing | - | 2 | M | 0.38 | 0.35 | | 0.133 |

**2. Honeycombing observed on LHS HC Abutment Wall, measuring 0.38 m in length and 0.35 m in width, covering an area of 0.133 m<sup>2</sup>.**

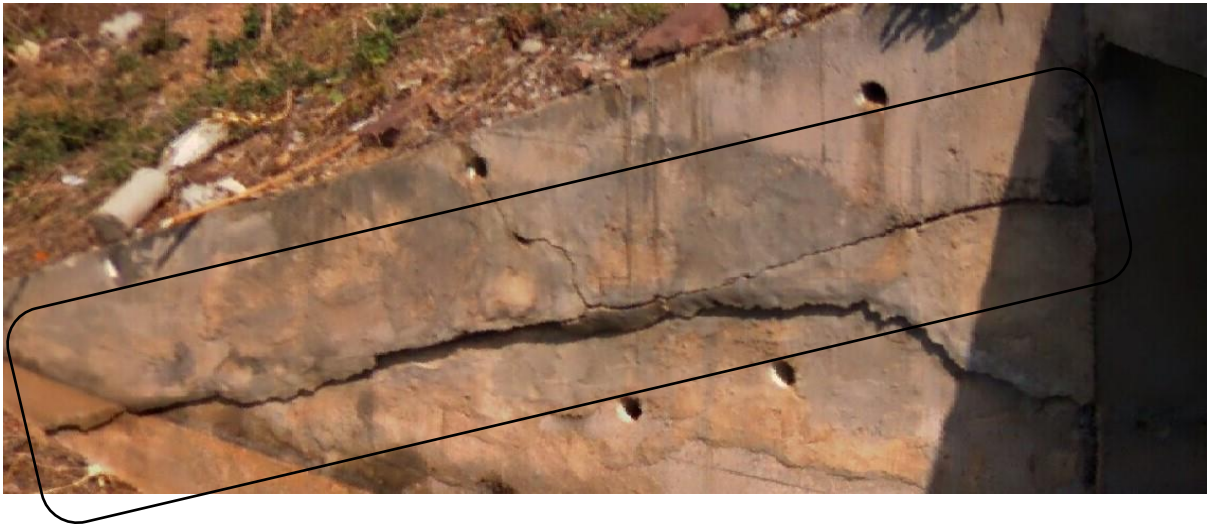
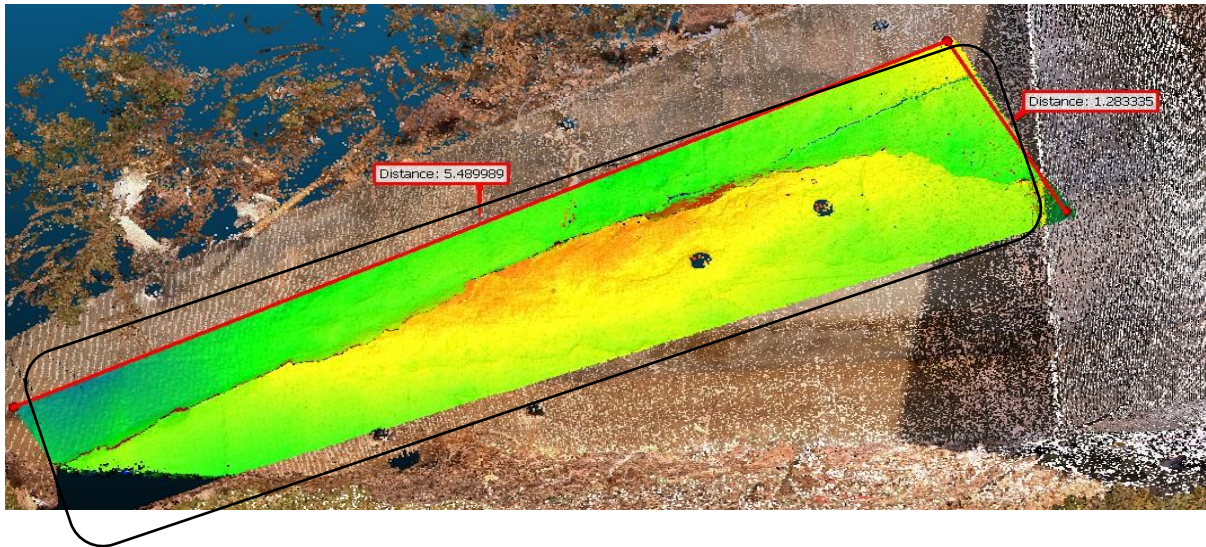
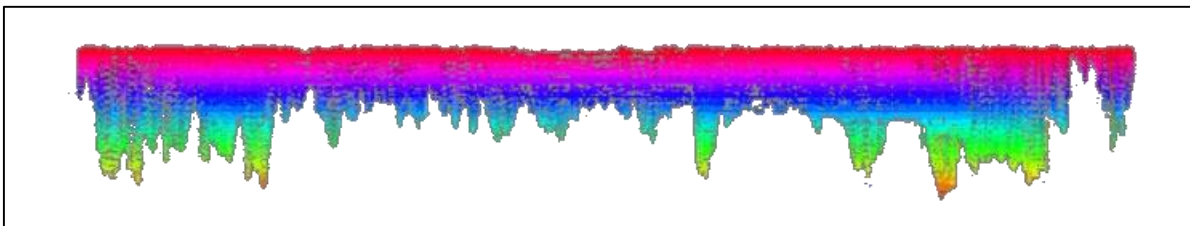
| Element Name | Observation | Location of Distress | Photo No. | Units | Distress Details | | | Area of Repair (Sq.m/R MT/m3) |
|---|---|---|---|---|---|---|---|---|
| Abutment | Crack | - | 3 | M | 5.48 | 1.28 | | 5633.44 |

**3. Crack observed on LHS Abutment Wall, measuring 5.48 m in length and 1.28 m in width, covering an area of 5.633 m<sup>2</sup>.**

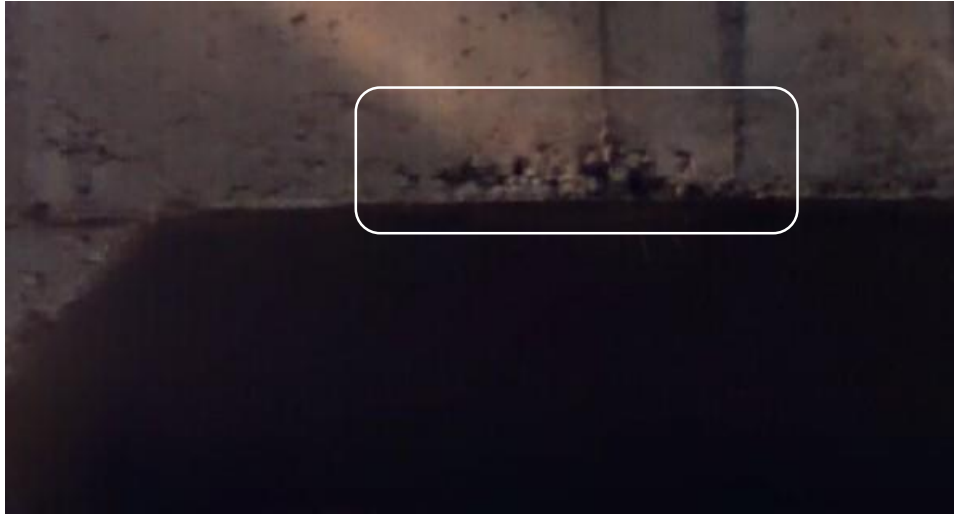
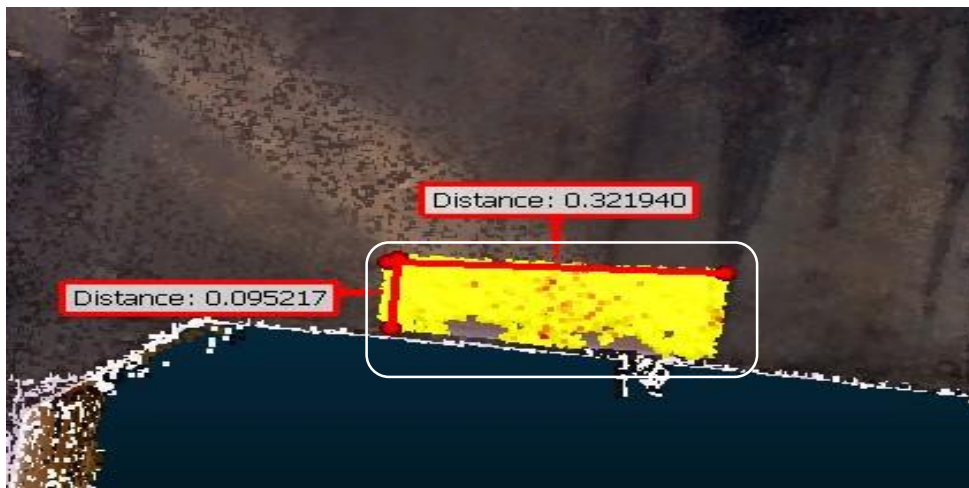
| Element Name | Observation | Location of Distress | Photo No. | Units | Distress Details | | | Area of Repair (Sq.m /RMT/ m3) |
|---|---|---|---|---|---|---|---|---|
| Parapet wall | Honeycombing | - | 4 | M | 0.32 | 0.09 | | 0.028 |

**4. Honeycombing observed on HC Parapet Wall, measuring 0.32 m in length and 0.09 m in width, covering an area of 0.028 m<sup>2</sup>**

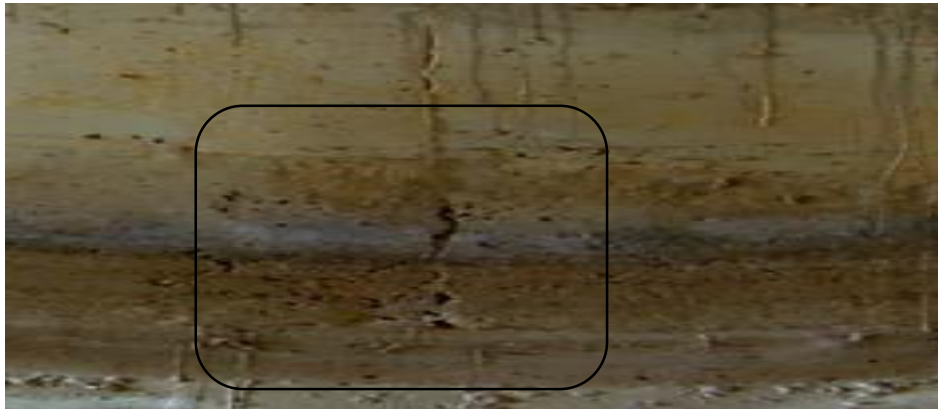
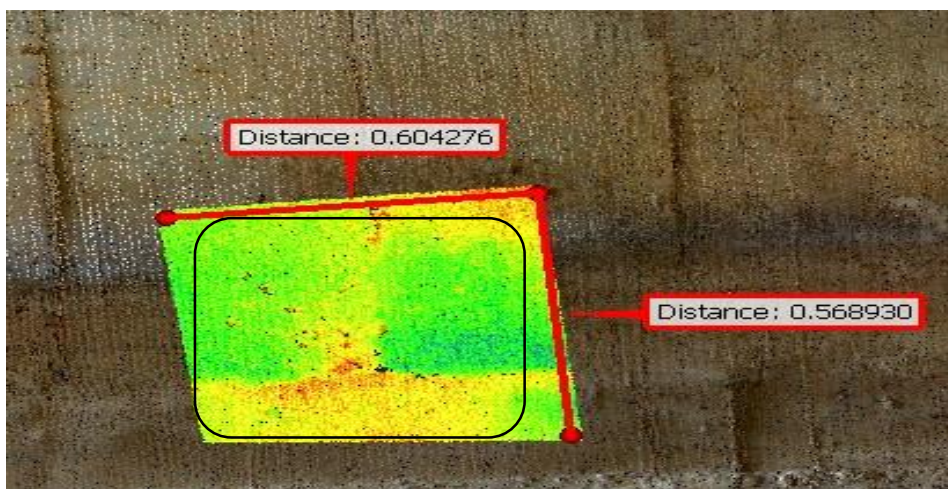
| Element Name | Observation | Location of Distress | Photo No. | Units | Distress Details | | | Area of Repair (Sq.m /RMT/ m3) |
|---|---|---|---|---|---|---|---|---|
| Abutment | Scaling | - | 5 | M | 0.60 | 0.56 | | 0.336 |

**5. Scaling observed on SCL Abutment Wall, measuring 0.60 m in length and 0.56 m in width, covering an area of 0.336 m<sup>2</sup>.**
