# LIDAR Inspection Report of **Box Culvert** ch.986+180

**Bridge Chainage:** 986+180(CKRP)

# **CH: 986+180 – Box CULVERT**

**DISTRESS PHOTOS**

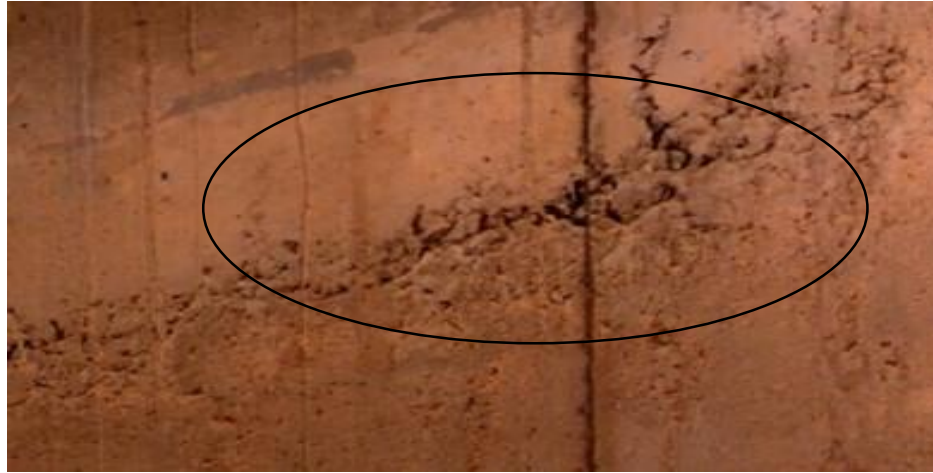
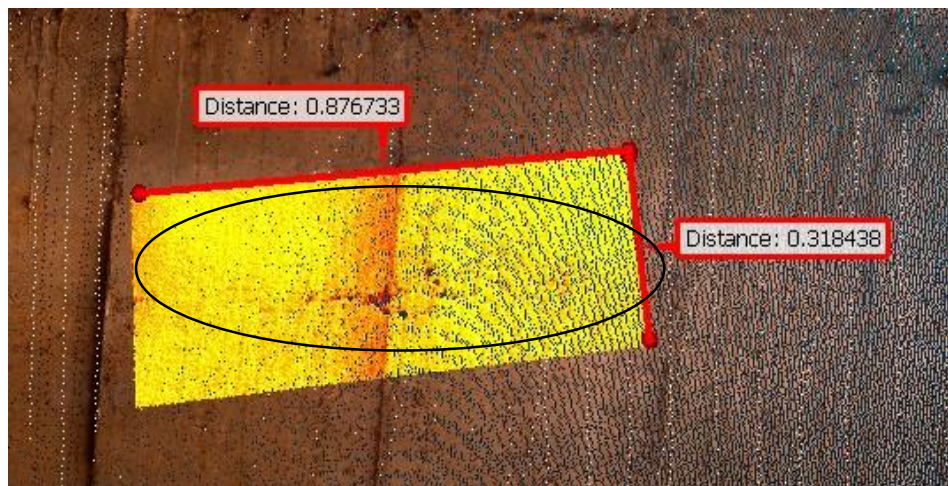
| Element Name | Observation | Location of Distress | Photo No. | Units | Distress Details | | | Area of Repair (Sq.m/R MT/m3) |
|---|---|---|---|---|---|---|---|---|
| Abutment | Honeycombing | - | 1 | M | 0.87 | 0.31 | | 0.2697 |

**1. Honeycombing on Abutment Wall , measuring 0.87 m in length and 0.31 m in width, covering an area of 0.270 m<sup>2</sup>**

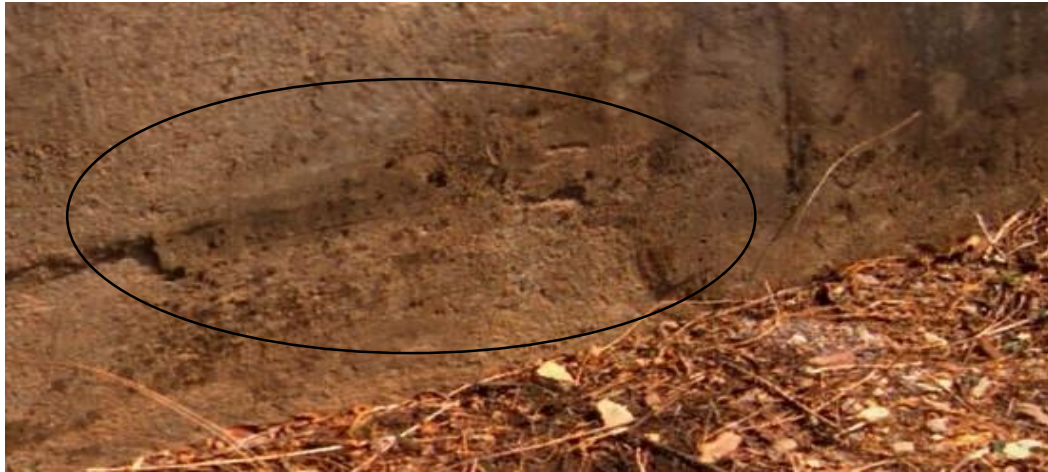
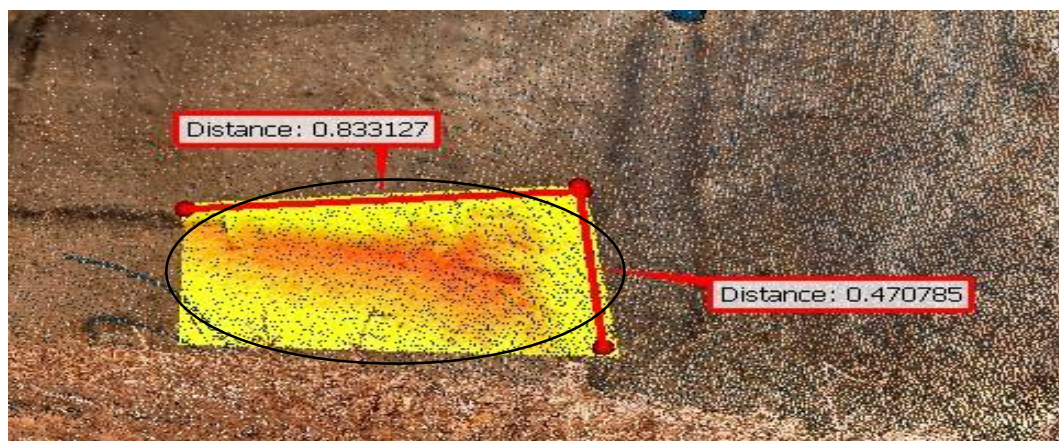
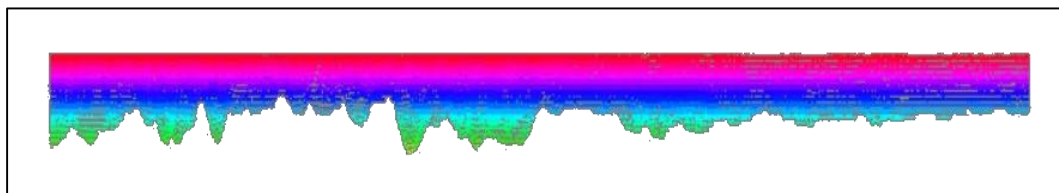
| Element Name | Observation | Location of Distress | Photo No. | Units | Distress Details | | | Area of Repair (Sq.m/R MT/m3) |
|---|---|---|---|---|---|---|---|---|
| Abutment | Scaling | - | 2 | M | 0.83 | 0.47 | | 0.3901 |

**2. Scaling observed on Abutment Wall , measuring 0.83 m in length and 0.47 m in width, covering an area of 0.390 m<sup>2</sup>**

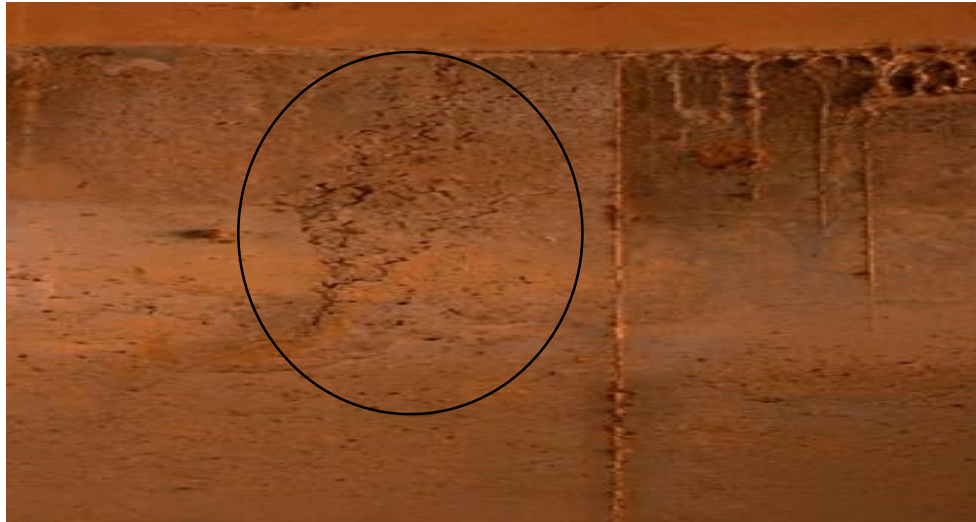
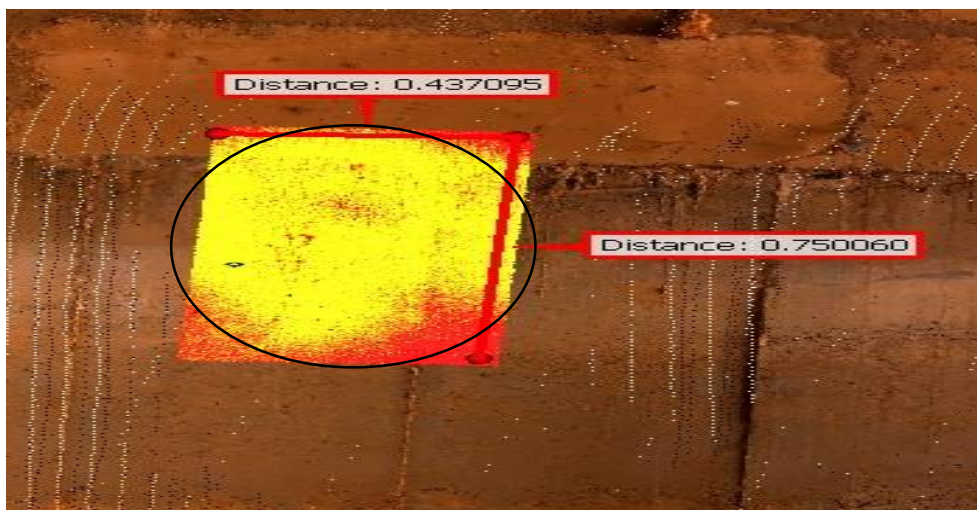
| Element Name | Observation | Location of Distress | Photo No. | Units | Distress Details | | | Area of Repair (Sq.m/R MT/m3) |
|---|---|---|---|---|---|---|---|---|
| Abutment | Scaling | | 3 | M | 0.43 | 0.75 | | 0.3225 |

**3. Scaling observed on Abutment Wall , measuring 0.43 m in length and 0.75 m in width, covering an area of 0.323 m<sup>2</sup>**
