# LIDAR Inspection Report of **Slab Culvert** ch.986+855

**Bridge Chainage:** 986+855 (CKRP)

- **Bridge No:** -
- **Chainage:** 986+855
- **Structure type:** Slab Culvert

- **CKRP:** Chittorgarh to kota
- **State:** Rajasthan NH 27
- **Zone:** RJ-06

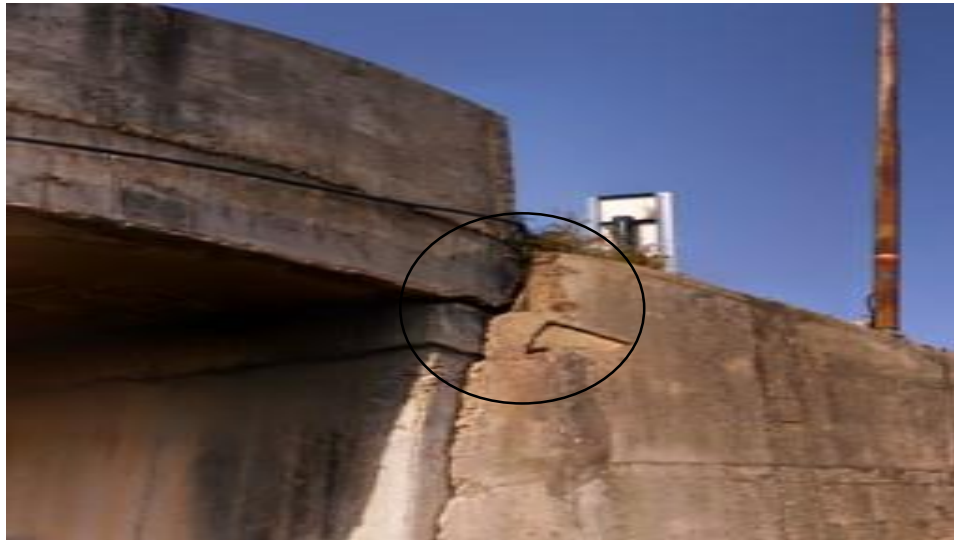
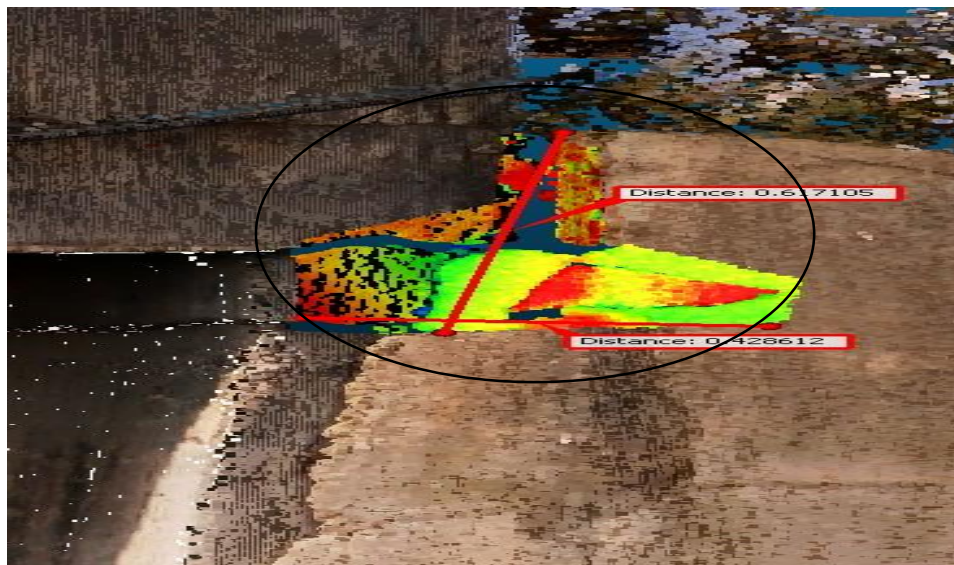
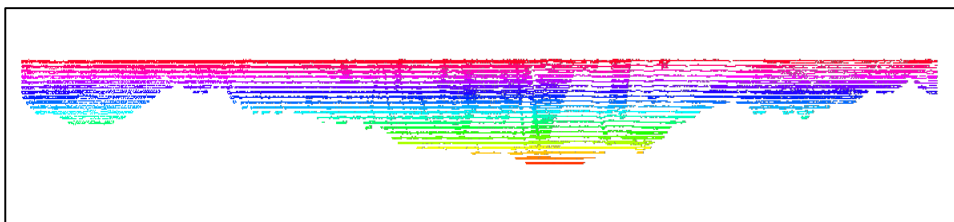
| Element Name | Observation | Location of Distress | Photo No. | Units | Distress Details | | | Area of Repair<br>(Sq.m/R<br>MT/m3) |
|---|---|---|---|---|---|---|---|---|
| Abutment Wall | Damage | - | 1 | M | 0.61 | 0.42 | - | 0.256 |

**1. Concrete damage observed on Wing Wall, measuring 0.61 m in length and 0.42 m in width, covering an area of 0.26 m<sup>2</sup>.**

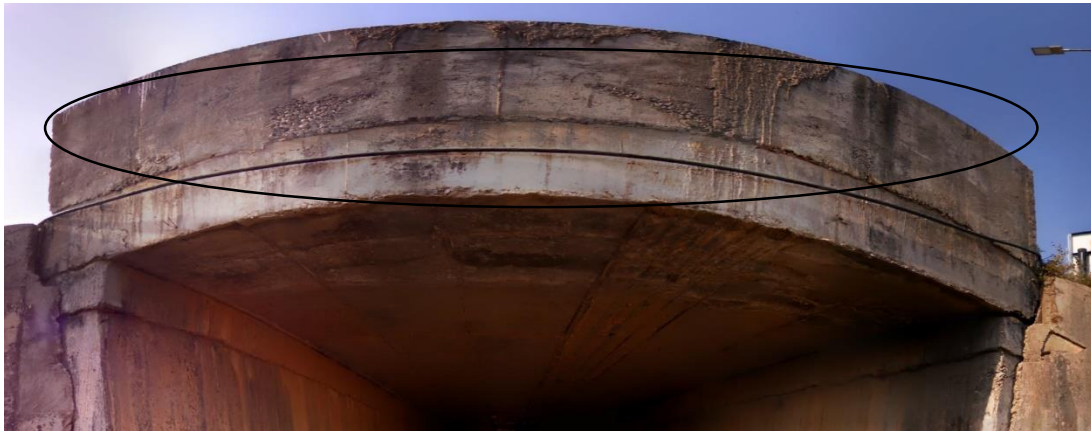
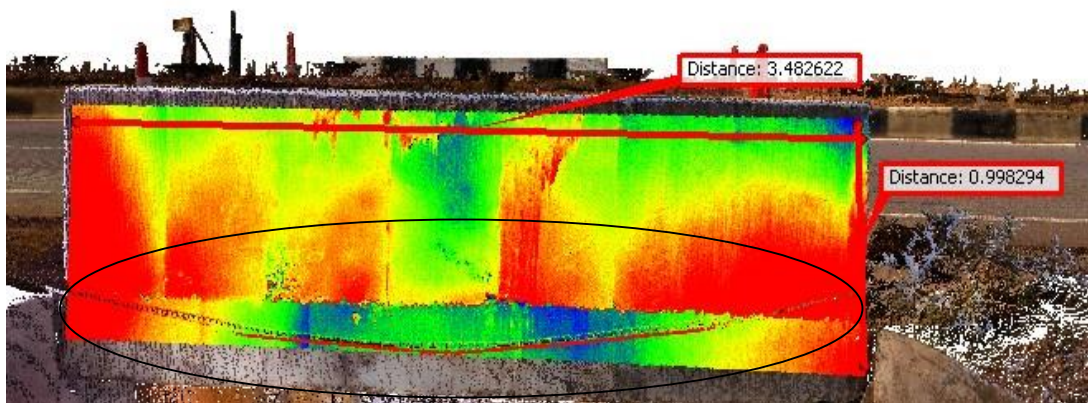
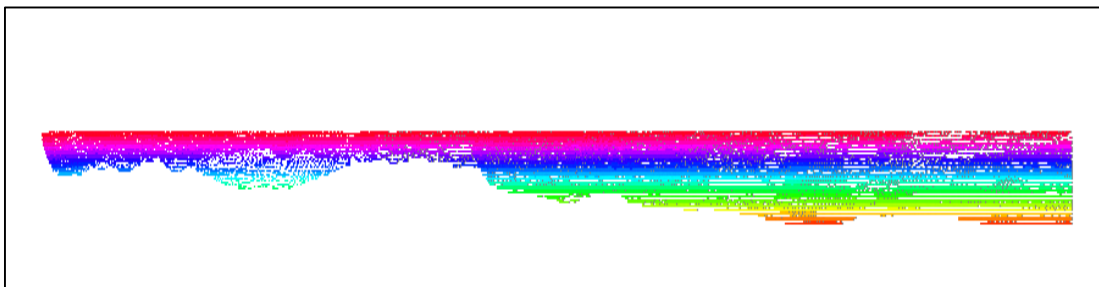
| Element Name | Observation | Location of Distress | Photo No. | Units | Distress Details | | | Area of Repair<br>(Sq.m/R<br>MT/m3) |
|---|---|---|---|---|---|---|---|---|
| Parapet Wall | Damage | - | 2 | M | 3.48 | 0.99 | - | 3.445 |

- 2. Honeycombing observed on Parapet Wall, measuring 3.48 m in length and 0.99 m in width, covering an area of 3.45 m<sup>2</sup>.**

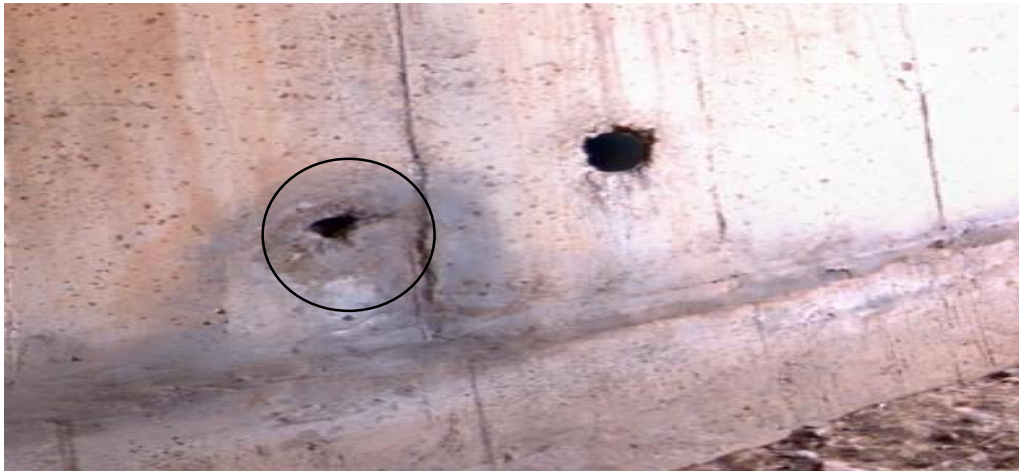
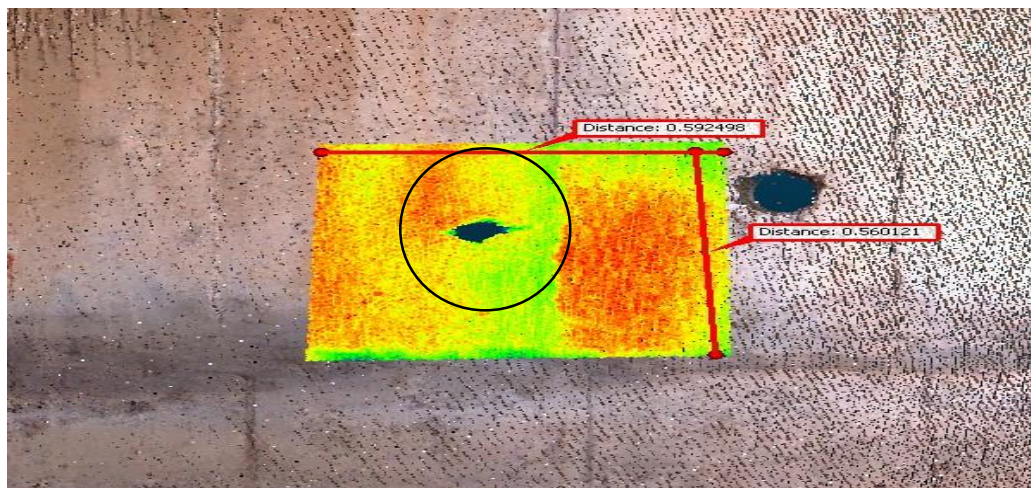
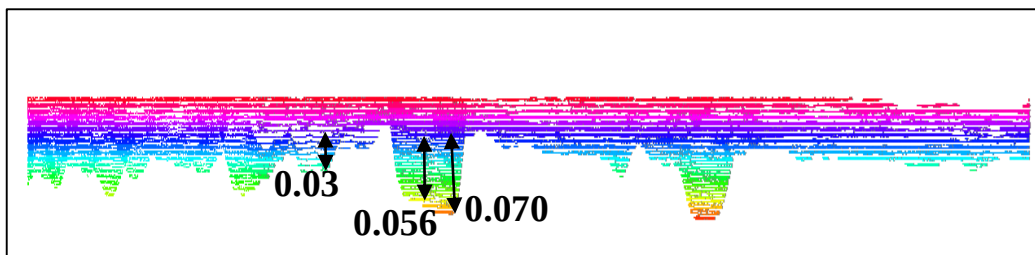
| Element Name | Observation | Location of Distress | Photo No. | Units | Distress Details | | | Area of Repair<br>(Sq.m/R<br>MT/m3) |
|---|---|---|---|---|---|---|---|---|
| Abutment Wall | Damage | - | 3 | M | 0.59 | 0.56 | 0.056 | 0.018 |

**3. Concrete damage observed on Wall, measuring 0.59 m in length and 0.56 m in width, covering an area of 0.33 m<sup>2</sup>. Depth ranges from 0.03 (min) to 0.070 m (max), with an average depth of 0.056 m. The calculated volume of the distress is 0.018 m<sup>3</sup>.**
