# **LIDAR Inspection Report of Box Culvert ch.988+455**

**Bridge Chainage:** 988+455

- **Bridge No:** -
- **Chainage:** 988+455
- **Structure type:** Box Culvert

- **CKRP:** Chittorgarh to kota
- **State:** Rajasthan NH 27
- **Zone:** RJ-20

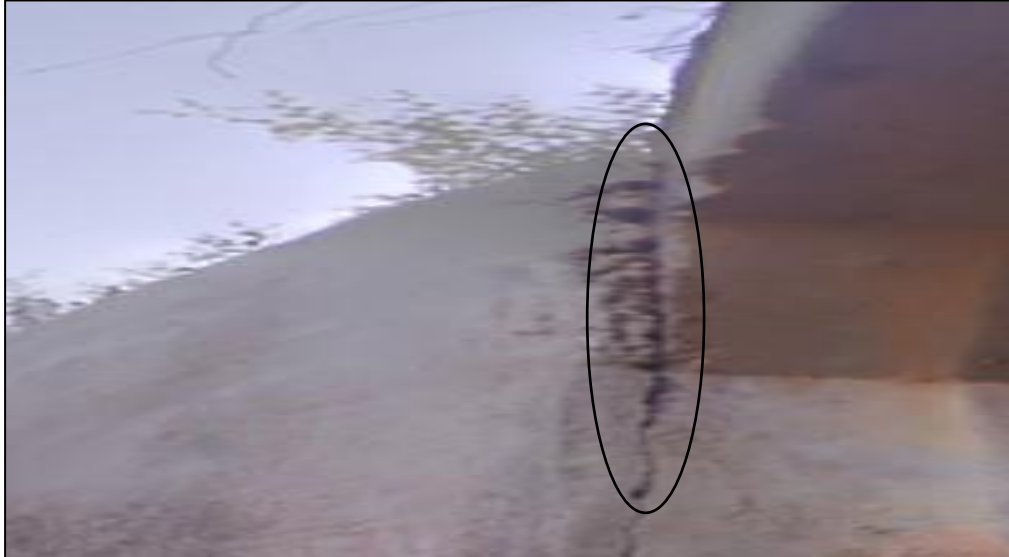
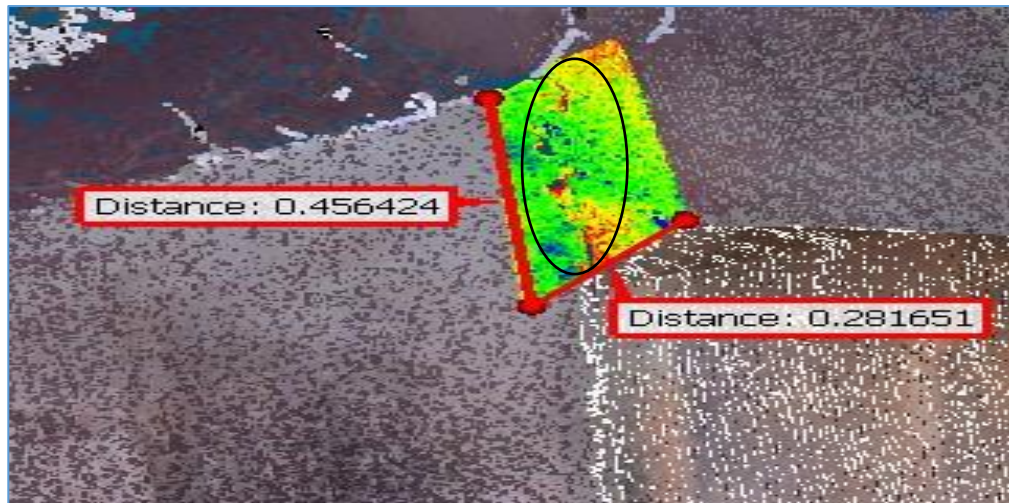
| Element Name | Observation | Location of Distress | Photo No. | Units | Distress Details | | | Area of Repair (Sq.m/ RMT/ m3) |
|---|---|---|---|---|---|---|---|---|
| Wing Wall | Damage | | 1 | Sq m | 0.45 | 0.28 | | 1.126 |

| Sl. No. | Description | Distress Notation | Observation | Location | | Distress Details | | | Area of Repair |
|---|---|---|---|---|---|---|---|---|---|
| 3 | Wing wall | | Damage | | | | | | |

1. Damage observed on A1 (RHS), measuring 0.45 m in length and 0.28 m in width, covering an area of 0.126 m<sup>2</sup>.
