# **LIDAR Inspection Report of VUP ch.988+500**

**Bridge Chainage:** 988+500 (CKRP)

- **Bridge No:** -
- **Chainage:** 988+500
- **Structure type:** VUP

- **CKRP:** Chittorgarh to kota
- **State:** Rajasthan NH 27
- **Zone:** RJ-06

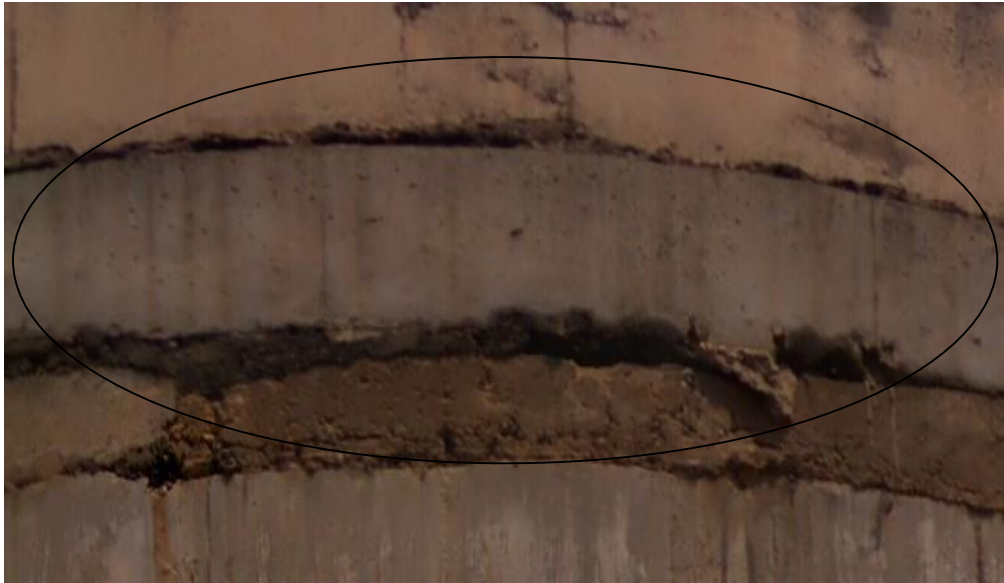
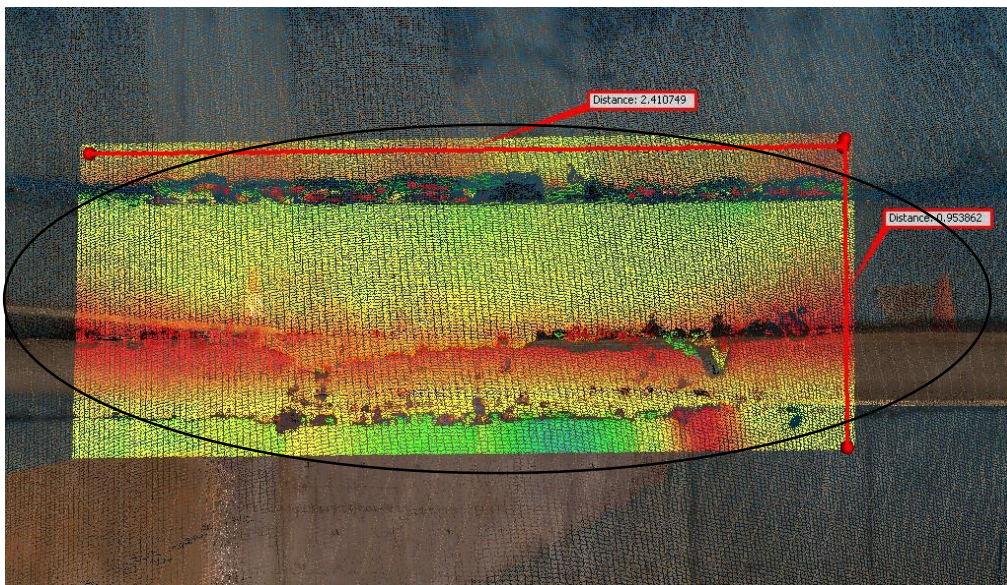
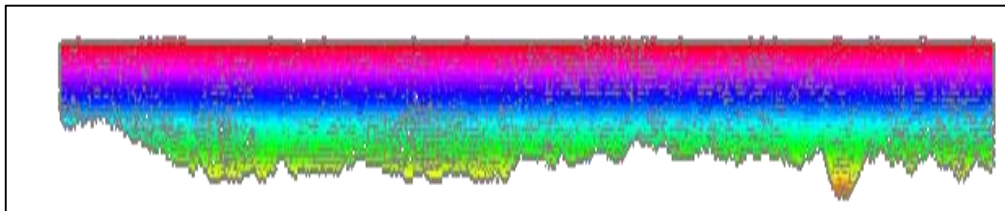
| Element Name | Observation | Location of Distress | Photo No. | Units | Distress Details | | | Area of Repair (Sq.m/R MT/m3) |
|---|---|---|---|---|---|---|---|---|
| Abutment 1 | Honeycombing | - | 1 | M | 2.41 | 0.95 | - | 2.289 |

**1. Honeycombing and damage observed on LHS A1 wing wall, measuring 2.41 m in length and 0.95 m in width, covering an area of 2.289 m<sup>2</sup>.**
