# LIDAR Inspection Report of **Box Culvert** ch.988+870

**Bridge Chainage:** 988+ 870 (CKRP)

- **CKRP:** Chittorgarh to kota
- **State:** Rajasthan NH 27
- **Zone:** RJ-06

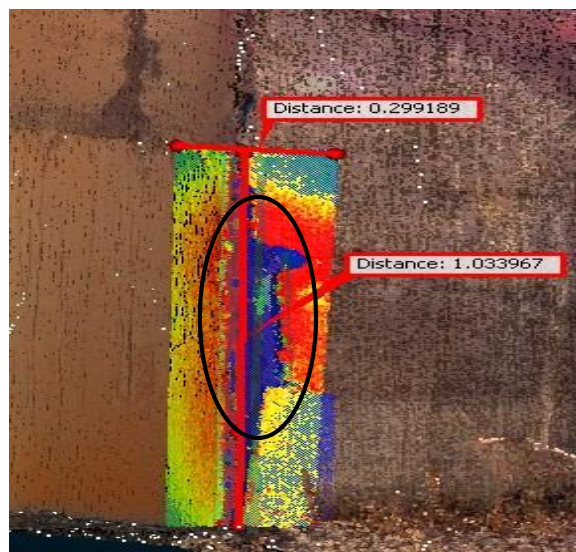
| Element Name | Observation | Location of Distress | Photo No. | Units | Distress Details | | | Area of Repair (Sq.m /RMT/ m3) |
|---|---|---|---|---|---|---|---|---|
| Abutment-1 Wing wall | Damage | - | 1 | M | 0.29 | 1.03 | | 0.298 |

**1. Wing wall damage observed on LHS Abutment 1, measuring 0.29 m in length and 1.03 m in width, covering an area of 0.298 m<sup>2</sup>.**

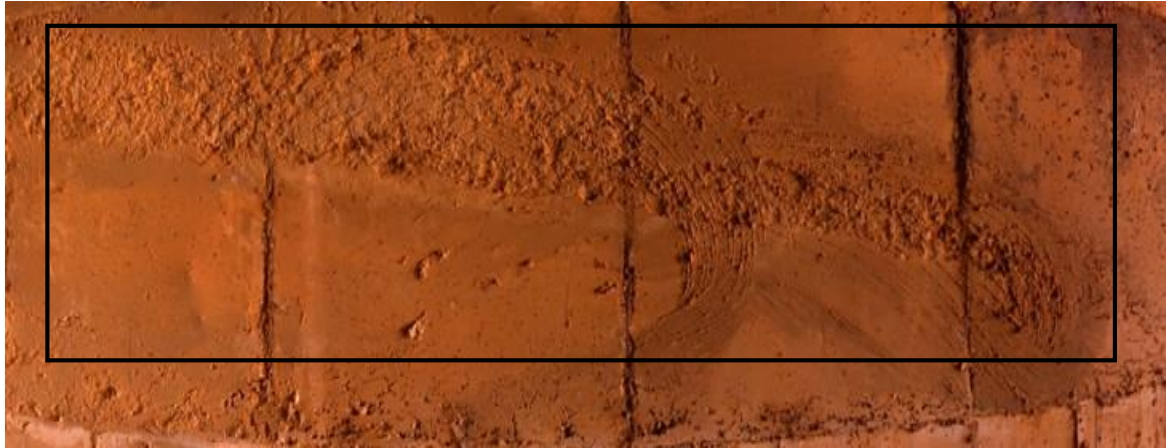
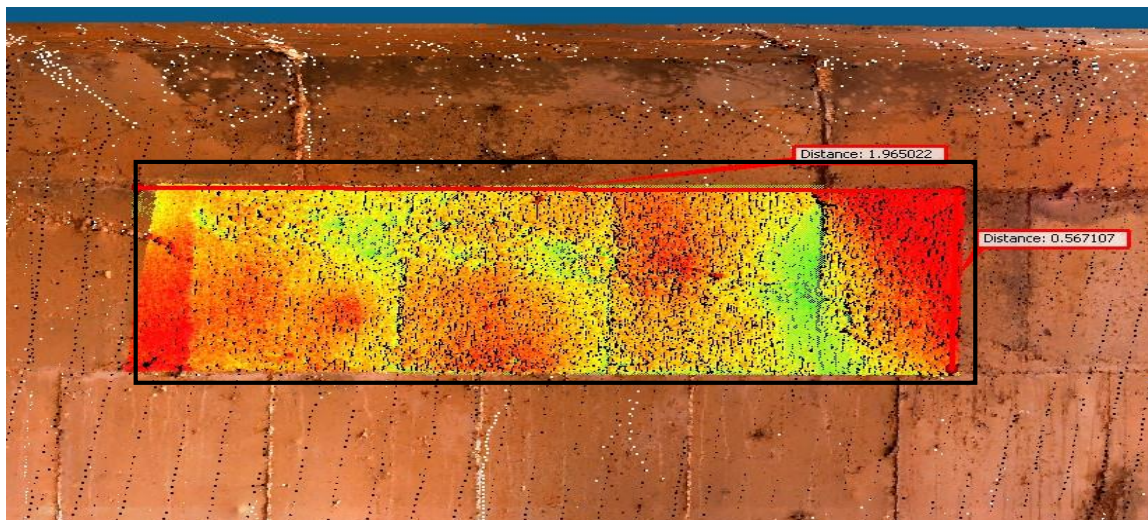
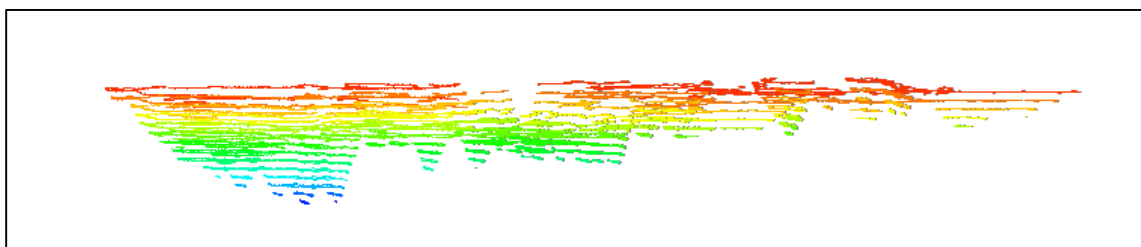
| Element Name | Observation | Location of Distress | Photo No. | Units | Distress Details | | | Area of Repair (Sq.m /RMT/ m3) |
|---|---|---|---|---|---|---|---|---|
| Abutment-1 | Honeycombing | - | 2 | M | 1.96 | 0.56 | | 1.097 |

**2. Wall damage observed on LHS, measuring 1.96 m in length and 0.56 m in width, covering an area of 1.097 m<sup>2</sup>.**
