# **LIDAR Inspection Report of Slab Culvert ch.989+730**

**Bridge Chainage:** 989+730 (CKRP)

- **Bridge No:** -
- **Chainage:** 989+730
- **Structure type:** Slab Culvert

- **CKRP:** Chittorgarh to kota
- **State:** Rajasthan NH 27
- **Zone:** RJ-06

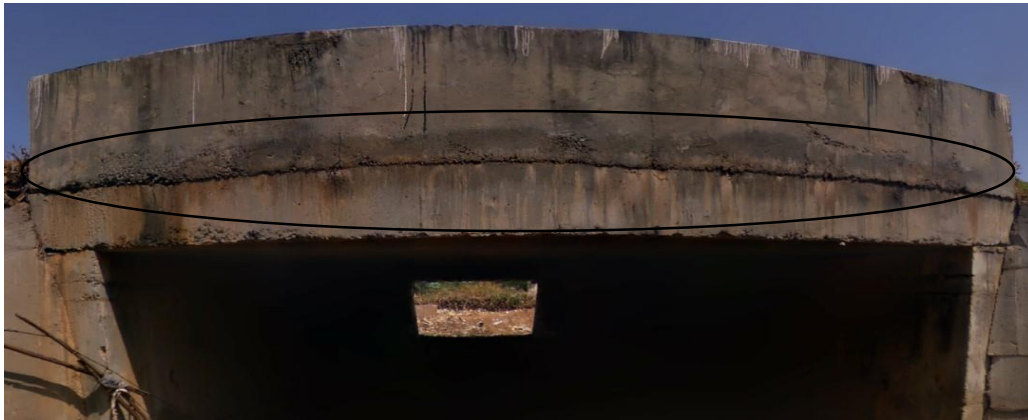
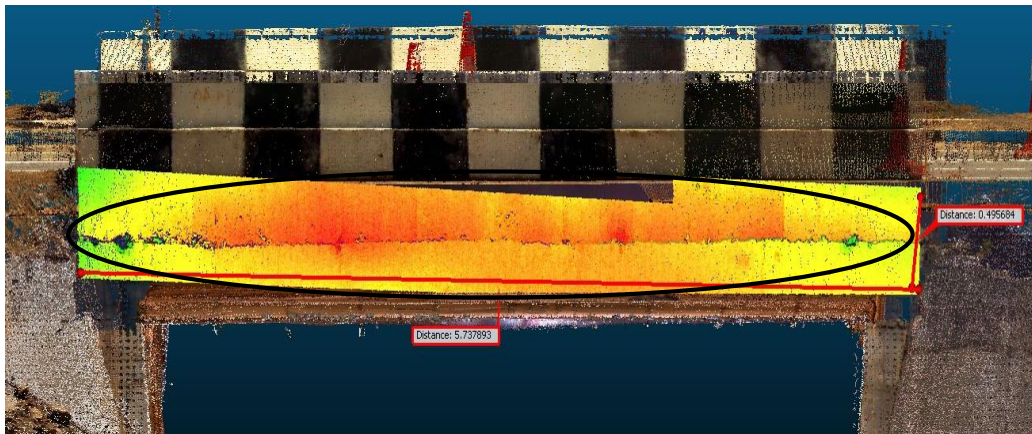
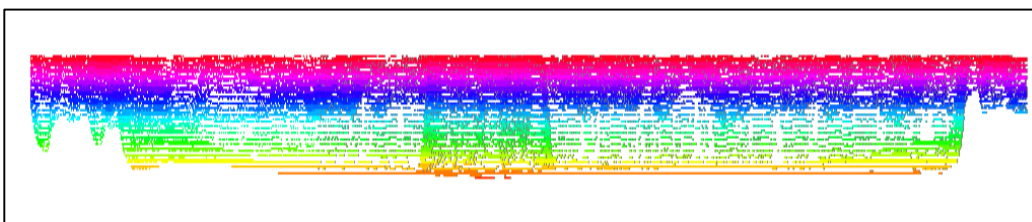
| Element Name | Observation | Location of Distress | Photo No. | Units | Distress Details | | | Area of Repair<br>(Sq.m/R MT/m3) |
|---|---|---|---|---|---|---|---|---|
| Parapet Wall | Honeycombing | - | 1 | M | 5.73 | 0.49 | - | 2.807 |

**1.Honeycombing observed on LHS Parapet Wall, measuring 5.73 m in length and 0.49 m in width, covering an area of 2.81 m<sup>2</sup>.**

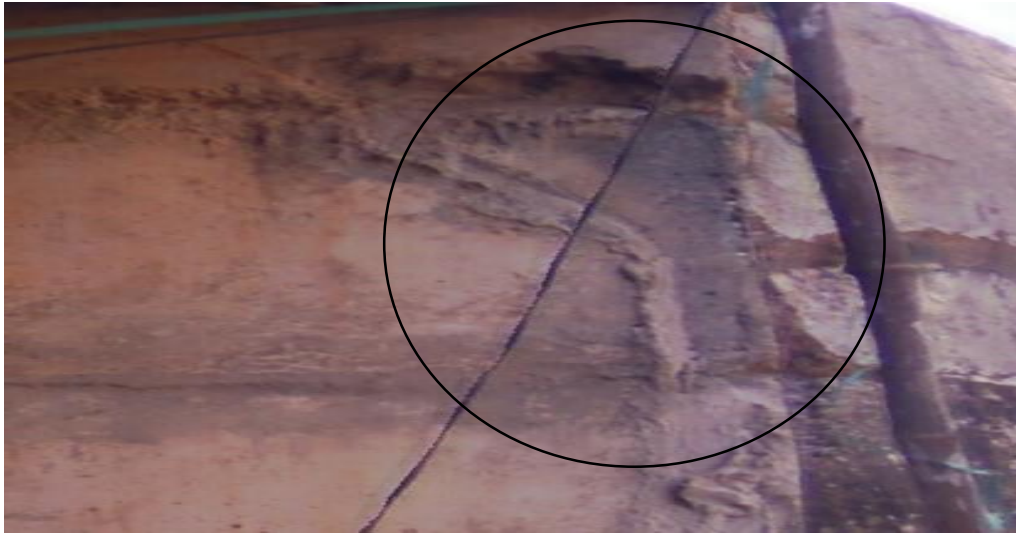
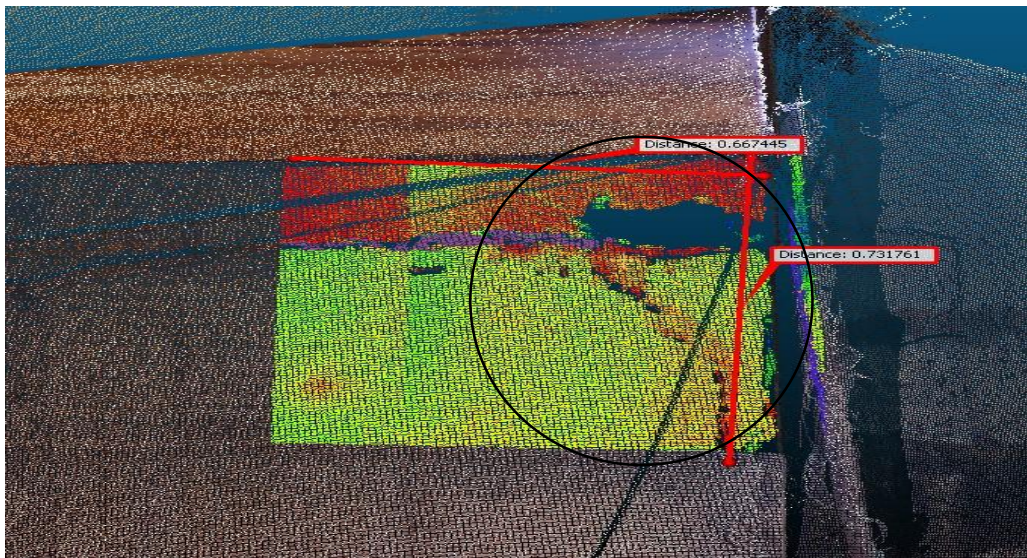
| Element Name | Observation | Location of Distress | Photo No. | Units | Distress Details | | | Area of Repair<br>(Sq.m/R MT/m3) |
|---|---|---|---|---|---|---|---|---|
| Abutment 1 | Damage | - | 2 | M | 0.66 | 0.73 | - | 0.481 |

| Sl. No. | Description | Distress Notation | Observation | Location | | Distress Details | | | Area of Repair |
|---|---|---|---|---|---|---|---|---|---|
| 3 | Wing wall | | Damage (RHS) | | | | | | |

**2. Concrete damage observed on A1 RHS Wing Wall, measuring 0.66 m in length and 0.73 m in width, covering an area of 0.48 m<sup>2</sup>.**
