# LIDAR Inspection Report of **Box Culvert** ch.990+520

**Bridge Chainage:** 990+ 520 (CKRP)

- **Bridge No:** -
- **Chainage:** 990+ 520
- **Structure type:** Box Culvert

- **CKRP:** Chittorgarh to kota
- **State:** Rajasthan NH 27
- **Zone:** RJ-06

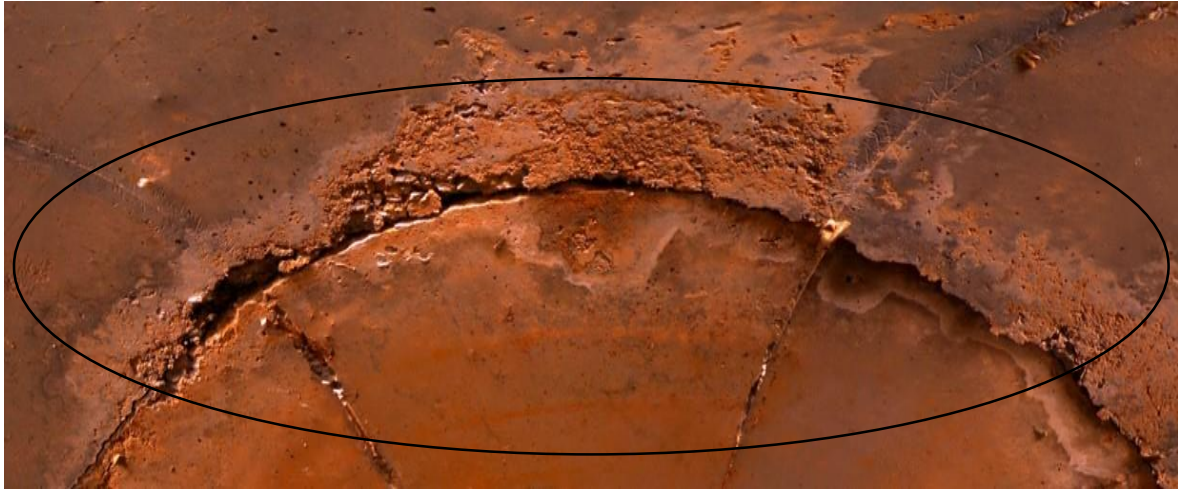
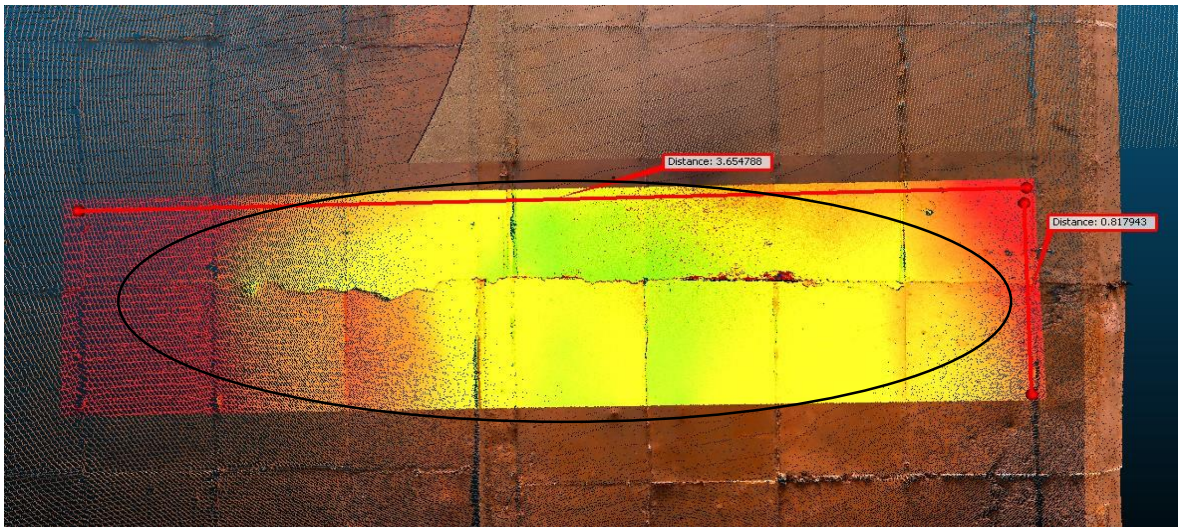
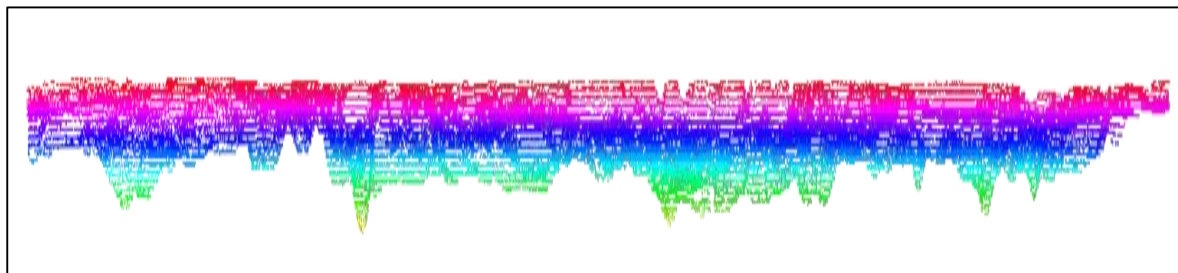
| Element Name | Observation | Location of Distress | Photo No. | Units | Distress Details | | | Area of Repair (Sq.m/R MT/m3) |
|---|---|---|---|---|---|---|---|---|
| Deck slab | Honeycombing | - | 1 | M | 3.65 | 0.81 | - | 2.956 |

**1. Honeycombing observed on top slab, measuring 3.65 m in length and 0.81 m in width, covering an area of 2.956 m<sup>2</sup>.**
