# **LIDAR Inspection Report of Slab Culvert ch.991+880**

**Bridge Chainage:** 991+880 (CKRP)

- **Bridge No:** -
- **Chainage:** 991+880
- **Structure type:** Slab Culvert

- **CKRP:** Chittorgarh to kota
- **State:** Rajasthan NH 27
- **Zone:** RJ-06

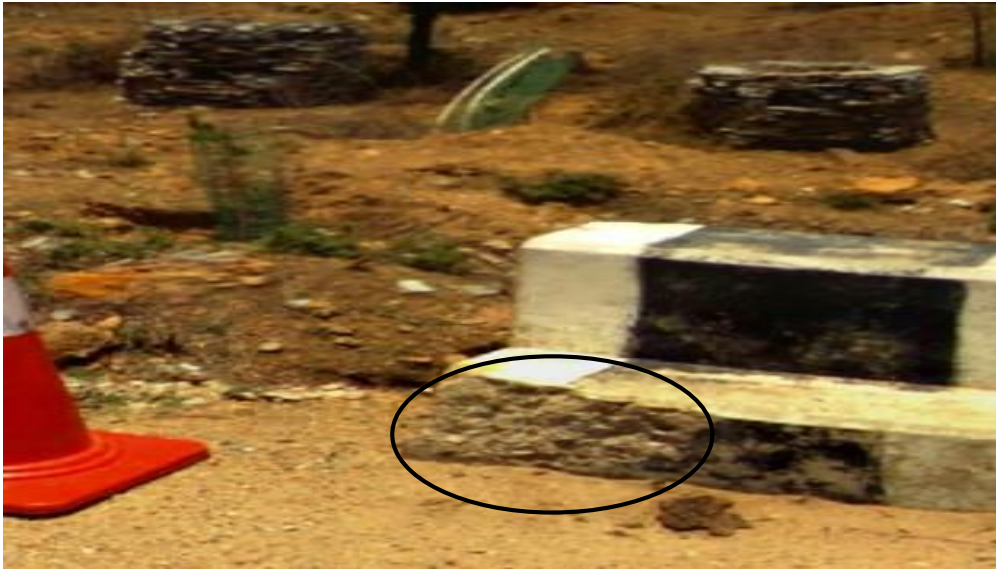
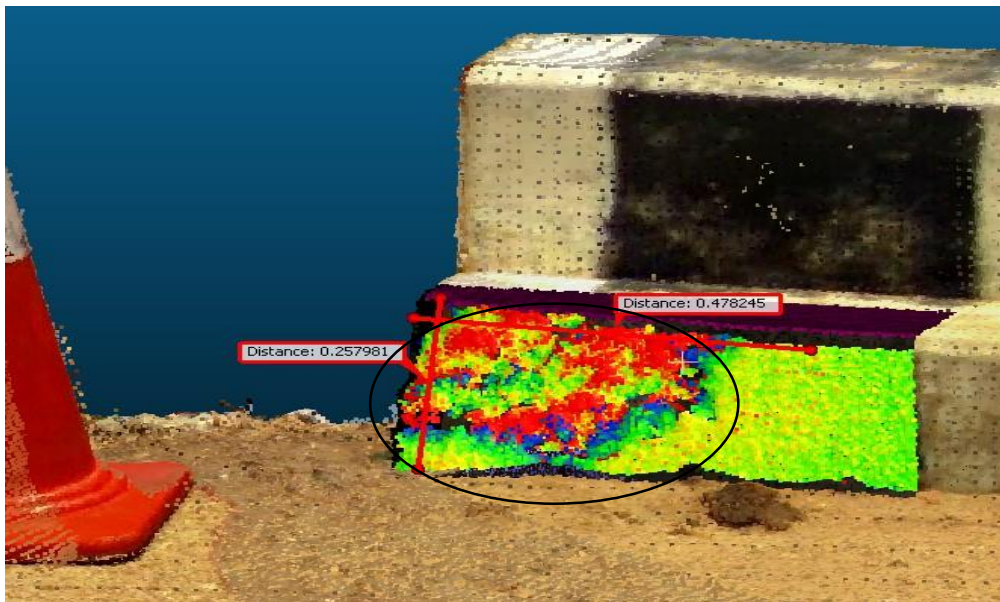
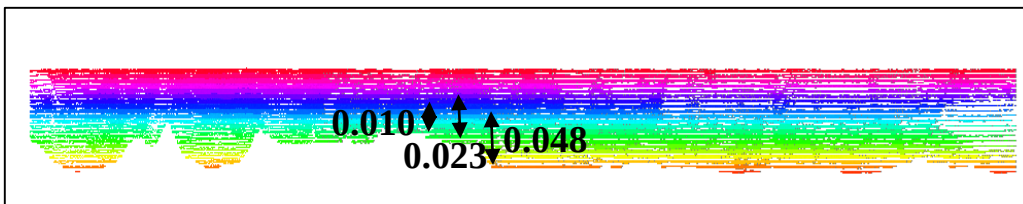
| Element Name | Observation | Location of Distress | Photo No. | Units | Distress Details | | | Area of Repair (Sq.m/R MT/m3) |
|---|---|---|---|---|---|---|---|---|
| Parapet Wall | Damage | - | 1 | M | 0.47 | 0.25 | 0.023 | 0.0027 |

**1. LHS parapet wall damage observed, measuring 0.47 m in length and 0.25 m in width. Depth ranges from 0.010(min) to 0.048 m (max), with an average depth of 0.023m. The calculated volume of the distress is 0.0027m<sup>3</sup>.**

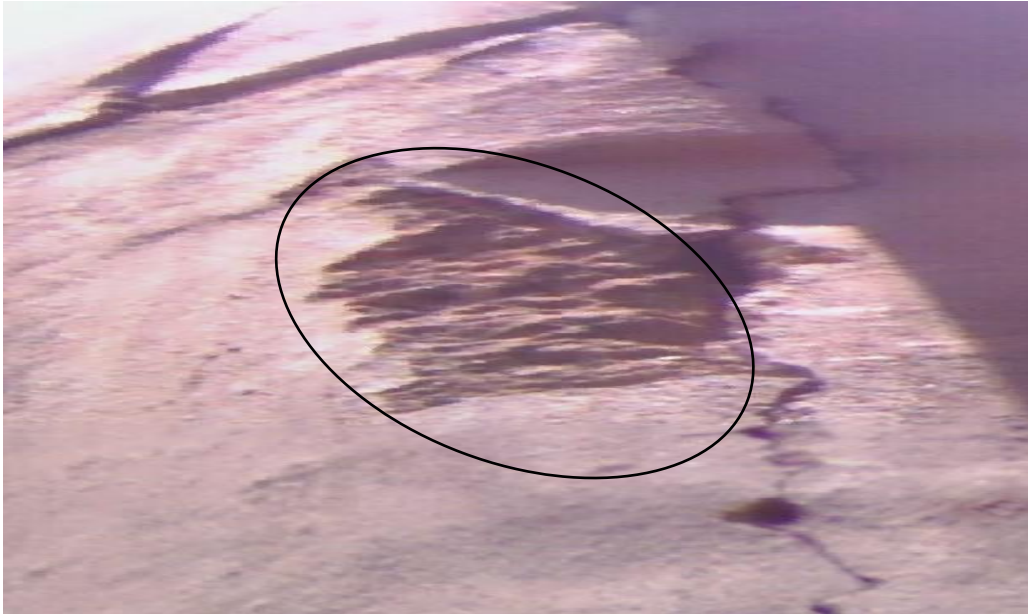
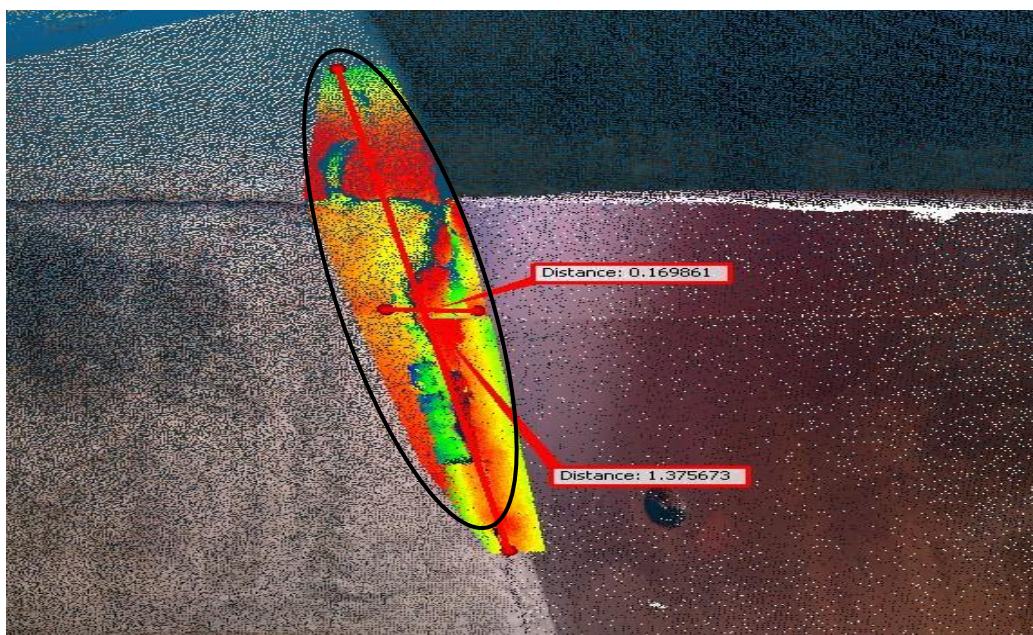
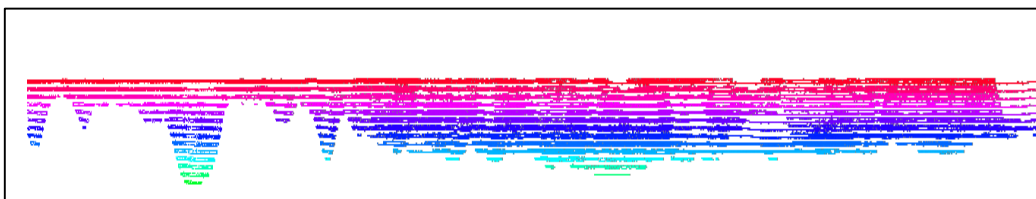
| Element Name | Observation | Location of Distress | Photo No. | Units | Distress Details | | | Area of Repair (Sq.m/R MT/m3) |
|---|---|---|---|---|---|---|---|---|
| Abutment 1 | Damage | - | 2 | M | 1.37 | 0.16 | - | 0.219 |

**2.Damage observed on A1 RHS wing wall, measuring 1.37 m in length and 0.16 m in width, covering an area of 0.219 m<sup>2</sup>.**
