# LIDAR Inspection Report of **Box Culvert** ch.992+510

**Bridge Chainage:** 992+ 510 (CKRP)

# **CH: 992+510 – Box CULVERT**

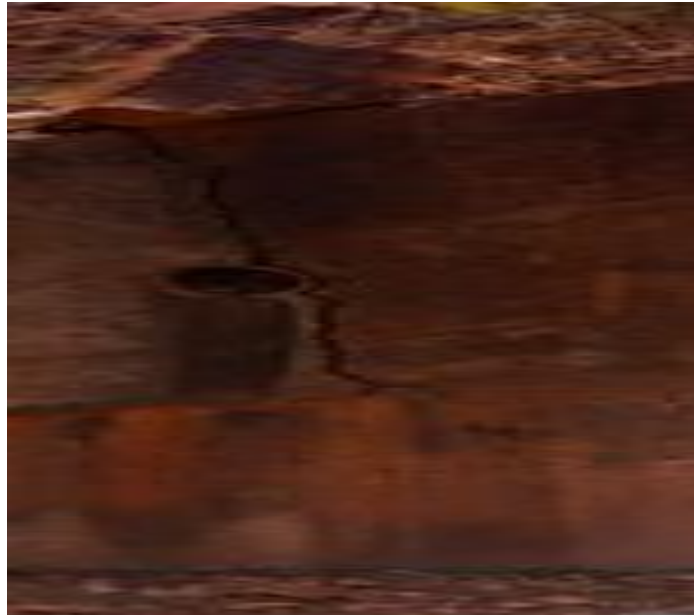
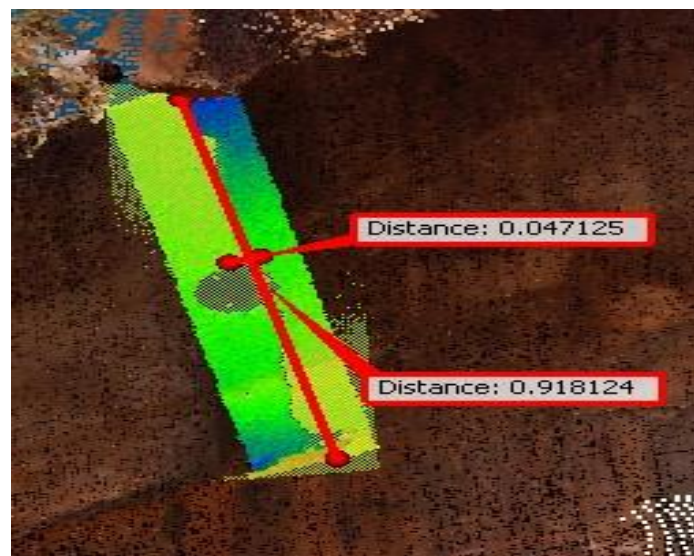
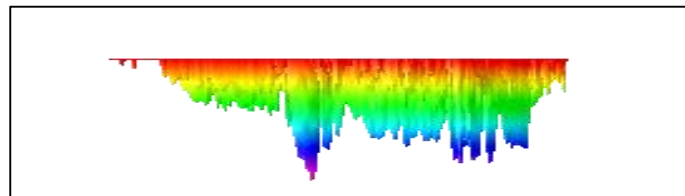
| Element Name | Observation | Location of Distress | Photo No. | Units | Distress Details | | | Area of Repair (Sq.m/R MT/m3) |
|---|---|---|---|---|---|---|---|---|
| Wing Wall | Damage | - | 1 | M | 0.91 | 0.04 | | 0.036 |

| Sl. No. | Description | Distress Notation | Observation | Location | | Distress Details | | | Area of Repair |
|---|---|---|---|---|---|---|---|---|---|
| 3 | Wing wall | | Damage | | | | | | |

**1. Wing wall damage observed on LHS, measuring 0.91 m in length and 0.04 m in width, covering an area of 0.036 m<sup>2</sup>.**
