# **LIDAR Inspection Report of Slab Culvert ch.993+970**

**Bridge Chainage:** 993+970(CKRP)

- **Bridge No:** -
- **Chainage:** 993+970
- **Structure type:** Slab Culvert

- **CKRP:** Chittorgarh to kota
- **State:** Rajasthan NH 27
- **Zone:** RJ-06

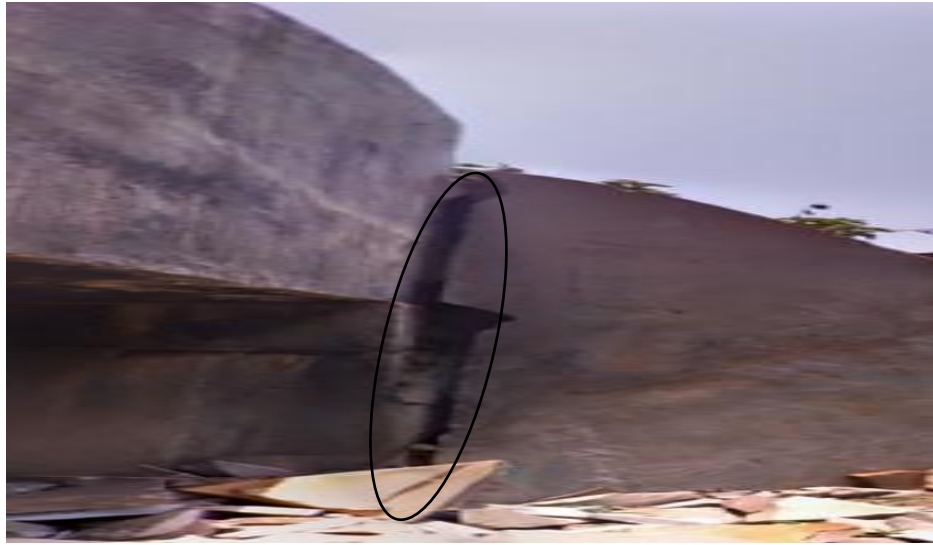
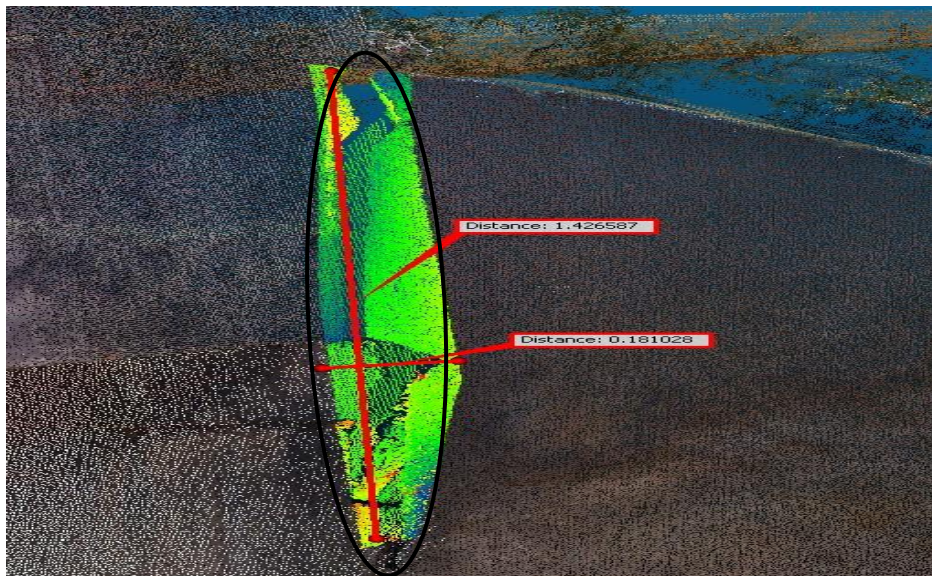
| Element Name | Observation | Location of Distress | Photo No. | Units | Distress Details | | | Area of Repair<br>(Sq.m/R<br>MT/m3) |
|---|---|---|---|---|---|---|---|---|
| Abutment Wall | Damage | | 1 | | 0.18 | 1.42 | | 0.255 |

| Sl. No. | Description | Distress Notation | Observation | Location | | Distress Details | | | Area of Repair |
|---|---|---|---|---|---|---|---|---|---|
| 3 | Wing wall | | Damage(LHS) | | | | | | |

**1.Damage observed on A1 LHS wing wall, measuring 0.18 m in length and 1.42 m in width, covering an area of 0.255 m<sup>2</sup>.**
