# **LIDAR Inspection Report of VUP ch.994+520**

**Bridge Chainage:** 994+520 (CKRP)

**Latitude/Longitude:** 25.119241/75.265783

- **CKRP:** Chittorgarh to kota
- **State:** Rajasthan NH 27
- **Zone:** RJ-06

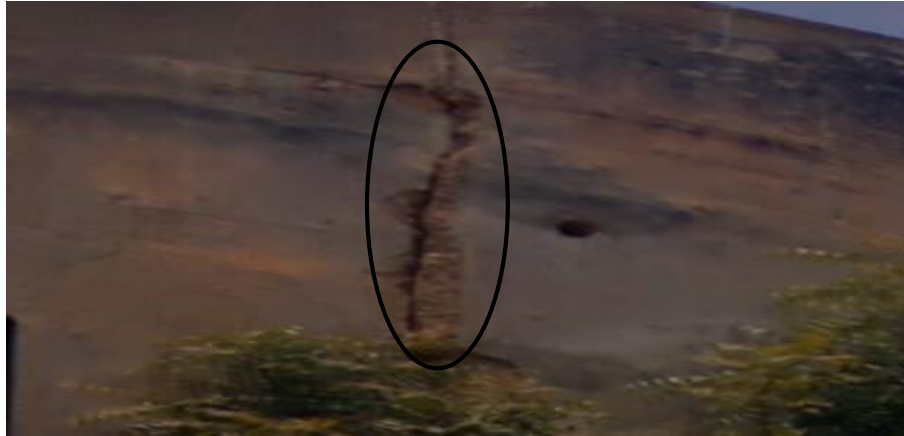
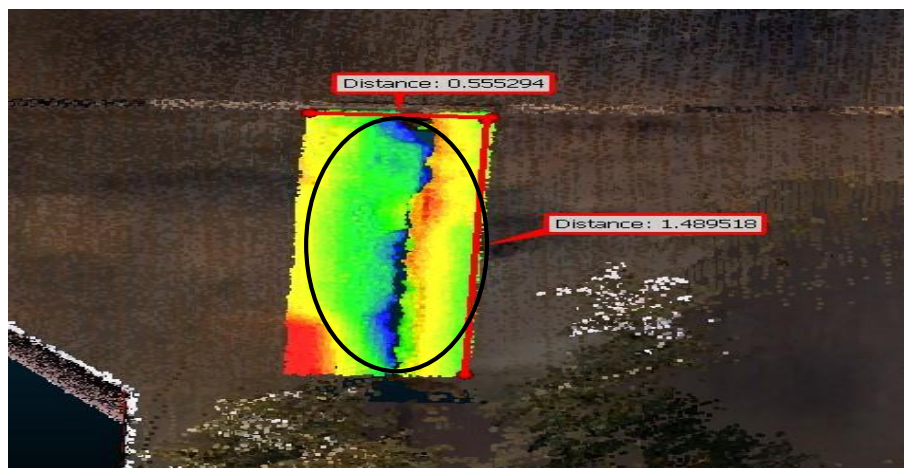
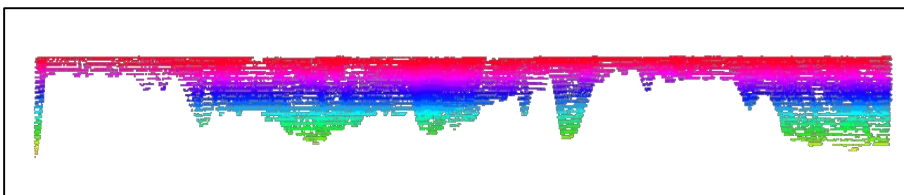
| Element Name | Observation | Location of Distress | Photo No. | Units | Distress Details | | | Area of Repair (Sq.m/ RMT/ m3) |
|---|---|---|---|---|---|---|---|---|
| Abutment 1 | Damage | - | 1 | M | 0.55 | 1.48 | | 0.814 |

**1. Wall damage observed on Abutment 1, measuring 0.55 m in length and 1.48 m in width, covering an area of 0.814 m<sup>2</sup>.**

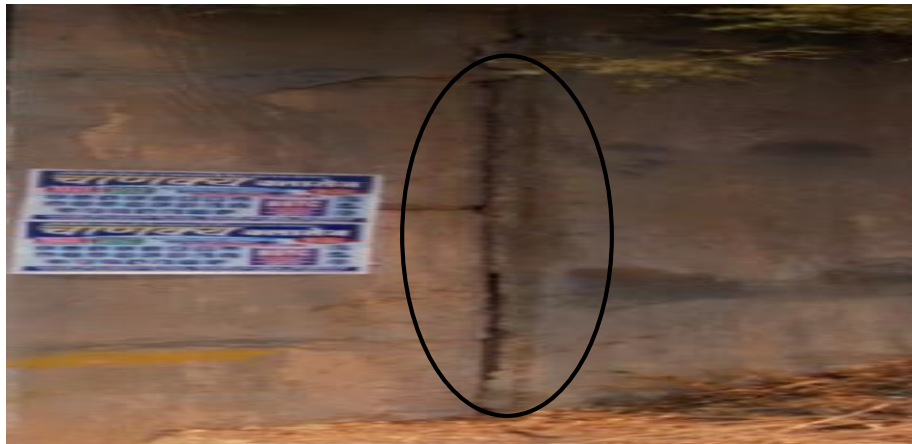
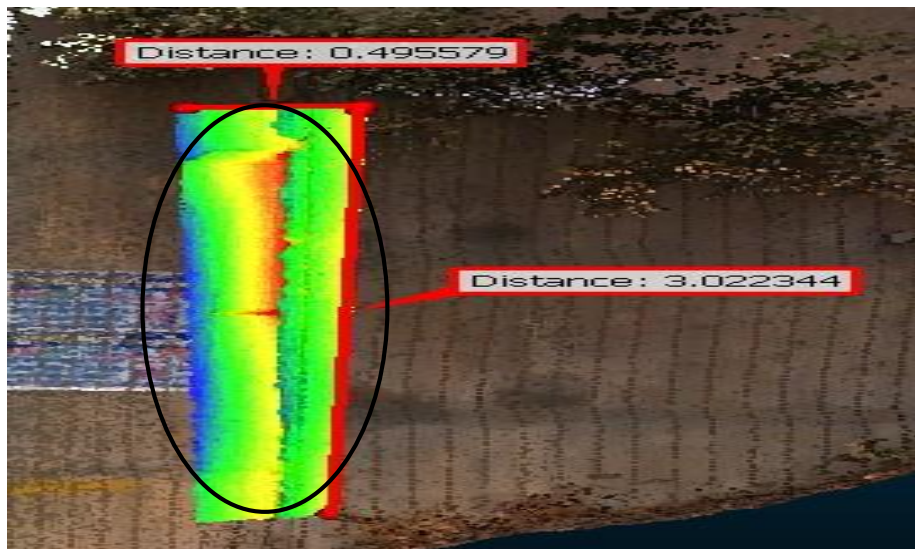
| Element Name | Observation | Location of Distress | Photo No. | Units | Distress Details | | | Area of Repair (Sq.m/ RMT/ m3) |
|---|---|---|---|---|---|---|---|---|
| Abutment 1 | Crack | - | 2 | M | 0.49 | 3.02 | | 1.47 |

**2. Crack observed on Abutment 1 wall, measuring 0.49 m in length and 3.02 m in width, covering an area of 1.47 m<sup>2</sup>.**

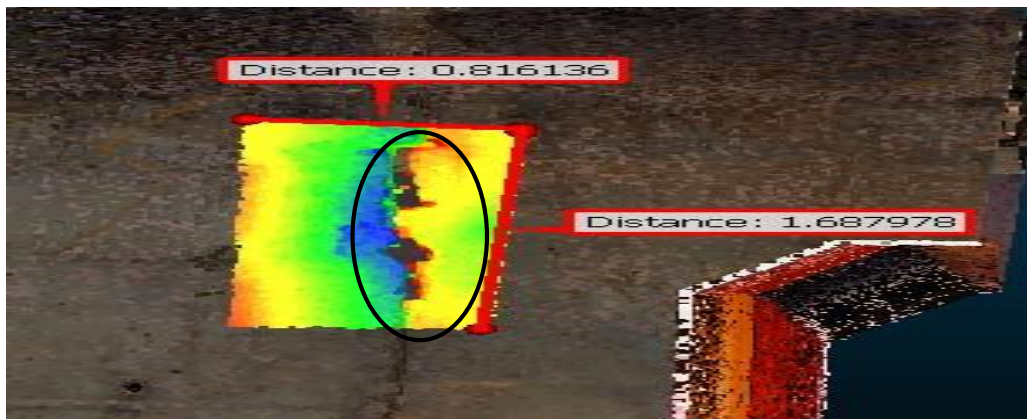
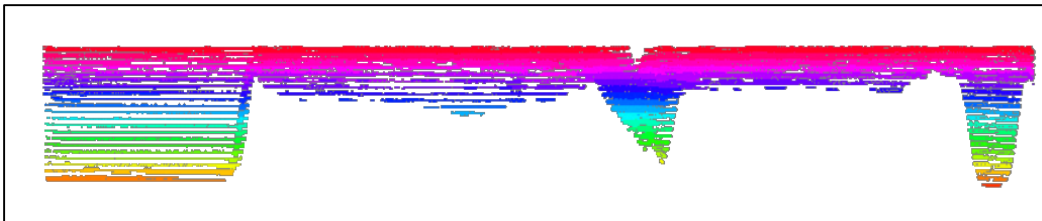
| Element Name | Observation | Location of Distress | Photo No. | Units | Distress Details | | | Area of Repair (Sq.m/ RMT/ m3) |
|---|---|---|---|---|---|---|---|---|
| Abutment 2 | Damage | | 3 | M | 0.81 | 1.68 | | 1.36 |

**3. Wall damage observed on Abutment 2, measuring 0.81 m in length and 1.68 m in width, covering an area of 1.36 m<sup>2</sup>.**

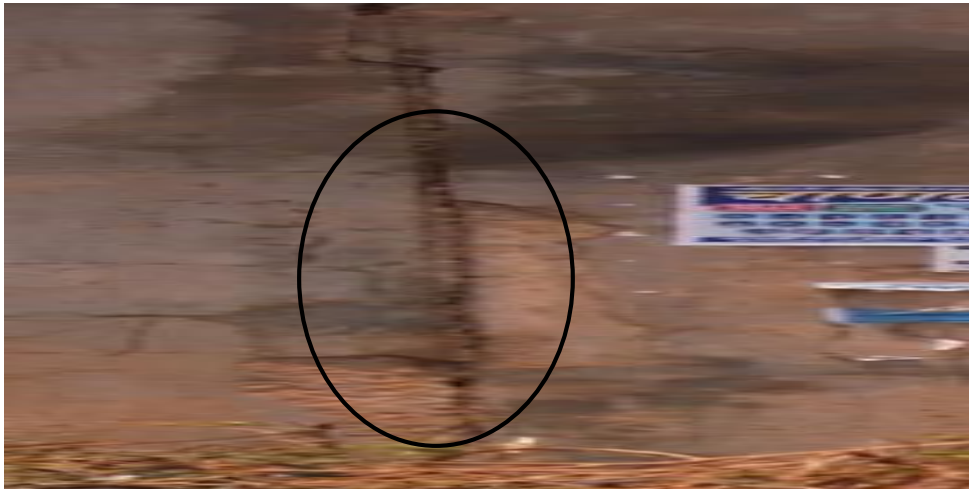
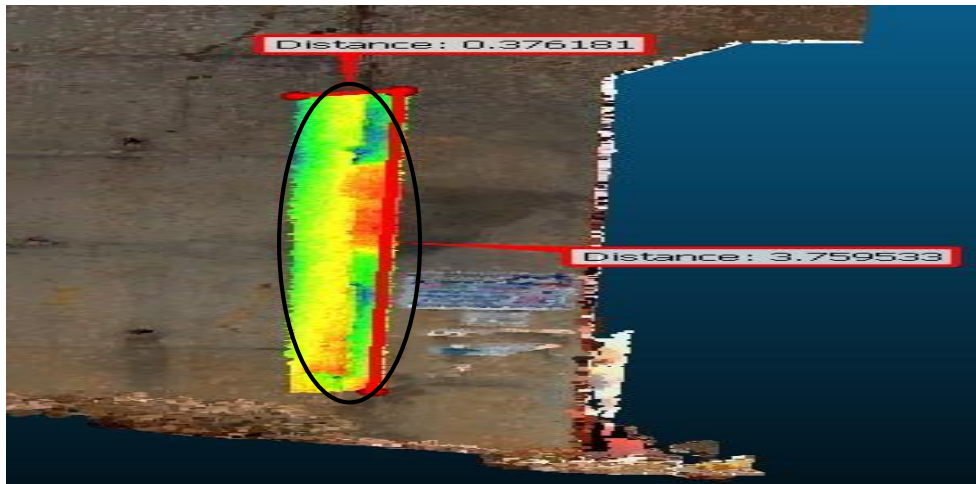
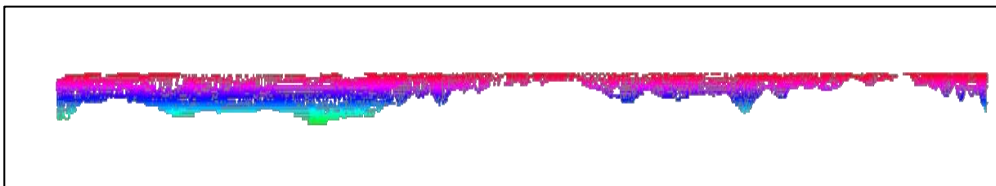
| Element Name | Observation | Location of Distress | Photo No. | Units | Distress Details | | | Area of Repair (Sq.m/ RMT/ m3) |
|---|---|---|---|---|---|---|---|---|
| Abutment 2 | Crack | | 4 | M | 0.37 | 3.75 | | 1.38 |

**4. Crack observed on Abutment 2 wall, measuring 0.37 m in length and 3.75 m in width, covering an area of 1.38 m<sup>2</sup>.**

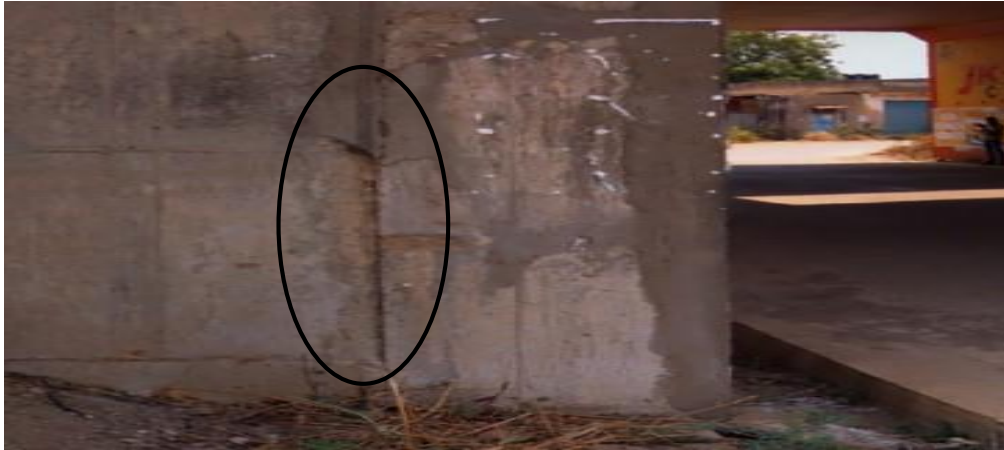
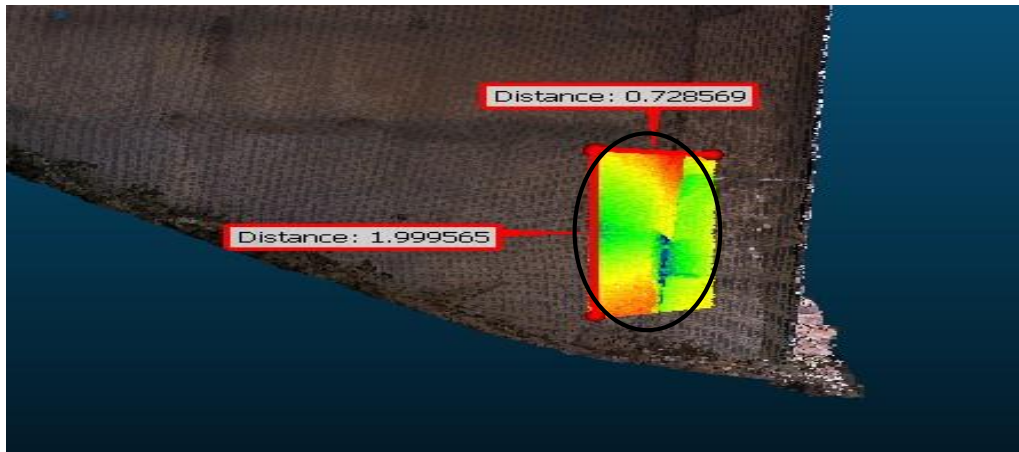
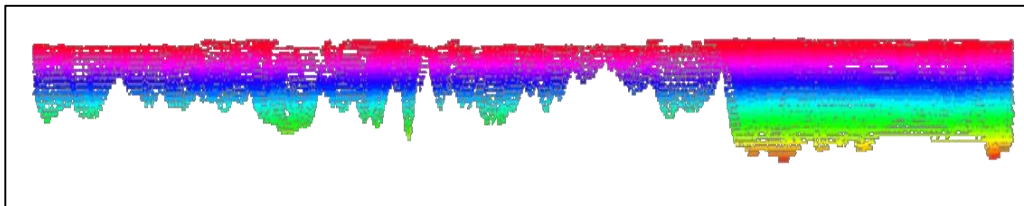
| Element Name | Observation | Location of Distress | Photo No. | Units | Distress Details | | | Area of Repair (Sq.m/ RMT/ m3) |
|---|---|---|---|---|---|---|---|---|
| Abutment 1 | Scaling | - | 5 | M | 0.72 | 1.99 | | 1.43 |

**5. Scaling observed on Abutment 1 wall, measuring 0.72 m in length and 1.99 m in width, covering an area of 1.43 m<sup>2</sup>.**

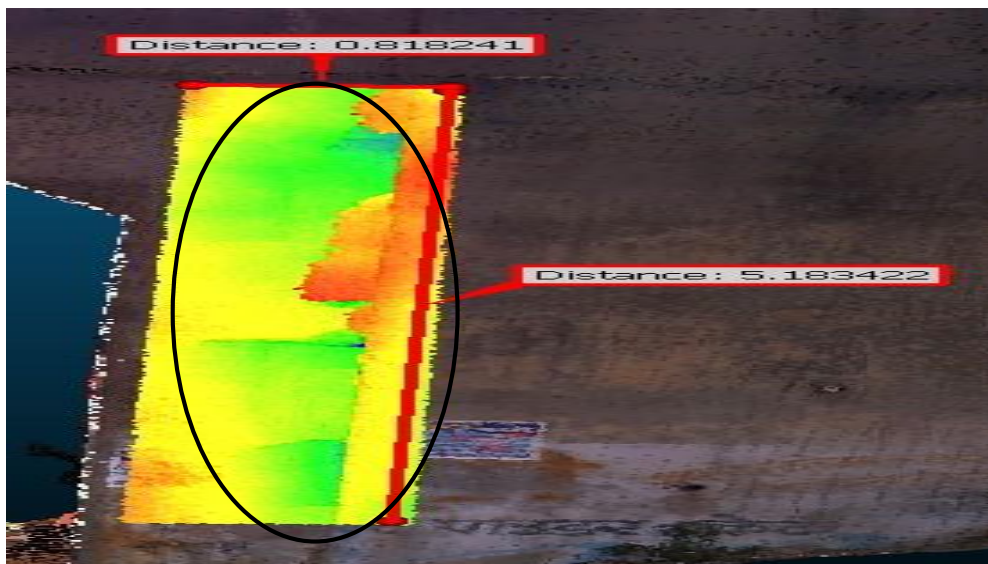
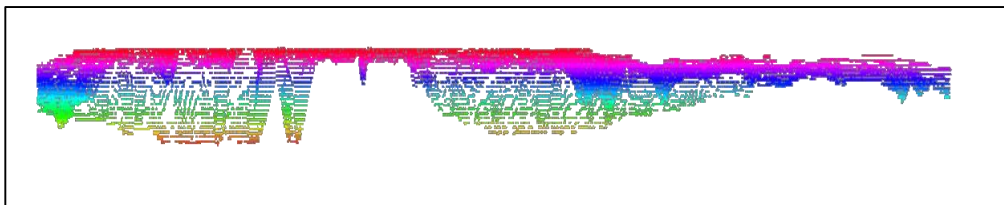
| Element Name | Observation | Location of Distress | Photo No. | Units | Distress Details | | | Area of Repair (Sq.m/ RMT/ m3) |
|---|---|---|---|---|---|---|---|---|
| Abutment 2 | Damage | | 6 | M | 0.81 | 5.18 | | 4.15 |

**6. Wall damage observed on Abutment 2, measuring 0.81 m in length and 5.18 m in width, covering an area of 4.19 m<sup>2</sup>.**

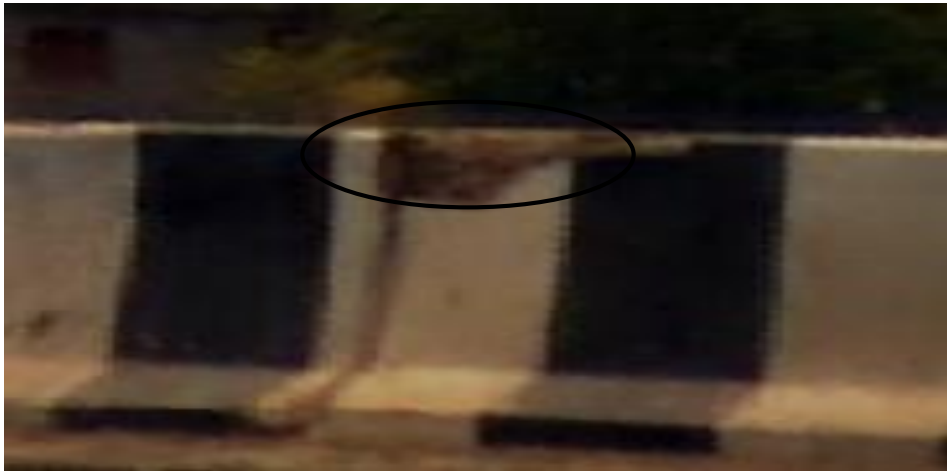
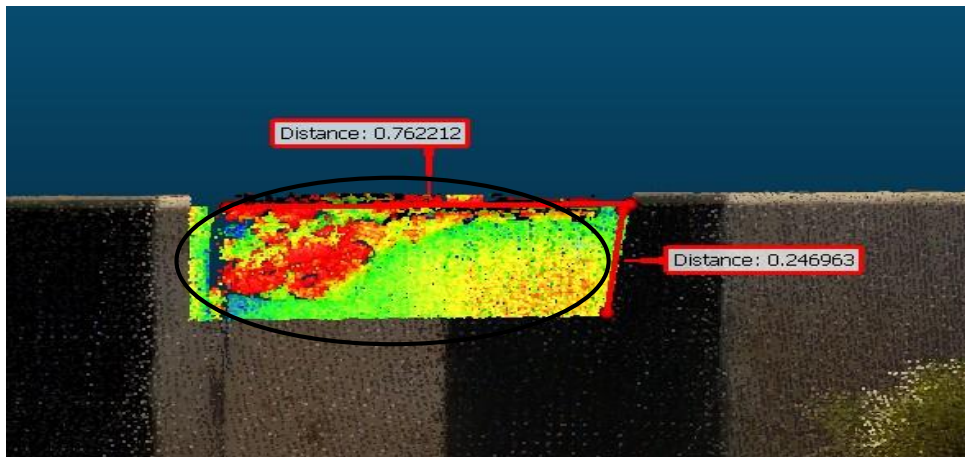
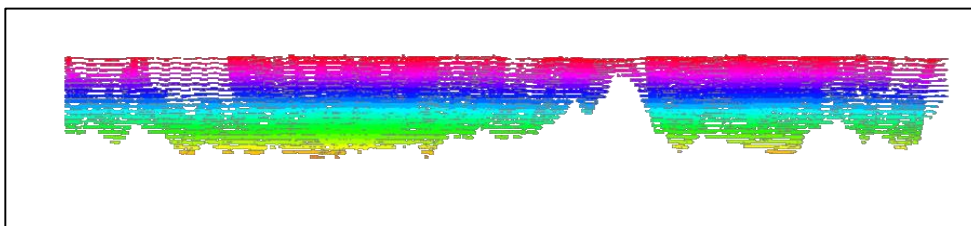
| Element Name | Observation | Location of Distress | Photo No. | Units | Distress Details | | | Area of Repair (Sq.m/ RMT/ m3) |
|---|---|---|---|---|---|---|---|---|
| Abutment 1 Side Barrier | Damage | | 7 | M | 0.76 | 0.24 | | 0.1824 |

**7. Damage observed on Abutment 1 side barrier, measuring 0.76 m in length and 0.24 m in width, covering an area of 0.1824 m<sup>2</sup>.**
