# LIDAR Inspection Report of **Box Culvert** ch.995+010

**Bridge Chainage:** 995+ 010 (CKRP)

- **CKRP:** Chittorgarh to kota
- **State:** Rajasthan NH 27
- **Zone:** RJ-06

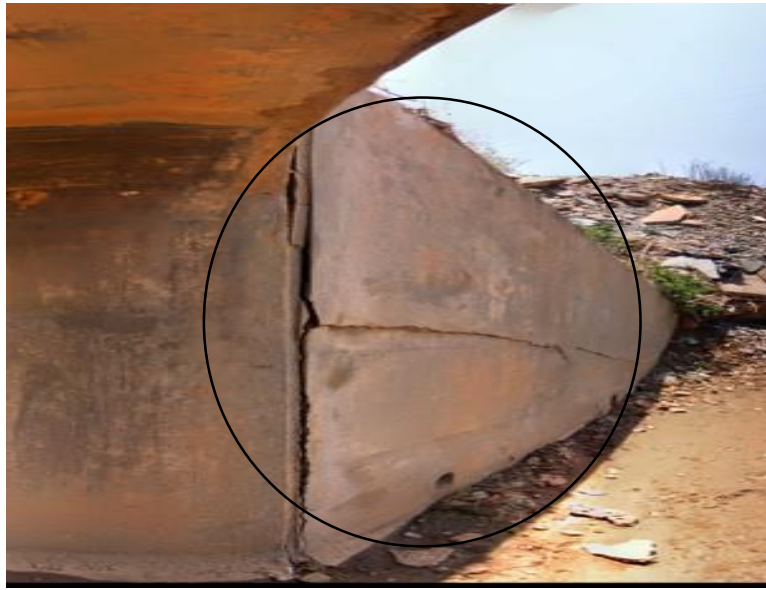
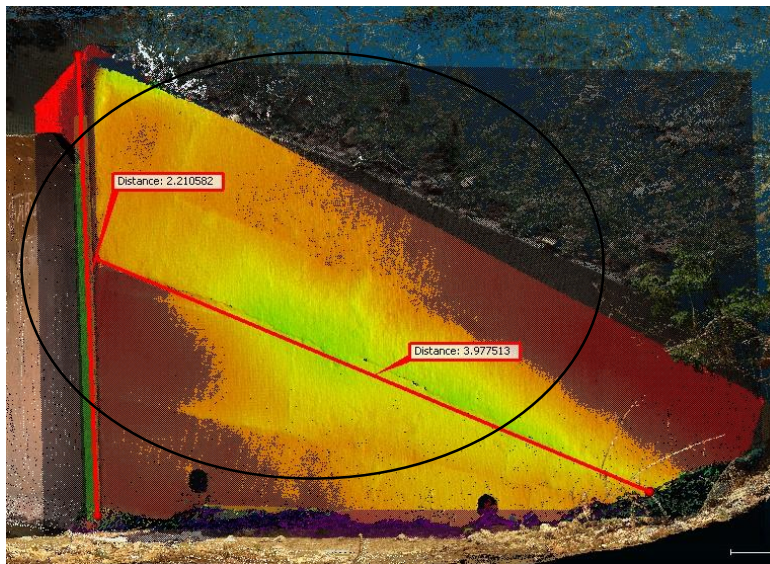
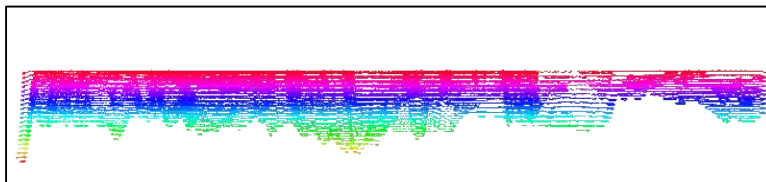
| Element Name | Observation | Location of Distress | Photo No. | Units | Distress Details | | | Area of Repair (Sq.m/R MT/m3) |
|---|---|---|---|---|---|---|---|---|
| Abutment wing Wall | Damage | - | 1 | M | 3.97 | 2.21 | - | 8.773 |

**1. Abutment wall damage observed on LHS, measuring 3.97 m in length and 2.21 m in width, covering an area of 8.773 m<sup>2</sup>.**

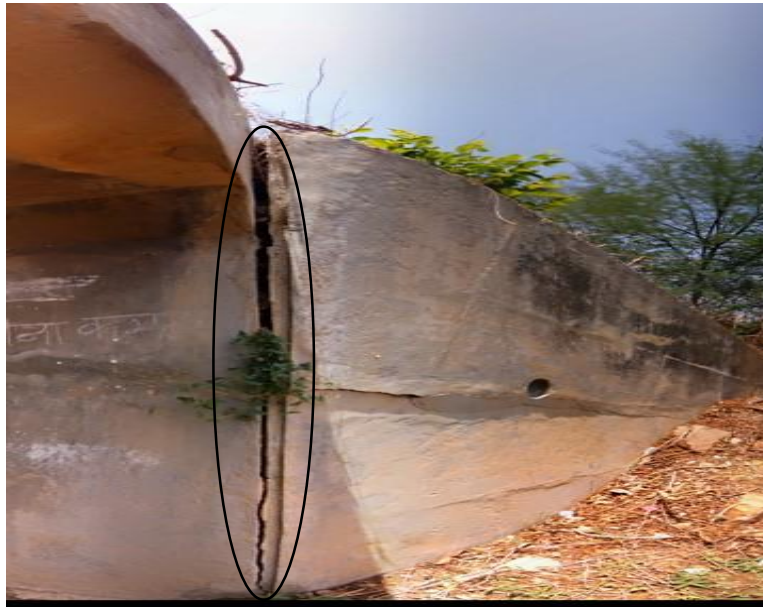
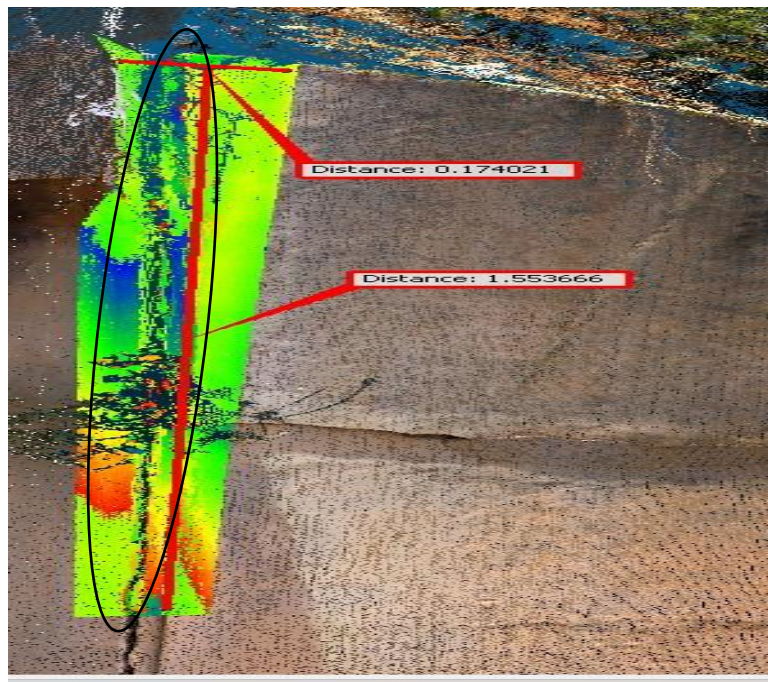
| Element Name | Observation | Location of Distress | Photo No. | Units | Distress Details | | | Area of Repair (Sq.m/R MT/m3) |
|---|---|---|---|---|---|---|---|---|
| Abutment Wing Wall | Damage | - | 2 | M | 0.91 | 0.04 | - | 0.124 |

**2. Abutment wall damage observed on RHS, measuring 1.55 m in length and 0.08 m in width, covering an area.**
