# **LIDAR Inspection Report of Slab Culvert ch.995+580**

**Bridge Chainage:** 995+580 (CKRP)

- **CKRP:** Chittorgarh to kota
- **State:** Rajasthan NH 27
- **Zone:** RJ-06

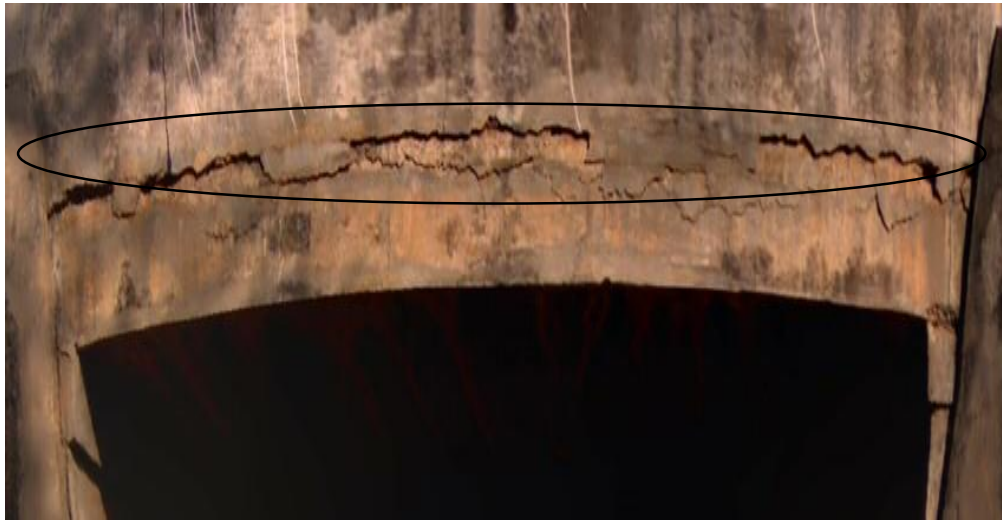
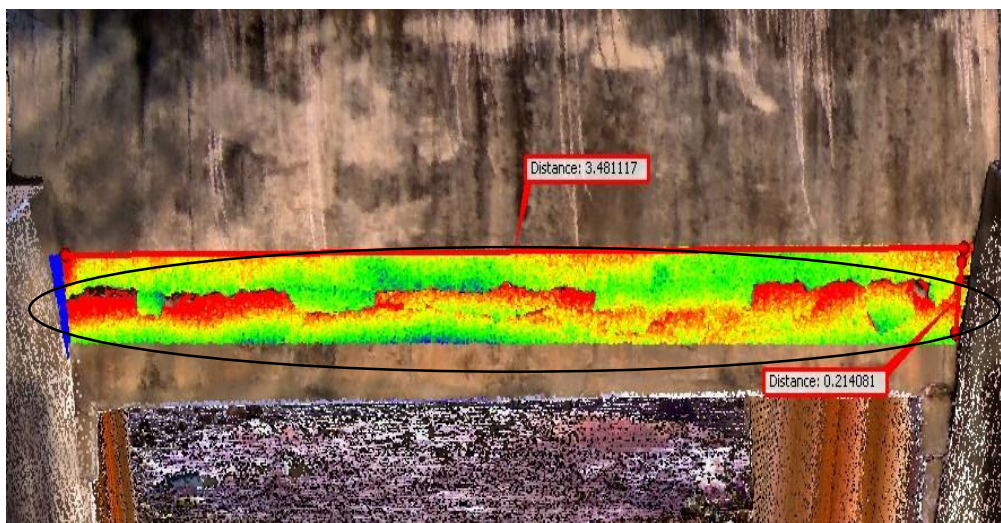
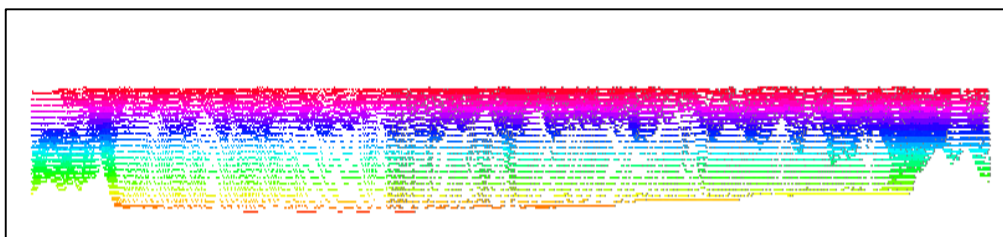
| Element Name | Observation | Location of Distress | Photo No. | Units | Distress Details | | | Area of Repair (Sq.m/R MT/m3) |
|---|---|---|---|---|---|---|---|---|
| Parapet wall | Damage | - | 1 | - | 3.48 | 0.21 | - | 0.730 |

**1.Parapet wall damage observed on LHS, measuring 3.48 m in length and 0.21 m in width, covering an area of 0.730 m<sup>2</sup>.**

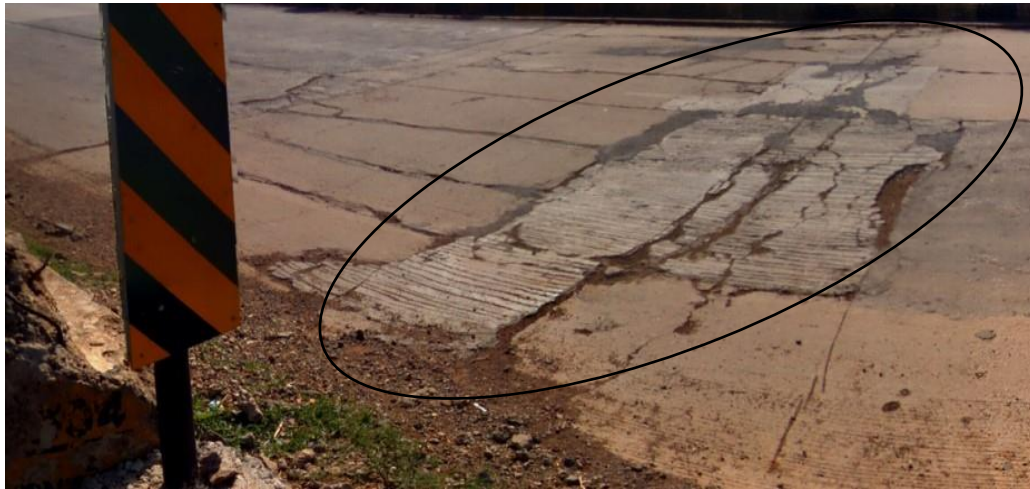
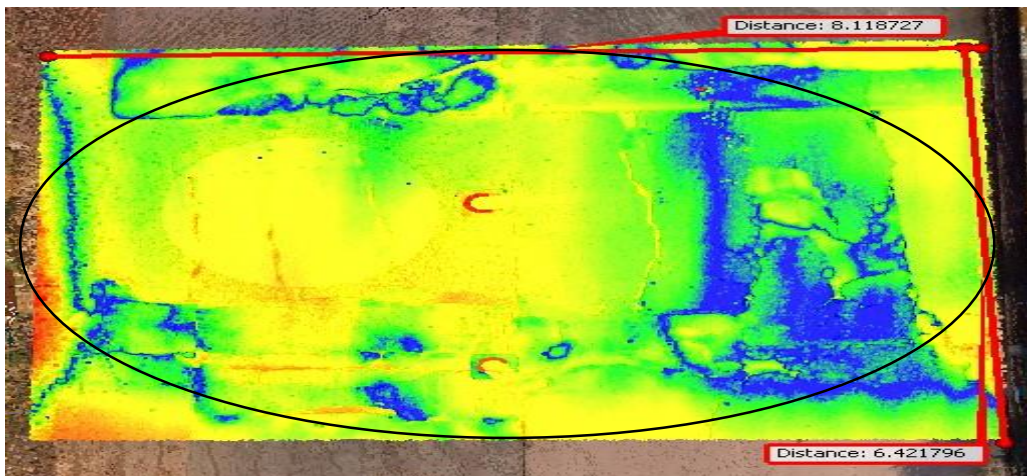
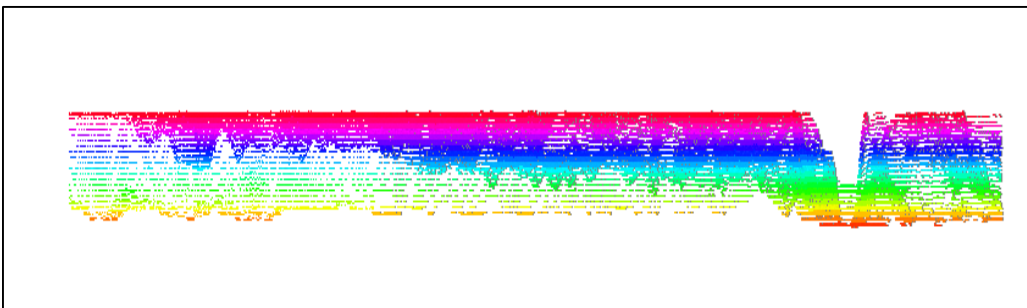
| Element Name | Observation | Location of Distress | Photo No. | Units | Distress Details | | | Area of Repair (Sq.m/R MT/m3) |
|---|---|---|---|---|---|---|---|---|
| Road | Damage | - | 2 | - | 8.11 | 6.42 | - | 52.066 |

**2. Road damage observed on LHS, measuring 8.11 m in length and 6.42 m in width, covering an area of 52.066 m<sup>2</sup>.**

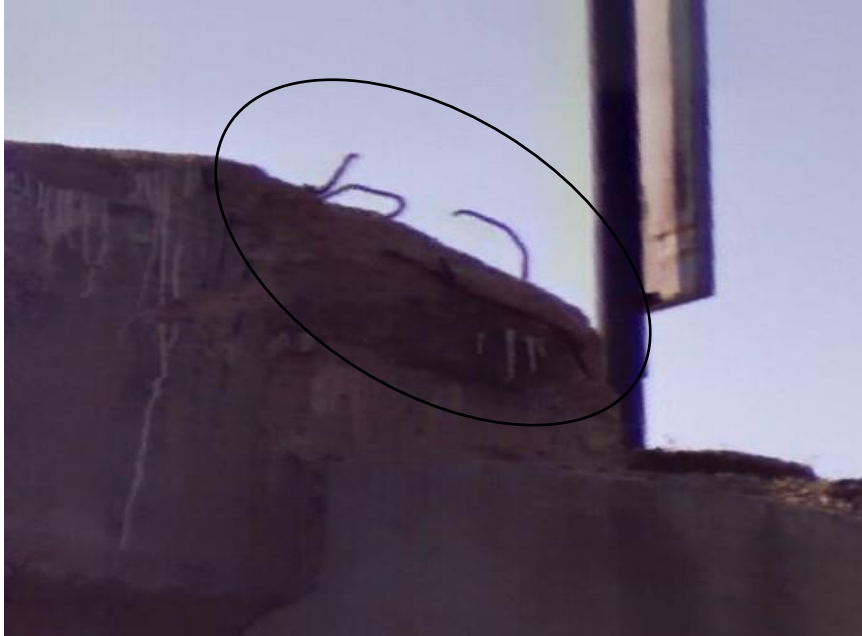
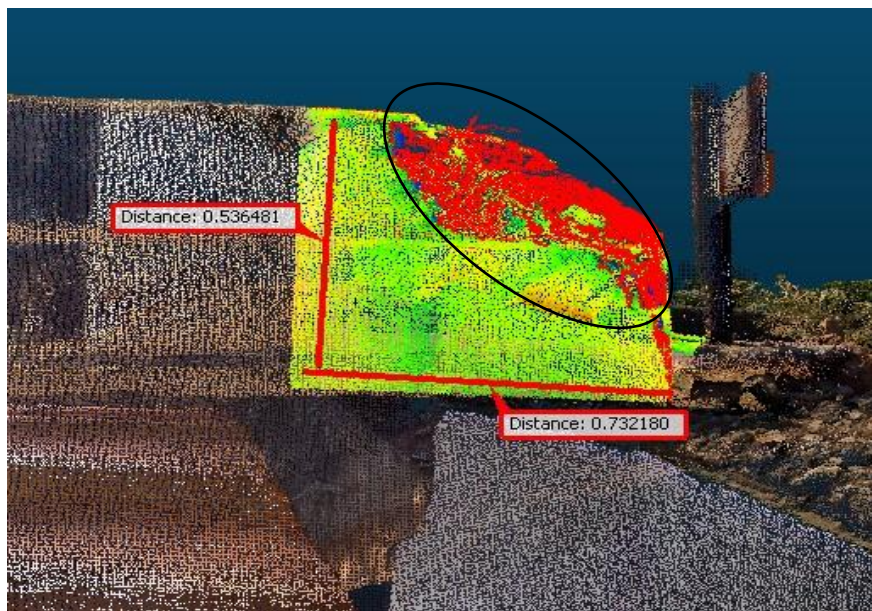
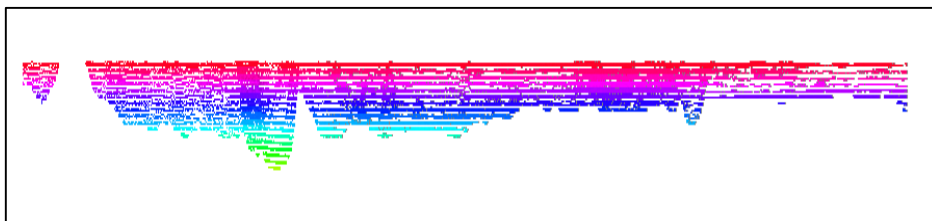
| Element Name | Observation | Location of Distress | Photo No. | Units | Distress Details | | | Area of Repair (Sq.m/R MT/m3) |
|---|---|---|---|---|---|---|---|---|
| Parapet wall | Damage | - | 3 | - | 0.73 | 0.53 | - | 0.386 |

**3. Parapet wall damage observed on RHS, measuring 0.73 m in length and 0.53 m in width, covering an area of 0.386 m<sup>2</sup>.**

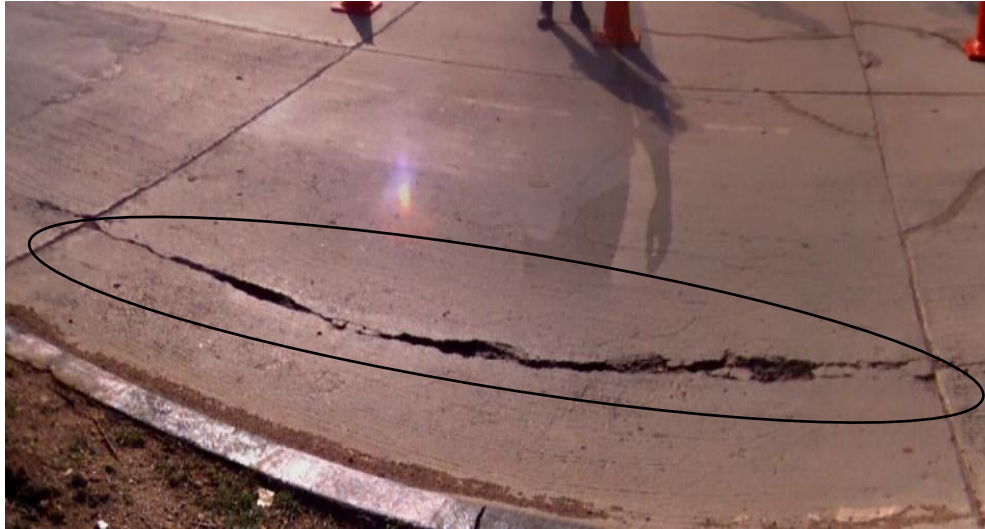
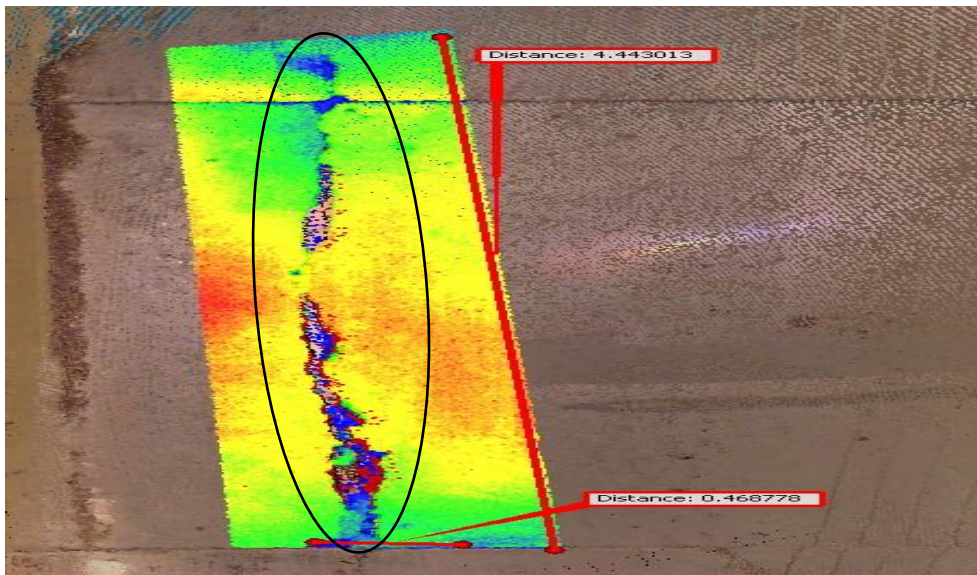
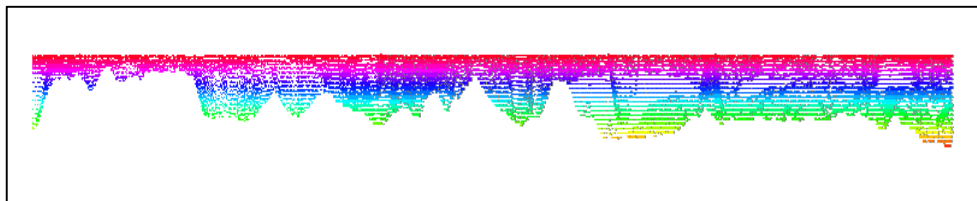
| Element Name | Observation | Location of Distress | Photo No. | Units | Distress Details | | | Area of Repair (Sq.m/R MT/m3) |
|---|---|---|---|---|---|---|---|---|
| Road | Damage | - | 4 | - | 4.44 | 0.46 | - | 2.042 |

**4. Road damage observed on RHS, measuring 4.44 m in length and 0.46 m in width, covering an area of 2.042 m<sup>2</sup>.**
