# **LIDAR Inspection Report of VUP ch.996 + 850**

**Bridge Chainage:** 996 + 850 (CKRP)

- **CKRP:** Chittorgarh to kota
- **State:** Rajasthan NH 27
- **Zone:** RJ-06

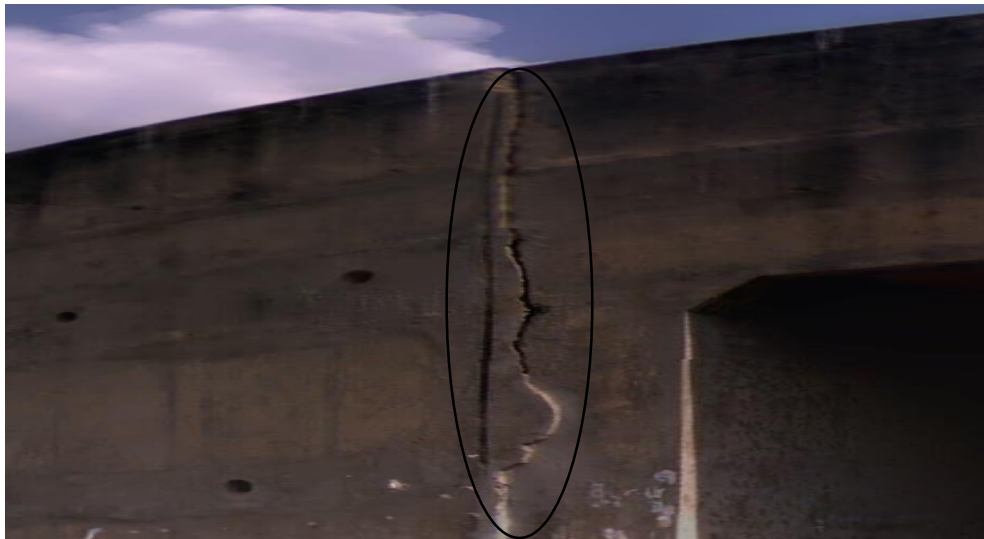
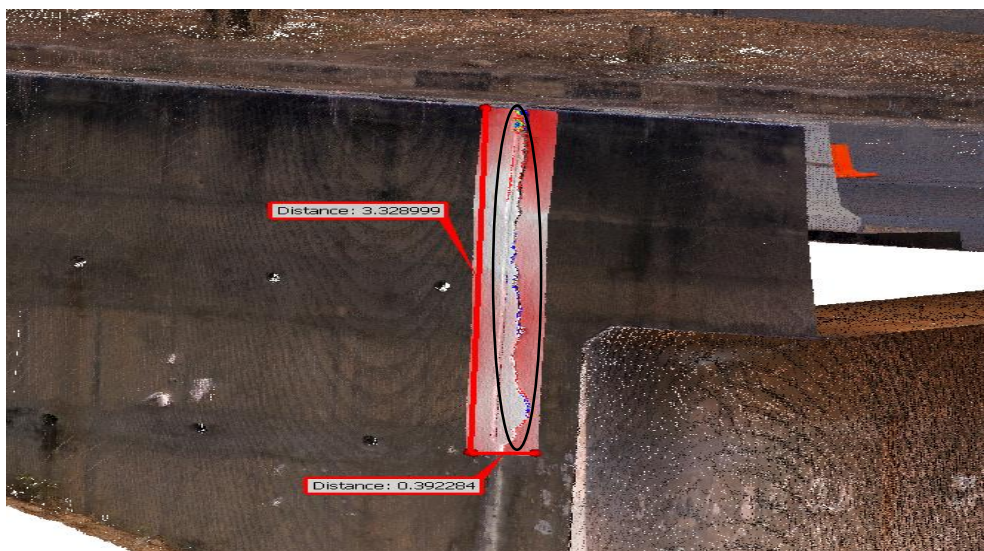
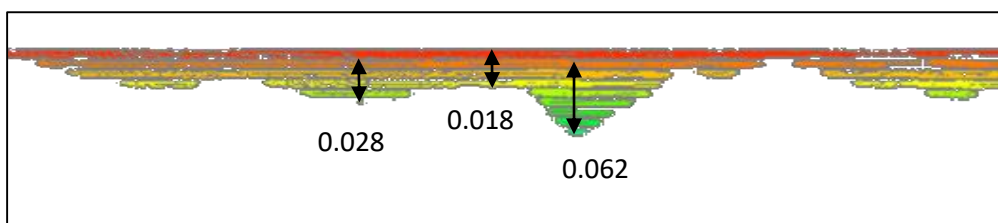
| Element Name | Observation | Location of Distress | Photo No. | Units | Distress Details | | | Area of Repair (Sq.m /RMT /m3) |
|---|---|---|---|---|---|---|---|---|
| Wing Wall | Damage | | 1 | M | 3.32 | 0.39 | 0.028 | 0.0362 |

**1. Damage observed on A1 RHS Wing Wall 1, measuring 3.32 m in length and 0.39 m in width, Depth ranges from 0.021 m (min) to 0.062 m (max), with an average depth of 0.028 m. The calculated volume of the distress is 0.0362m<sup>3</sup>.**

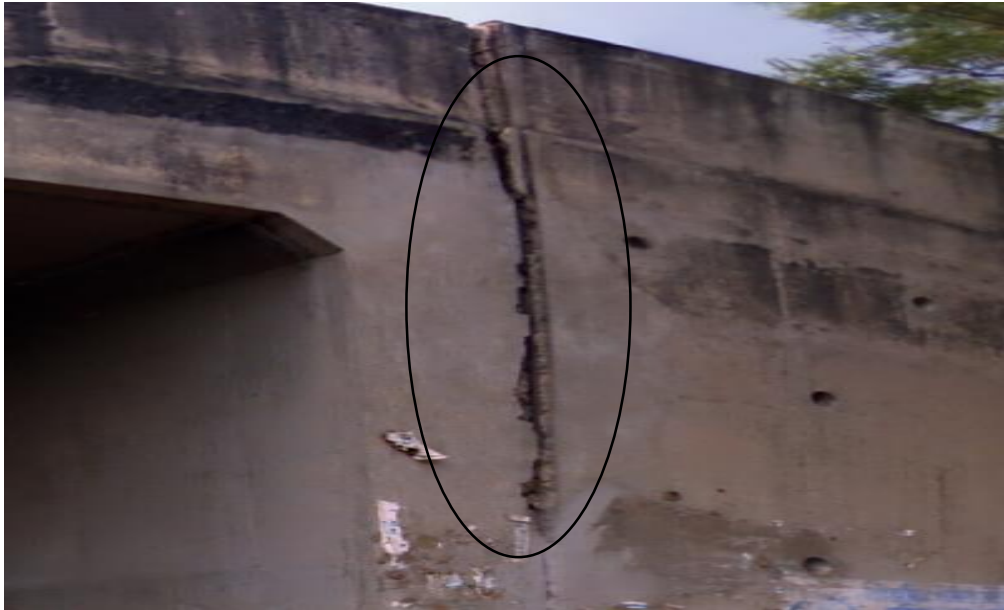
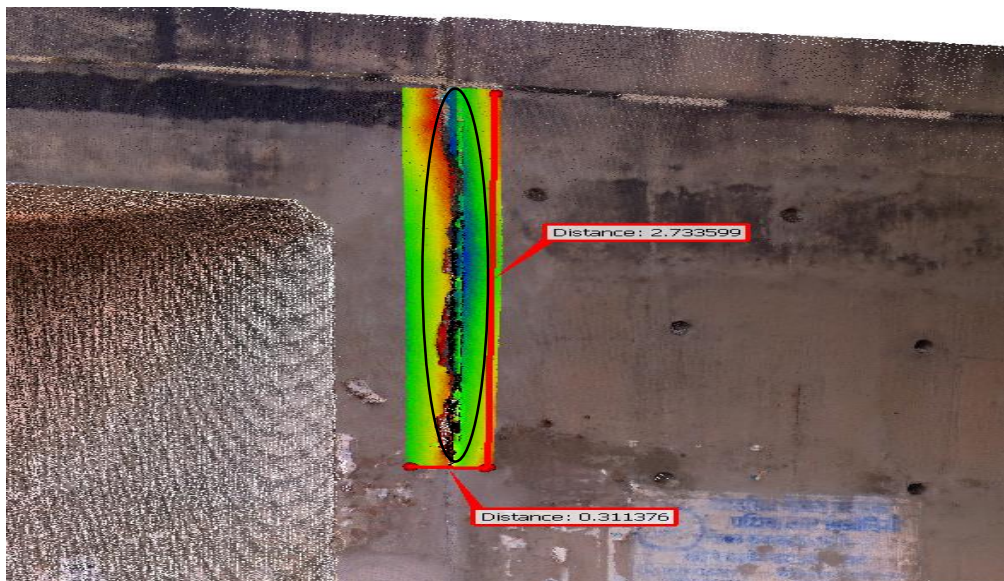
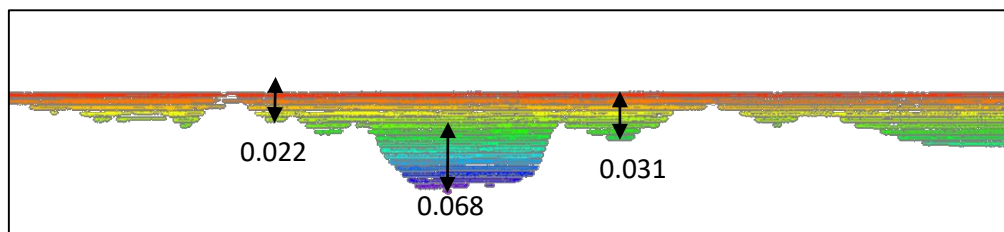
| Element Name | Observation | Location of Distress | Photo No. | Units | Distress Details | | | Area of Repair (Sq.m /RMT /m3) |
|---|---|---|---|---|---|---|---|---|
| Wing Wall | Damage | | 2 | M | 2.73 | 0.31 | 0.022 | 0.0186 |

**2. Damage observed on A1 LHS Wing Wall 2, measuring 2.73 m in length and 0.31 m in width, Depth ranges from 0.022 m (min) to 0.068 m (max), with an average depth of 0.022 m. The calculated volume of the distress is 0.0186m<sup>3</sup>.**

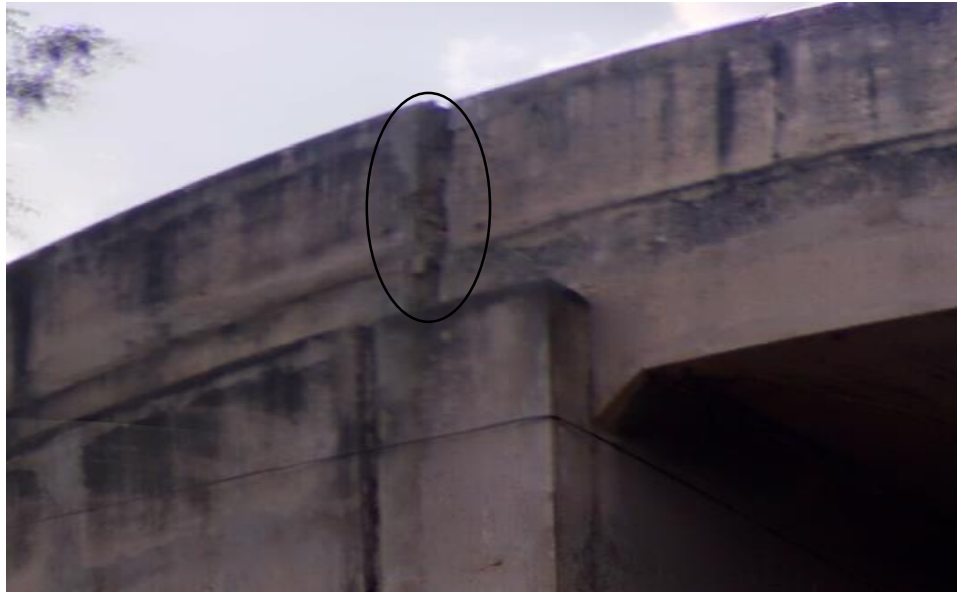
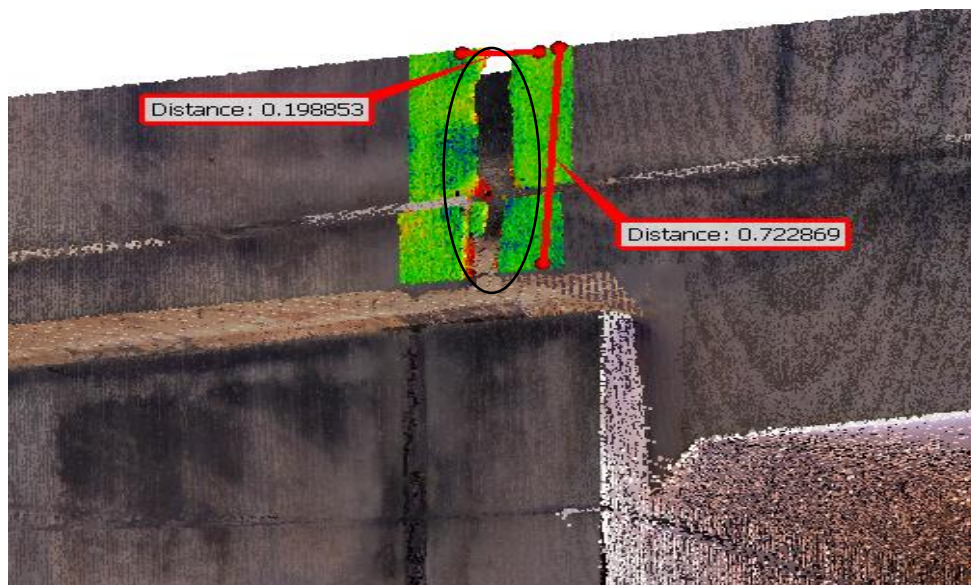
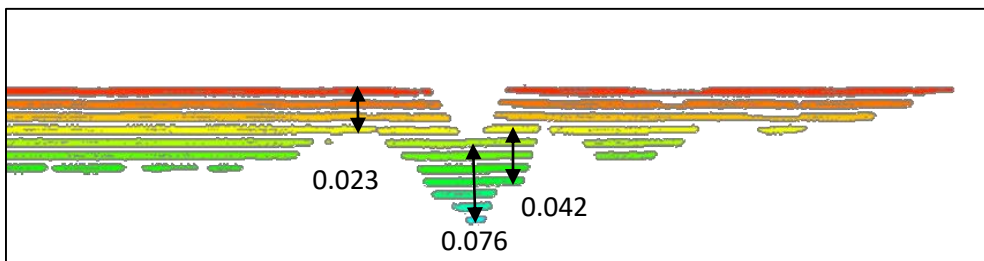
| Element Name | Observation | Location of Distress | Photo No. | Units | Distress Details | | | Area of Repair (Sq.m /RMT /m3) |
|---|---|---|---|---|---|---|---|---|
| Parapet Wall | Damage | | 3 | M | 0.72 | 0.19 | 0.042 | 0.0057 |

**3. Damage observed on A2 LHS Parapet Wall, measuring 0.72 m in length and 0.19 m in width, Depth ranges from 0.023 m (min) to 0.076 m (max), with an average depth of 0.042 m. The calculated volume of the distress is 0.0057m<sup>3</sup>.**
