# LIDAR Inspection Report of **Box Culvert** ch.996+600

**Bridge Chainage:** 996+ 600 (CKRP)

- **Bridge No:** -
- **Chainage:** 996+ 600
- **Structure type:** Box Culvert

- **CKRP:** Chittorgarh to kota
- **State:** Rajasthan NH 27
- **Zone:** RJ-06

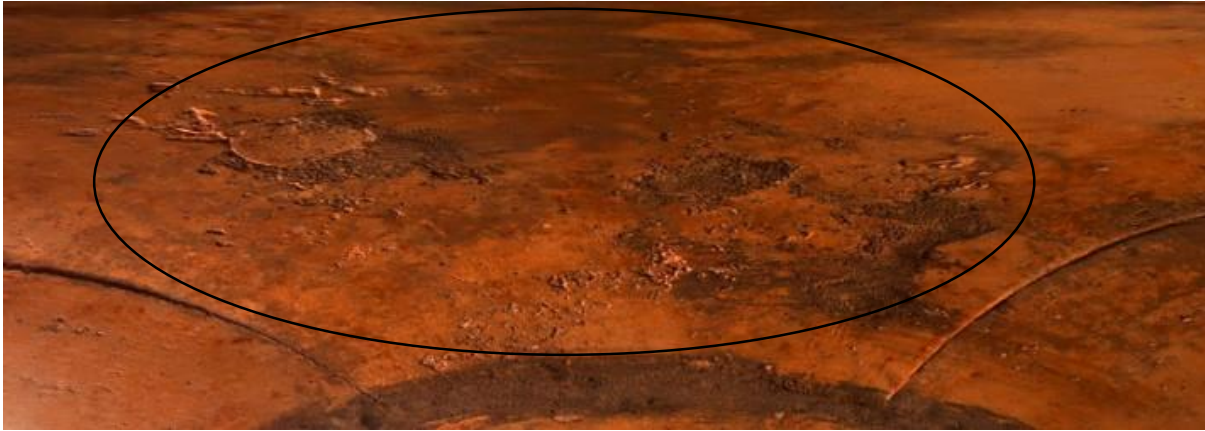
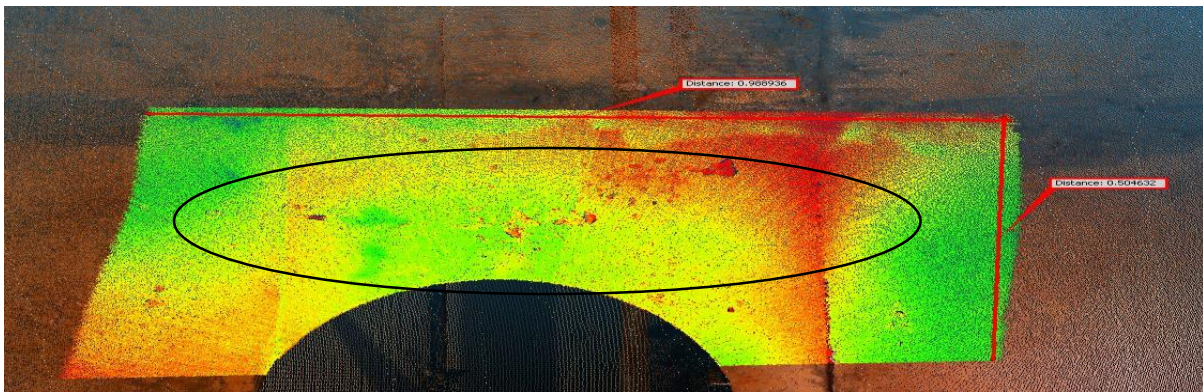
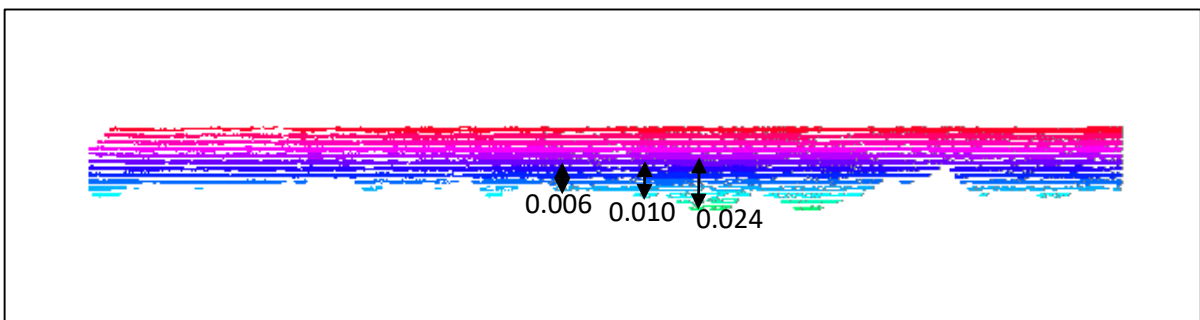
| Element Name | Observation | Location of Distress | Photo No. | Units | Distress Details | | | Area of Repair (Sq.m/R MT/m3) |
|---|---|---|---|---|---|---|---|---|
| TOP slab | Damage | - | 1 | M | 0.98 | 0.50 | 0.010 | 0.0049 |

**1. Hollow pocket observed on Top Slab, measuring 0.98 m in length and 0.50 m in width, Depth ranges from 0.006 (min) to 0.024 m (max), with an average depth of 0.010 m. The calculated volume of the distress is 0.0049 m<sup>3</sup>.**

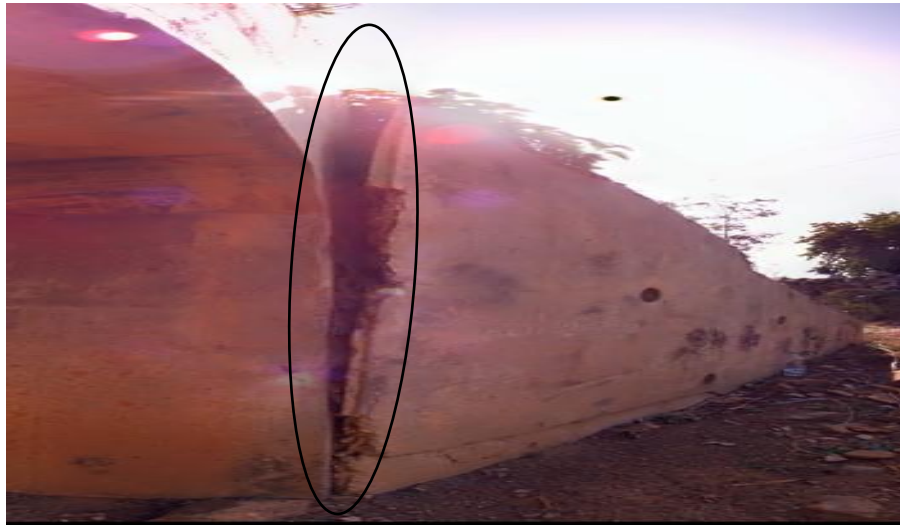
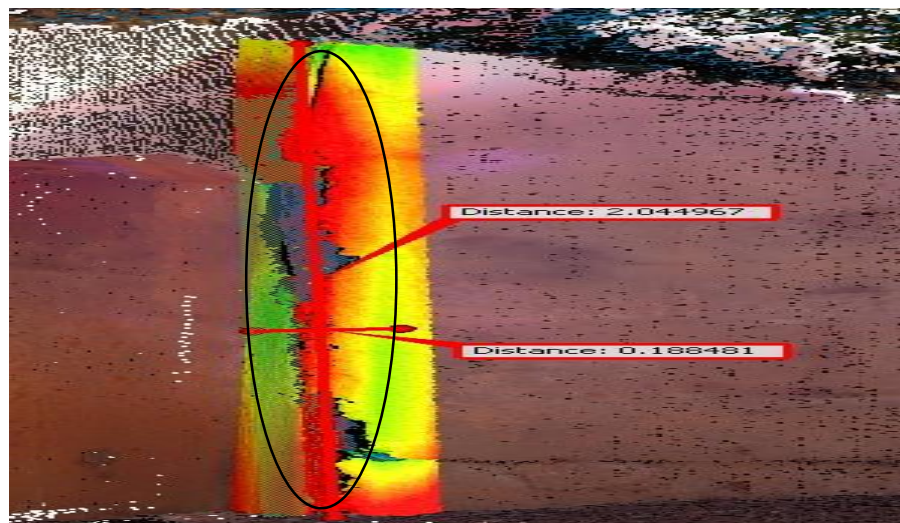
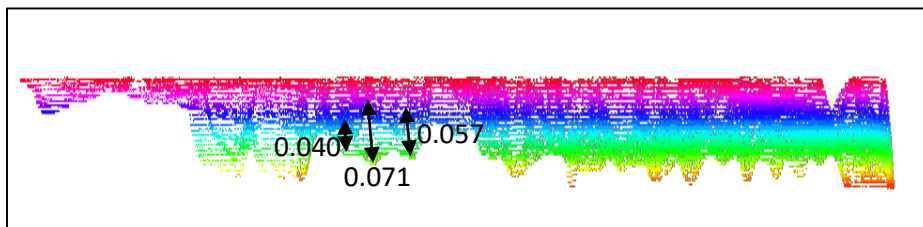
| Element Name | Observation | Location of Distress | Photo No. | Units | Distress Details | | | Area of Repair (Sq.m/R MT/m3) |
|---|---|---|---|---|---|---|---|---|
| Abutment Wing Wall | Damage | - | 2 | M | 2.04 | 0.18 | 0.057 | 0.020 |

**2. Damage observed on LHS Abutment Wall, measuring 2.04 m in length and 0.18 m in width, Depth ranges from 0.040 (min) to 0.071 m (max), with an average depth of 0.057 m. The calculated volume of the distress is 0.020 m<sup>3</sup>.**
