# LIDAR Inspection Report of **Box Culvert** ch.999+941

**Bridge Chainage:** 999+941(CKRP)

- **CKRP:** Chittorgarh to kota
- **State:** Rajasthan NH 27
- **Zone:** RJ-06

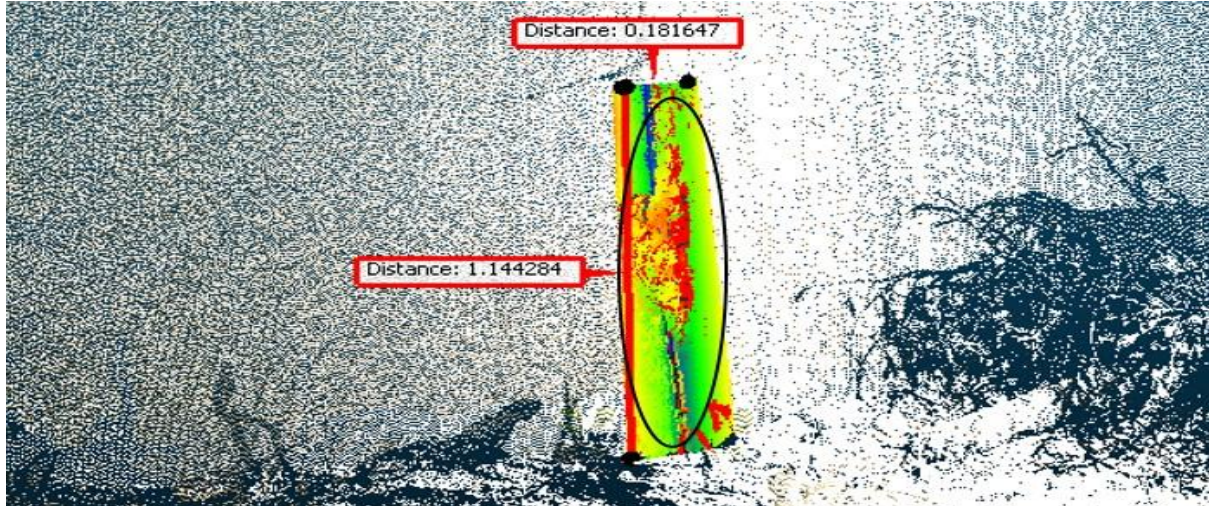
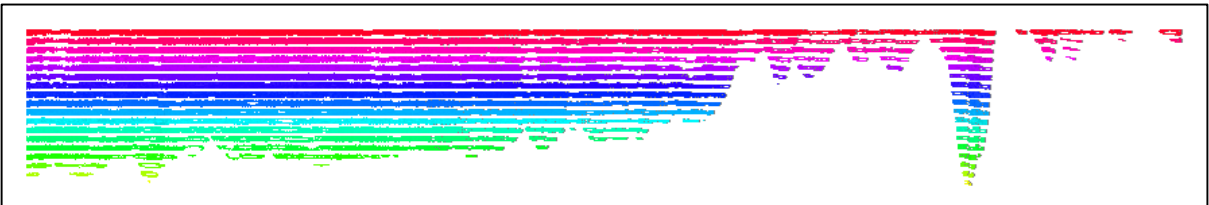
1. "Damage observed on Wing Wall, measuring 0.18 m in length and 1.14 m in width, covering an area of 0.2052 m<sup>2</sup>."

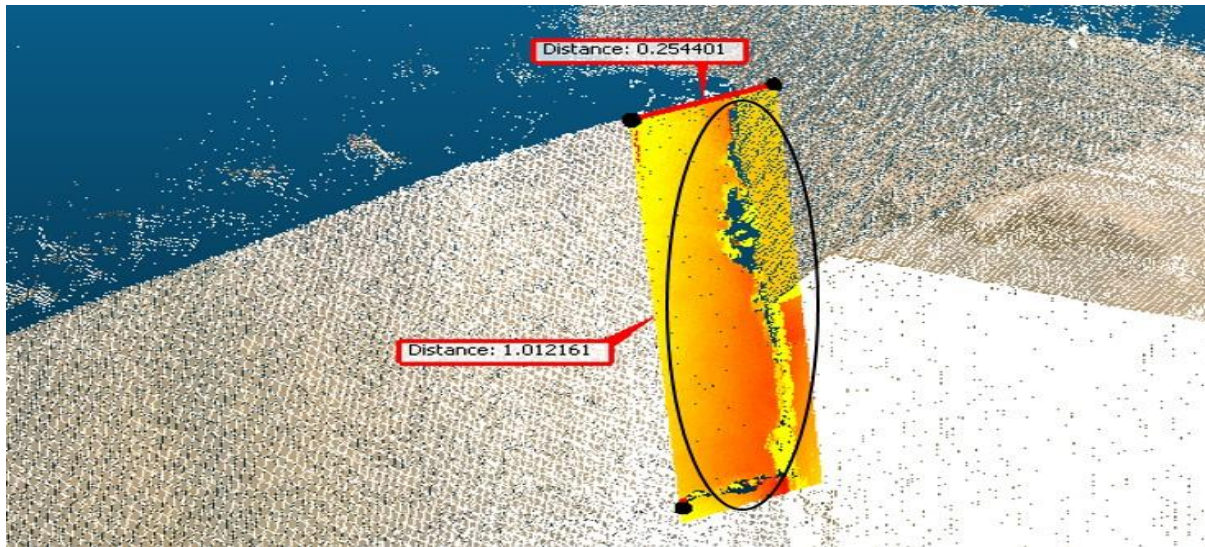
**2. "Damage observed on Wing Wall, measuring 0.25 m in length and 1.01 m in width, covering an area of 0.2525 m<sup>2</sup>."**

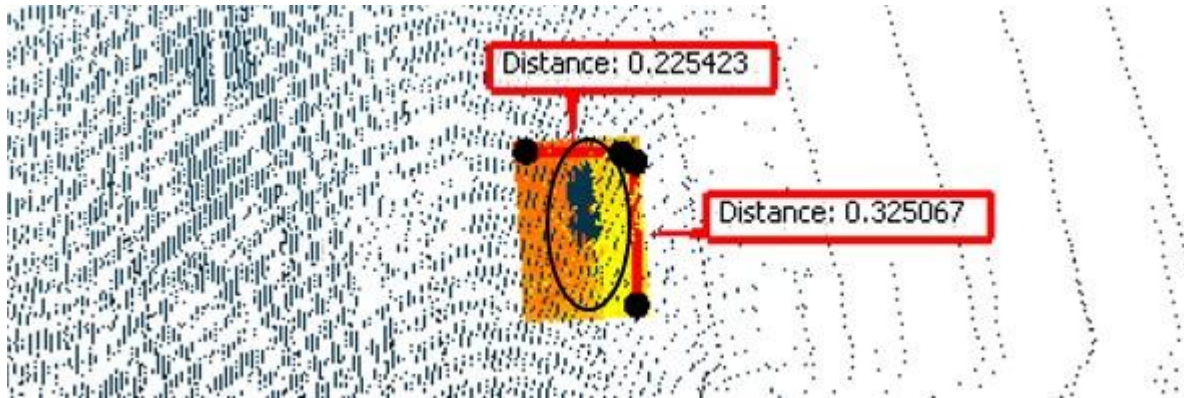
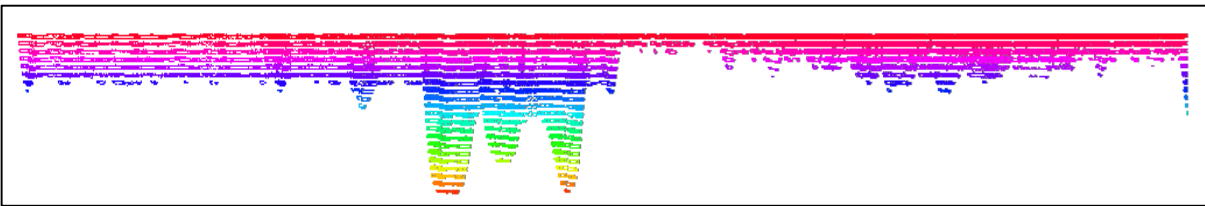
**3. "Damage observed on Abutment Wall, measuring 0.22 m in length and 0.32 m in width, covering an area of 0.0704 m<sup>2</sup>."**

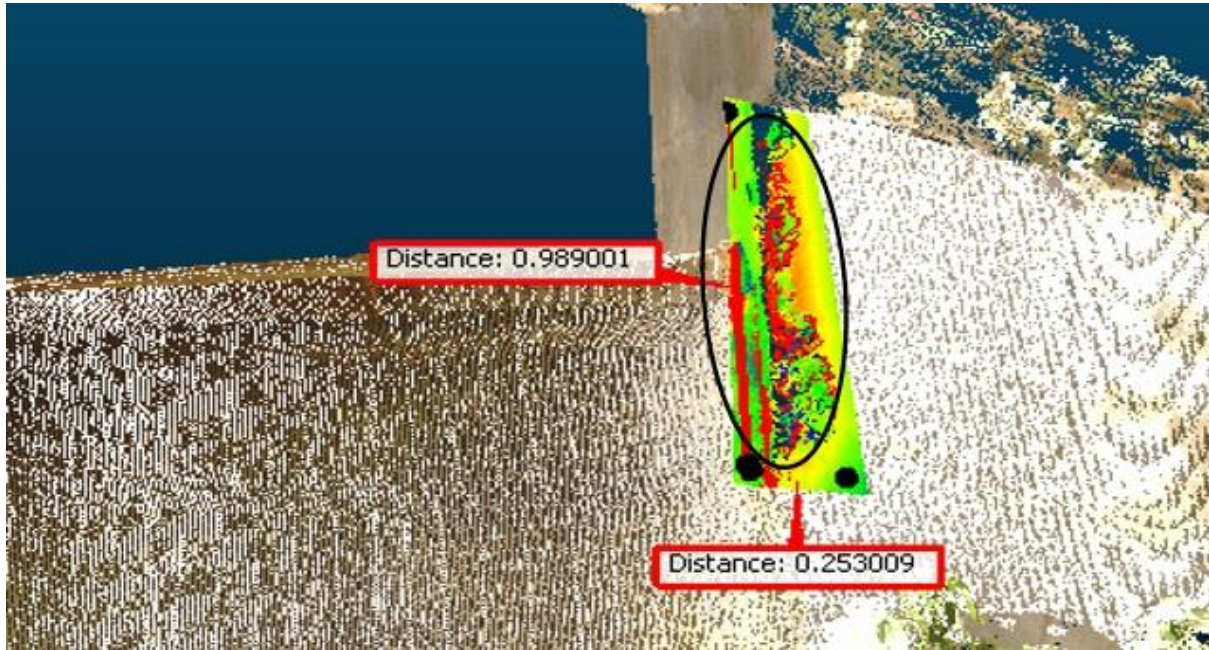
**4. "Damage observed on Wing Wall, measuring 0.25 m in length and 0.98 m in width, covering an area of 0.245 m<sup>2</sup>."**

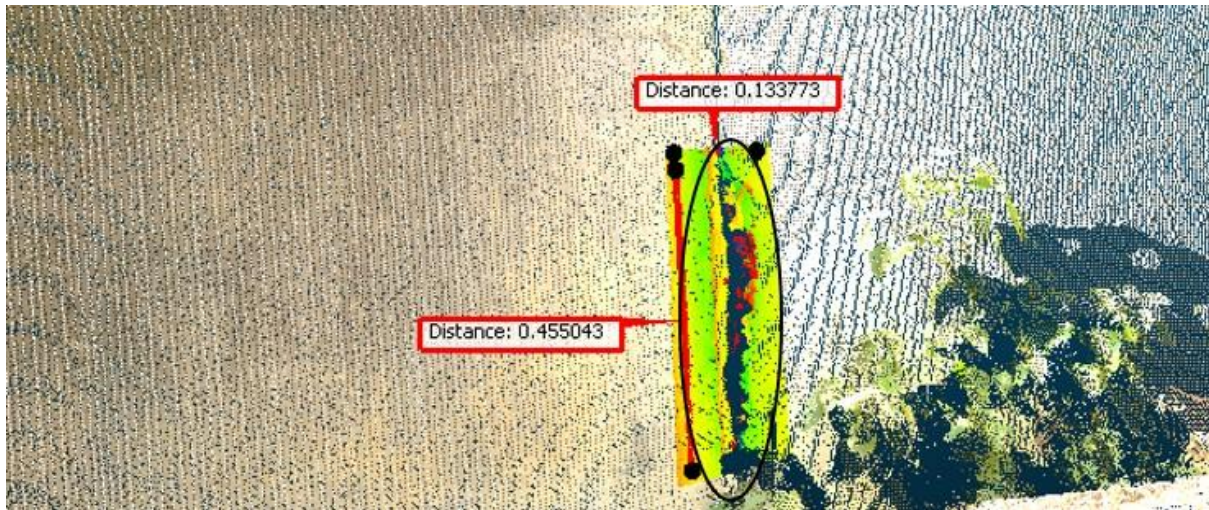
**5. "Damage observed on Wing Wall, measuring 0.13 m in length and 0.45 m in width, covering an area of 0.0585 m<sup>2</sup>."**

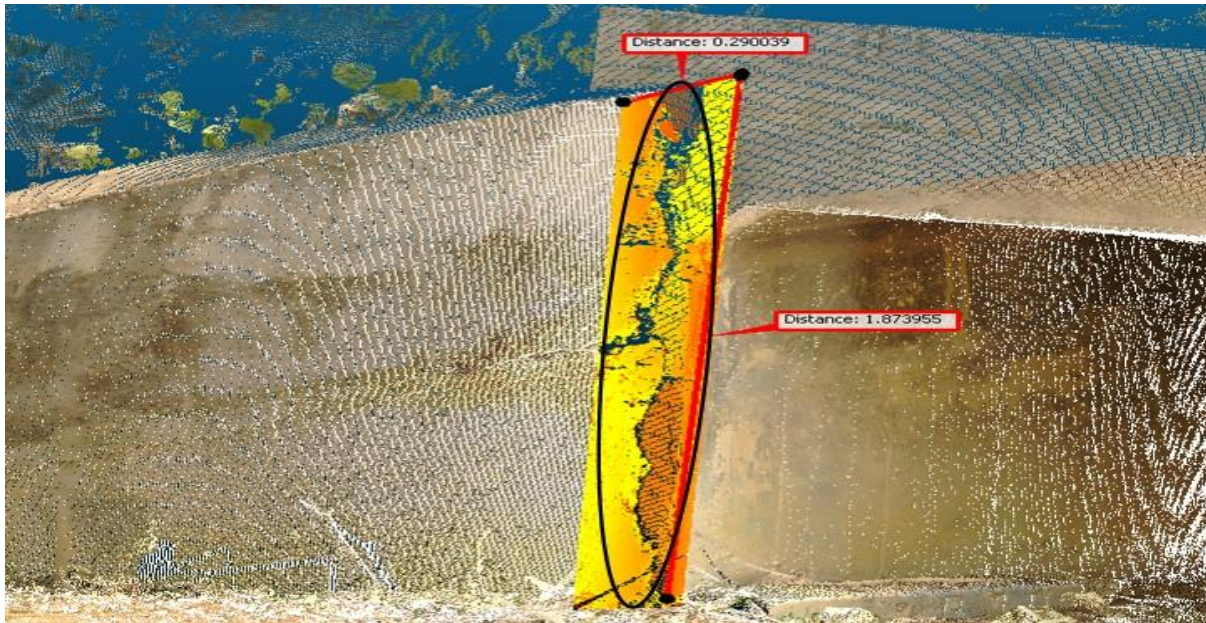
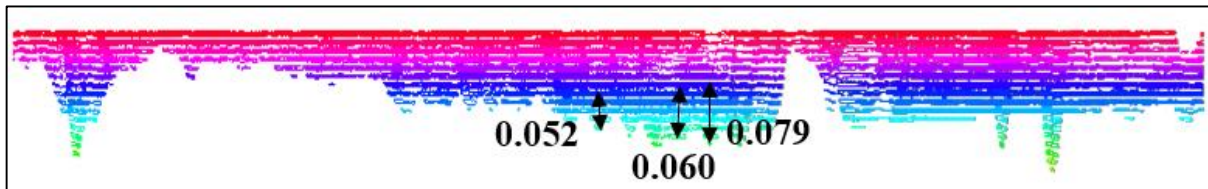
**6. Damage observed on Wing Wall, measuring 0.29 m in length and 1.87 m in width, Depth ranges from 0.052 m (min) to 0.079 m (max), with an average depth of 0.060 m. The calculated volume of the distress is 0.0325 m<sup>3</sup>.**

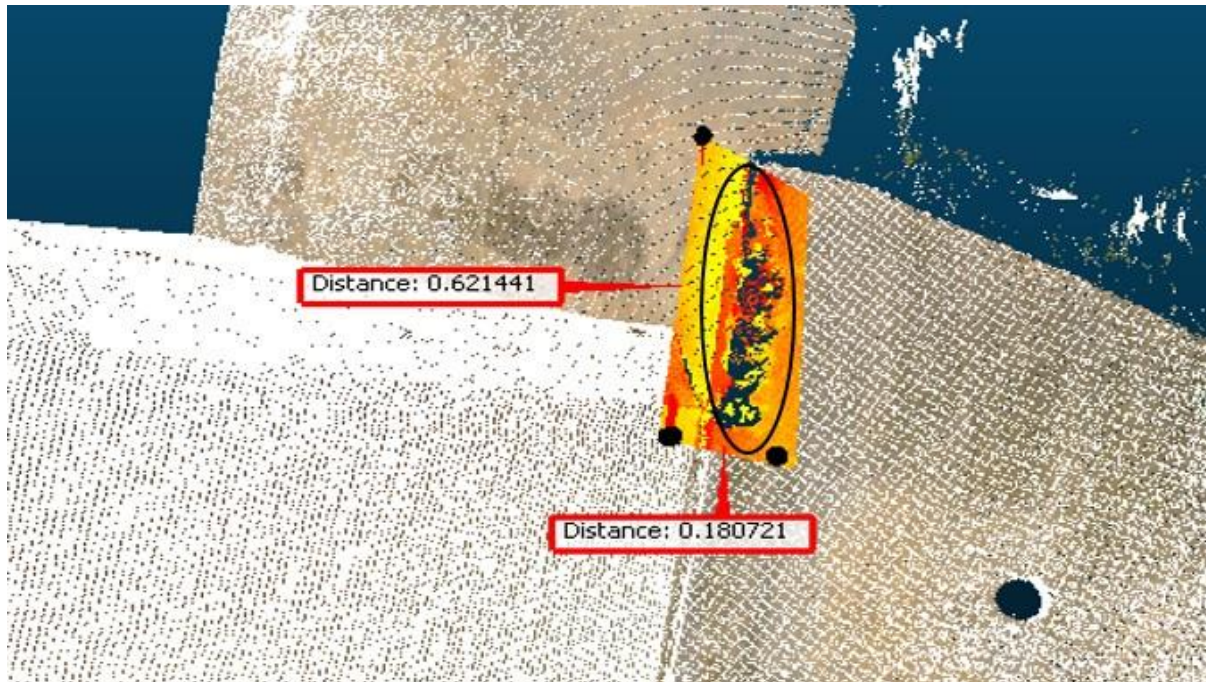
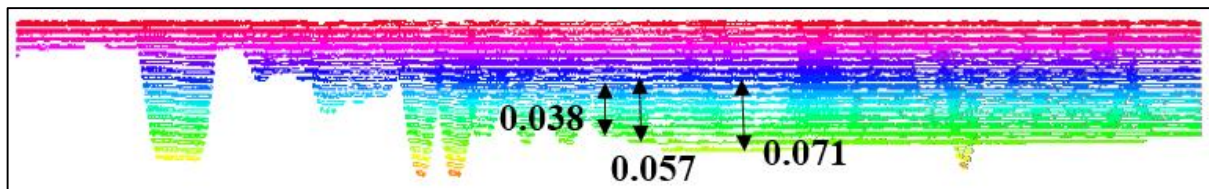
7. "Damage observed on Wing Wall, measuring 0.18 m in length and 0.62 m in width, Depth ranges from 0.038 m (min) to 0.071 m (max), with an average depth of 0.057 m. The calculated volume of the distress is 0.0063 m<sup>3</sup>.
