STUDY OF THE “ESCOLA SUPERIOR DE TECNOLOGIA DA SAÚDE DE LISBOA”

This work was requested by the professors João Gomes Ferreira, João Ramôa Correia, José Dinis Silvestre, Arch. Clara Pereira with the objective of studying the possible pathologies and forms of rehabilitation.

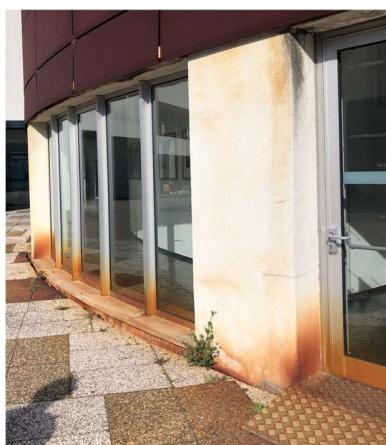
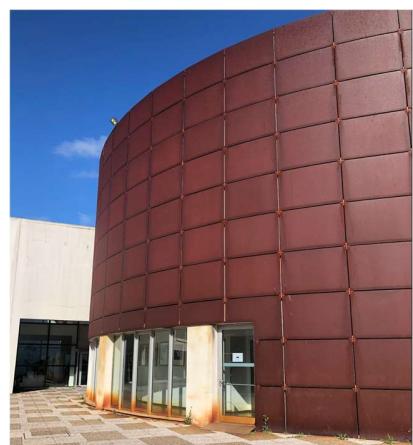
The external walls in this compound have been affected in various ways and areas. In building A, where the large circular structure is located it is perceivable that on the external wall, all over the structure but more specifically behind the constructions’ external metal cladding, there is a reddish, rust-like staining on the white coating covering the plaster. On the ceramic used at the bottom of the windows surrounding the structure (the windows here are as tall as the door to enter the building); And on the aluminum of the windows and door frames as shown in figures 5 and 6.

Figure 5: Anomaly 3.1A zoomed in

Figure 6: Anomaly 3.1A zoomed out

Considering that the metal cladding is attached to the wall by a metal bolted connection, it’s safe to assume that the cause for this anomaly is because of rust that developed on the metal and transferred by water (when it rains) to the wall. This also

explains the stains on the ceramic floor and aluminum frames, since this color of stain indicates the presence of metal particles which comes from the metal cladding, and can be transferred to the surrounding structures by air or by rain water fall.

This is not a structural problem, but considering that the wall coating is not just there for an aesthetical purpose, but it also serves as protection from external agents, the proposal here is to use repair techniques that could be cover-up or protection.

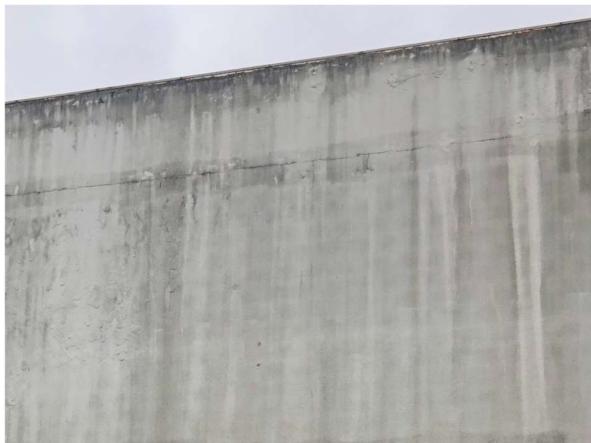
Also in building A, the facade has visible signs of tear, with significant vertical, black stains as well as the formation of bubbles under the white coating as shown in Figure 7 and flaking of the paint as shown in figure 8.

Figure 7: Anomaly 3.1B

These facade anomalies were all most likely caused by environmental actions and require no in-situ testing. The most likely cause for these three pathologies on this facade is efflorescence and crypto florescence, which characterizes the prolonged presence of moisture or soluble salt in the render. Since there is no draining system on the facade, the rainwater runs down the structure, and overtime, moisture has most likely entered between the surface and the layer of paint of the building, and then, the bubble was formed. Moisture also explains the flaking of the paint since it can cause the adhesion between the paint and the concrete to weaken and consequently peel off.

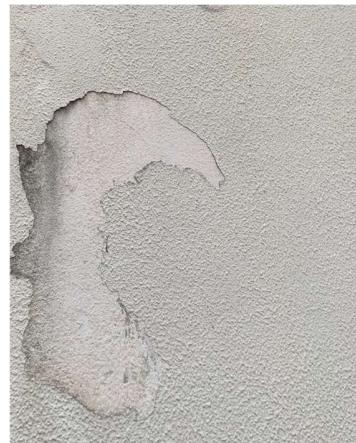
Figure 8: Anomaly 3.1C

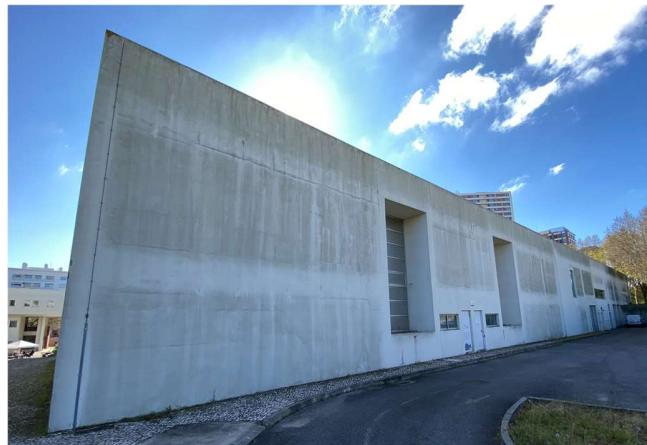
On the back of building A, where the facade faces North and West, the outer side of the wall has very characteristic ghosting stains, where it is possible to see the structure inside the wall by following the stains patterns. This anomaly presents itself from top to bottom of the facade, with darker stains centered in the middles and white spots surrounding the darker areas, as shown in figure 9. The picture shows the facade facing west, but the facade facing north presents itself with the exact same type of anomalies, leaving space to assume that this is not a localized issue, but something related to

structure itself and that the stains are a consequence of thermophoresis. It's important to mention that the internal part of the left side of the building is an open space with no roof covering. The right side of the building is covered.

Figure 9: Image of Anomaly 3.1E

What is known for this anomaly is that it is most likely caused by temperature differences and particles that move air borne (can be vehicle exhaust, road particles, etc) that attach themselves to the cooler and most moisturized area of the wall, causing staining. Further inspection using a thermostat was used, and it was found that the masonry part of the facade was warmer than the concrete part.

This leads to a number of possible causes: Either lack of insulation in the wall, the structure has air currents that travel inside the cavity causing a difference in temperature between areas or the presence of mold and algae on the masonry part caused by the fact that masonry brick is a more porous material than concrete and more vulnerable to the proliferation of these fungus' and the sticking of air borne particles that cause staining.

3.1D/3.1E Like the previous anomalies, these ones do not impose a risk to the building or its users and they are mainly an aesthetic and protective issue. The course of action in this case is to remove any loose paint flaking, clean the surface, make sure the wall is dry and apply a new paint coating. Additionally, a gutter drain should be installed in order to avoid this issue happening in the future.

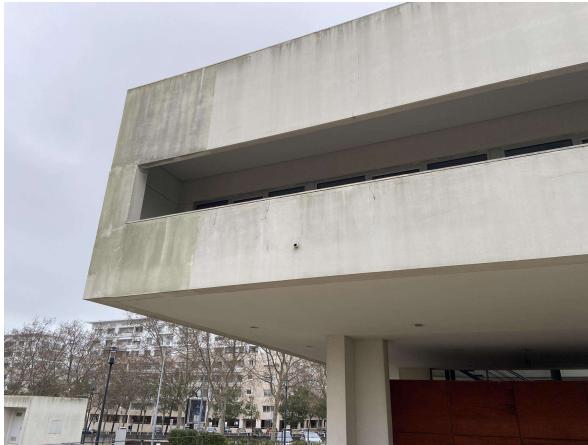
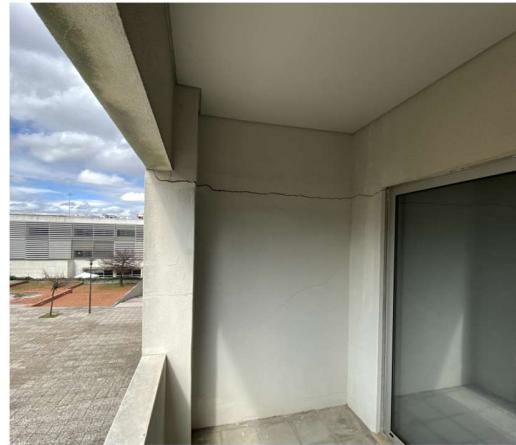
In the facade of building B, the masonry loaded on the cantilever span presents cracks in the upper part, the union of masonry and the beam, in both external and internal regions. The figures 10 and 11 represent the view of the disconnection from outside and inside, respectively.

Figure 10: Anomaly 3.2A exterior view

Figure 11: Anomaly 3.2A interior view

3.2A Considering the average of the crack, its width, location and exposure to environmental factors, repairs will be necessary. It's important to gather more information about the crack in order to have a better understanding of its properties. For instance, there's an urge to make more tests to check if the crack is alive or dead, which means if

In the case that the structure stopped moving, a repair should be made only in the masonry located between the inferior and superior beam. For filling the cracks voids it is advisable to use mortar due to the width of the crack. If it's concluded that the structure is still settling it is necessary to make more tests, to check the quality of concrete and the resistance of the structure, and define what are the real causes of this problem, because based on the life expectancy, with no different uses and loads, the structure designed should be enough.

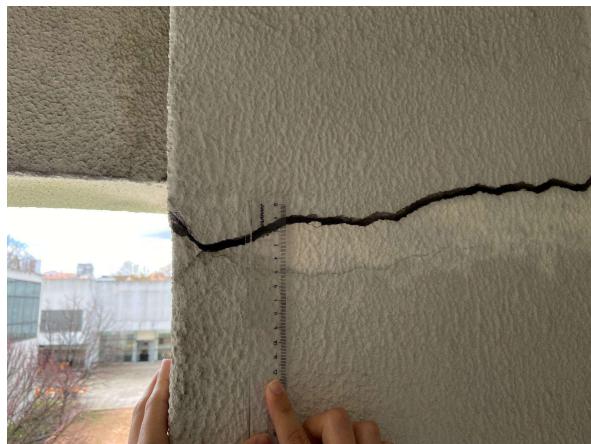
This crack has a thickness of 5-10mm, as shown in figure 12, and the orientation follows the aforementioned elements. It's noticeable that the direction of the masonry changed, they are not at the same plane as before, what characterizes a 3D crack, and it is still connected on the bottom part. This is evidence of structural creep settlement, probably, the load was bigger than the beam could handle so it bent.

Figure 12: Anomaly 3.2A crack measuring

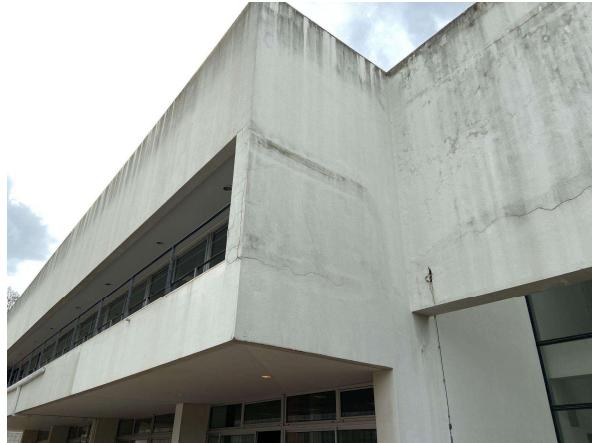
The façade of building A presents a similar pathology, probably occurring by the same causes, however the cracks present different patterns. As shown in the figure 13, the upper part of the masonry is still connected and the masonry presents cracks in the surface in addition to the connections.

Figure 13: Anomaly 3.2B external view

Considering the disposition of the cracks, it can be concluded that the masonry suffered compression loads, probably caused by the settlement of the beams. Furthermore, it can be observed that in the bottom face of the lower beam there are cracks disposed in a way that can indicate a principle of detaching, this anomaly can be well seen in figure 14.

3.2B As the superior intervention, it will be needed to check if the structure is still moving; in case of denying, the render of masonry should be repaired, so it will be needed to be completely dry to fill the cracks void with epoxy and then apply another layer of painting coating. And for the bottom of the beam it is necessary to check the depth of the crack; if it is superficial, the solution is to fill the cracks with epoxy resin and then apply a layer of painting coating.

In case the bars are not well conserved it's necessary to replace them or increase the number of bars. If it is still moving, same as the upper one, it's necessary to make the tests to check what elements are affected and present failure to be certain repaired.

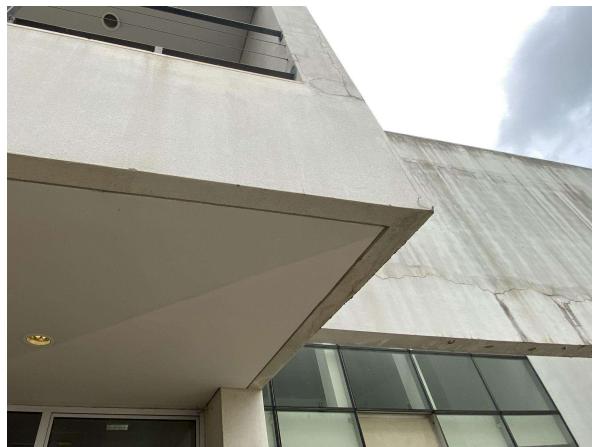
Figure 14: Anomaly 3.2B bottom view

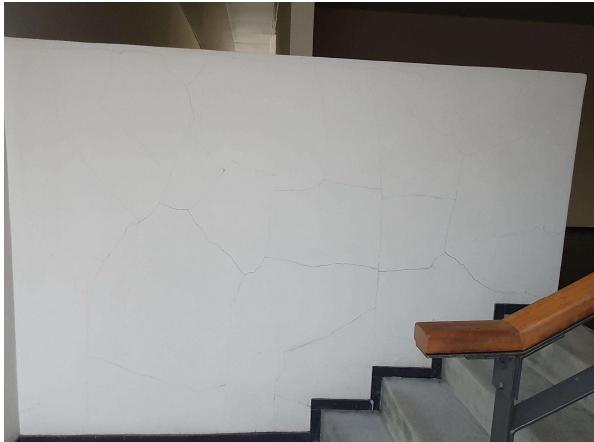
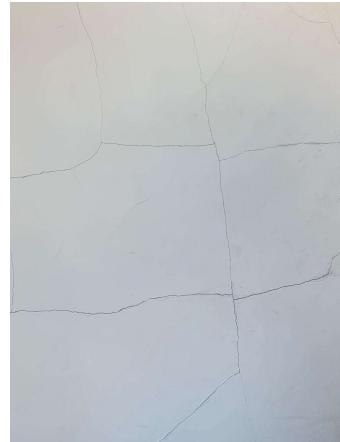
The internal walls analyzed in this part of the project were all seen in the building A. In most parts of the internal walls it is possible to see cracks in an irregular shape (3.3A), as shown in Figures 17 and 18, that go through the whole area of the wall, this anomaly is presented by the presence of cracks. The anomaly is probably caused by

thermal variations or due to shrinkage, when the temperature varies constantly causing the expansion of the coatings of the walls and accordingly causing cracks.

Figure 17: Anomaly 3.3A zoomed out

Figure 18: Anomaly 3.3A zoomed in

3.3A Most of the cracks due to thermal variation have a small width, but in some cases where the width is bigger it is necessary to seek the aid of a professional. To confirm that this is the real case can monitor the temperatures. But in the majority of the cases the procedure is cleaning the crack, filling the crack with a sealant able to withstand the thermal expansion without cracking, wait for the proper cure of the sealant and paint the area to match with the surrounding surface.

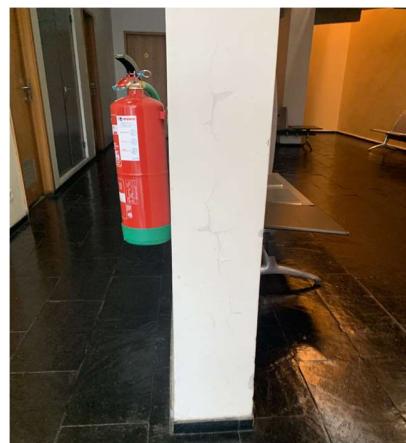
In some walls it's possible to see some spalling in the corners (3.3B), as shown in Figure 19, probably due to presence of moisture, which as explained in the external walls can cause the lack of adherence between the walls and the coatings, causing the wall to spall. Or due to the friction of objects in the corner, being in a wall at the start/end of a corridor.

Figure 19: Anomaly 3.3B

3.3B Knowing that spalling is a common pathology and is mostly superficial, no further tests need to be made, because it's localized in a small area. To repair the pathology, first it's necessary to remove the loose material and clean the surface, after that it is possible to repair by filling the damaged area with a mortar mix and after the cure, paint and do the finishes.

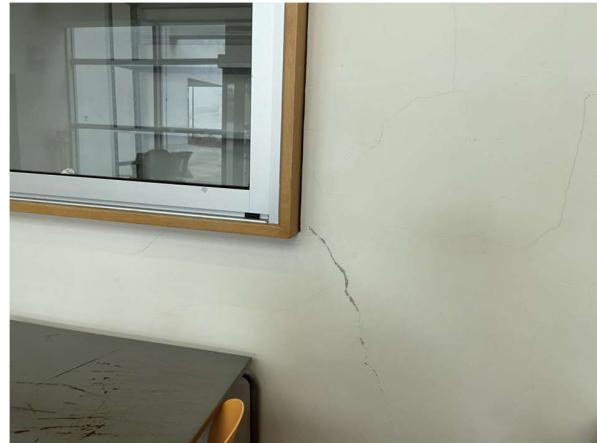
In the photo below, it is possible to see a crack in part of the depth (3.3C), as shown in figure 20, well aligned and unique, probably due to a static load caused by the window, leading to stress. This kind of crack happens in the bottom part of the window, all the way to the other end of it.

Figure 20: Anomaly 3.3C

3.3C Because of the existence of a static load, it would be necessary to do the analysis of the crack to know if it has already stabilized. If it's not stable, it may be necessary to strengthen the wall, to avoid more severe cracks to appear, but the strengthening may not be necessary, because the cracks won't affect any other area directly. If it has already stabilized, it is necessary to clean the crack, then prepare the crack to help with the adherence of the material, then fill the crack with a high-strength epoxy, wait for it to cure and then do the finishes on the surface.

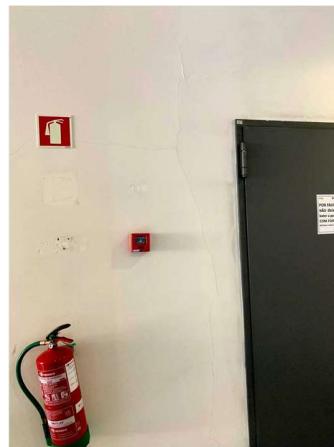
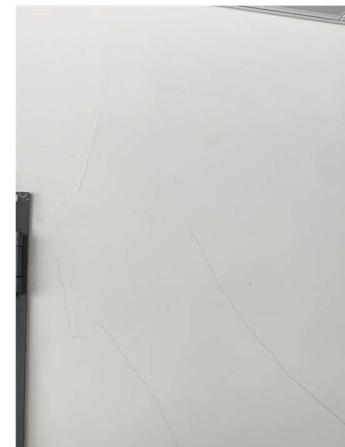
In the walls near doors, it is possible to see the existence of cracks (3.3D), as shown in figures 21 and 22, that seems to be related to the form that the doors were attached to the walls causing the appearance of tensions in different spots. Another possible cause is the presence of temperature changes in the masonry walls, causing the superficial cracks.

Figure 21: Anomaly 3.3D

Figure 22: Anomaly 3.3D

3.3D This pathology is similar to the 3.3A, but due to the fact that it can be related to the installation of the door, it has to be inspected for a period of time to see if it is already stable. If so the proposal of intervention is the same as 3.3A, and if not, it is necessary to test the wall to see its strength, and make sure it can take the stress caused by the door, but the probable fix would be the repair by injection.

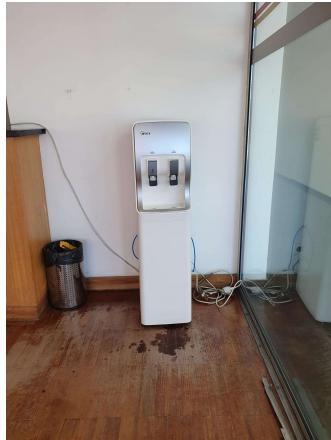
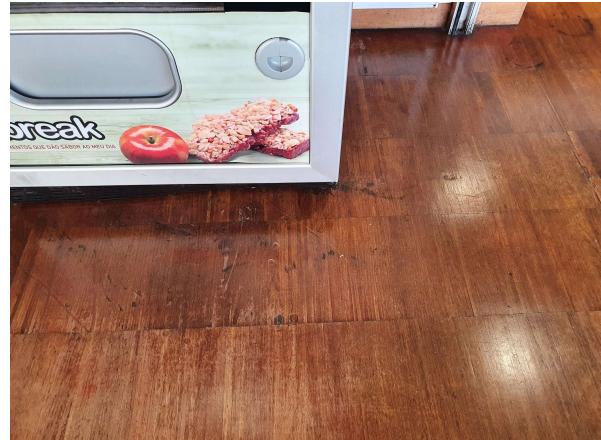
The wooden laminate has stains due to water in the corner of the room. In addition, there are dark spots and wear due to friction of heavy equipment's displacement (coffee machine). It can be also noted wear due traffic and successive washes.

Figure 23: Anomaly 3.4A

Figure 24: Anomaly 3.4A

3.4A There's no alternative to these pathologies but replacing the parts of wooden laminate that are damaged, which does not require high complexity intervention. Concerning the areas affected by water, nevertheless, it's equally important to avoid situations that could promote this kind of pathology. Considering wood is highly prone to

be affected by water, moving the water filter to a more appropriate location is recommended, like external areas or internal wet areas with porcelain flooring. This strategy could eliminate the cause and it can also avoid the appearance and proliferation of fungi.

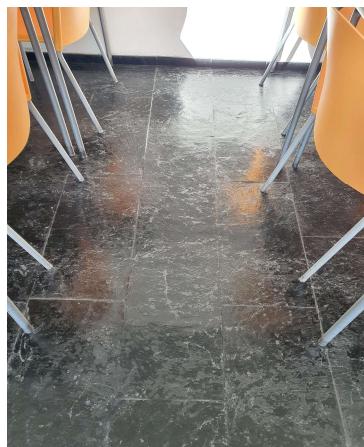
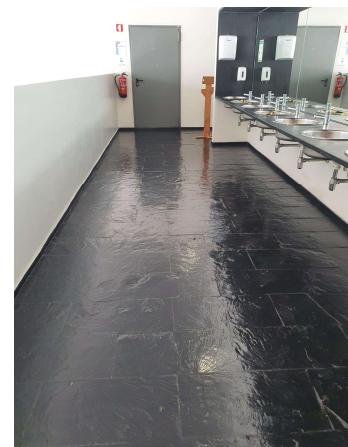
The slate floor also presents wear due to mechanical actions (friction and impact). As it can be verified in the photos below, areas that suggest concentration of repetitive movements are the most likely to be affected by this pathology. Although it can't be assured for the bottom floor, on the upper floor it's conceivable by its black vibrant color that the slate has been recently coated with dark painting as an attempt to repair the visual defects.

Figure 25: Anomaly 3.4B

Figure 26: Anomaly 3.4B

3.4B During the in-site visit, no slate flooring debonding was observed. A wear process was the most visible pathology, which in this case can be more like an aesthetical issue than a concerning pathology. The most reliable strategy for this case is usually repairing the flooring with polishing or replacing the most damaged slates.

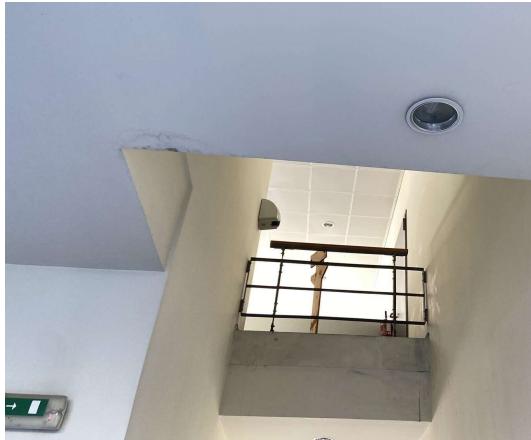
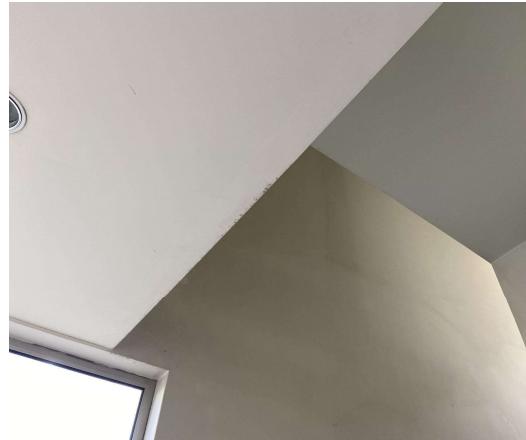
general, the visible slabs didn't present severe anomalies. Otherwise in building A, there are some stains in the bottom of slabs as shown in figure 27 and 28.

Figure 27: Anomaly 3.5A place 1

Figure 28: Anomaly 3.5A place 2

The stain is caused during the use of the building, precisely in the cleaning, when the water, from the washing the coating of the upper floor, drops and accumulates in the bottom of the slab.

3.5A The presence of stains caused by water accumulation is an indicator of the beginning of a possible severe aggression, because the cleaning water is full of chemicals that can react with the coating and affect the concrete, so for protect the coating, before it start to flaking it should be applied on the upper floor, some barrier in the border to avoid the water to drop. In addition, the stain should be cleaned and checked if it is only superficial or not. If it is superficial, only the cleaning will be enough, if the stain already affects the coaling, a paint repair should be made in the affected areas.

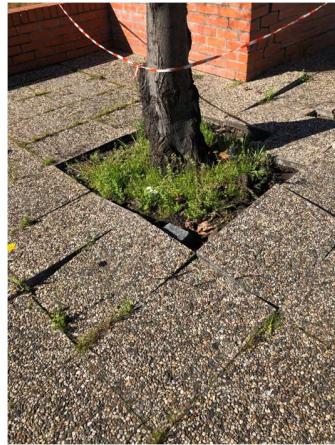
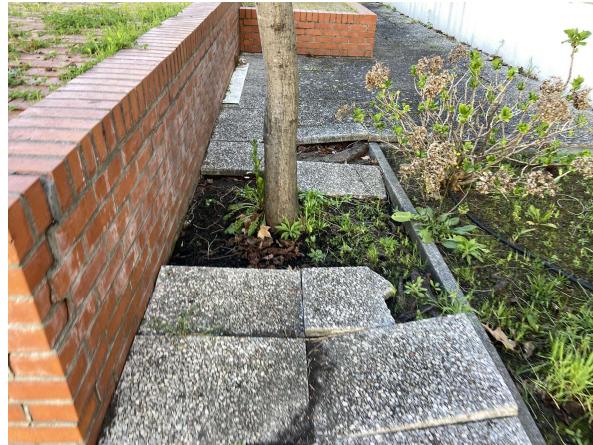
The outside ground structure consists of prefabricated concrete blocks assembled as masonry. In various areas surrounding trees, the same type of pathology is perceived, which is the detachment and pushing of the blocks of concrete towards the outside, as shown in figures 29 and 30.

This anomaly is caused by the growth of the surrounding vegetation, more specifically the extension of the tree roots that started out in the center but have overgrown with time. With the overgrowth of the tree roots under the concrete blocks on the ground, the same blocks are consequently pushed outwards and by that looking misplaced and overlapping each other.

Figure 29: Anomaly 3.6A

Figure 30: Anomaly 3.6A

3.6A No additional testing is required in this case the cause is clear to diagnose. The intervention proposal for this structure's anomaly varies according to the wish of the property owner. It is true that this pathology does not put the users of the building in imminent danger, but it can cause small accidents because it unlevel the ground in this area. The intervention here could be to just leave it as it is, but if the choice is to repair workers should cut the trim the roots of the trees and re-attach the concrete blocks. This should do periodically to avoid the same issue recurring (Pete & Ron's tree service inc., 2015)

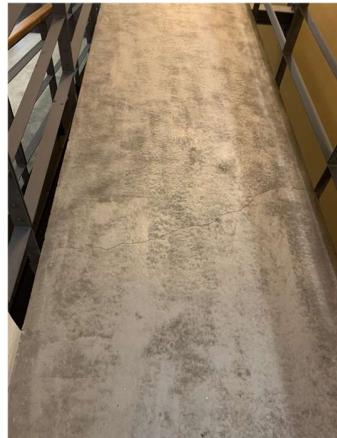
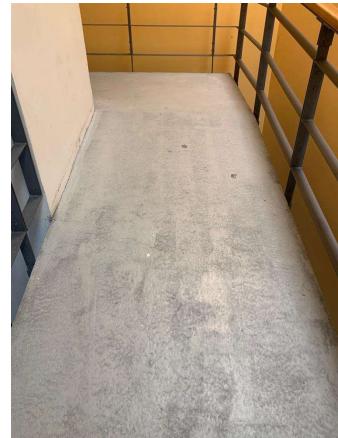
In the ramp it is possible to see some cracks that go through the whole depth, and are repetitive in some parts of it, as it's possible to see in Figures 31 and 32.

Figures 31: Anomaly 3.7A

Figure 32: Anomaly 3.7A

The cracks were probably caused by the shrinkage of the concrete, that happened due to the existence of temperature changes, that can cause the expansion and contraction of the concrete. And also can be related to factors such as humidity and the presence of sunlight, since there is a window in the upper part of the ramp, and the doors of the building are constantly open.

The reasonable way to repair the crack is by injection of epoxy into the crack filling it and preventing further cracking. But in cases of cracking due to shrinkage it's not a permanent fix, so it's important to look further to address the cause of the crack.

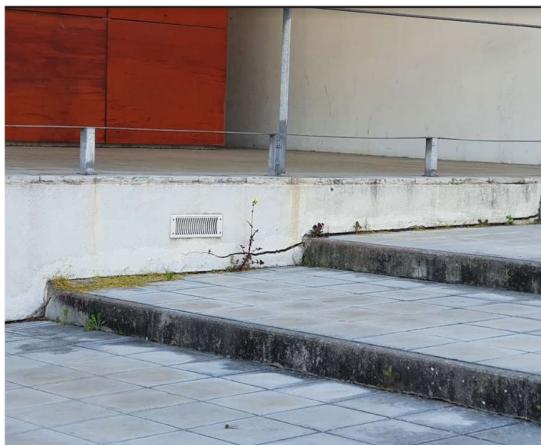
The external stairs leading access to Building B are made of reinforced concrete and are exposed to few pathologies. Its most important one is the crack due to relative displacement of supports on both sides.

In the figure 33, the coating suggests a previous attempt of repair that could not effectively solve the problem. The crack is reappearing and following its former path, since the root cause lies in a deformation of the structure. In the figure 34, it's notable the cracks reaching the drain, which tends to bring damage to the drainage system in the future and promote new pathologies to this structure.

Figure 33: Anomaly 3.8A

3.8A At first, it's recommended to check the evolution of the width of the crack along a predetermined period of time in order to verify whether it's an active or inactive crack. If it's still an on-going settlement process, a strengthening methodology would be the most appropriate. This topic requires further investigation, but as a first hypothesis the enlargement of the existing foundation could be considered the initial strengthening approach, considering this solution fits less complex cases and offers lower costs.

If it's already a dead crack, there is no need for interventions in the foundations and it's possible to repair by different approaches. In this case, considering the crack has $w > 1$ cm, a repair by injection with cement grout would be the most effective.

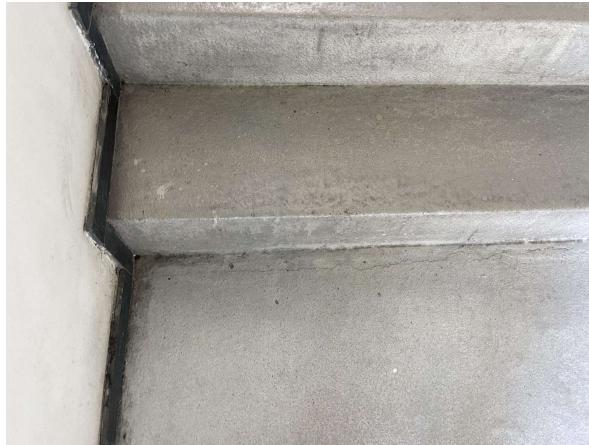
There are internal stairs in both buildings, but only the stair located on building A will be analyzed because that one presents some cracks. The stair is completely made of reinforced concrete and it's possible to check the conservation state of its structure. Out of that fact, it's visible superficial cracks on the surface, as shown in figure 35, these cracks were probably caused in the moment of fabrication, in the process of curing, and present no risk for users.

Figure 35: Anomaly 3.9A

3.9A Due to the fact of the cracks being only superficial and having characteristics of dead cracks, and considering in that point it does not affect the use and the security, it is recommended to just let it be as it is at the structural level. For aesthetic and security objectives, it would be necessary a new paint coating to make it look similar to the initial design and to keep the superficial roughness and avoid accidents.

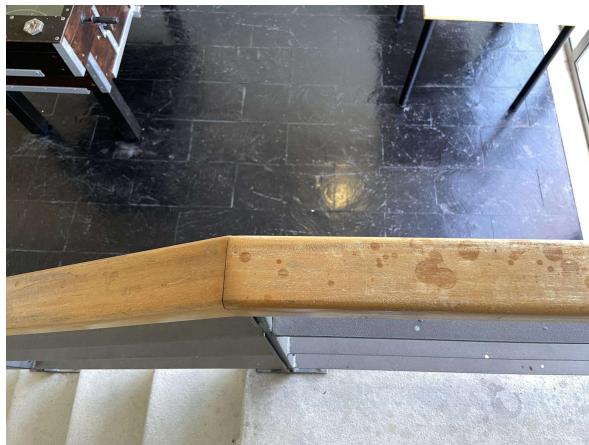
The handrail, made of steel and timber, presents some stains in the palm rest made of timber, pictured in figure 36. These stains probably are a consequence of some execution failure of painting, or it's caused by the daily use, by the interaction between the varnish and water drops, cleaning products or chemicals.

Figure 36: Anomaly 3.9B

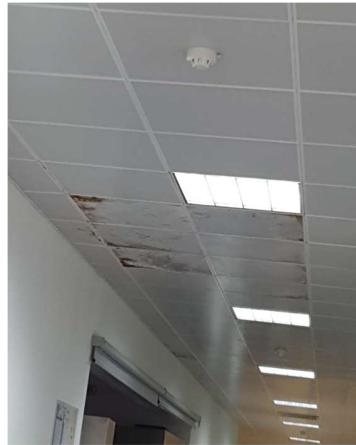
This suspended ceiling pathology, found in building A in the canteen area, consists of dark stains that are apparently distributed evenly across 7 ceiling blocks laid besides each other. The rest of the ceiling is clear and free from anomalies, which suggests a localized cause that is affecting a specific area.

This type of anomaly indicates the presence of a leak in the ceiling structure. In this case water can cause moisture stains and be an ideal spot for mold and mildew if not solved.

Figure 37: Anomaly 3.10A

To fully diagnose this pathology, a pre-intervention inspection is needed: A team specialized in water leakage should proceed with a “damage survey” where they will be able to push open the suspended ceiling in the localized area of the pathology and look for leakages or any other condition inside the ceiling structure that would explain this anomaly and proceed to the intervention strategy.

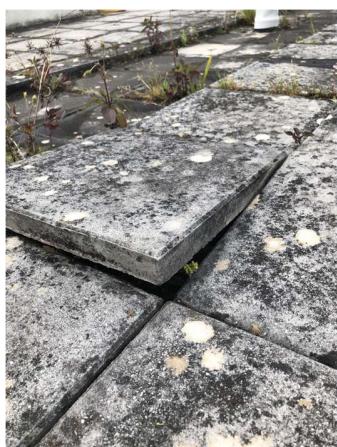
It is possible to see in the roof of the building B the presence of vegetation all through its space, as shown in figure 38 and also in some places there was a detachment of the tiles, as shown in figure 39. The pathology is probably caused by water damage, because of its location, it is susceptible to rainwater constantly, and without the proper drainage, the water intrusion can cause the concrete to weaken and detach. With the detachment of the concrete and the presence of water and moisture, the vegetation grows between the tiles causing more noticeable detachments.

Figure 38: Anomaly 3.11A
