# **Milos Restaurant Roof, Atlantis The Royal, Palm Jumeirah, Dubai**

Engineering Feasibility Report

**September 2023  
Rev. 01**

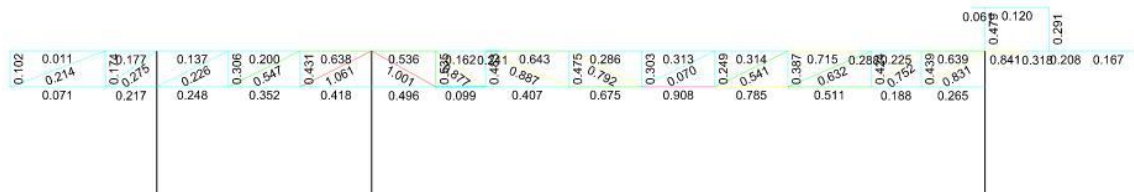
Truss At Grid-949 - Steel Members Design Capacity

The missing steel members definitions in the As-Built drawings have been assumed in the previous issued Report (Rev.0), and recently such steel members definitions are received in the Shop drawings and used in the updated structural analysis model. Accordingly, some failed members (in the previous) have been found adequate and some other members as shown by red color in the next figures (which are exceeding 1.0) are inadequate and require strengthening or adding new members.
