Infrastructure Crack Detection Report

Report Date:	2026-02-08 21:56:42
Image File:	00070.jpg
Analysis Status:	Complete

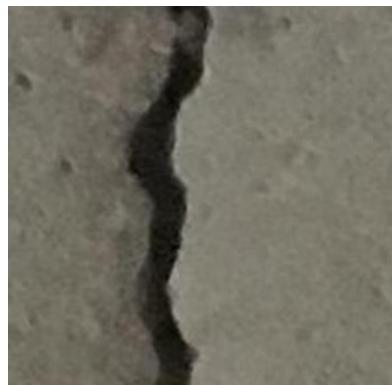
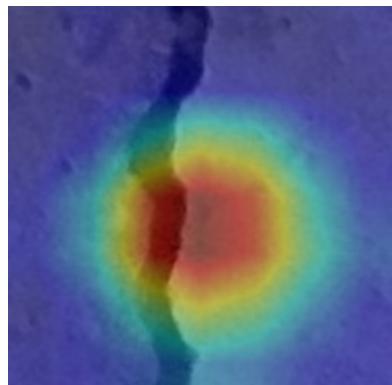
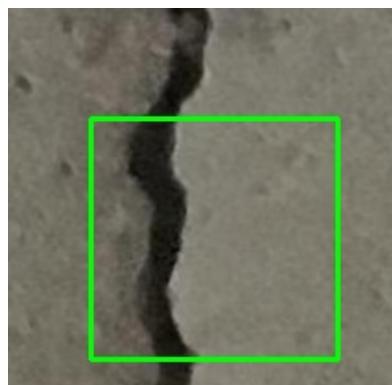
CRACK DETECTED

Confidence: 54.19%

Severity Level:	MEDIUM
Severity Score:	53.6/100
Affected Area:	8.41%
Estimated Length:	200.8 pixels
Estimated Width:	48.5 pixels
Recommendation:	Schedule inspection. Potential structural concern.
