Cathodic Protection of Embedded Iron in Church Towers

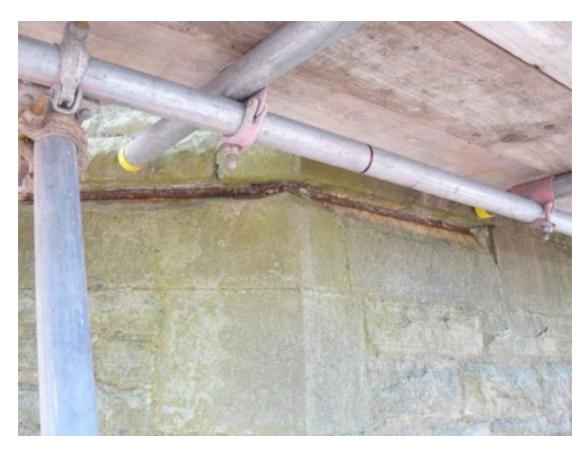
Examples of corroding iron tie bars, which are connected together to form ring beams around church towers, are shown in Figures 1 and 2. Both these examples show spalling of the stones. Ring beams were originally incorporated into the towers to resist the masonry buckling outwards and to strengthen the walls to resist wind loading. Normally they are embedded within the external masonry to maximise

Figure 1 Tie bars embedded in the outer masonry and judged to be too disruptive too remove, St Mary's church, Balderstone.

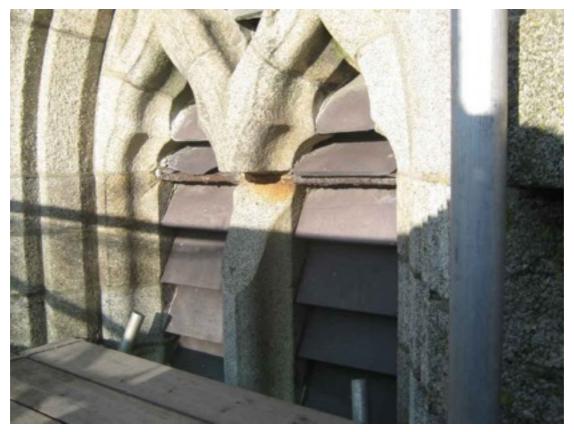
Figure 2 Large tie bars embedded in the inner masonry and passing through the mullions, resulting in fracture of the granite, St Aidan's Cathedral, Enniscorthy.

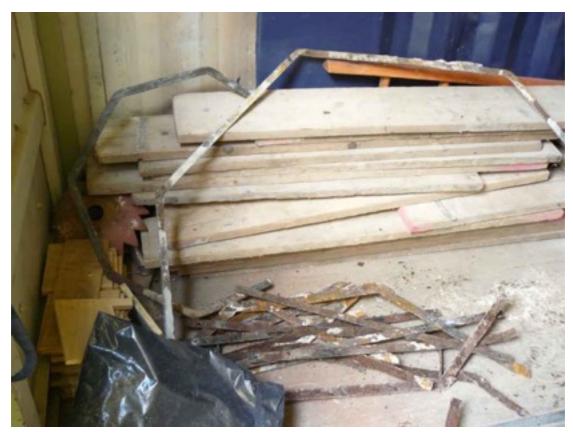
Figure 3 Corroding wrought iron fitments, which were readily removed from the tower, St Mary's church, Balderstone.

The conventional remedy has usually involved surgery to remove the iron fittings and cramps, Figure 3. They may sometimes be replaced with non-corroding phosphor bronze or stainless steel, or even left without replacement, prior to repair to the stonework. Conventional treatments can sometimes be highly invasive involving large-scale opening up to expose and treat affected components or even demolition to replace the iron. Cathodic protection offers a non-intrusive, alternative approach to the treatment of rusting iron embedded in masonry and stone.

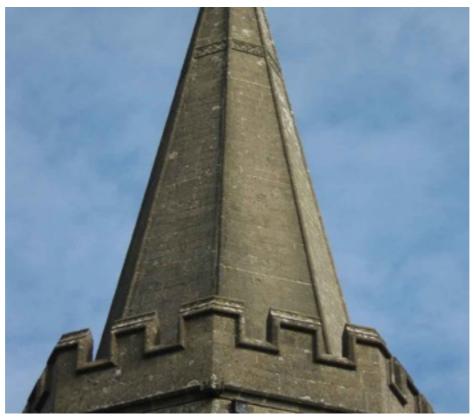
Figure 6 Expansion and re-pointing of the joints associated with ongoing corrosion of three ring beams, St Aldhelms church tower, Doulting.

The 'positive' side of the CP circuit is formed by the anode ribbon, which should be installed equidistantly above and below the tie bars or ring beam. If the ring beams are fitted externally then the anode ribbon should also be fitted in the external joints, Figure 5. This has the added benefit that the external faces of the stones normally have higher moisture contents, as compared to the inner faces, and their electrical resistance will therefore be lower, requiring a decreased driving potential. Sometimes the ring beams are mounted internally and this may require internal scaffolding, or possibly working with rope access specialists, to install the system, Figure 6 and 7.

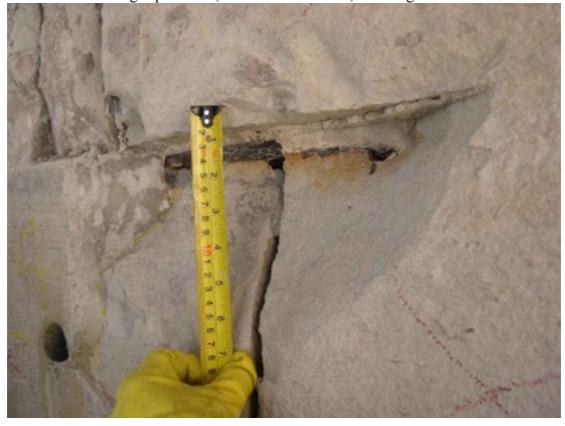
Wrought iron cramps are commonly found between stones in many church towers. Corrosion of the cramps results in expansion and cracking of the stones, Figure 8. If the situation is left unchecked, rainwater may have direct access to the iron cramps and the rate of corrosion increases, Figure 9.

Figure 8 Internal damage to the stones due to corrosion of an iron cramp, St Michael and All Angel's church, Great Witley.

Many of the corroded iron cramps could be removed when the wounded stones is repaired and/or stainless steel cramps re-inserted. For the remaining cramps which have not yet damaged the stones; these require 'daisy-chaining' to form a single 'negative' side for the CP circuit. The positive side again using MMO coated titanium anode ribbon and reference electrodes are again located close to the iron cramps.

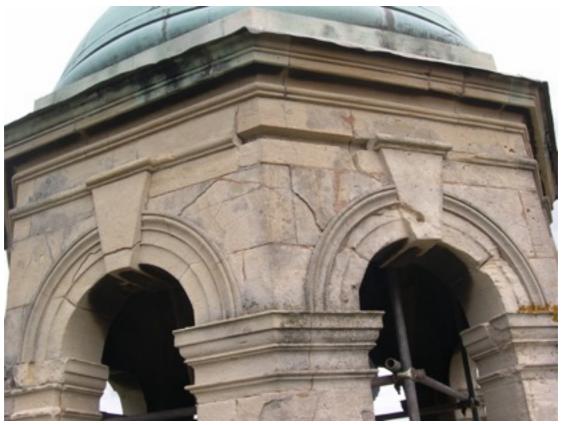
Figure 9 External damage to the tower due to corrosion of iron cramps, St Michael and All Angel's church, Great Witley.

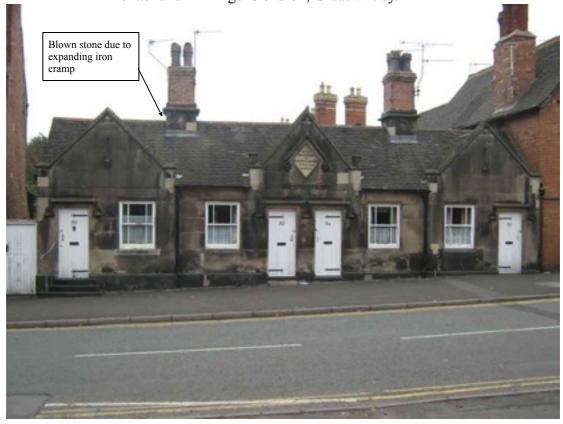
The cottages were inspected in 2009, ten years after installation, and a visual assessment showed no spalling or iron staining where CP had protected the cramps. However, a stray cramp within the chimney, which had not been detected in 1999 and which had been omitted from the SACP system, had continued to corrode and blown the stone, Figure 10.

Figure 10 Whitchurch Almshouses ten years after the installation of cathodic protection – showing an unprotected cramp on the chimney has now fractured the stone.
