Trellises Apartments, Florence Ohio

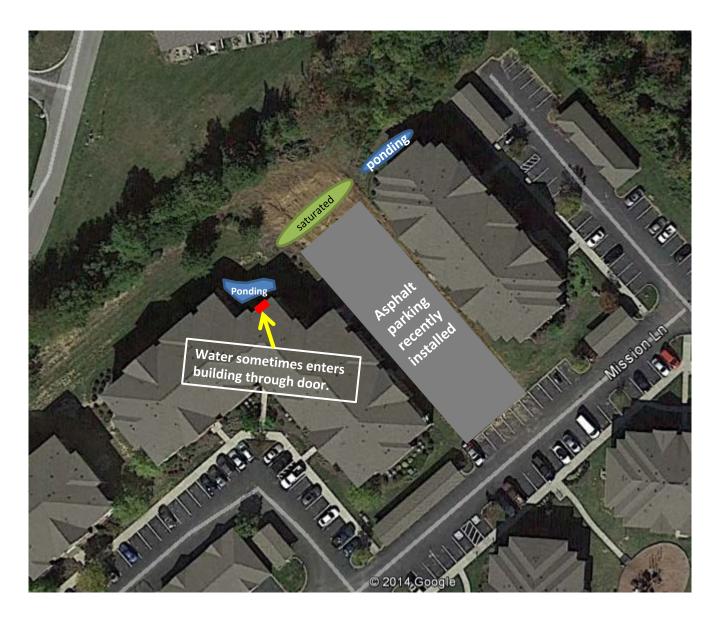
- 1. Water is sitting for a period of time at the base of the hill on the left
- 2. Water pools for a longer time behind building on right, but does not enter the building
- 3. Entire area remains wet 5 to 10 days after a heavy rain
- 4. After a big rain water pooling water can flow into the corner unit on the left building after a major rain.

- 1. Reduce incidents where water entering structure
- 2. Remove standing water after heavy rain within 48 hours.
- 3. Mitigate excessive water from "saturated" area within 48 hours.
