IAI Controller Repair by OEM

Valve Body

Final Visual VB Washer CK-200

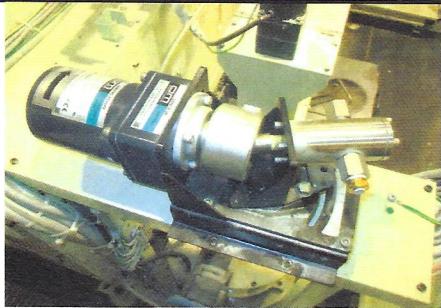
3. BEFORE

\$6,545.00

Lead Time: 60 Days

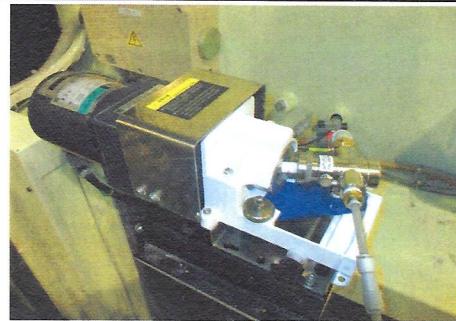
4. AFTER

\$1,100.00

Lead Time: 3-5 Days

By selecting a cheaper pump that is built to last, we have reduced the amount it costs to repair the machine and reduced Mean Time Between Failures (MTBF).

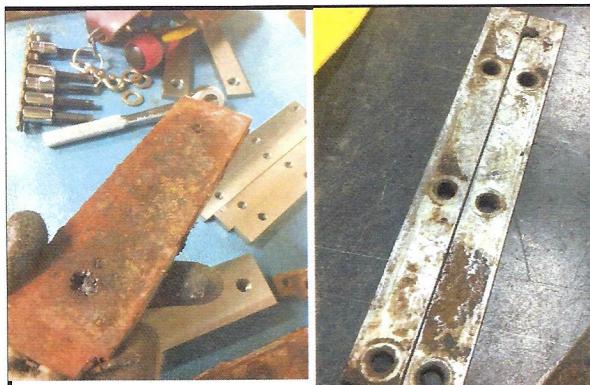
3. BEFORE

- 1) To insure OA is not lost whenever the pillow block bearing base plate, shims, pusher block, and side rails fail due to rust from intense temperature and moisture conditions inside the washer.

Old vs. New
Base Plate

Old Side
Rails
