# Vehicle Damage Inspection Report

Generated On : 07 July 2026, 03:41 PM

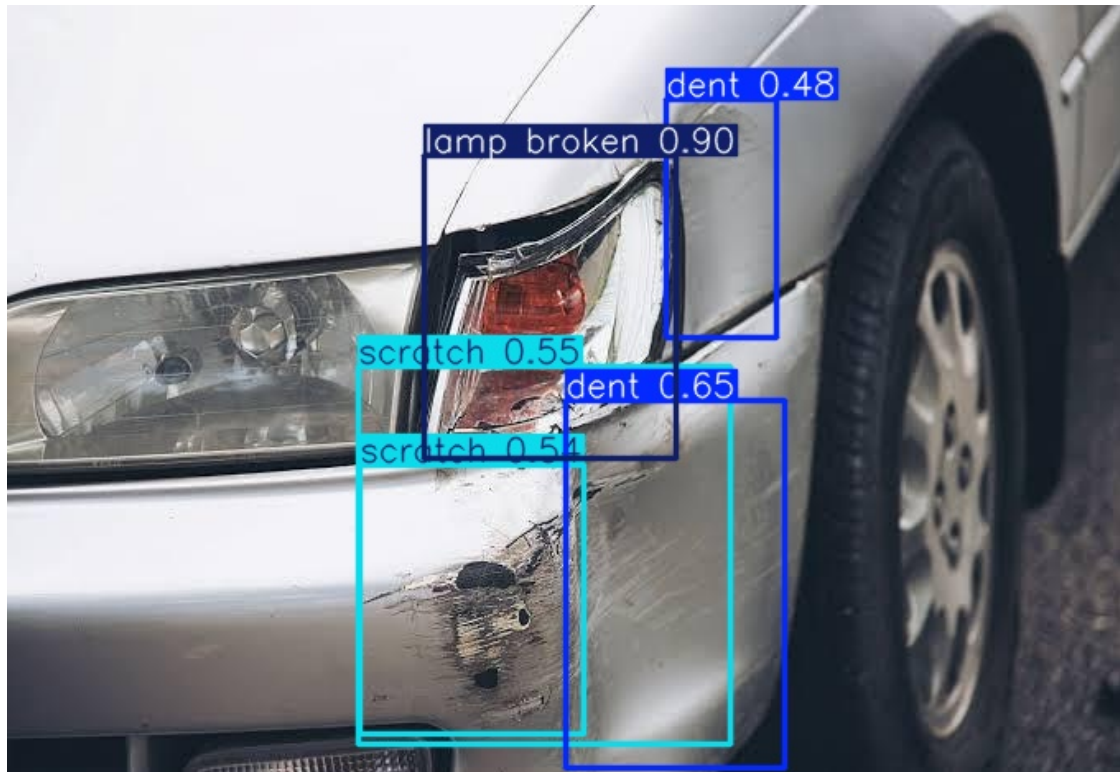
#### **Detected Damage Image**

| Damage | Severity | Location | Confidence | Priority | Estimated Cost |
|---|---|---|---|---|---|
| Lamp Broken | Medium | Rear Center Lamp | 89.8% | Medium | ■3,000 - ■12,000 |
| Dent | Medium | Rear Bumper | 65.4% | Medium | ■5,000 - ■15,000 |
| Scratch | Medium | Rear Bumper | 55.0% | Medium | ■2,000 - ■6,000 |
| Scratch | Medium | Rear Bumper | 53.9% | Medium | ■2,000 - ■6,000 |
| Dent | Minor | Front Bumper | 48.2% | Low | ■5,000 - ■15,000 |

Recommendation : Replace the damaged lamp assembly.

Recommendation : Dent removal and panel inspection recommended.

Severity : **Medium**  
Location : **Rear Bumper**  
Estimated Cost : **■2,000 - ■6,000**  
Repair Priority : **Medium**  
Recommendation : Buffing and repainting recommended.

**Damage #4**  
Damage Type : **Scratch**  
Severity : **Medium**  
Location : **Rear Bumper**  
Estimated Cost : **■2,000 - ■6,000**  
Repair Priority : **Medium**  
Recommendation : Buffing and repainting recommended.

**Damage #5**  
Damage Type : **Dent**  
Severity : **Minor**  
Location : **Front Bumper**  
Estimated Cost : **■5,000 - ■15,000**  
Repair Priority : **Low**  
Recommendation : Dent removal and panel inspection recommended.

Professional inspection is recommended before insurance claim approval.
