## **1 Pictures taken along the Paved National Road Network**

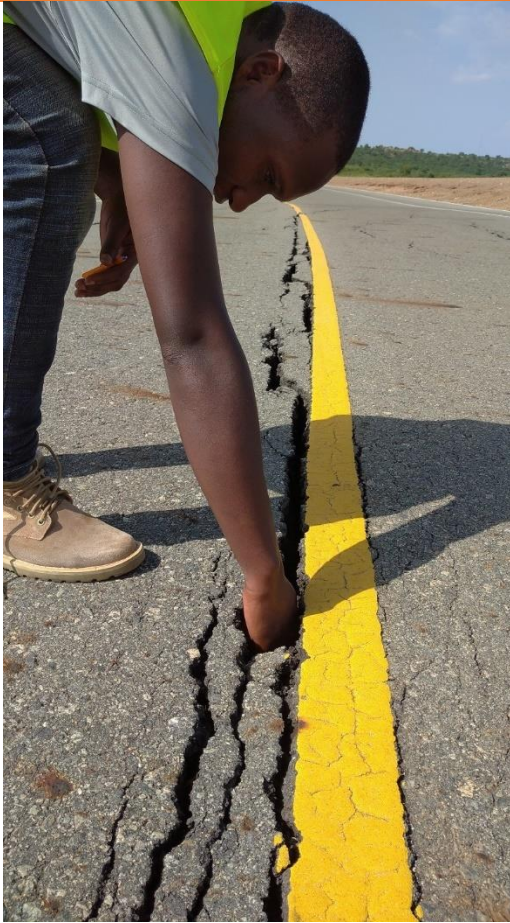
*Photograph 1-1: Sheer cracks along Kyehooro link 1 at chainage 3+950*

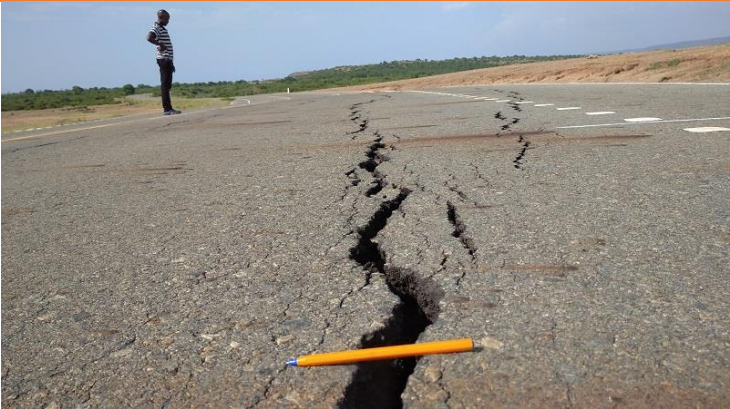
*Photograph 1-2:Wide cracks along Kyehooro 1 at chainage 4+200*

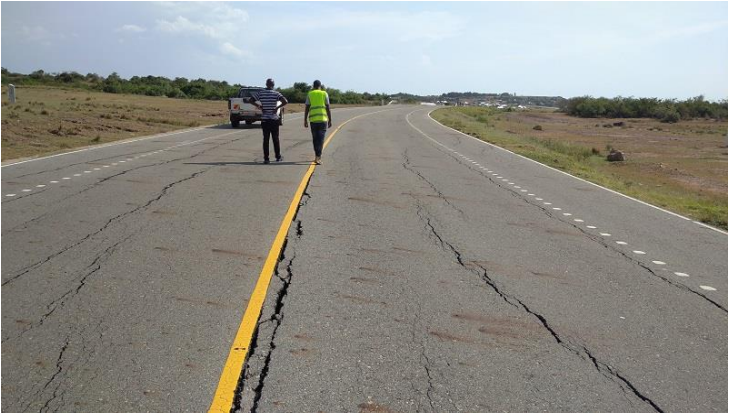
*Photograph 1-3:Sheer cracks along Kyehooro link 1 at chainage 4+800*

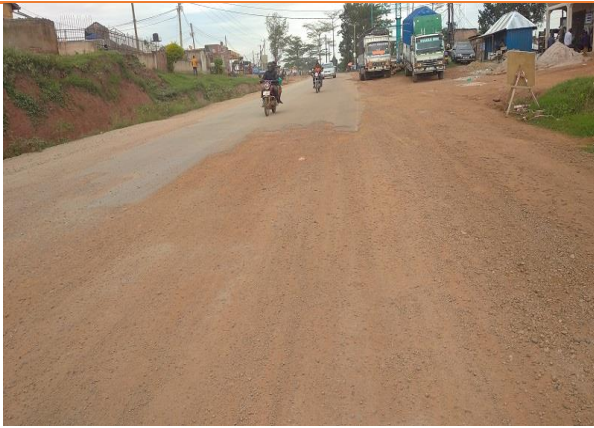
*Photograph 1-4: Severe width loss, Potholes, Cracks and edge break along Myanzi – Kiganda road at chainage 103+200.*

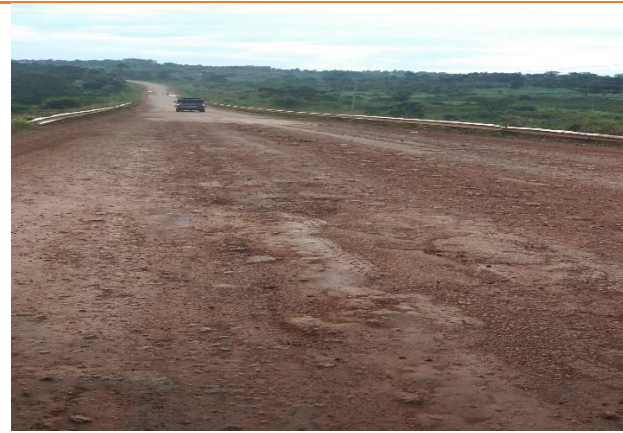
*Photograph 1-5: Ongoing Rehabilitation works along Kiganda - Kitenga road at chainage 108+000 to 109+000.*

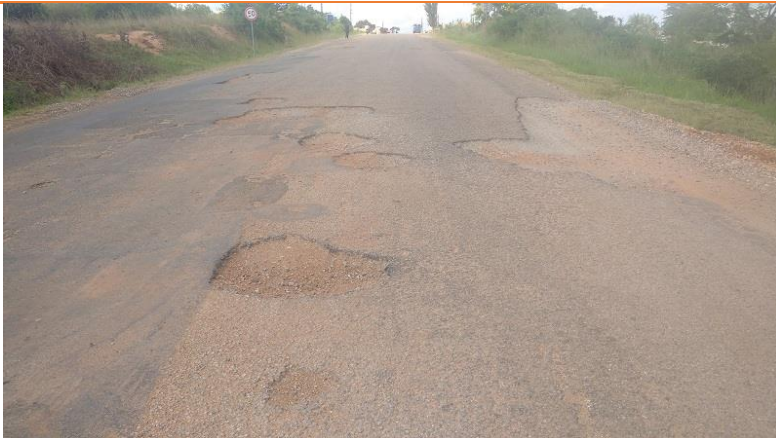
*Photograph 1-6: Potholes, wide cracks and Raveling along Kitenga - Mubende – Lusalira road.*

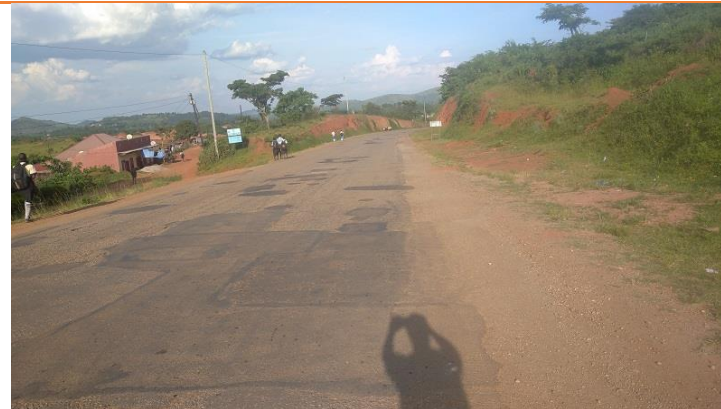
*Photograph 1-7: Patches, Potholes and ravelling along Kyegegwa - Kakabara – Kyenjojo road at chainage 232+000 to 234+000*

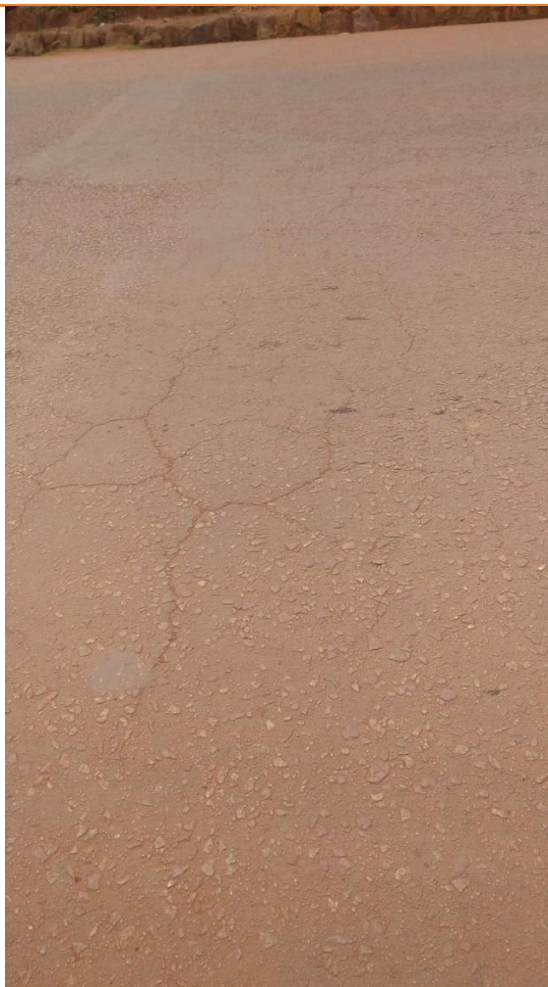
*Photograph 1-8: Block cracks along Kampala – Nansana road at chainage 1+000 to 3+000.*

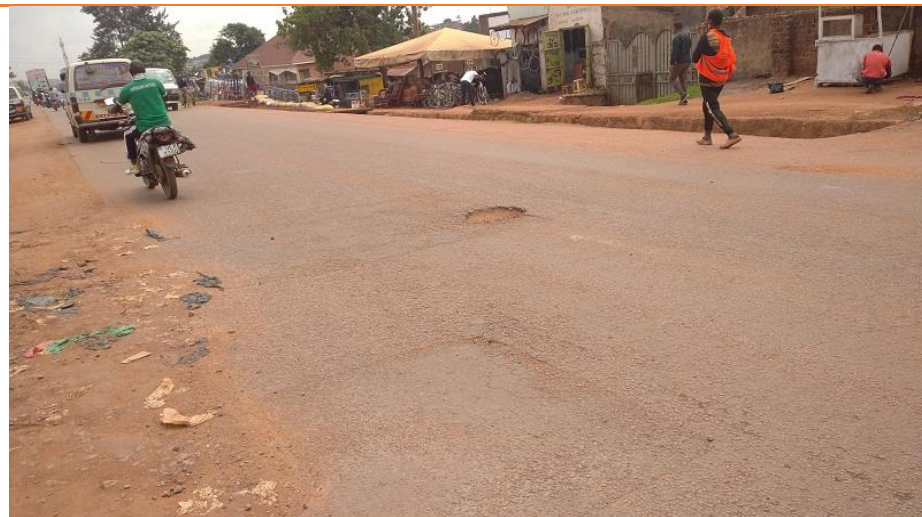
*Photograph 1-9: Section has severe width loss/Edge drop, Cracks and Potholes along Kampala - Nansana road at chainage 3+000.*

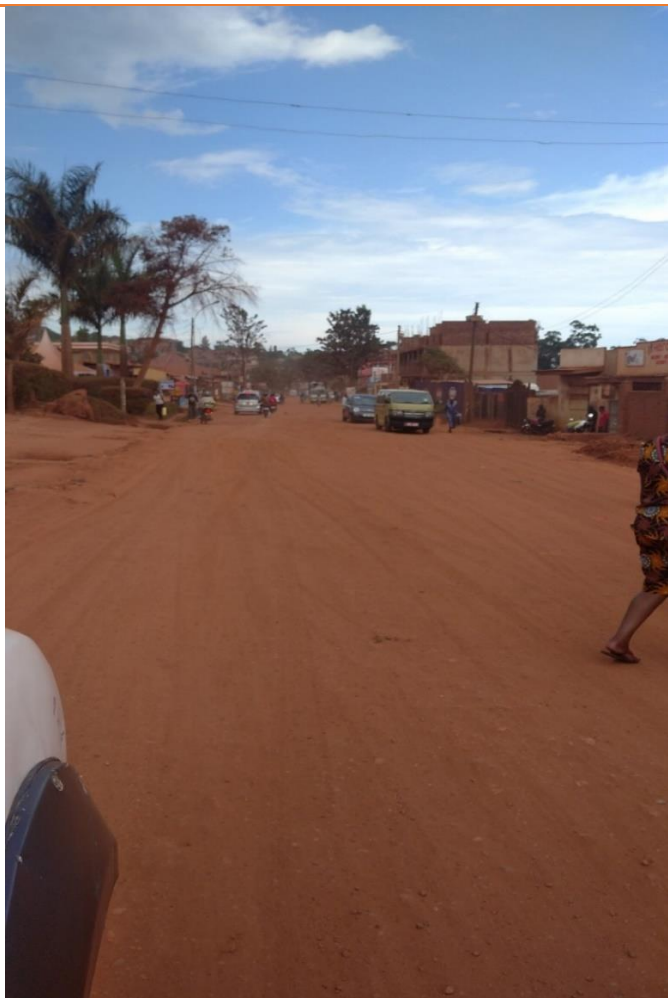
*Photograph 1-10: Most of the pavement has been completely scrapped off along Salaama road.*

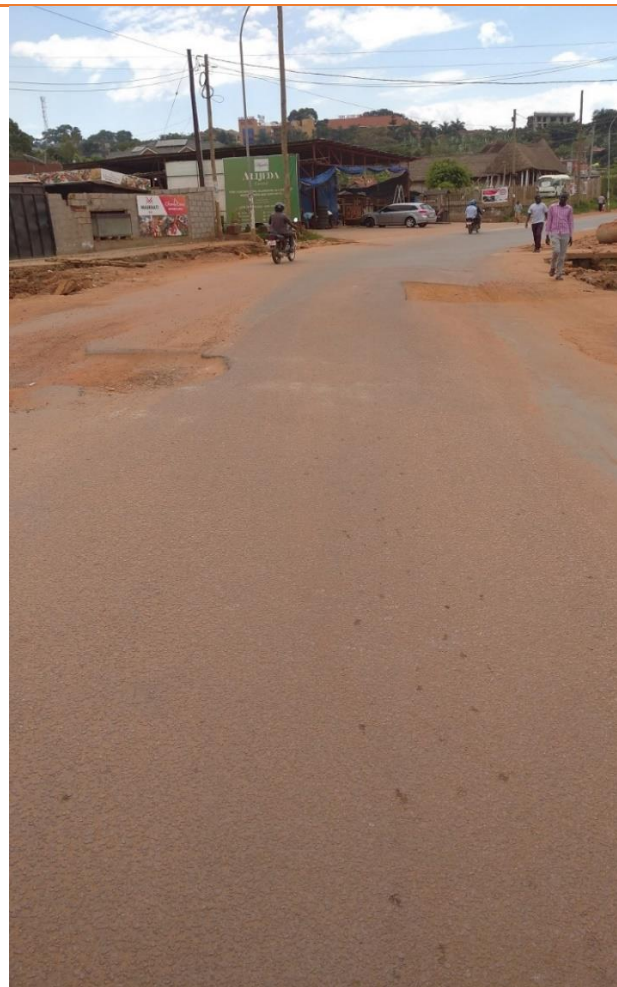
*Photograph 1-11: Cracks, deep Potholes, and width loss, especially in the first km along Nsambya - Capetown villa road.*

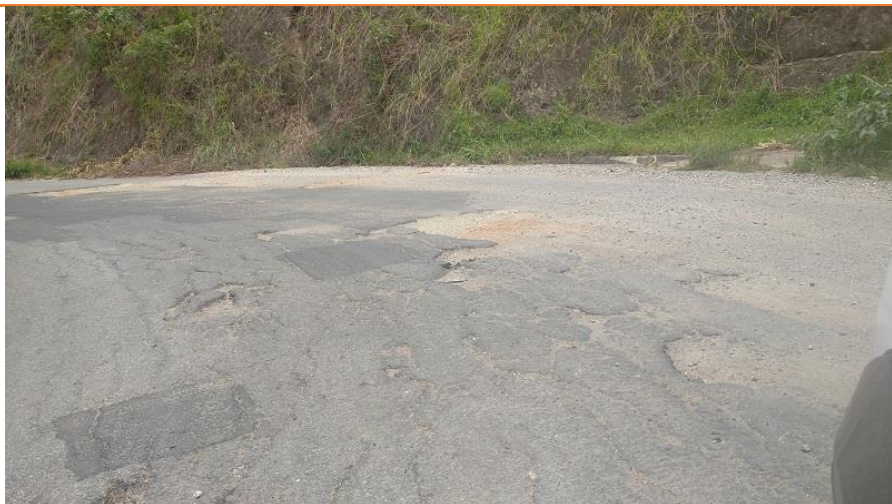
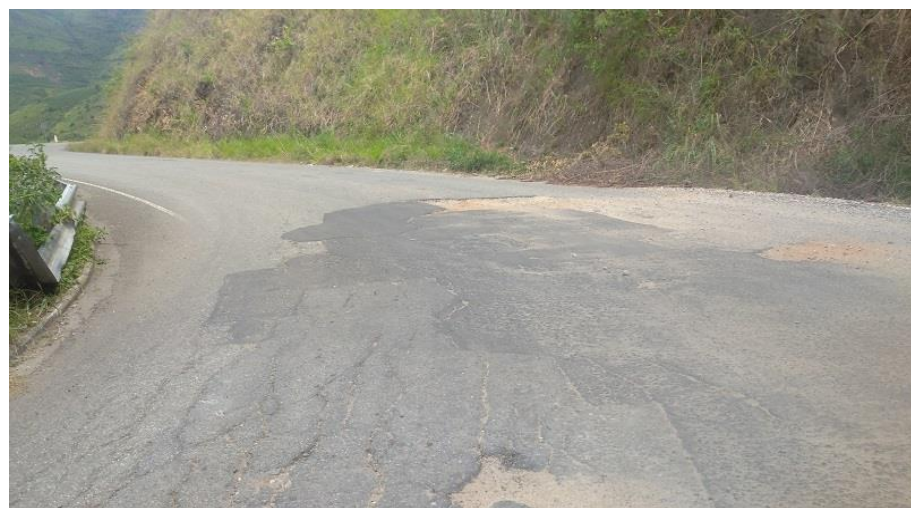
*Photograph 1-12: Several cracked sections in the sharp bends along Fortportal - Kichwamba - Karugutu road.*

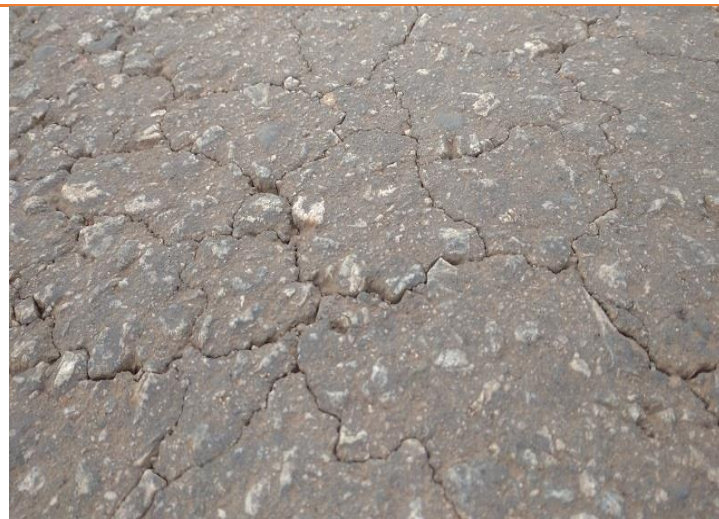
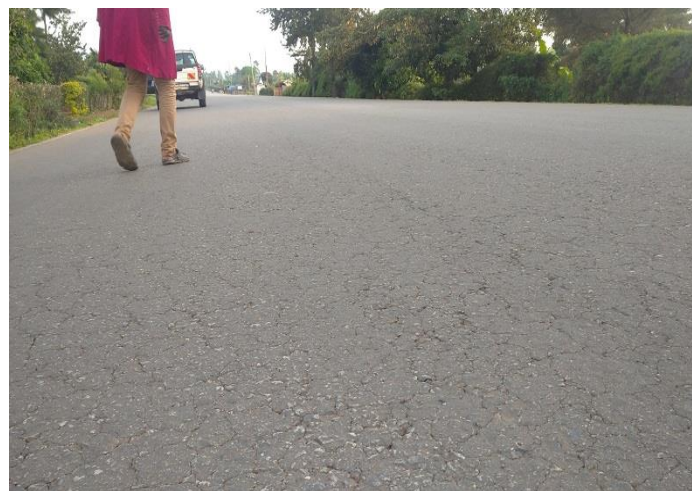
*Photograph 1-13: Severe cracking along Fortportal - Rwimi road at chainage 288+000 to 288+200.*

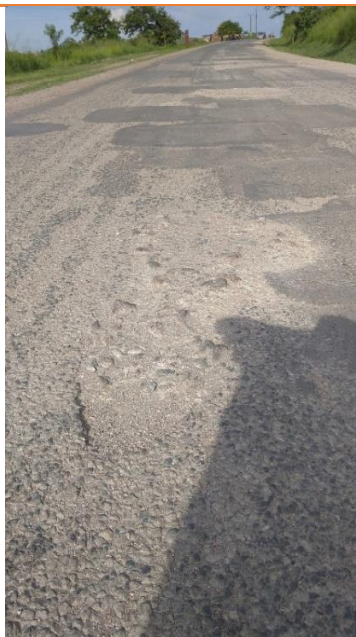
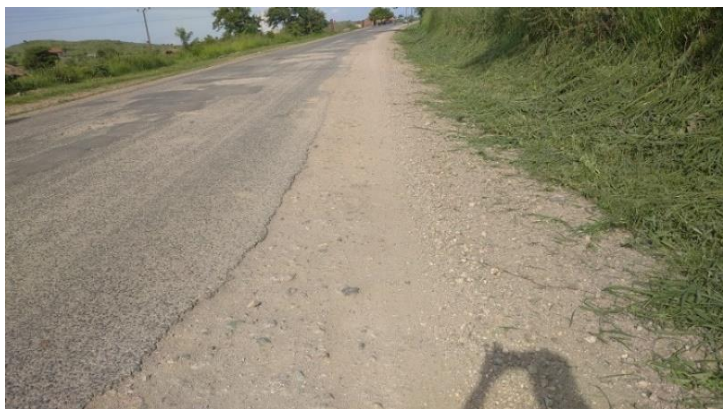
*Photograph 1-14: Severe width loss, Edge break, Wide Cracking and Potholes along Kikorongo - Bwera Mpondwe road.*

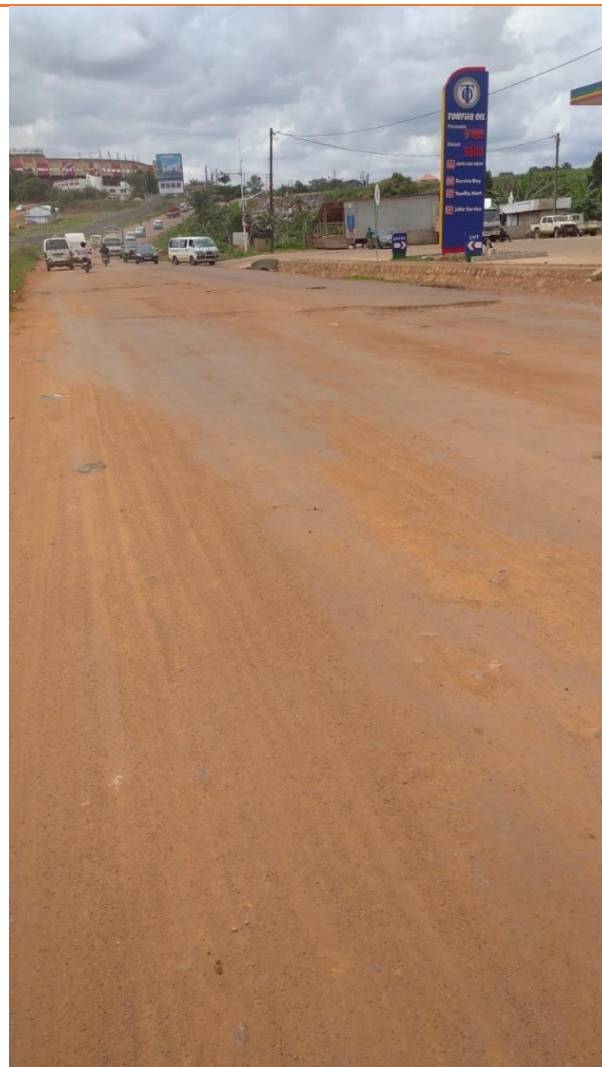
*Photograph 1-15: Wide cracks and Potholes along Namboole Access road.*

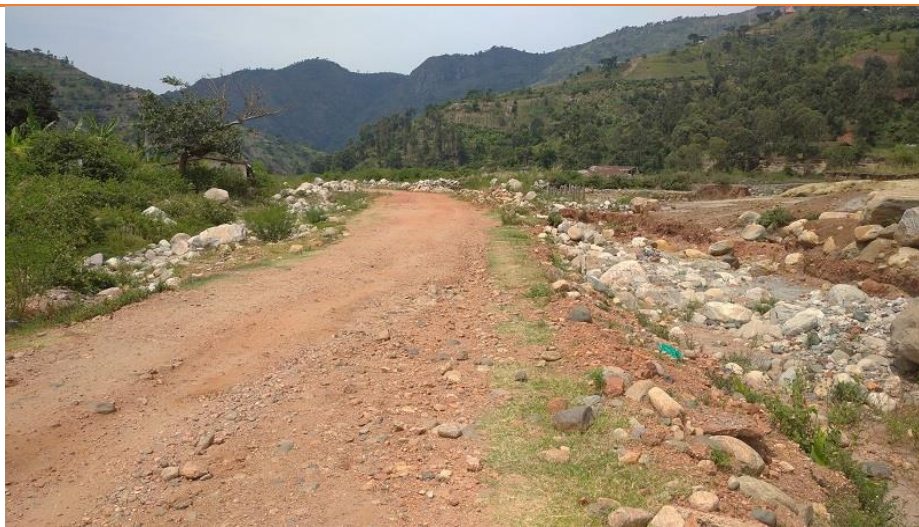
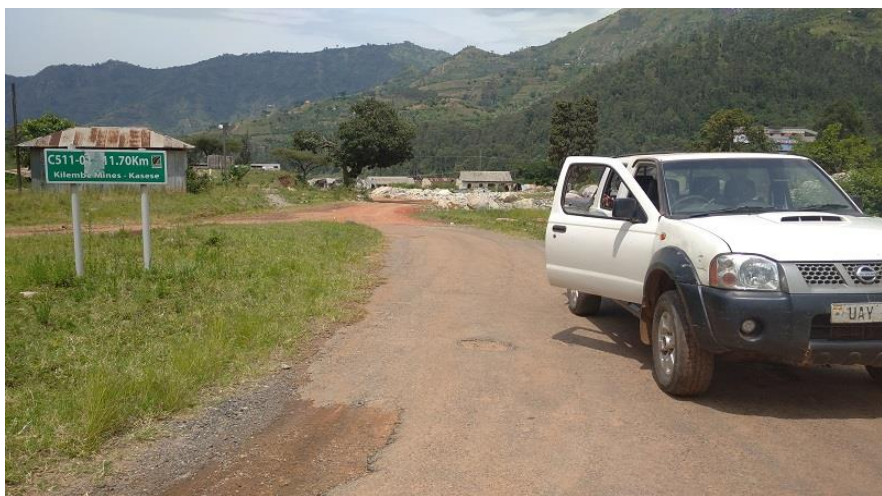
*Photograph 1-16: Pavement severely washed away due to overflow of River Mwamba along Kasese - Kilembe mines road.*

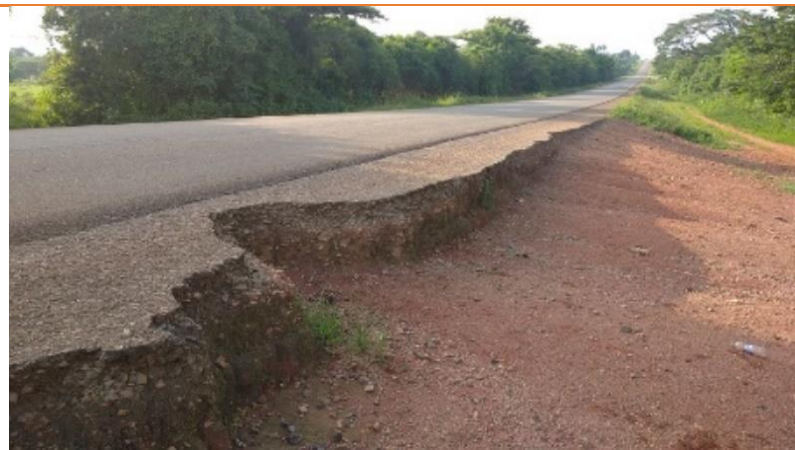
*Photograph 1-17: Severe edge drop/loss Lwamata - Hoima road at chainage 153+000 to 154+000.*

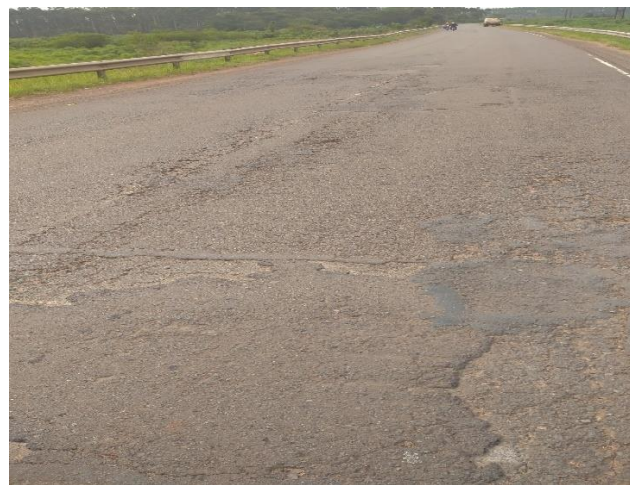
*Photograph 1-18: Critical section with Patches & Cracking along Lwamata - Hoima road at chainage 177+000 to 178+000.*

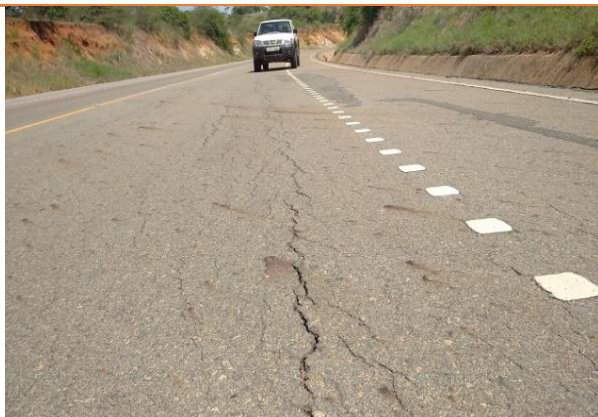
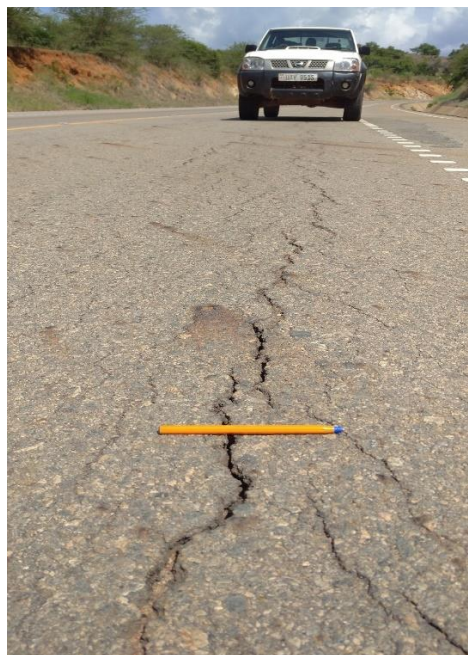
*Photograph 1-19: Wide cracks along Kabaale - Kaiso road at chainage 38+000 to 49+000.*

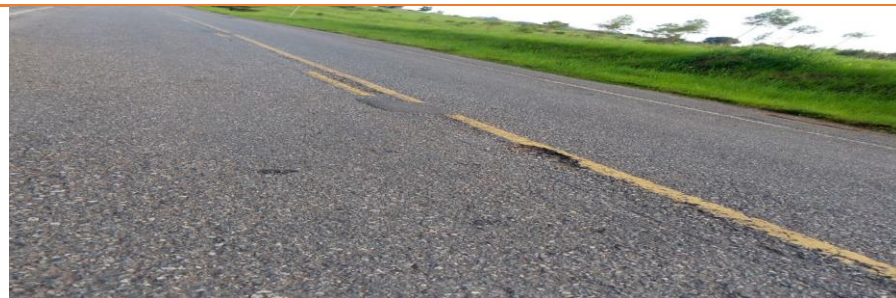
*Photograph 1-20: Patches, Potholes and surface deterioration along Karuma – Olwiyo road.*

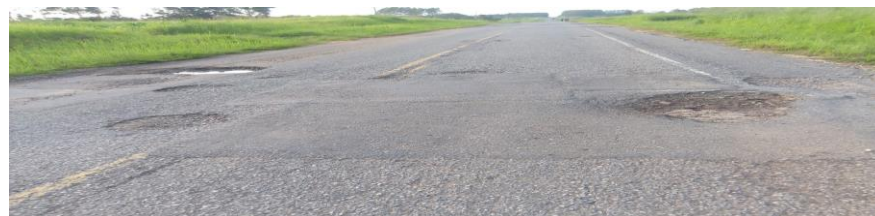
*Photograph 1-21: Patches, Potholes and surface deterioration along Olwiyo – Packwach road.*

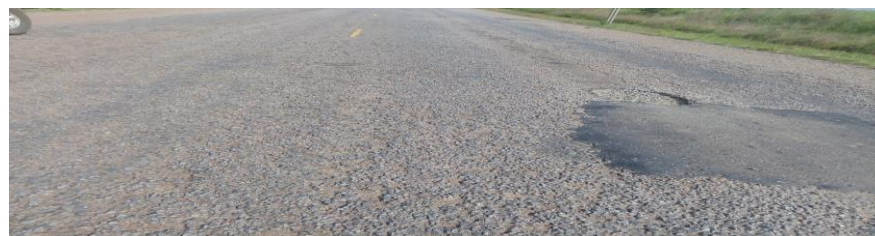
*Photograph 1-22: Patches, Potholes and surface deterioration along Packwach - Nebbi road.*

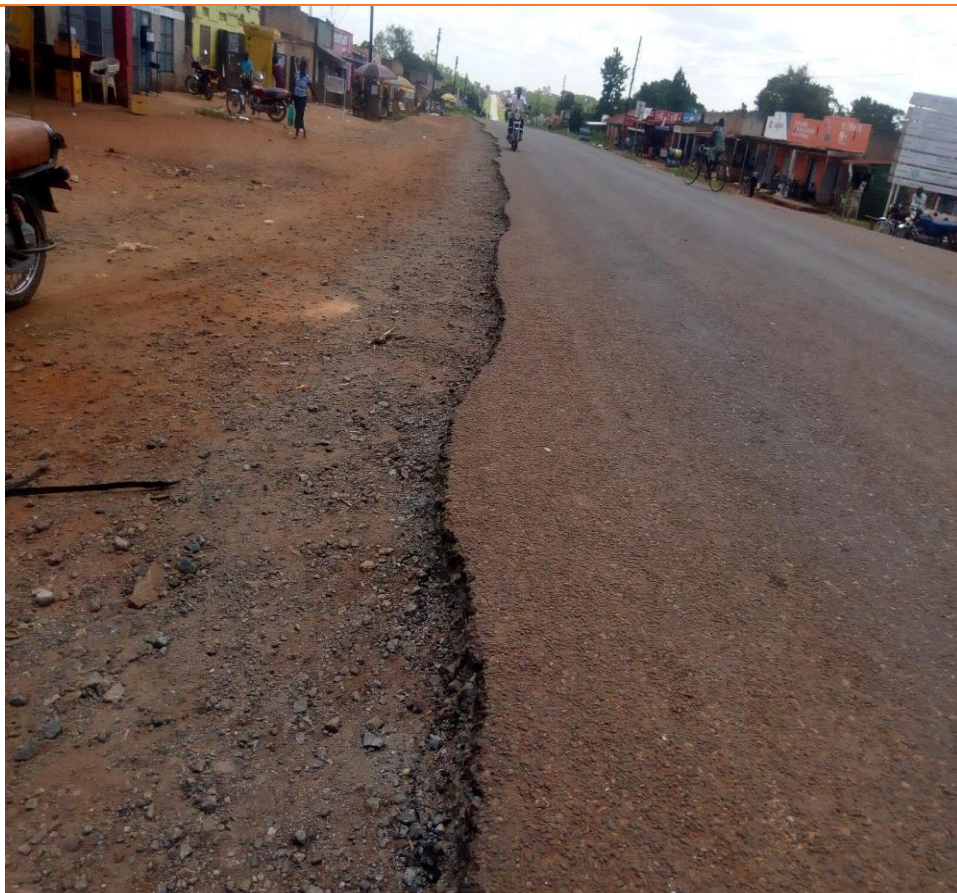
*Photograph 1-23: Width loss, edge loss/drop and surface deterioration along Gulu - Atiak - Nimule (Uganda/Sudan border) road.*

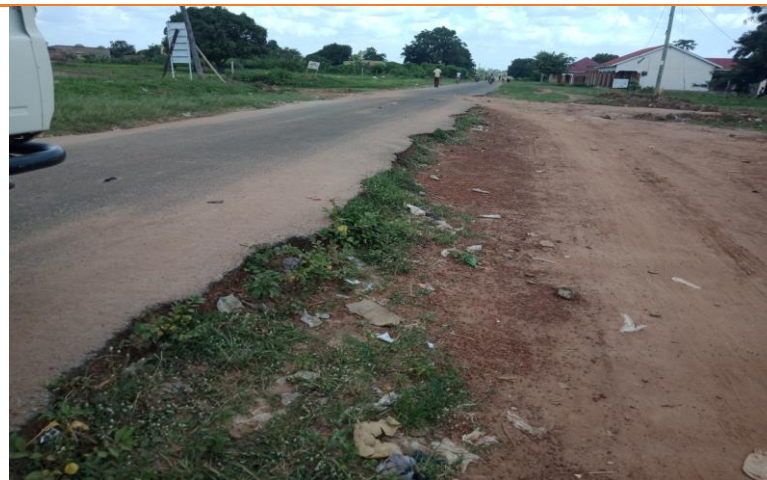
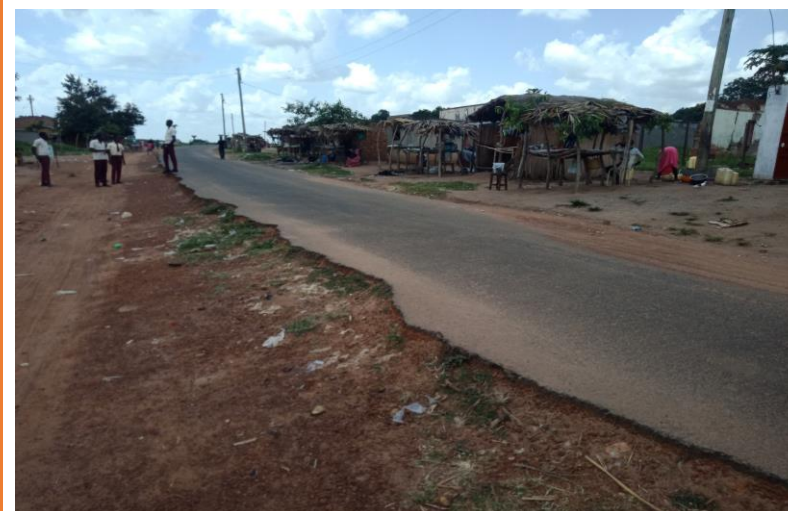
*Photograph 1-24: Width loss and surface deterioration along Arapai - Railway Station road.*

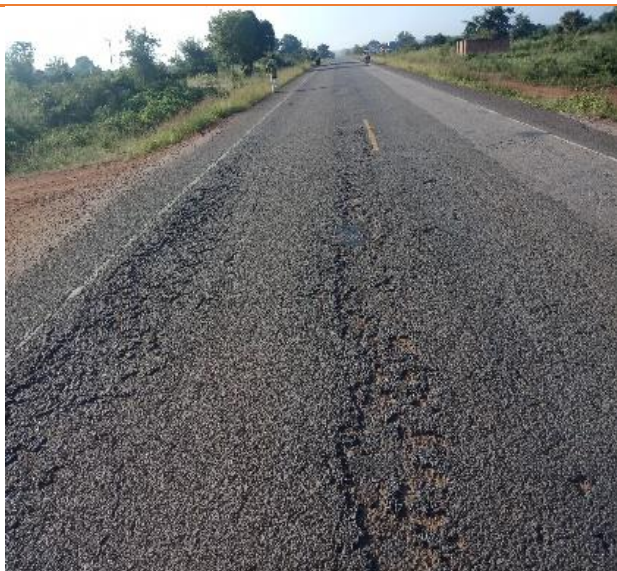
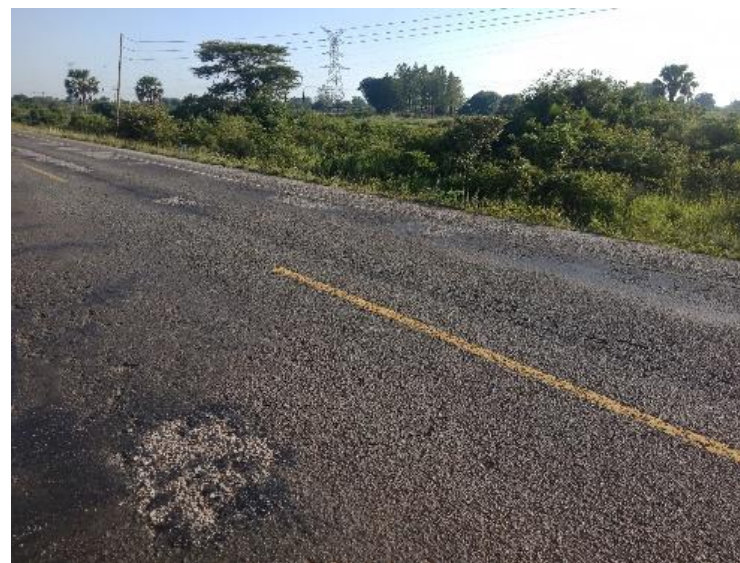
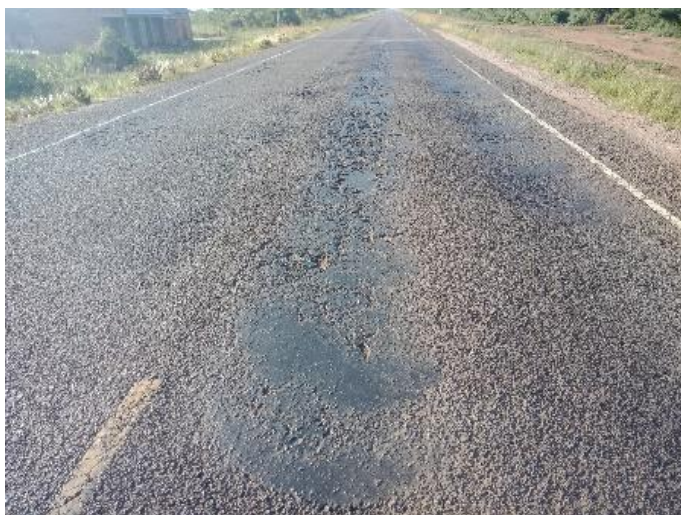
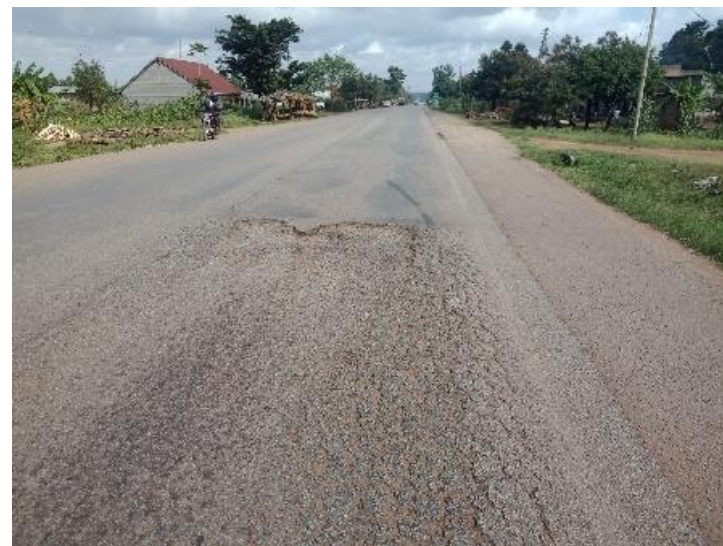
*Photograph 1-25: Severe surface deterioration, potholes and cracking along Soroti - Dokolo road.*

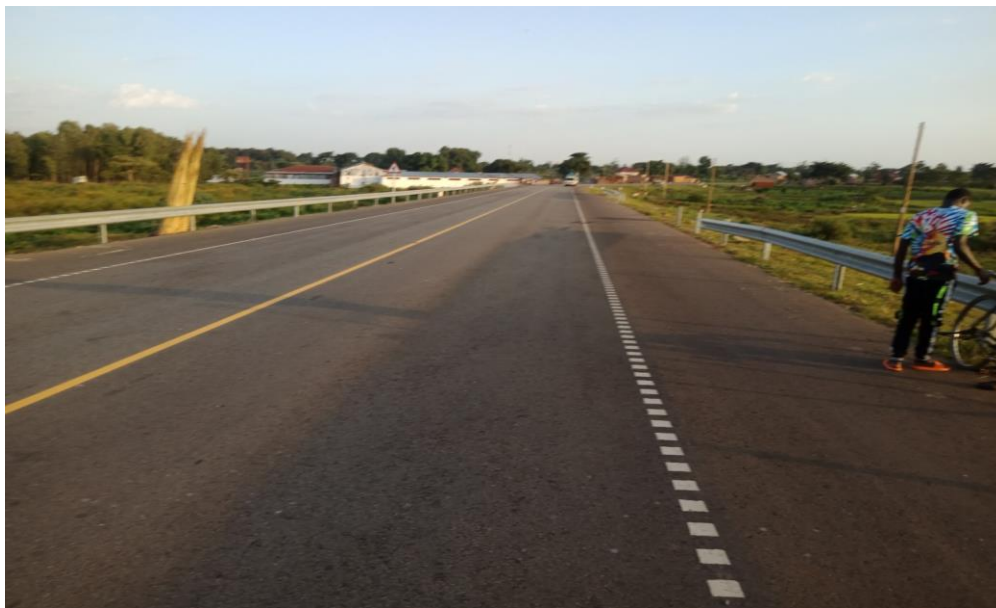
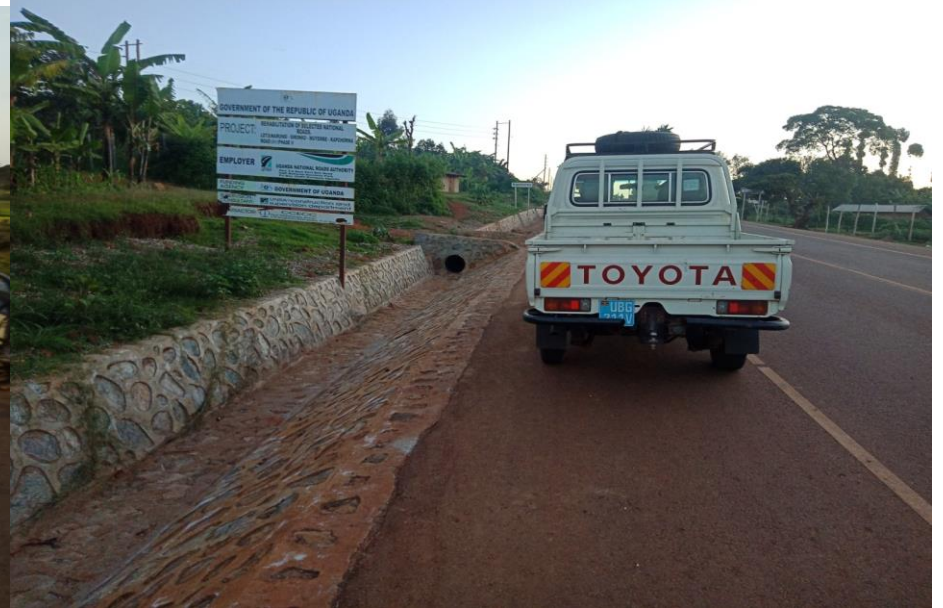
*Photograph 1-26: Newly upgraded pavement along Kapchorwa - Suam road.*

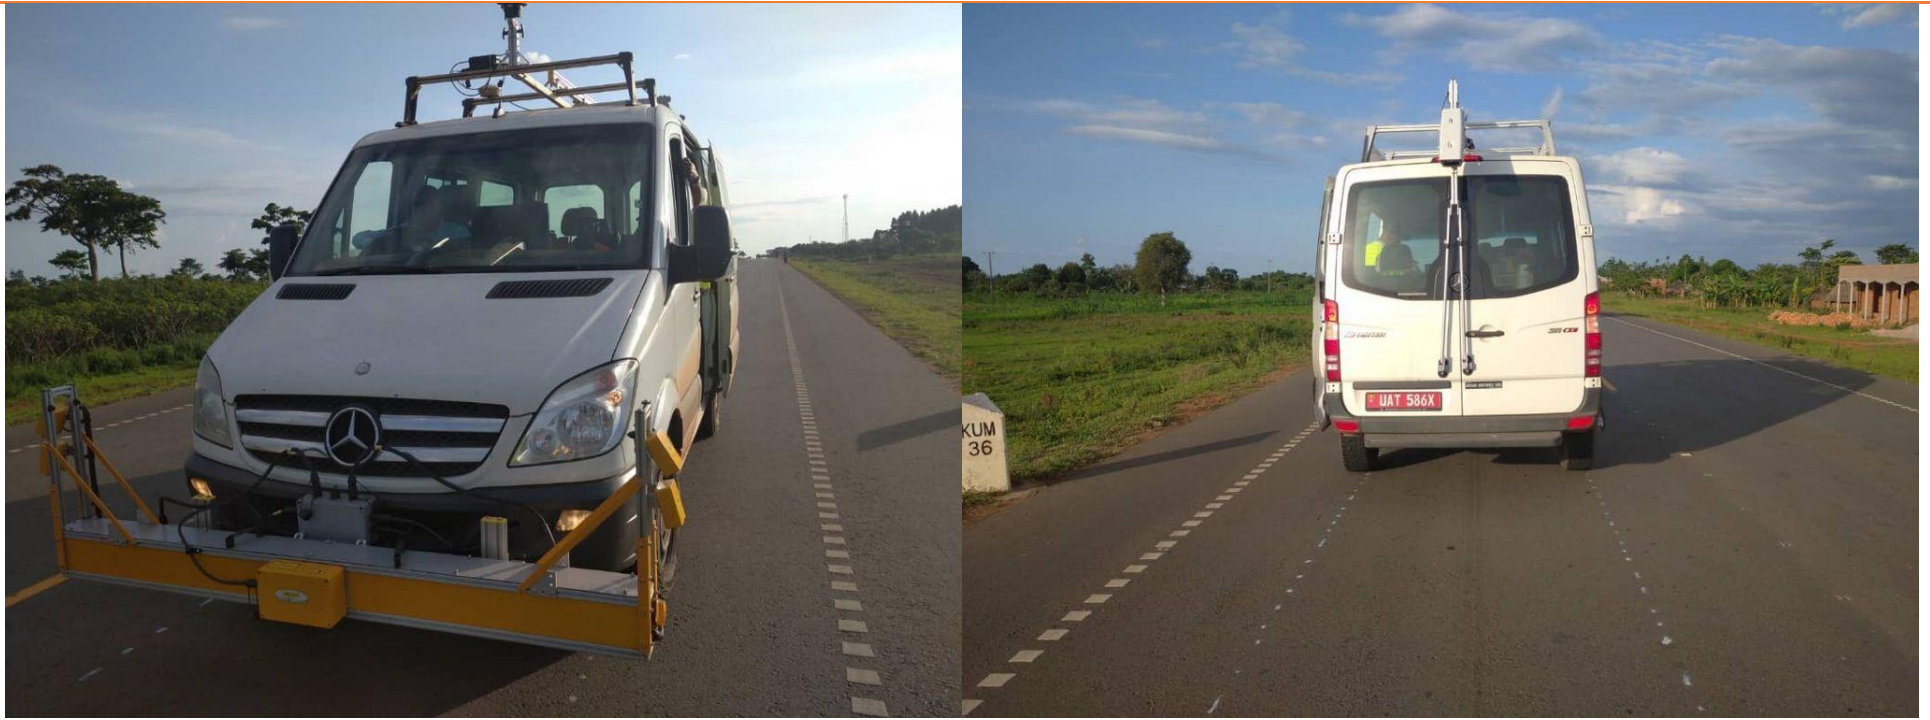
*Photograph 1-27: Newly upgraded pavement along Tirinyi - Pallisa - Kumi road.*

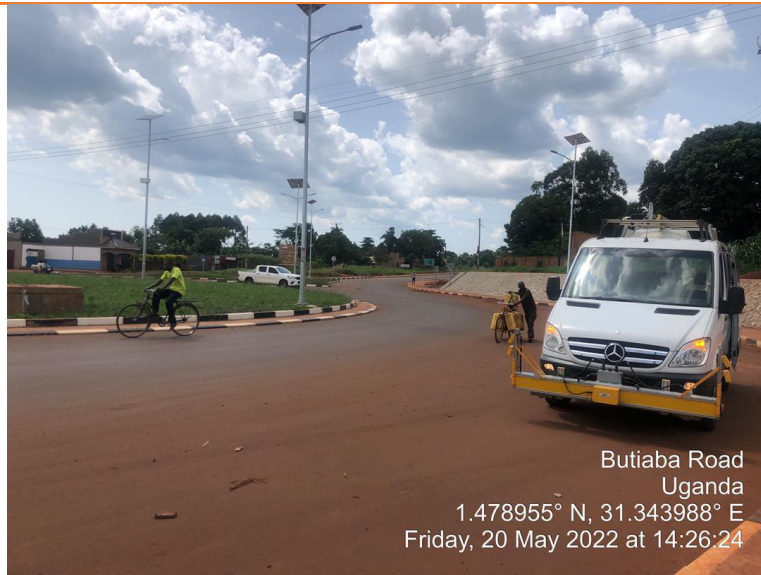
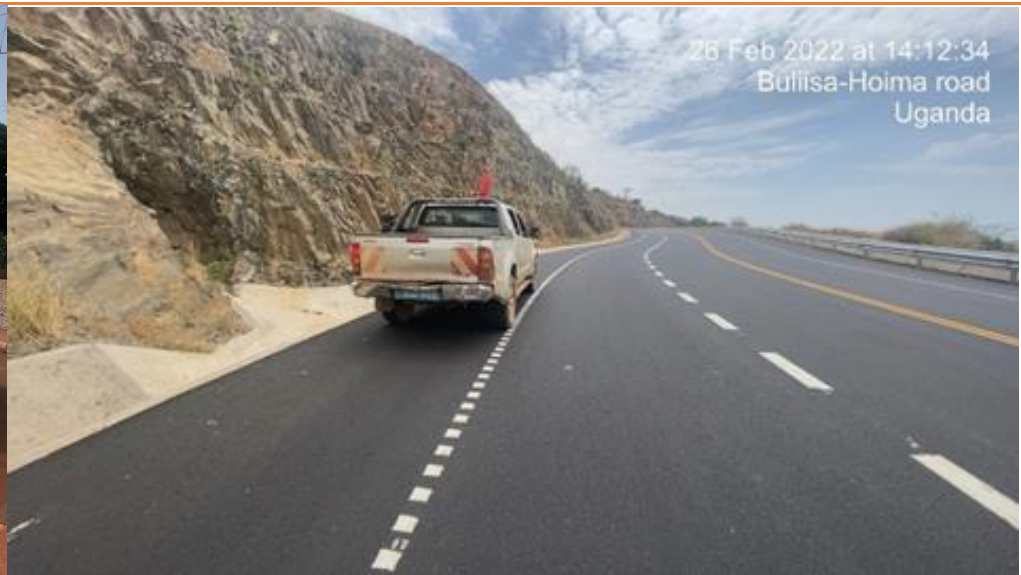
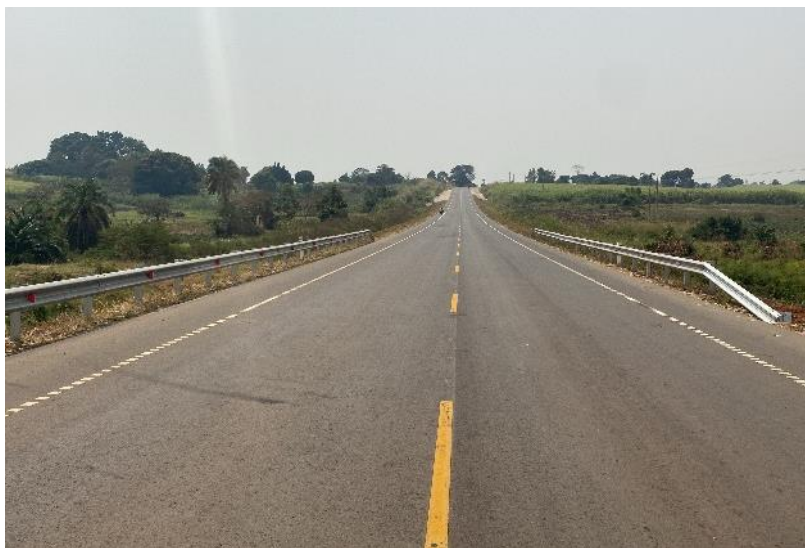
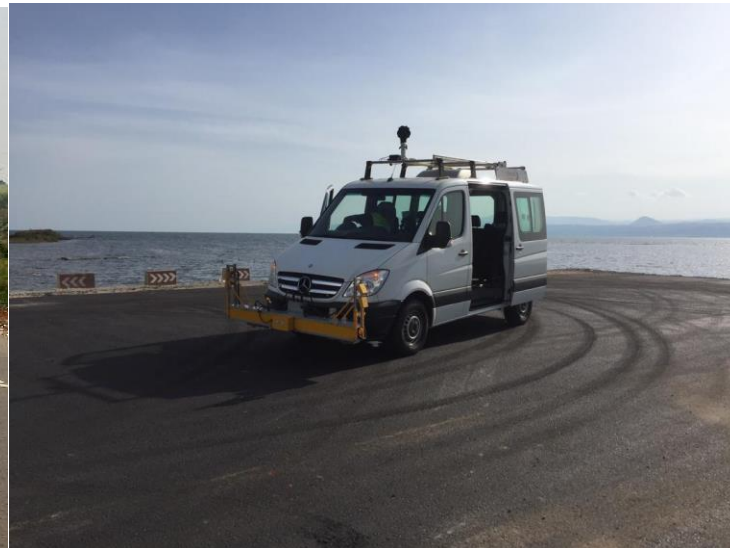
*Photograph 1-28: Newly upgraded pavement along Hoima - Buliisa - Wanseko road.*

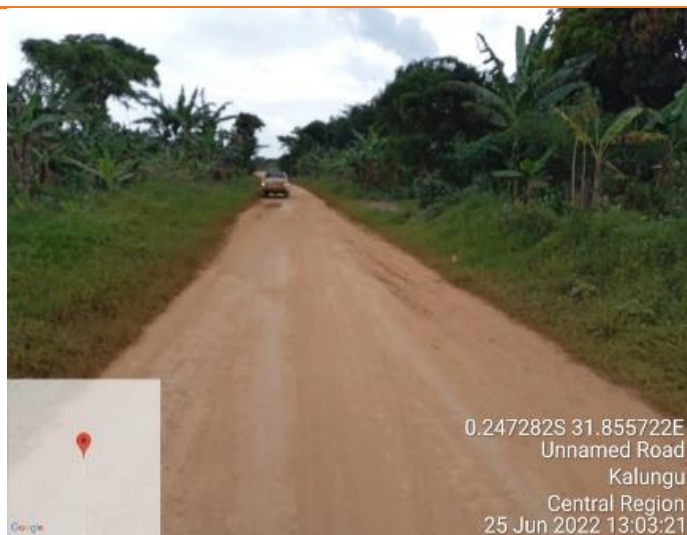
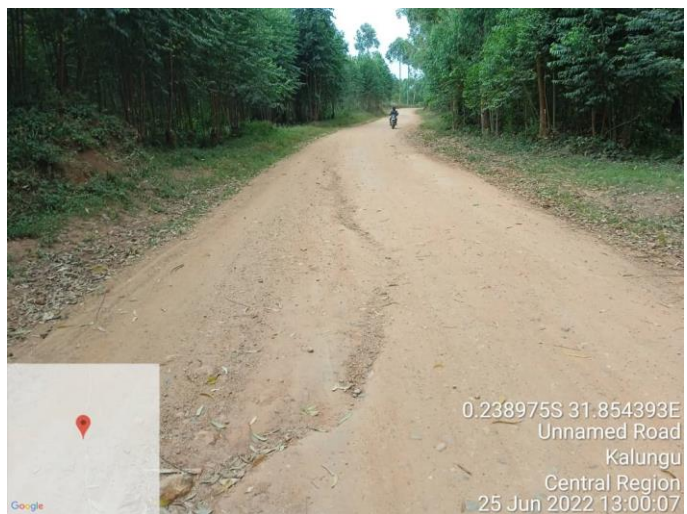
*Photograph 2-1: Rutting and poor material quality along Mukoko – Birinzi - Ssunga road.*

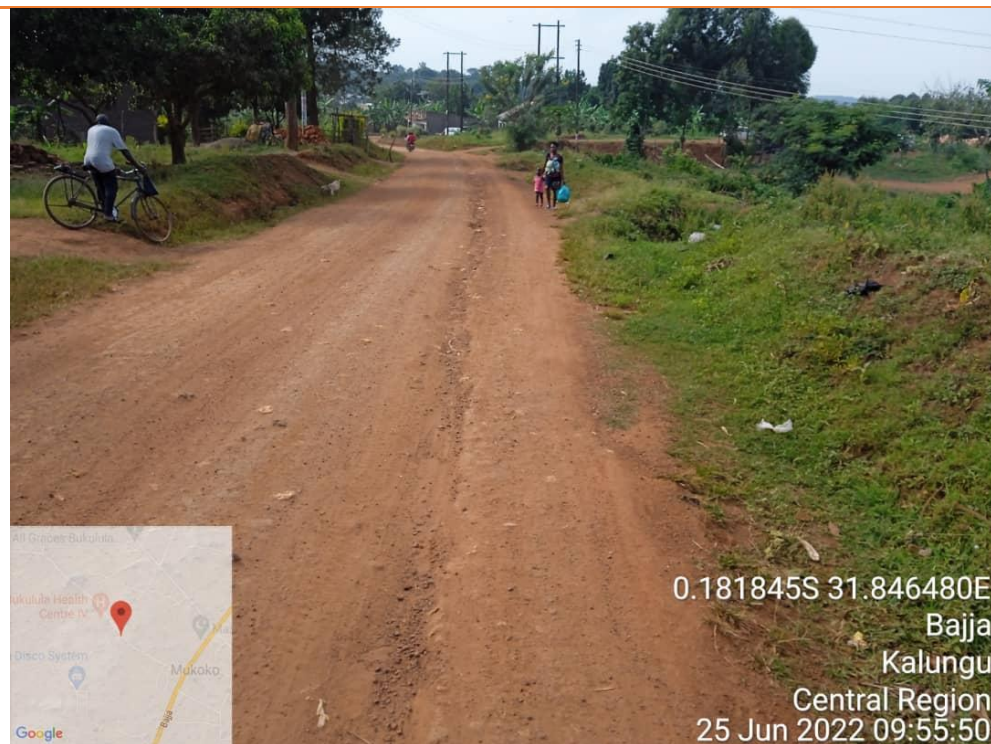
*Photograph 2-2: Rutting along Bukulula - Kalungu road.*

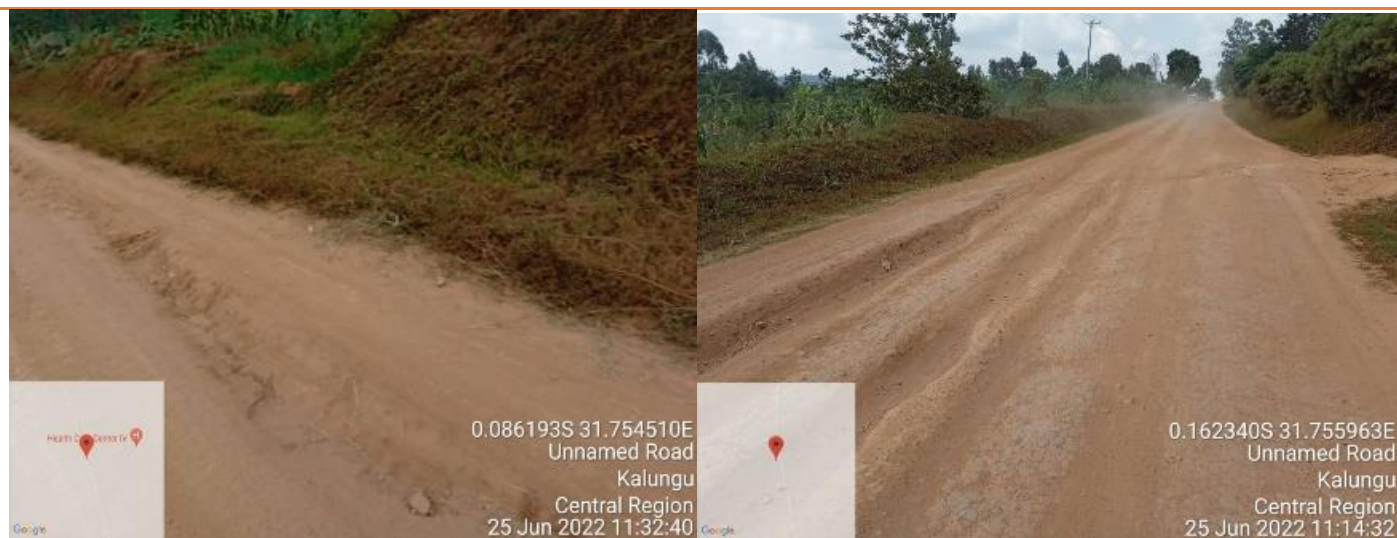
*Photograph 2-3: Severe rutting along Villa Maria - Kalungu road*

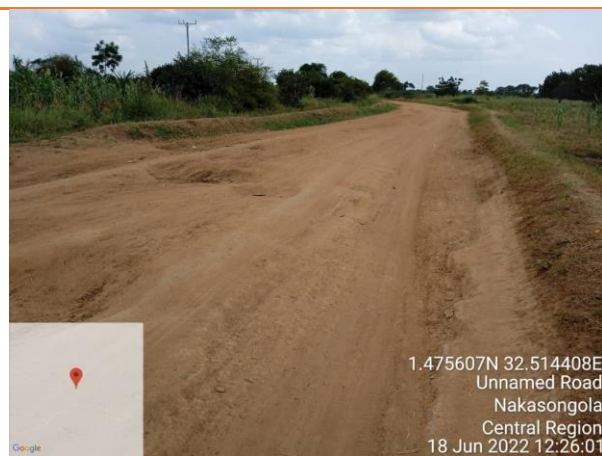
*Photograph 2-4: Severe potholes and gullies along Zengebe-Ferry-Access road.*

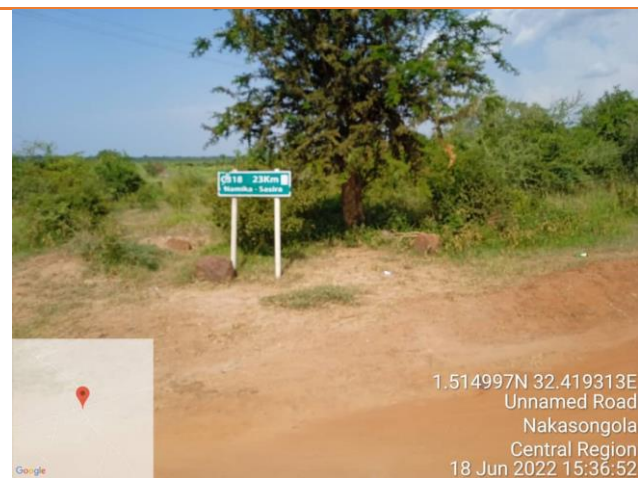
*Photograph 2-5: T - junction at the end Sasira - Namika road.*

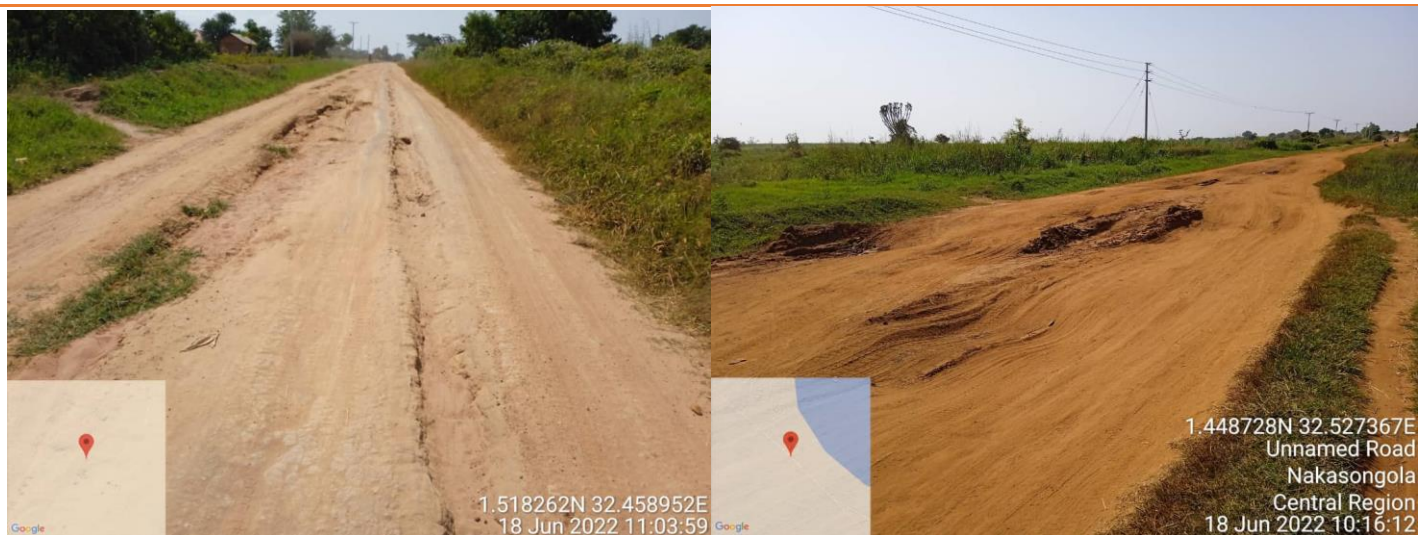
*Photograph 2-6: Deep erosion gullies along Lwampanga - Lwabyata road.*

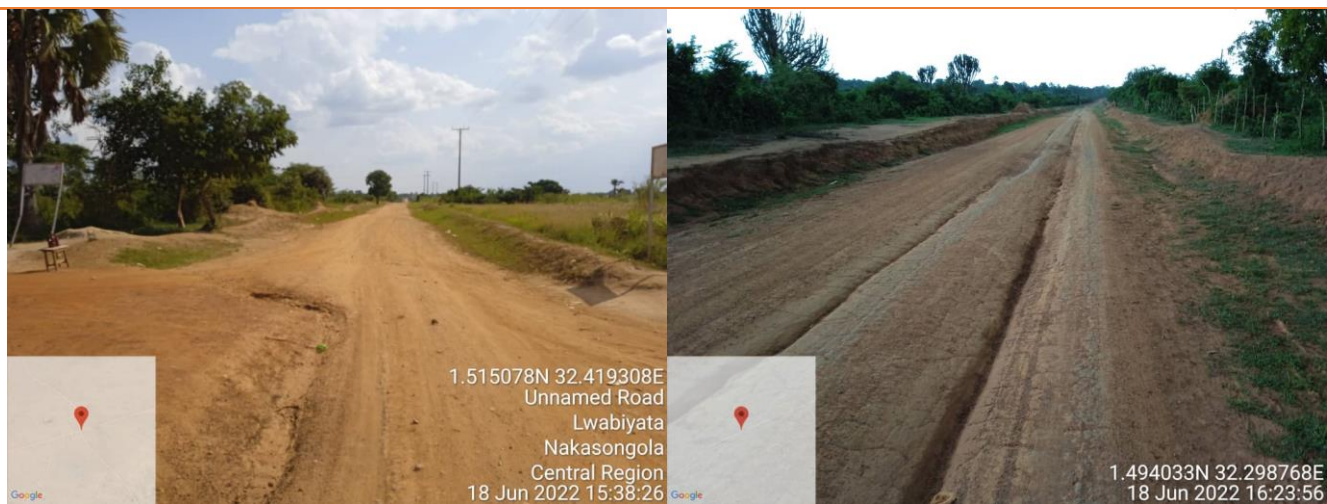
*Photograph 2-7: Rutting and other defects along Lwabyata - Kafu road.*

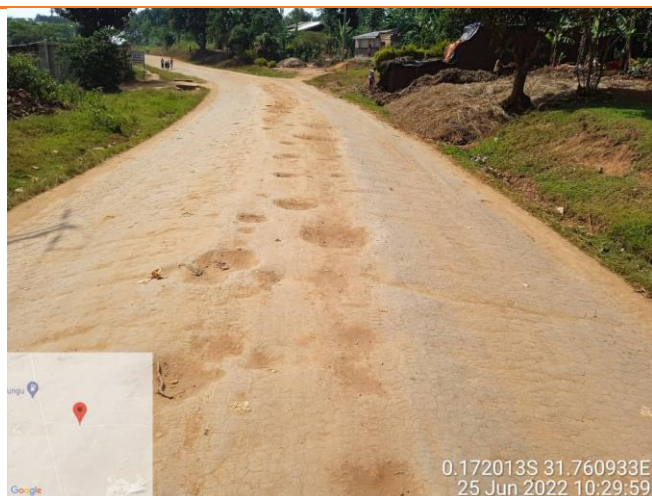
*Photograph 2-8: Potholes along Bukulula - Kalungu road.*
