## **1 Pictures taken along the Paved National Road Network**

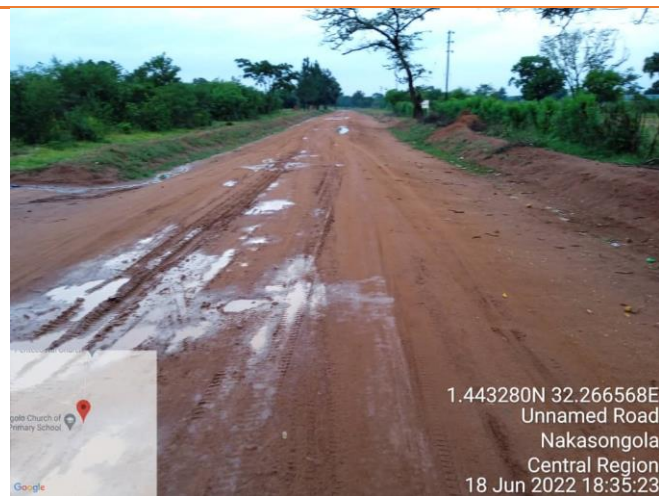
*Photograph 2-9: Rutting along Migeera - Nabisweera road.*

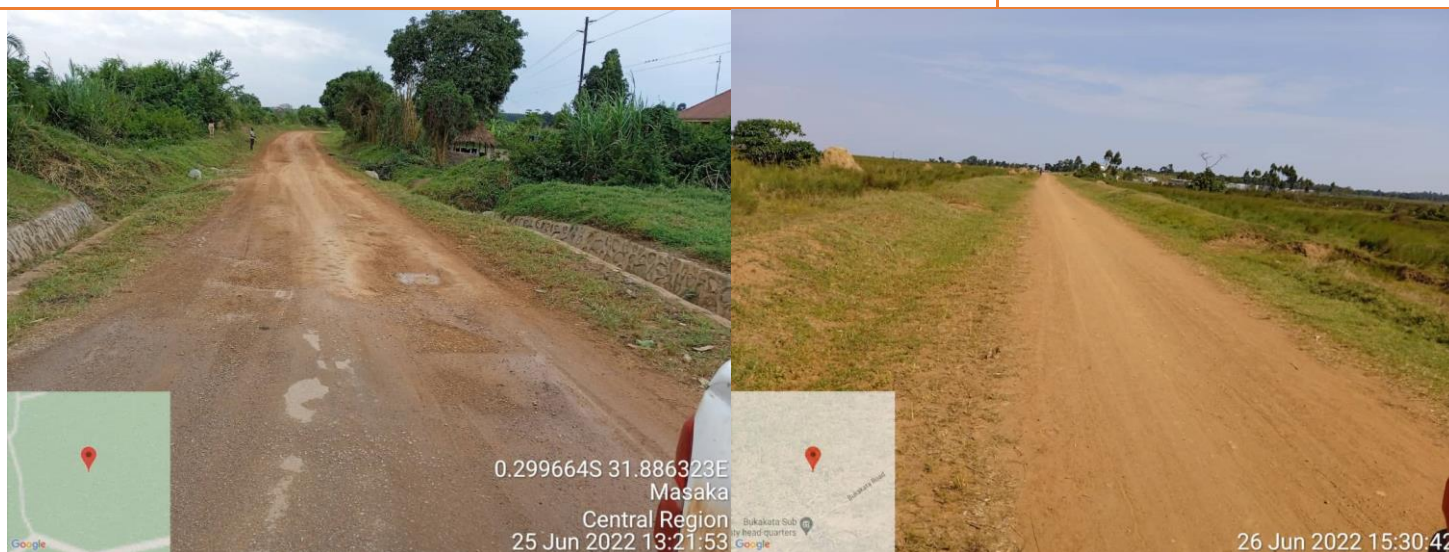
*Photograph 2-10: Potholes and poor formation level along Mukoko - Birinzi - Ssunga road*

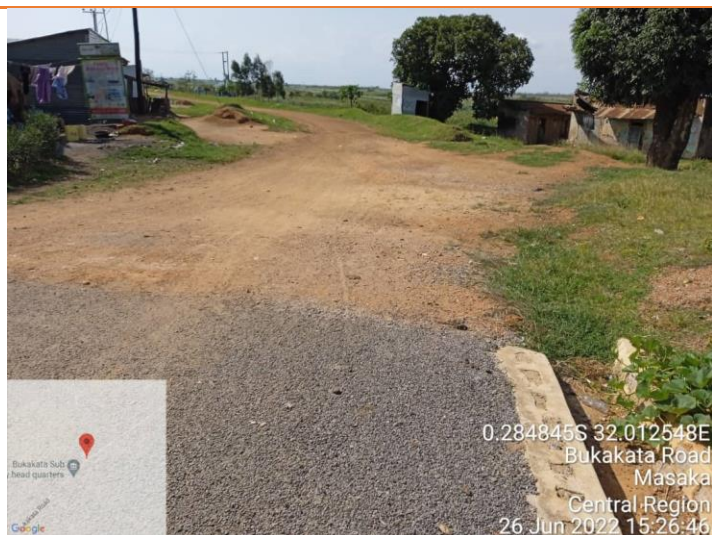
Photograph 2-11: Bukakata - Old Landing Site road.

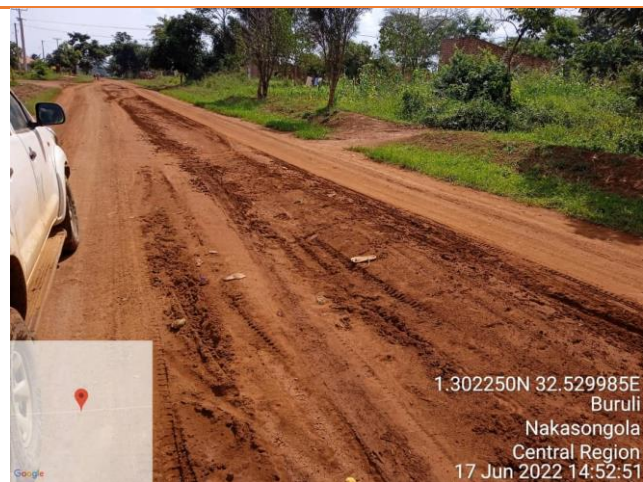
Photograph 2-12: Severe rutting along Kikyusa- Bamugolode - Kazwama - Nakasongola road.

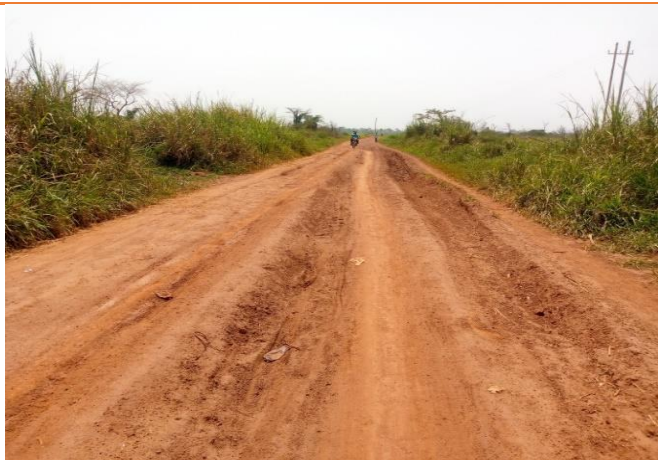
*Photograph 2-14: Rutting along Ami - Kidilani road.*

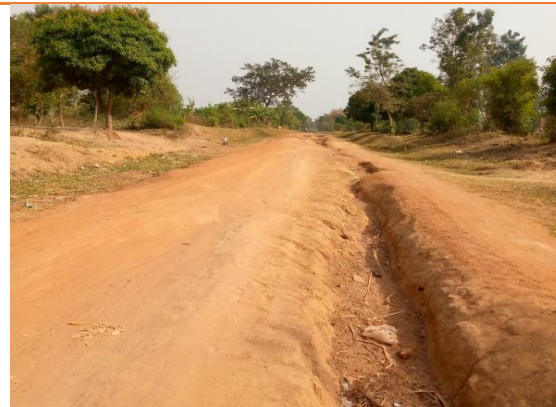
*Photograph 2-15: Severe Erosion gullies along Ngai – Abok – Otwal - Arom road.*

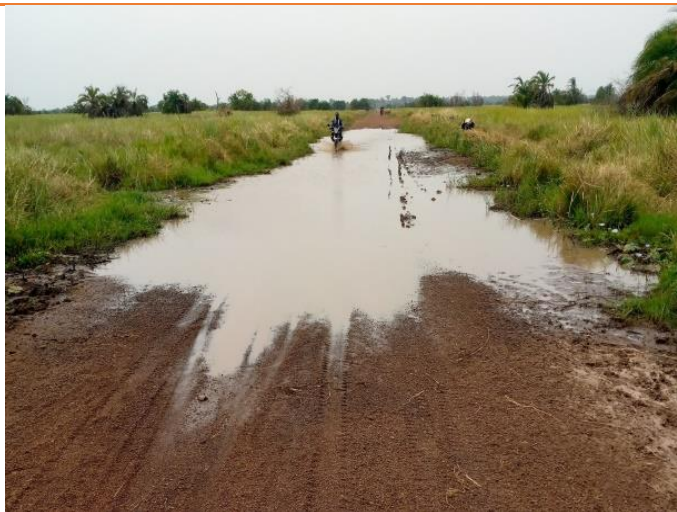
*Photograph 2-16: Flooding along Rhino camp-Ogoko - Inde road.*

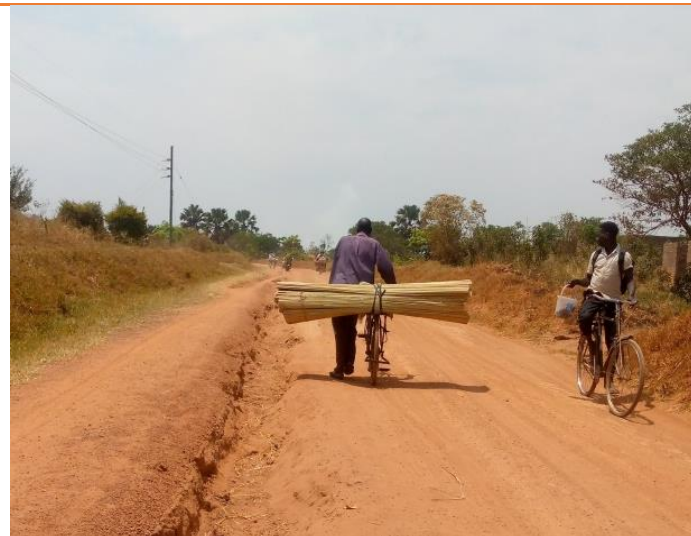
*Photograph 2-17: Erosion gullies along Kamdini - Zambia road.*

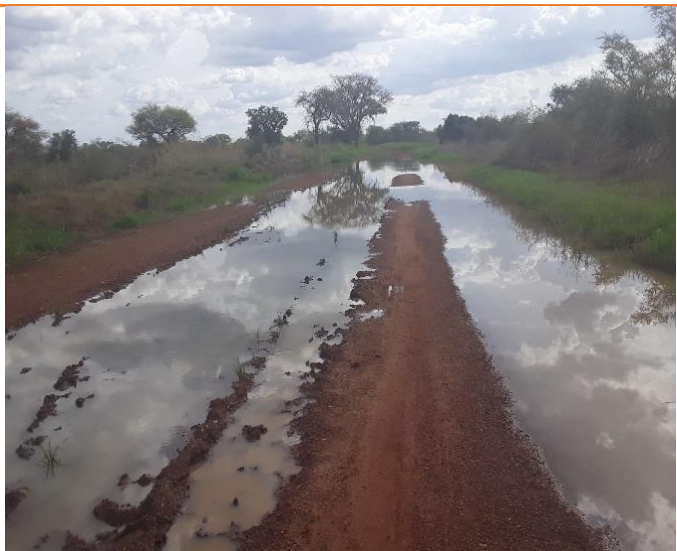
*Photograph 2-18: Flooding of River Nile along Tete - Nimule border road.*

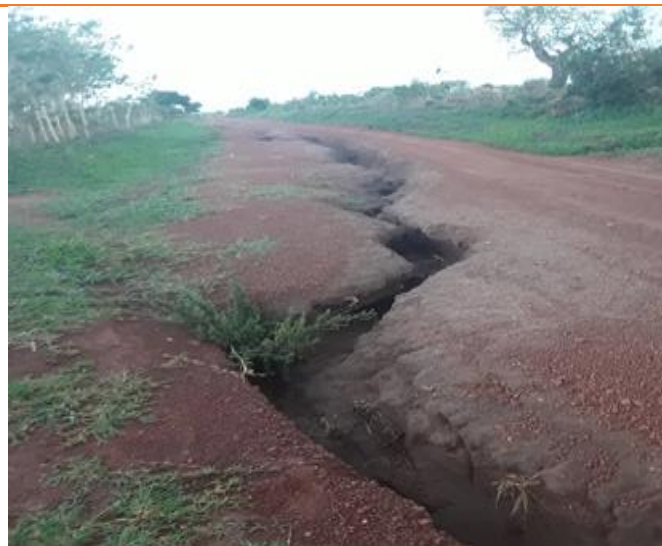
*Photograph 2-19: Erosion gullies along Ngai- Abok – Otwal - Aromo road.*

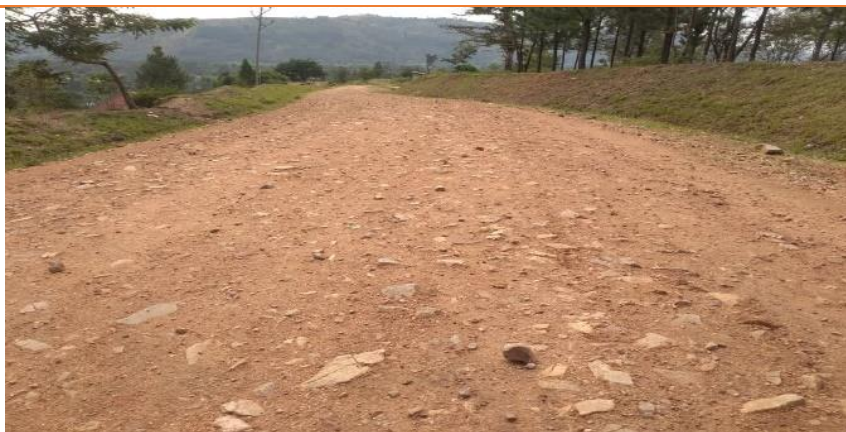
*Photograph 2-20: Poor material quality along Nkenda - Bugoye road.*

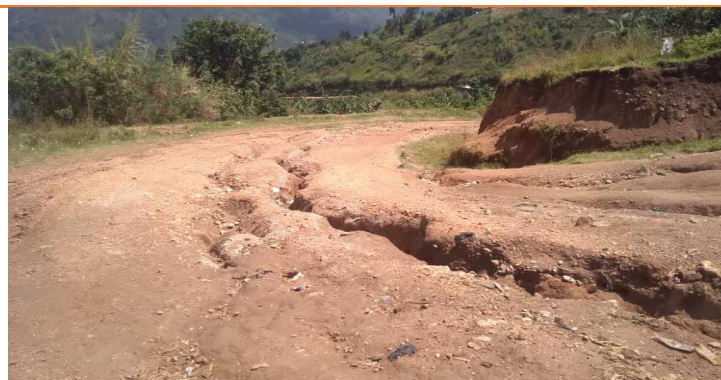
*Photograph 2-21: Erosion gullies along Rugendabara - Kasawangari road.*

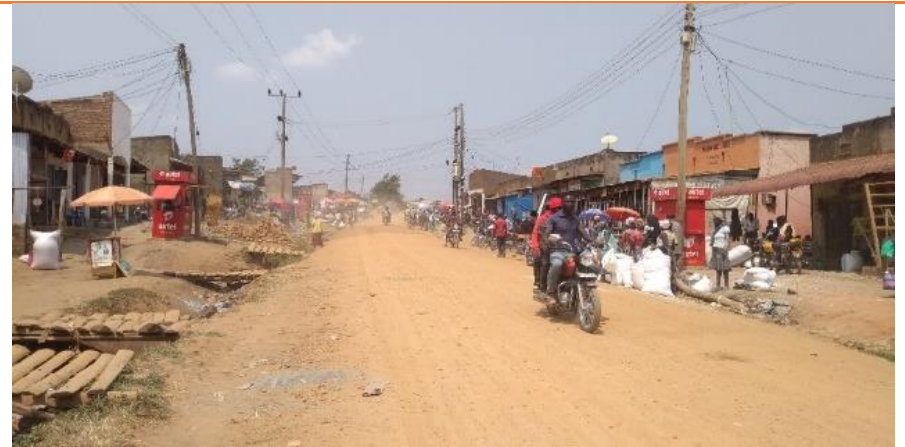
*Photograph 2-23: High road side friction along Katerera - Buhindagye road.*

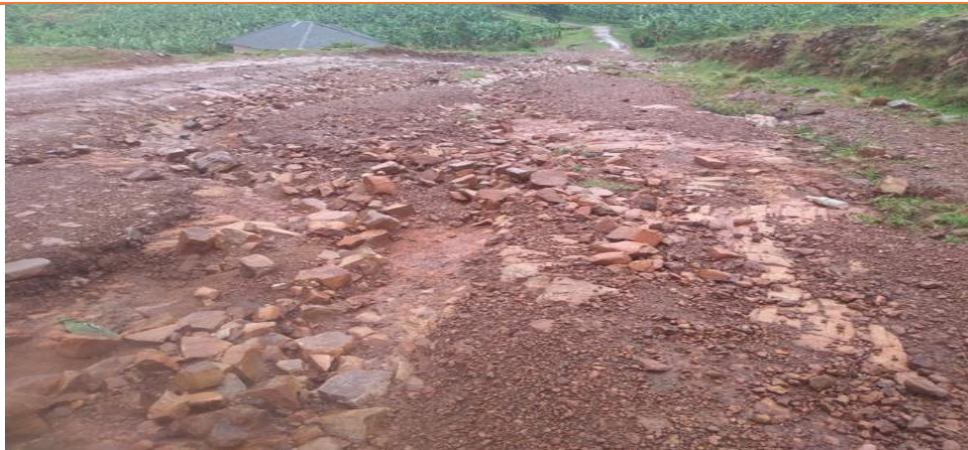
*Photograph 2-24: Poor material quality along Kityanza - Bugango access road.*

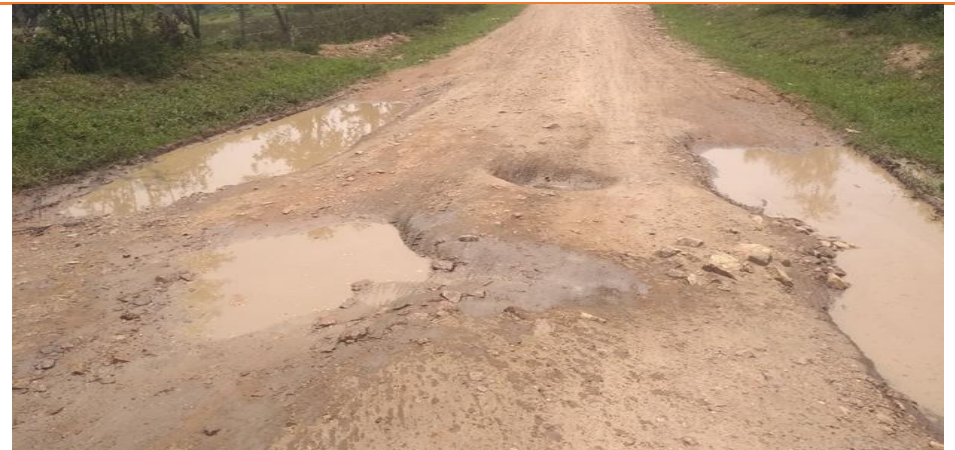
*Photograph 2-25: Potholes along Ruhoko - Kabujogera road.*

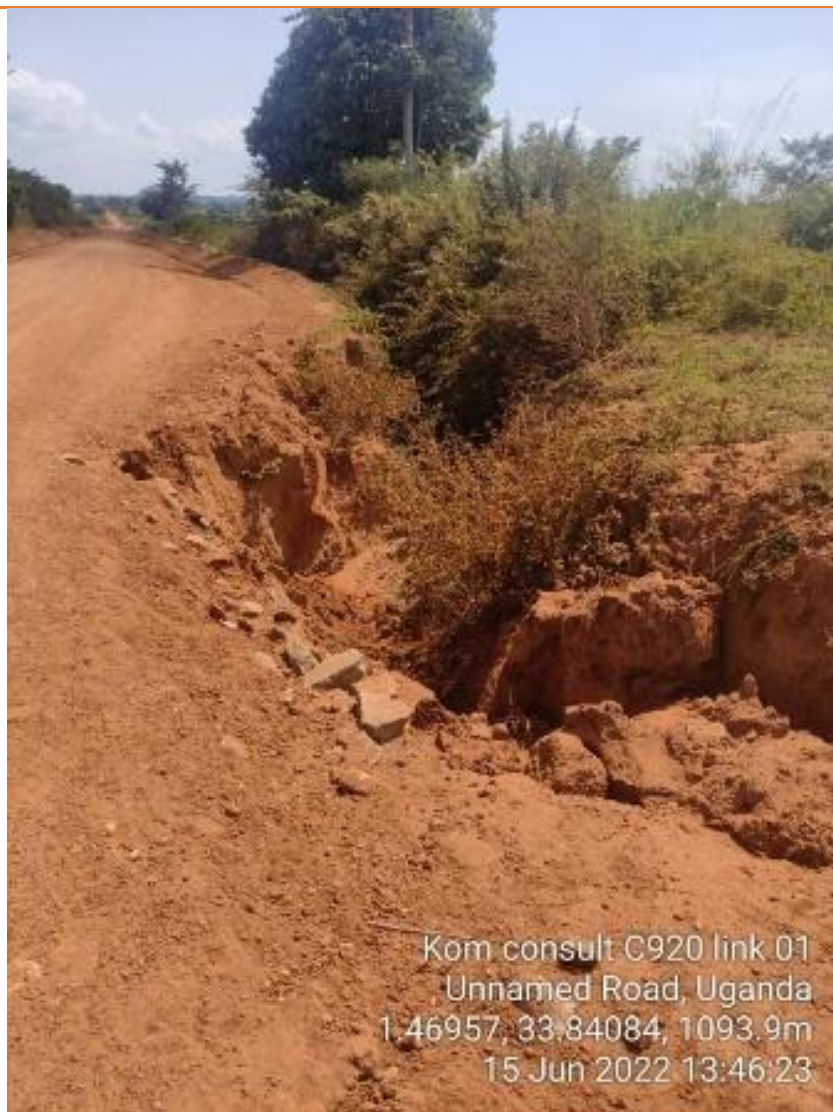
*Photograph 2-26: Defects along Kumi-Brooks corner road.*

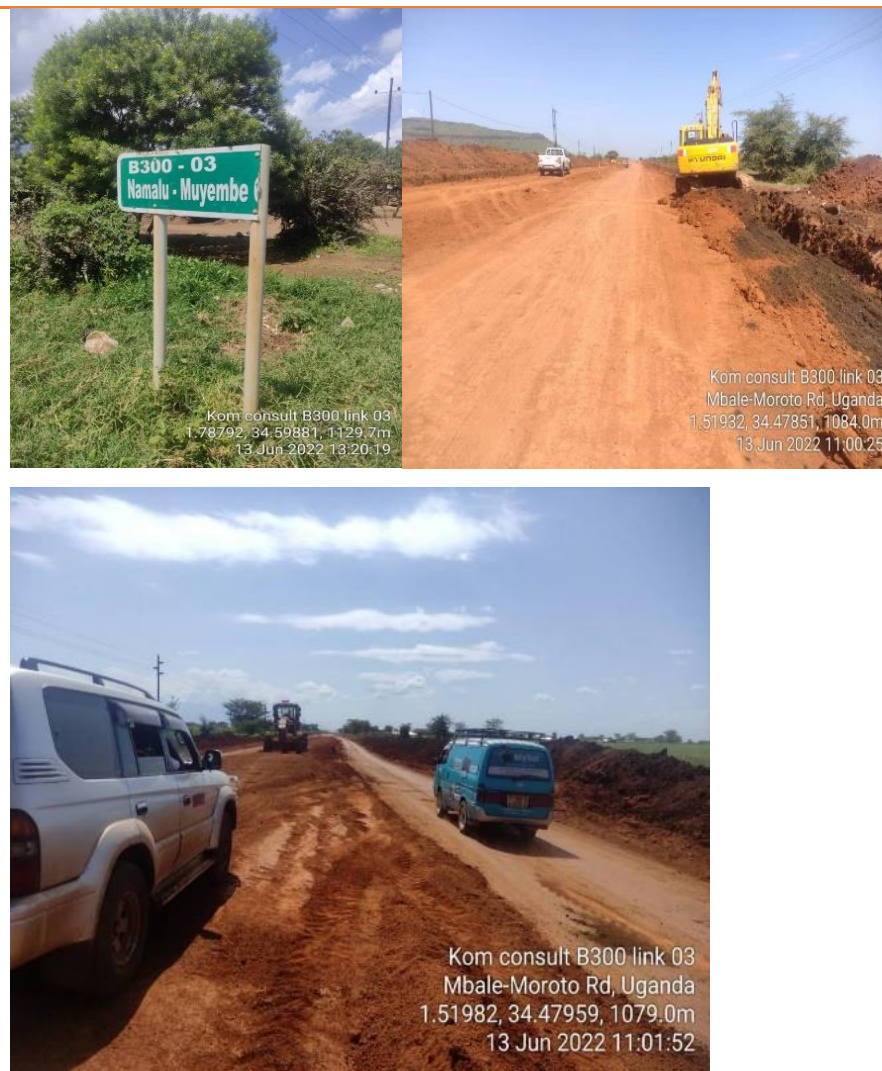
*Photograph 2-27: Construction works along Muyembe - Namalu road.*

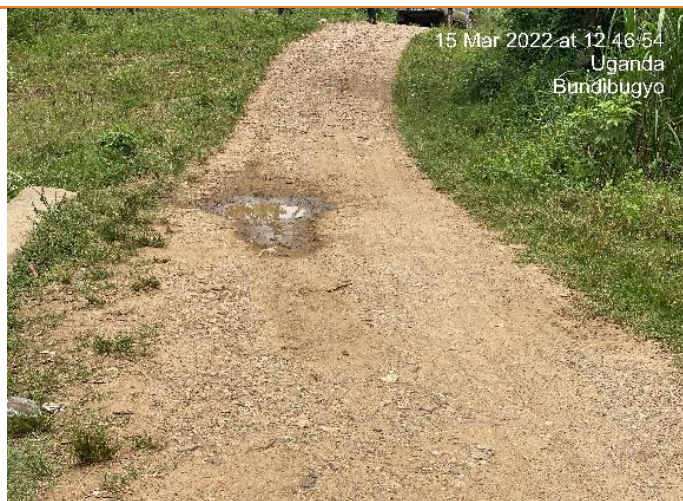
*Photograph 2-28: Narrow road width along Ntandi - Kicyo - Bundibugyo road.*

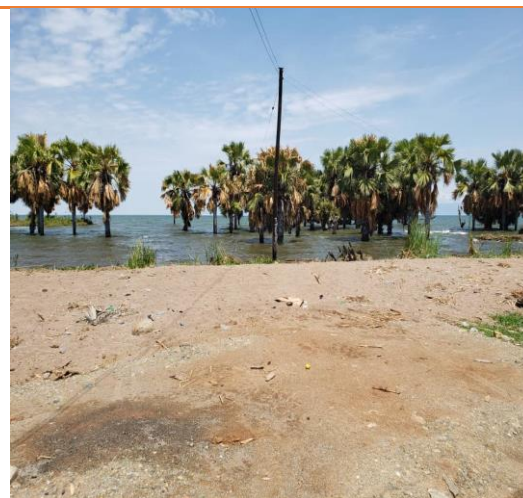
*Photograph 2-29: The end of Isunga - Bugwara road cut off by the lake.*

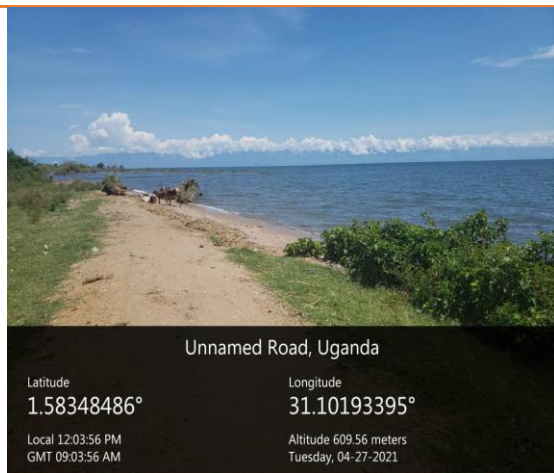
*Photograph 2-30: The end of Kaiso - Tonya cut off by the lake.*

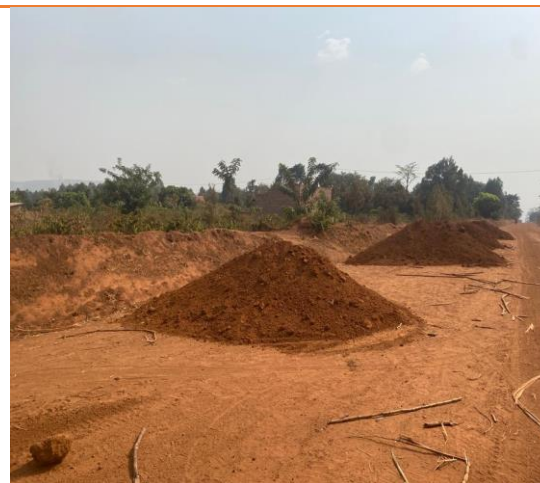
*Photograph 2-31: Construction works along Masindi - Biiso road.*

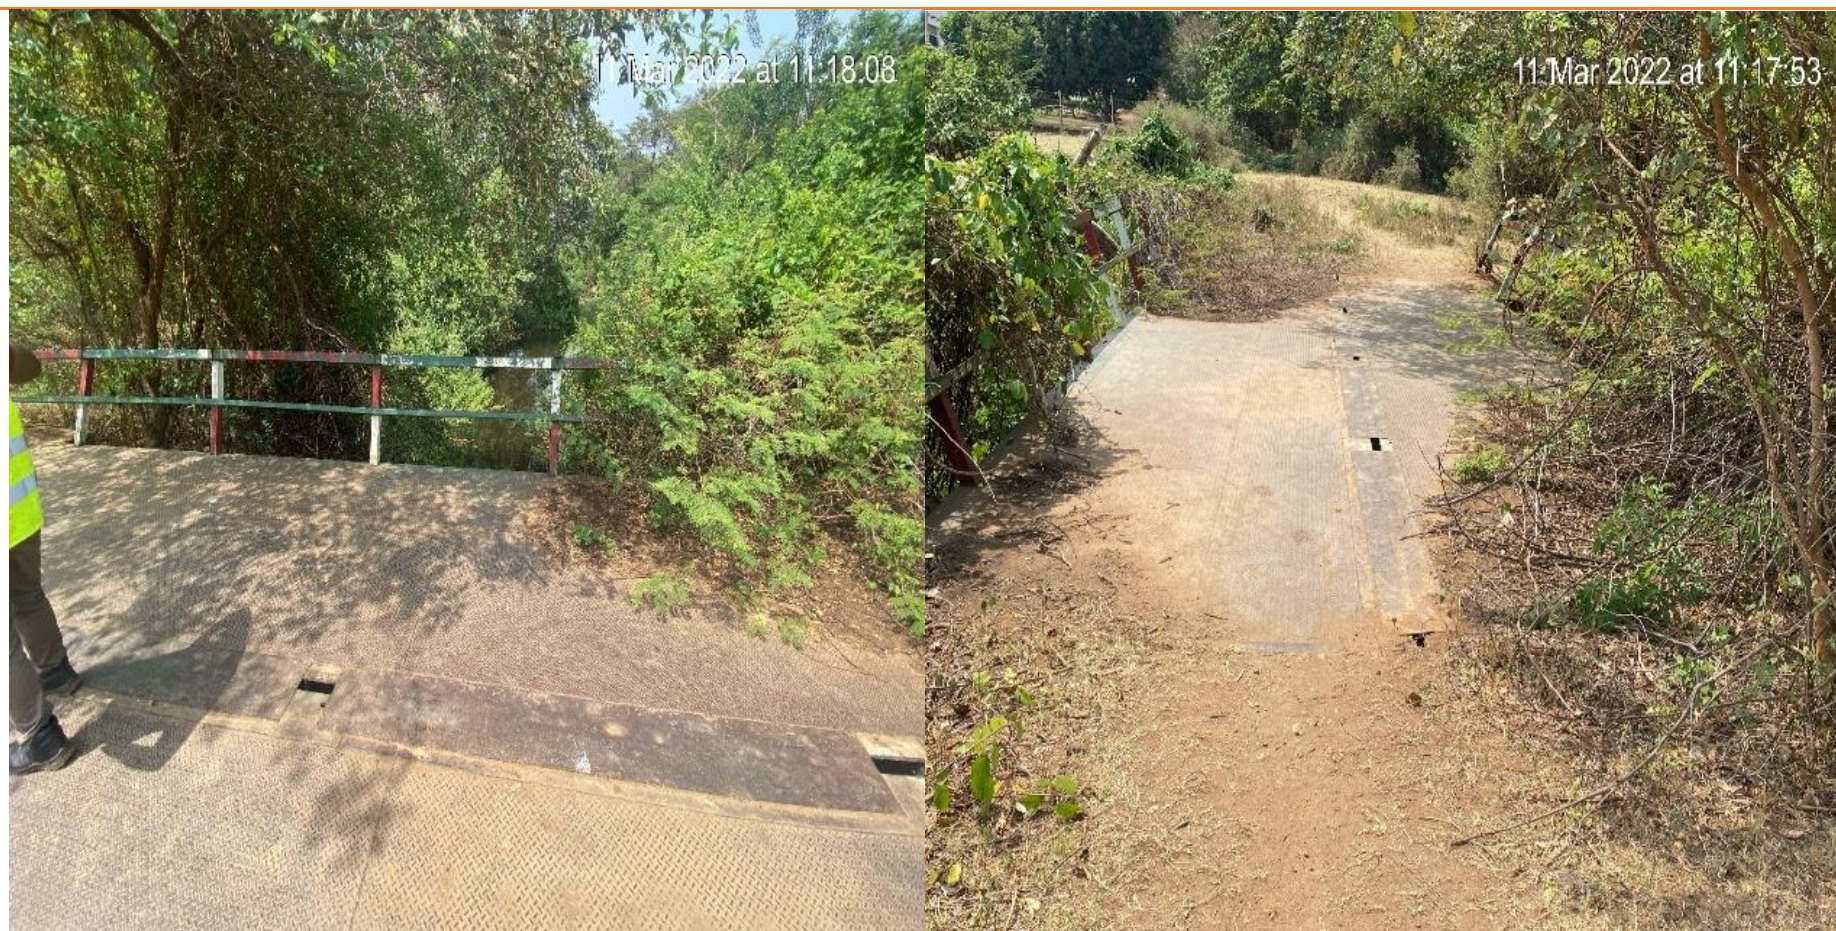
*Photograph 3-1: B275 along Buseruka - Tonya road is no longer in use.*

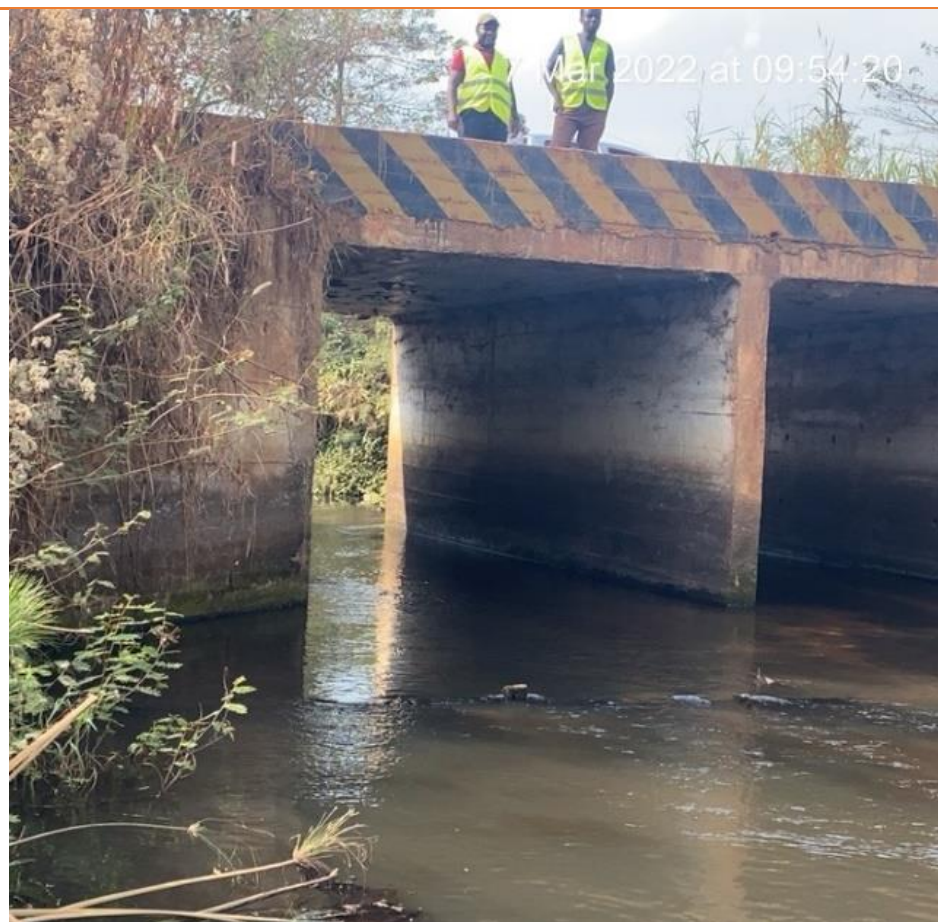
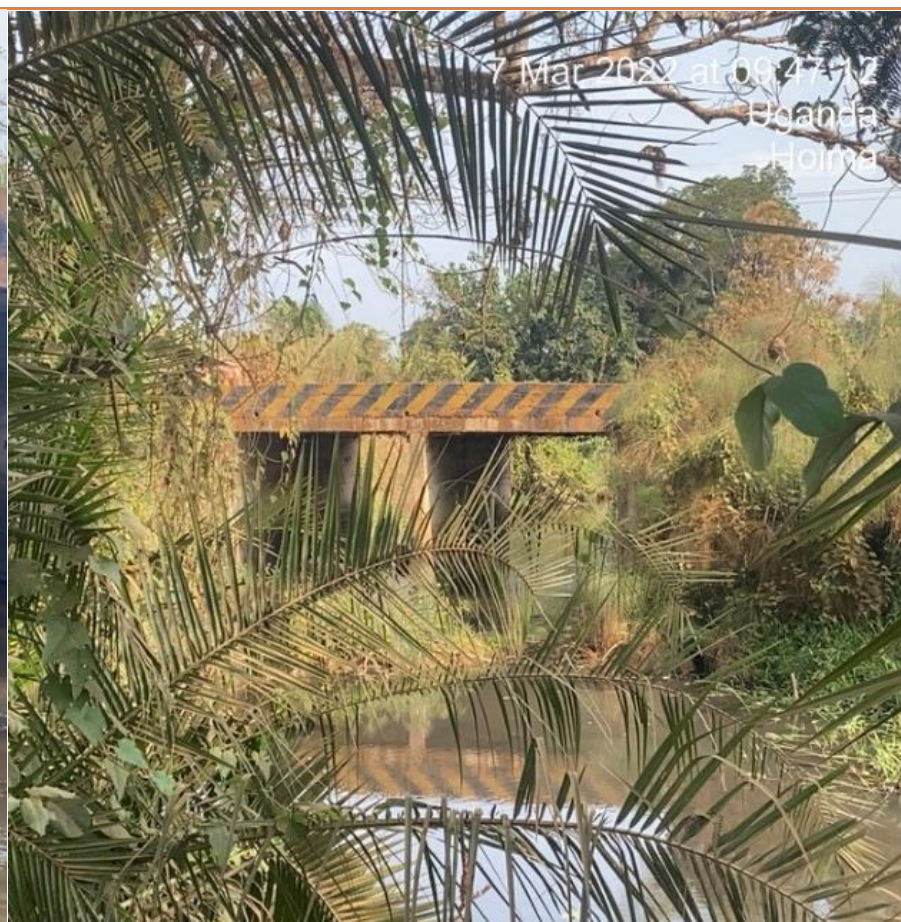
*Photograph 3-2: B264 along Kyenzige - Rugashali - Mabaale road is no longer in use as a new bridge is being constructed.*

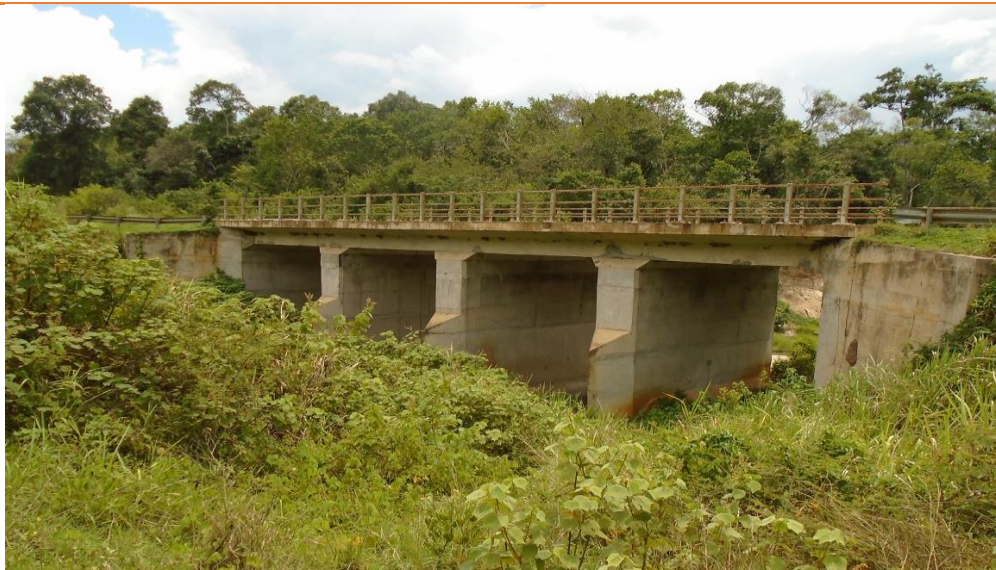
*Photograph 3-3: B071 along Katunguru - Ishasha road with poor waterway condition.*

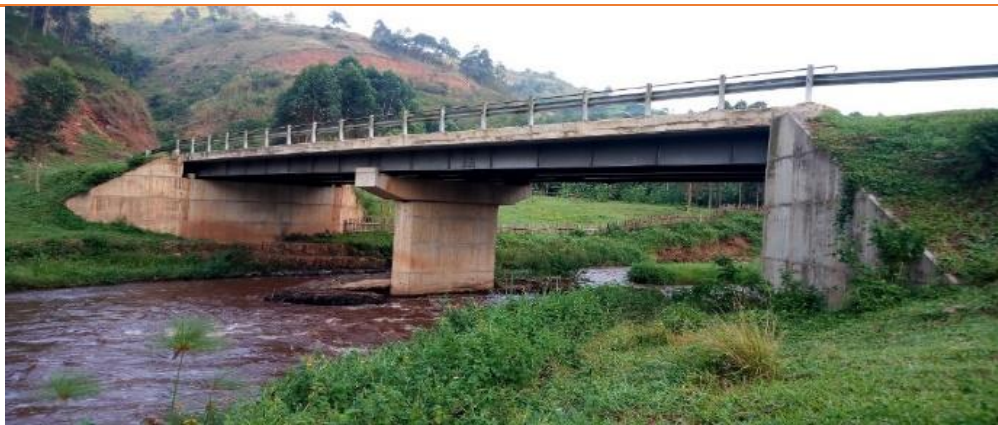
*Photograph 3-5: Waterway condition for B560 along Kisinga – Kyarumba - Kibirizi road.*
