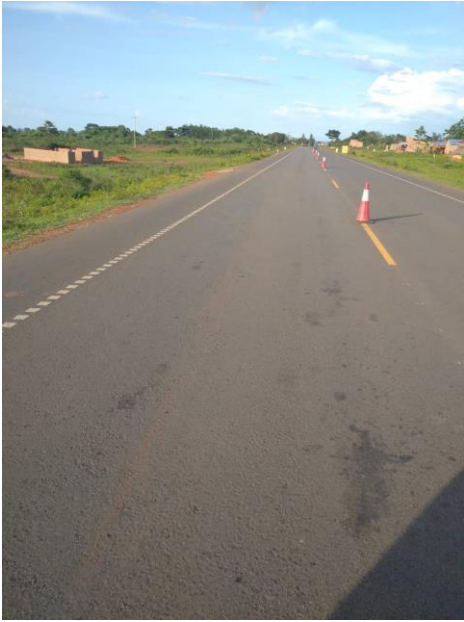
*Palisa-Kumi road is in very good condition since its upgrade*

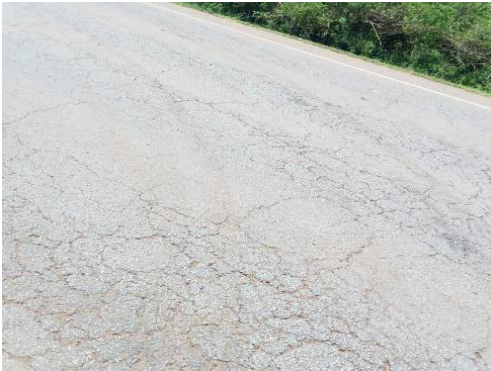
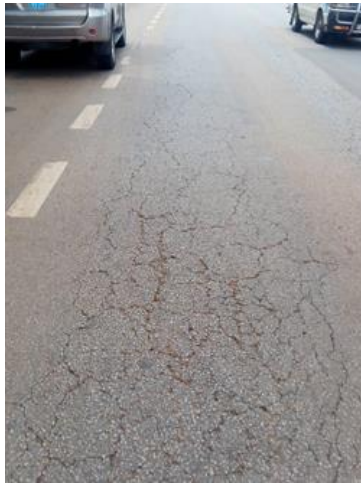
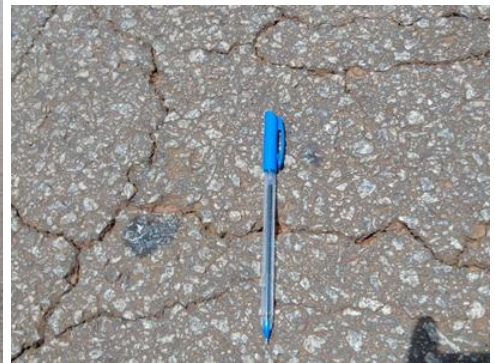
*Busitema junction-Busia has wide cracks on over 90% of the road width*

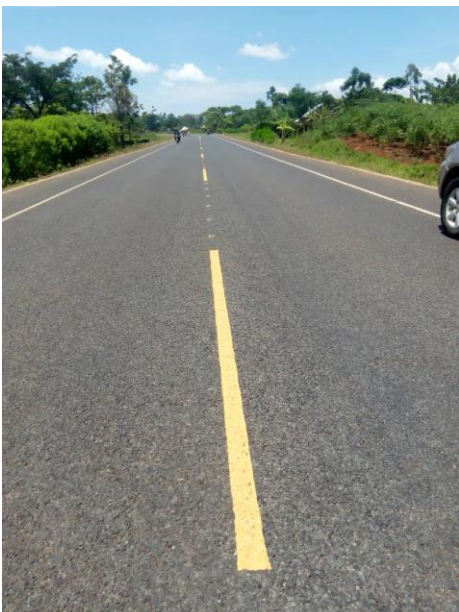
*Newly constructed section at Km 12 + 800 of Busia-Majanji road*

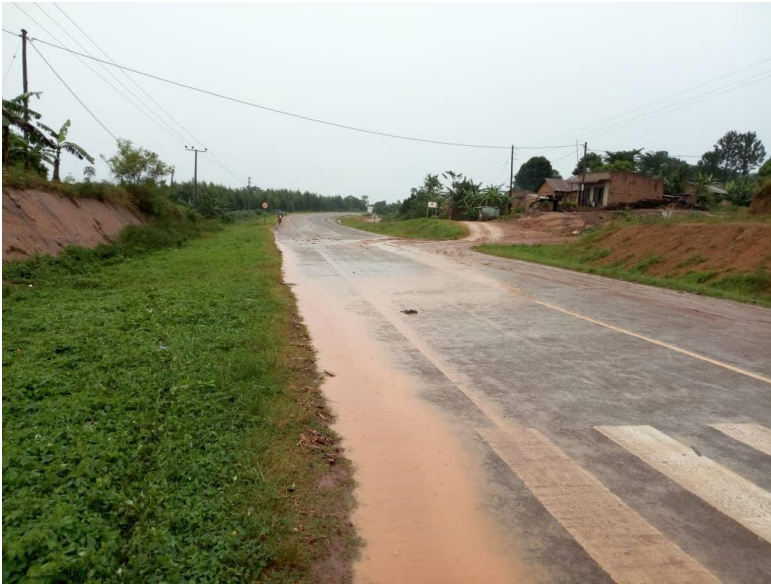
*Ponding section along Kisoga-Katosi road*

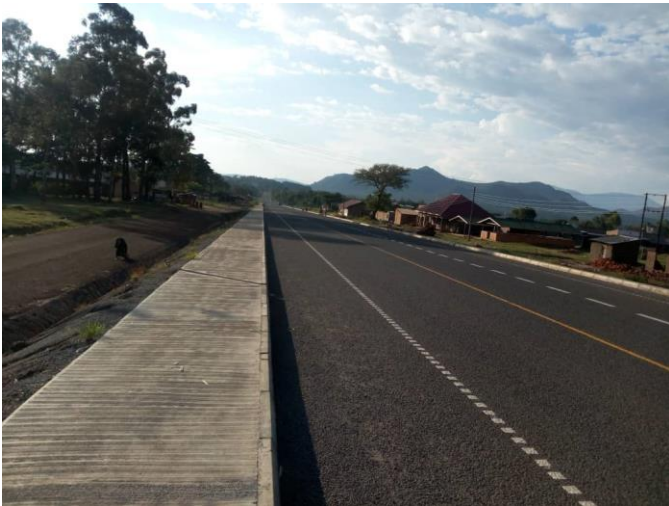
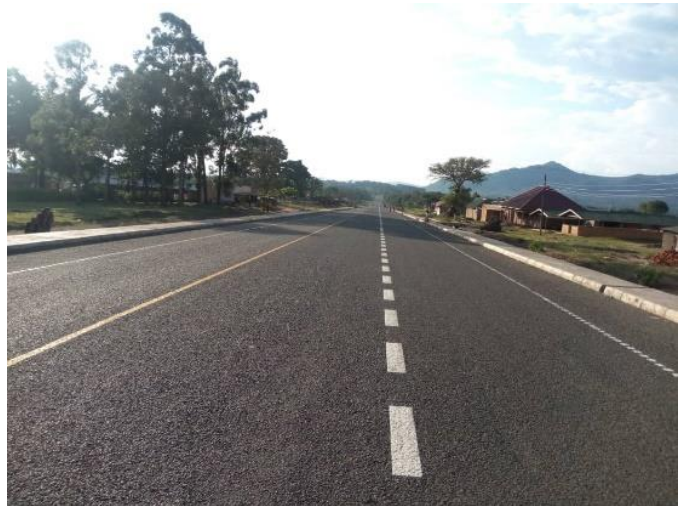
*Busumba- Munamba road in very good condition*

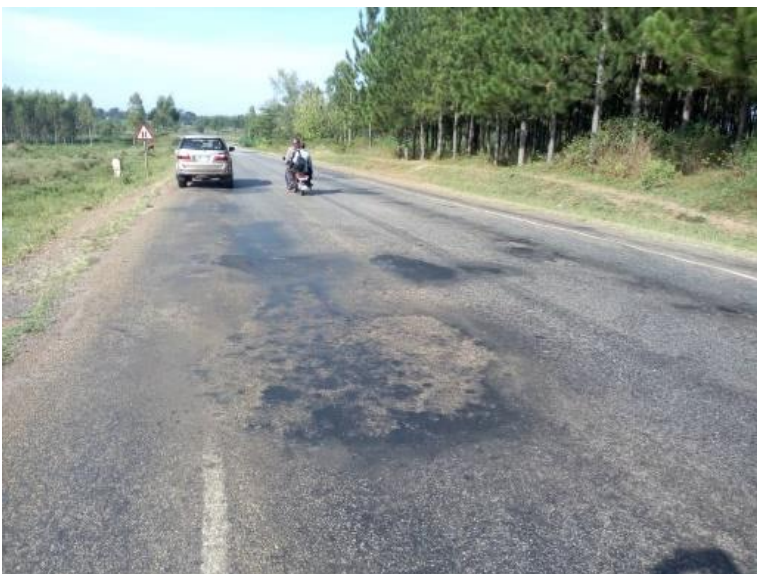
*Tororo-Magodes-Nabumali road in poor condition*

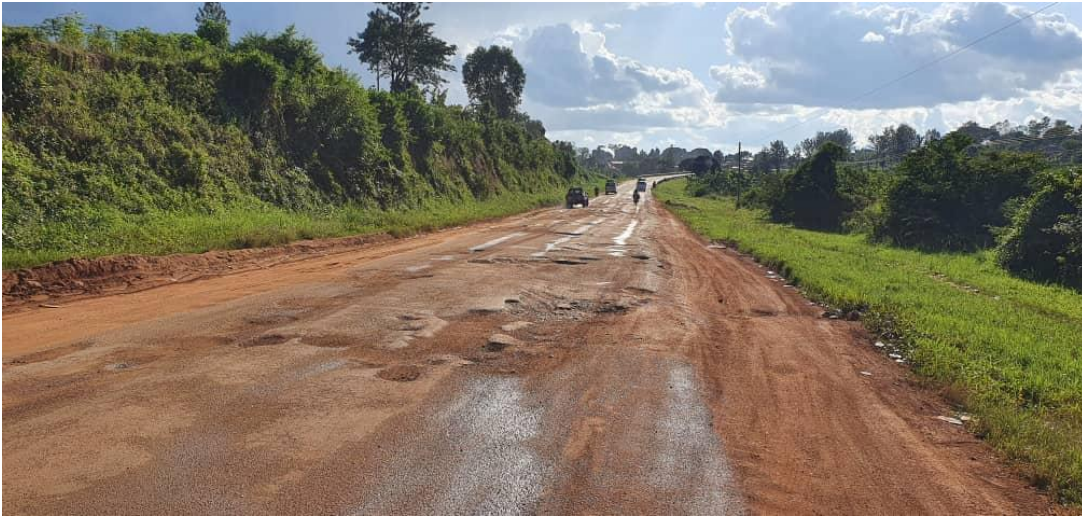
*Section on Kiganda-Kitenga (A005\_Link05) at Km 122 (between Mityana and Mubende) in very poor condition*

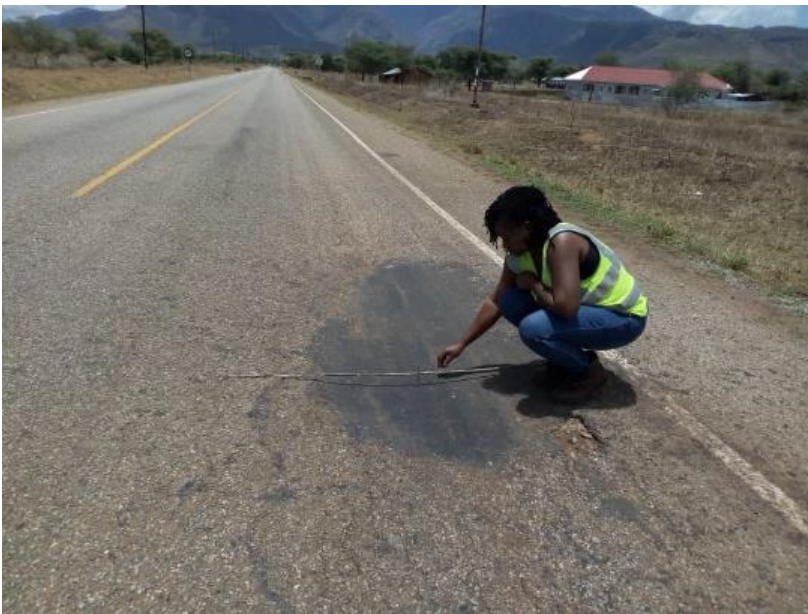
*Rutting at Km 3+ 100 from Moroto to Ariamoi*

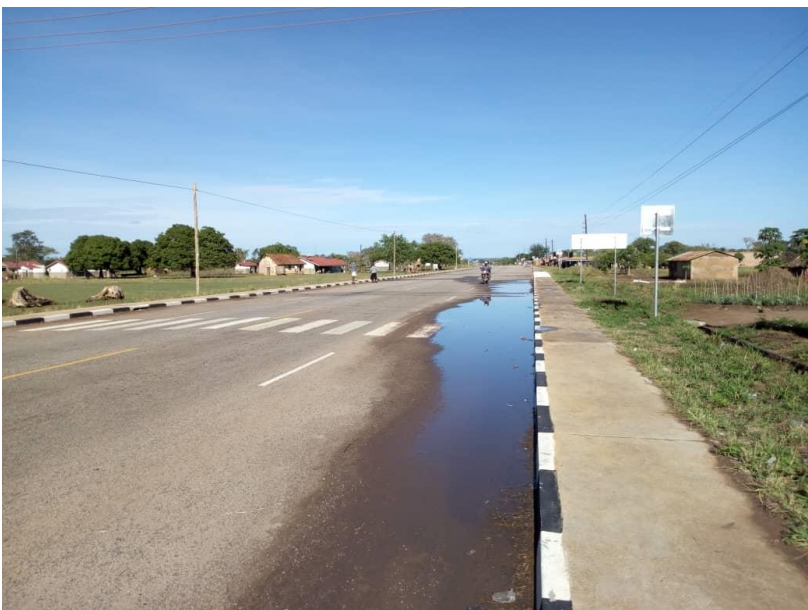
*Water ponding at Km 18 + 000 along Arapai-Katakwi-Iriri road. If the road drainage is not worked on, it will lead to pavement failures.*

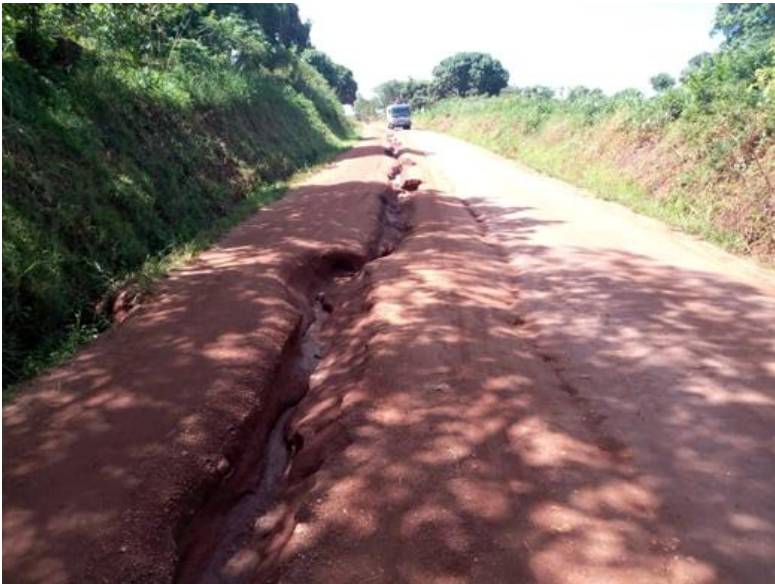
*Katikamu-Kikyusa road with deep erosion gulleys*

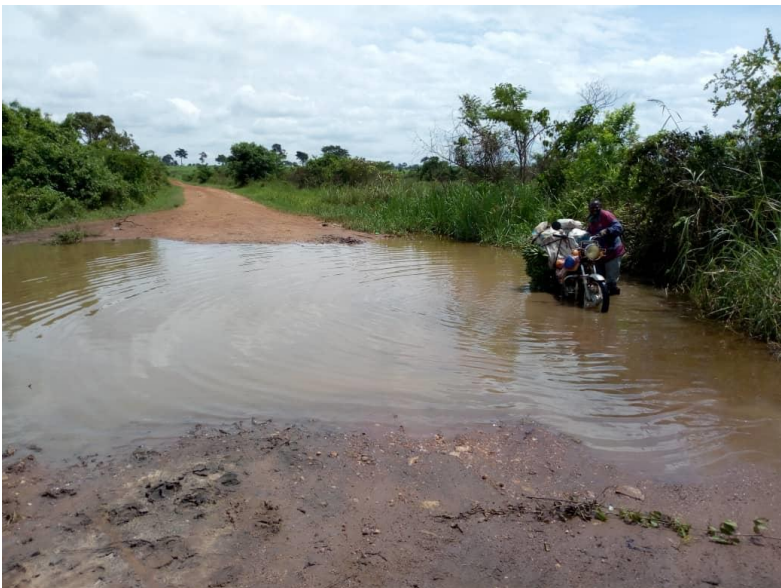
*Km 17 + 600 along Kakooge-Wabusana road has poor drainage*

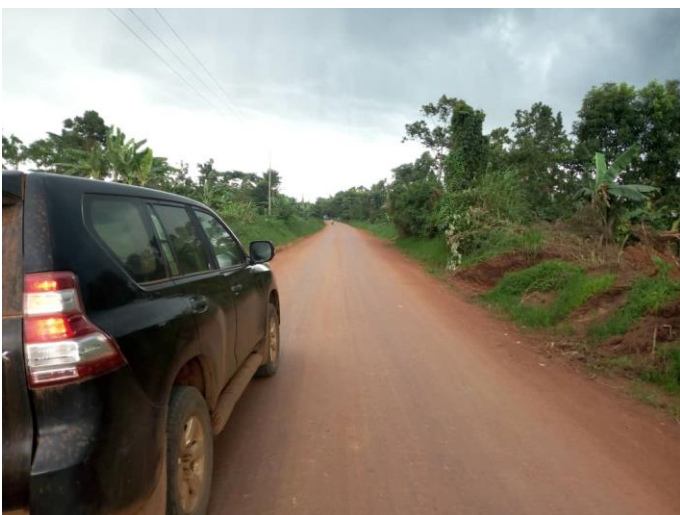
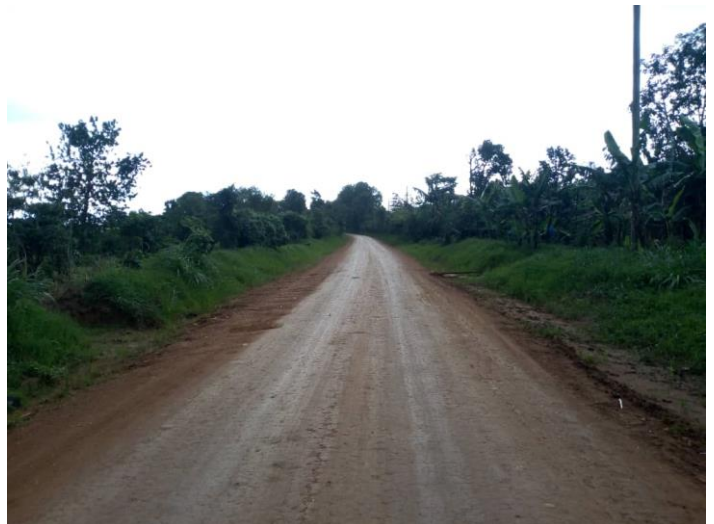
*Figure 1 Kakiri-Masulita-Kapeeka at Km 11+700 the road is in good condition*

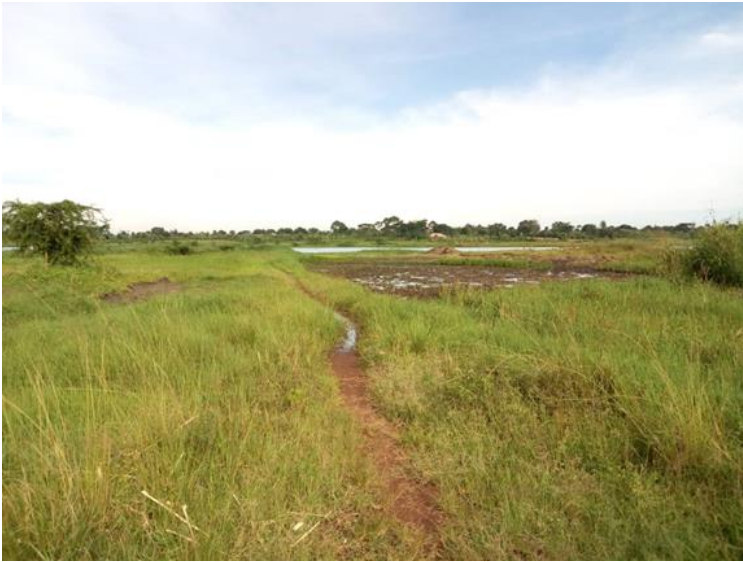
Nazigo-Kitimbwa at Km 24+020. A section of the road (19km) is swallowed by River Nile

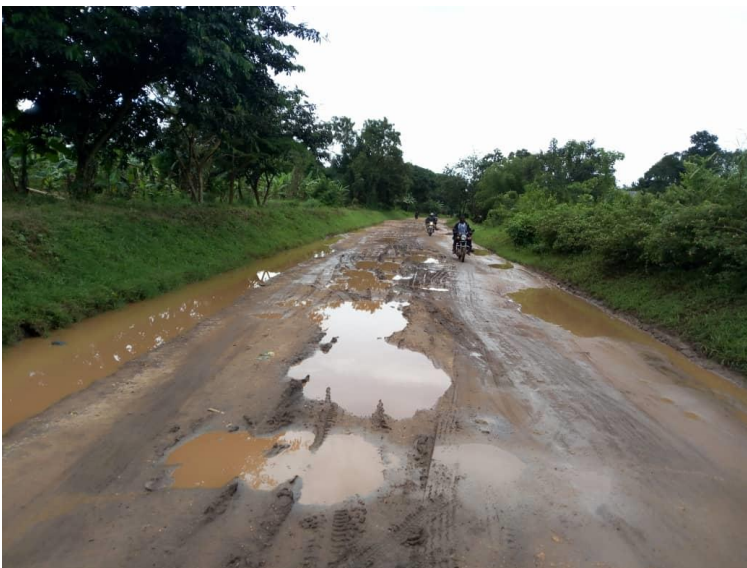
*Zirobwe-Bamunanika road with water ponding and deep potholes at 0+40 from Bamunanika*

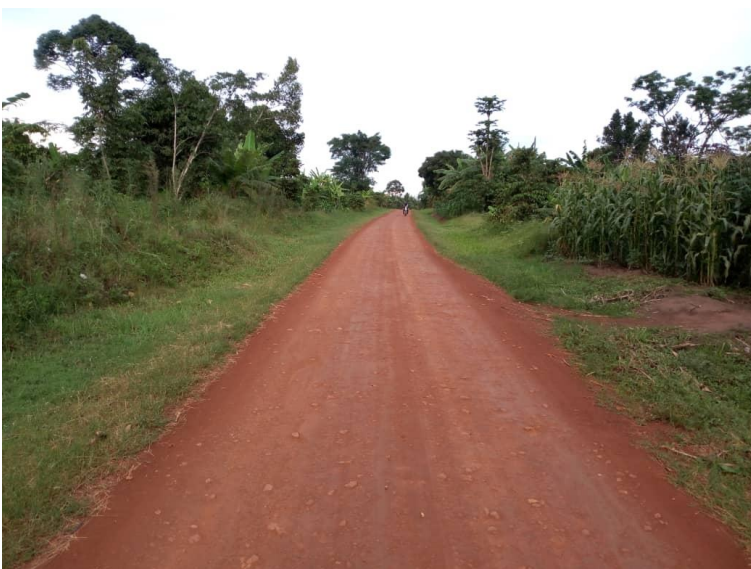
*Nazigo-Kitimbwa at Km 34+000 in good condition*

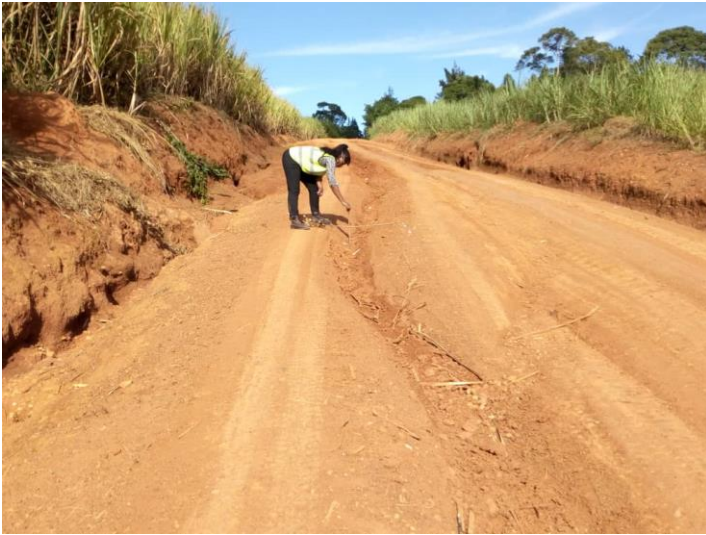
*Kagusa-Buikwe(Makindu) road with deep gullies*

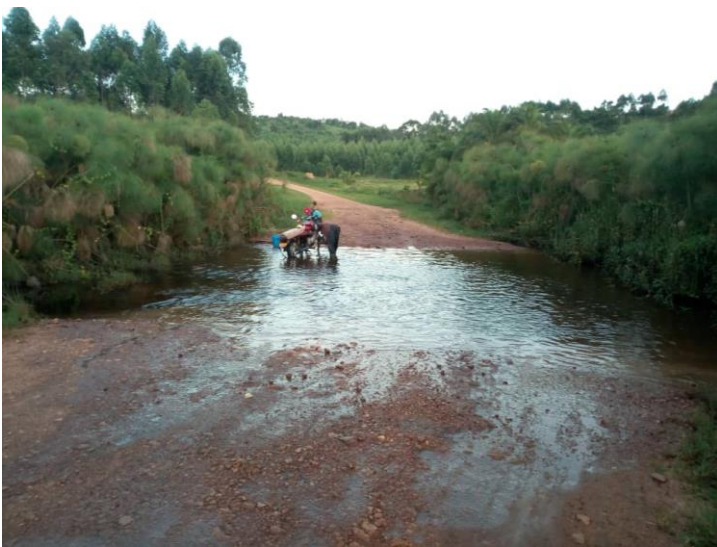
*Gobero-Kakonda at Km 9+ 600 where a river crosses the road*

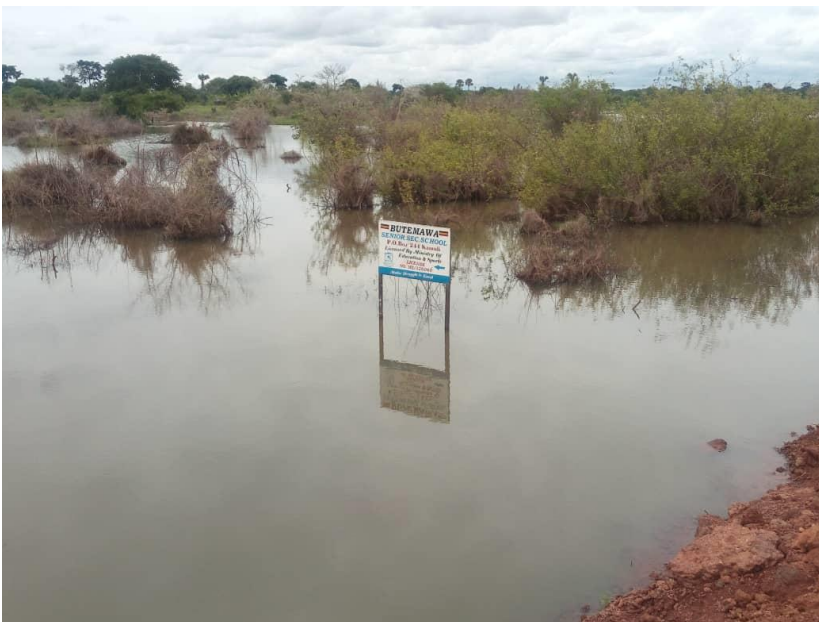
*Nawantale - Bukungu (B307\_Link04) coved by water from Lake Kyoga*

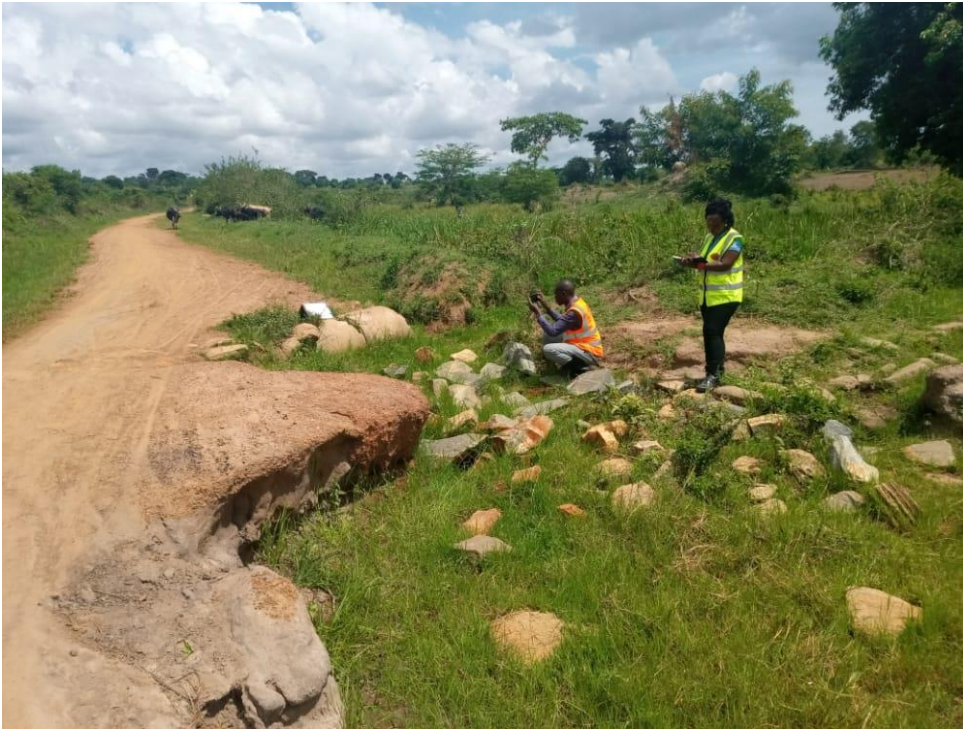
*Nabirumbi- Buyende - Nkondo - Kidera (C812\_Link01) with severe edge breaks*

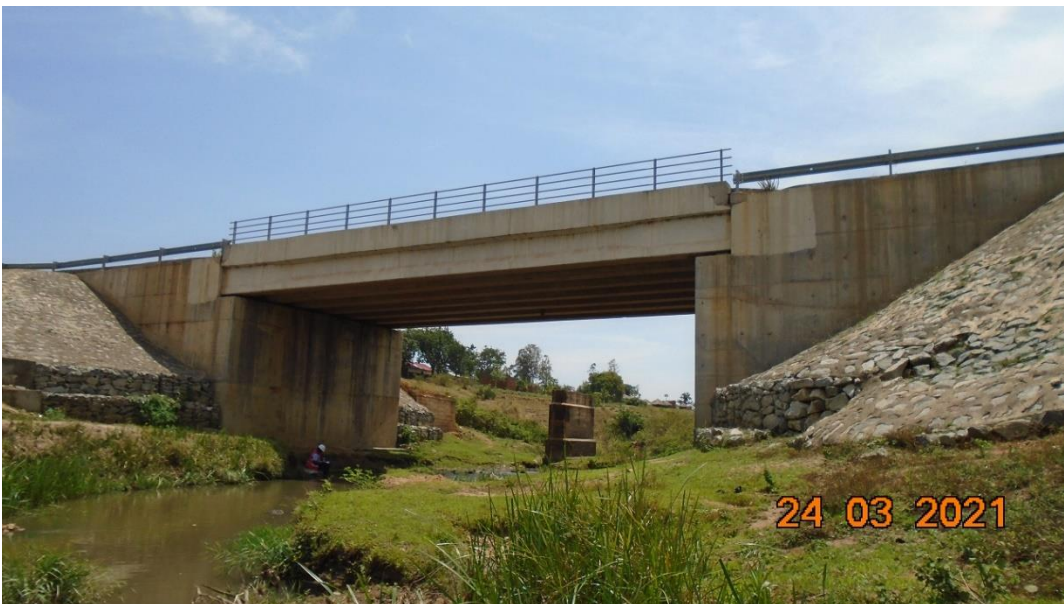
*Oluffe Bridge (B121) along Manibe - Maracha – Koboko (A008\_Link06) in very good condition*

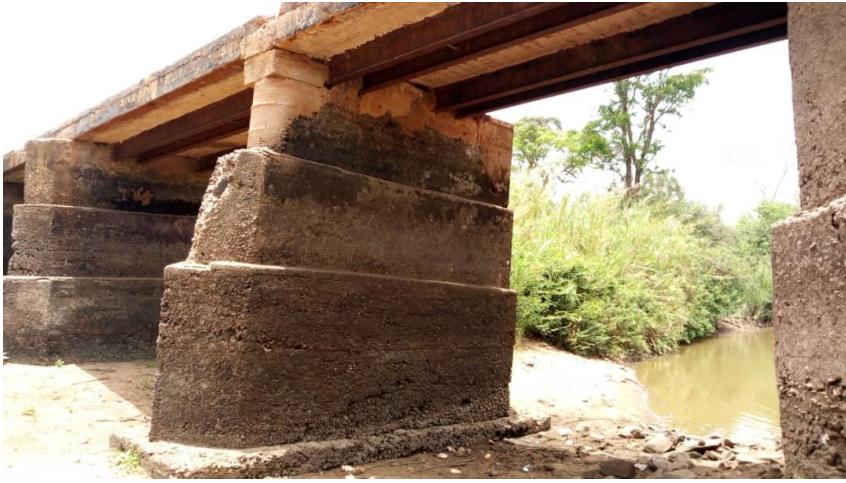
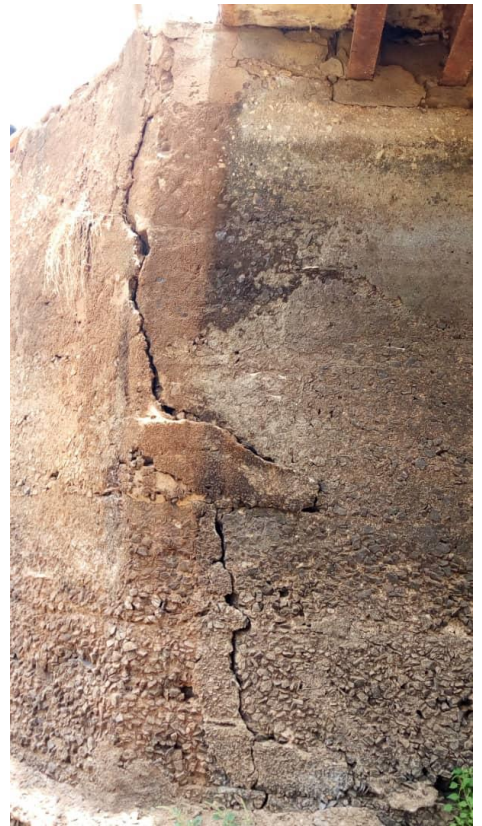
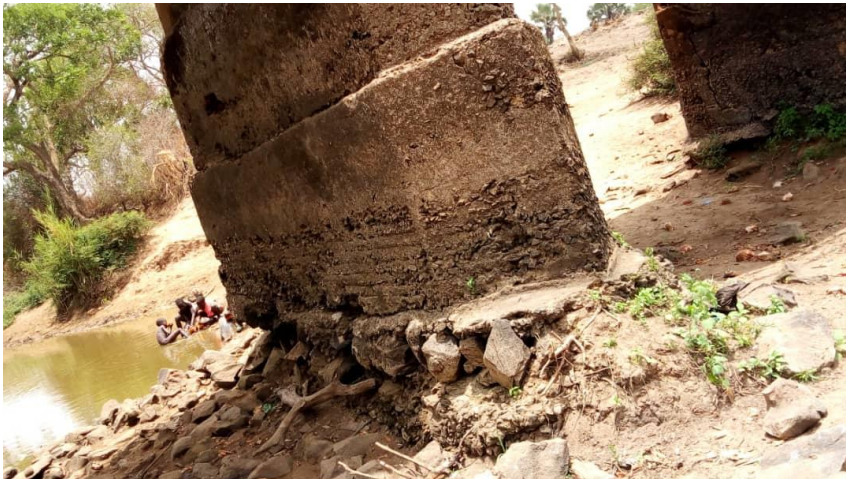
*Omposo Bridge (B333) along Moyo – Obongi (C722\_Link01) road in very poor condition*

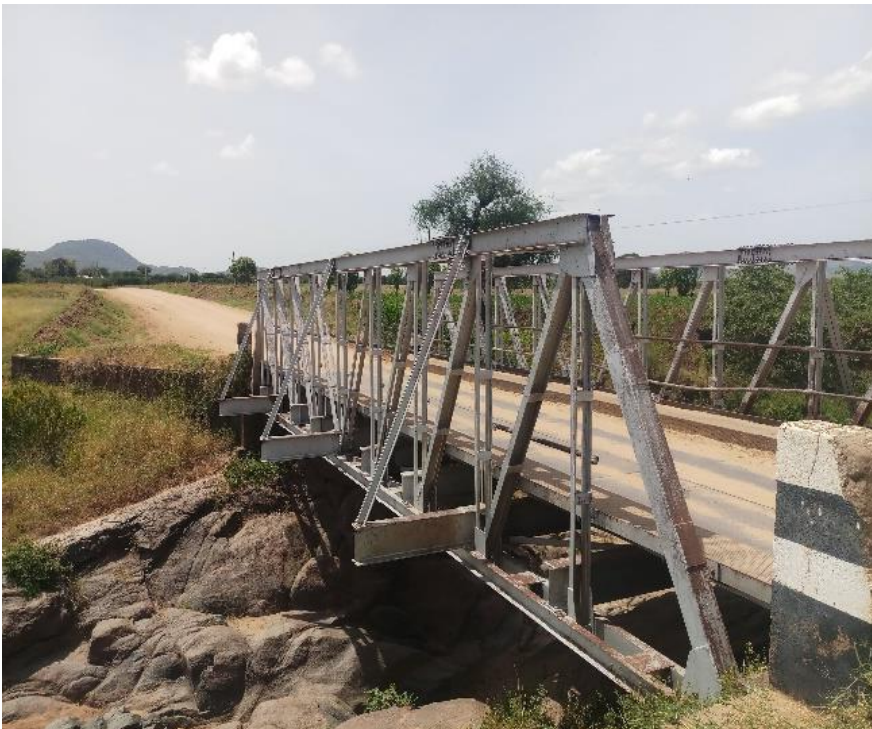
*Yadalala Bridge (B177) along Kotido - Apaán – Kabong road, Kotido station in good condition*

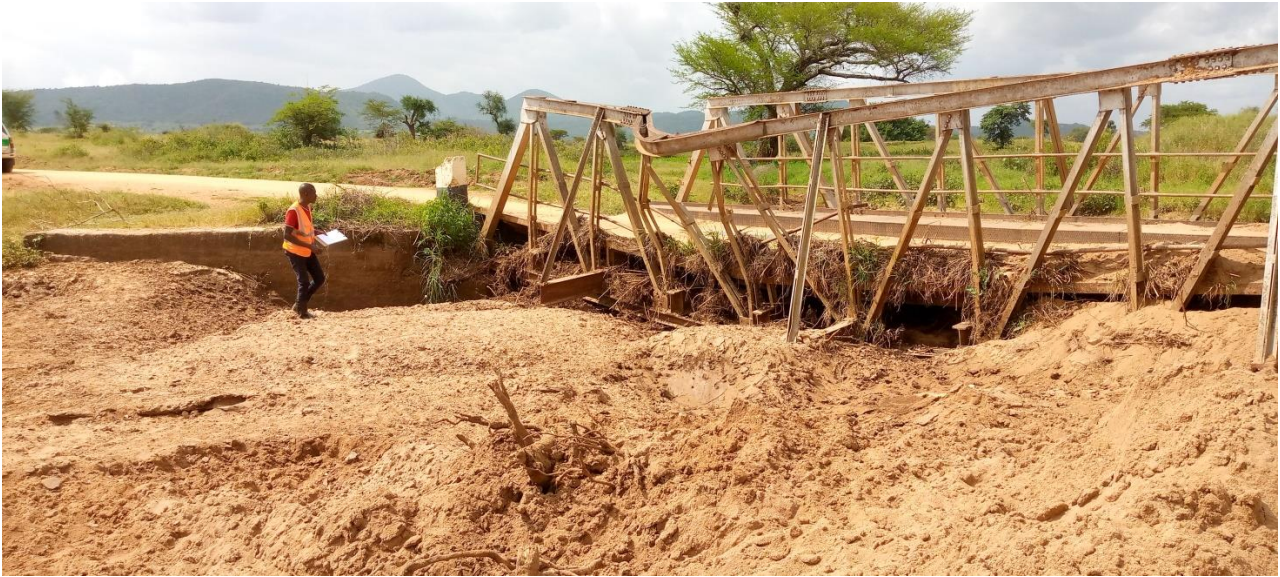
*Lakapelot bridge (B176) along Kotido - Apaan - Kabong (B301\_Link03) in a critical state*
