## 1 Pictures taken along the Paved National Road Network

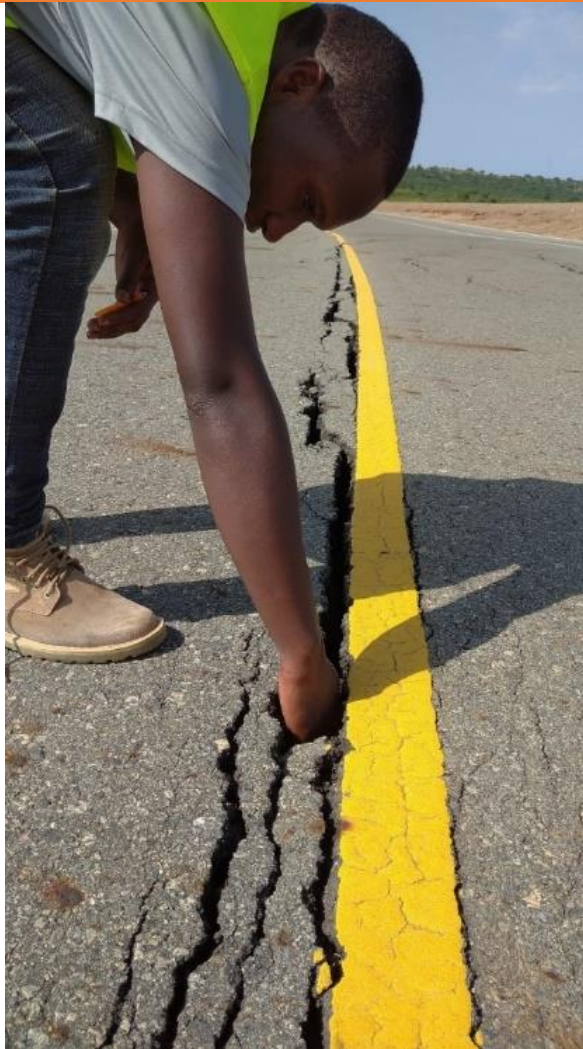
*Photograph 1-1: Wide shear cracks along Kyehooro link 1 at chainage 3+950*

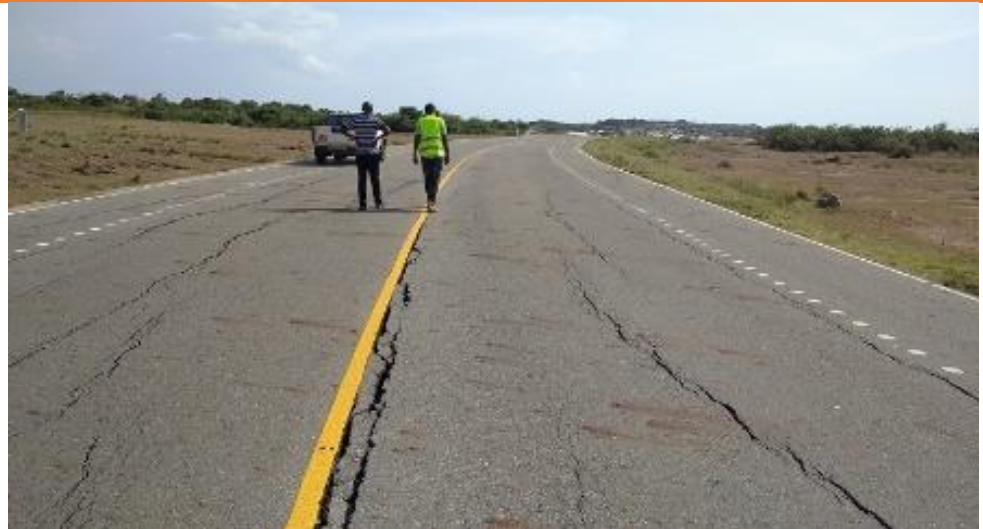
*Photograph 1-2: Sheer cracks along Kyehooro link 1 at chainage 4+800*

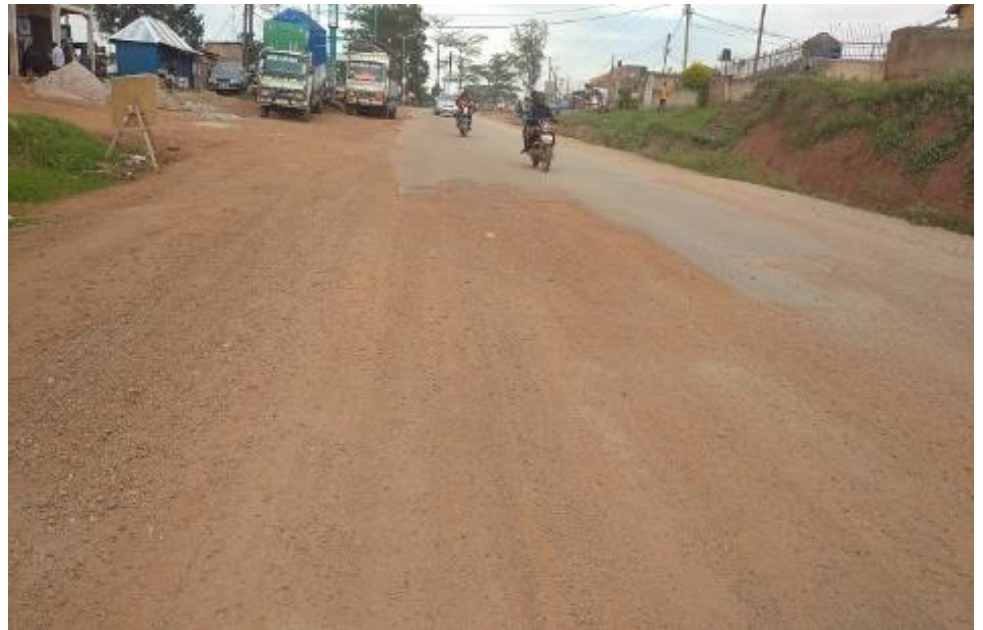
*Photograph 1-3: Severe width loss, potholes, cracks and edge break along Myanzi – Kiganda road at chainage 103+200.*

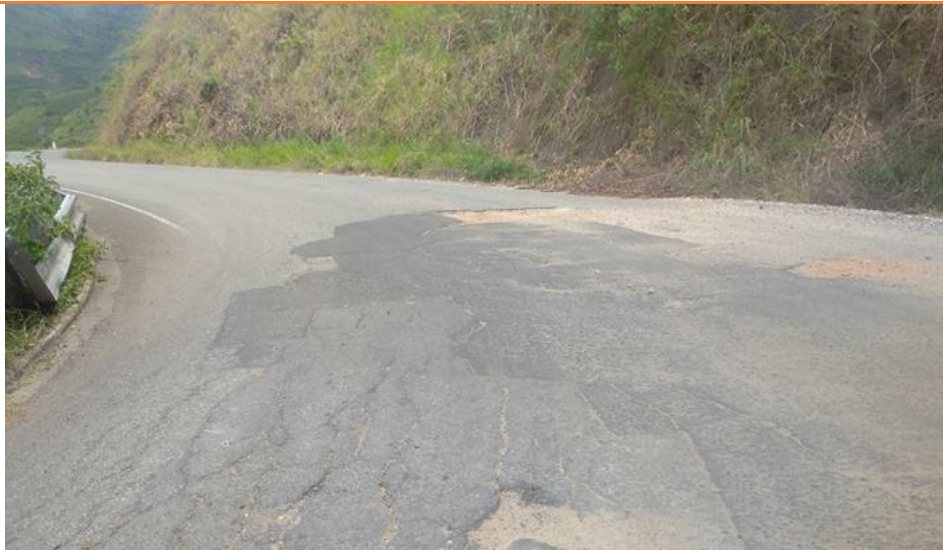
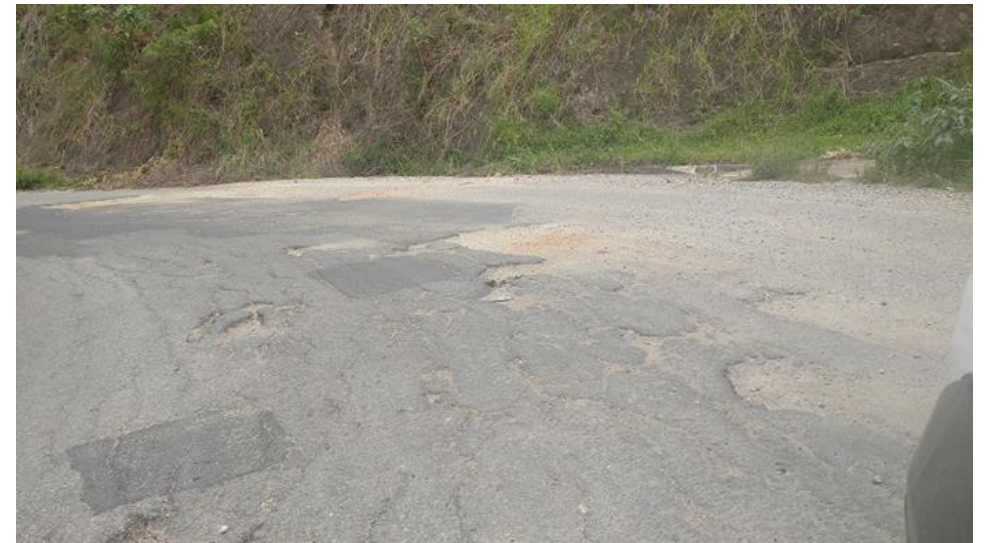
*Photograph 1-4: Several cracked sections in the sharp bends along Fortportal - Kichwamba - Karugutu road.*

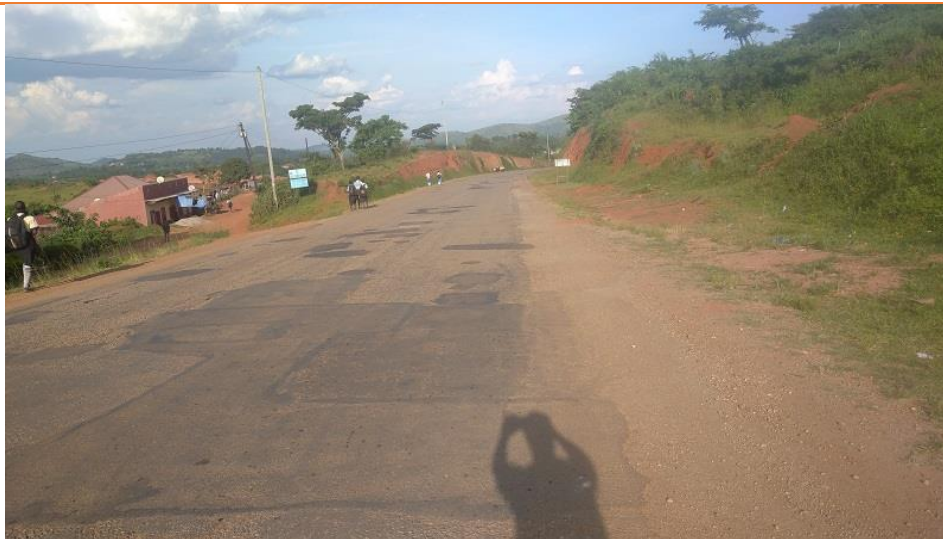
*Photograph 1-5: Patches, Potholes and raveling along Kyegegwa - Kakabara – Kyenjojo road at chainage 232+000 to 234+000*

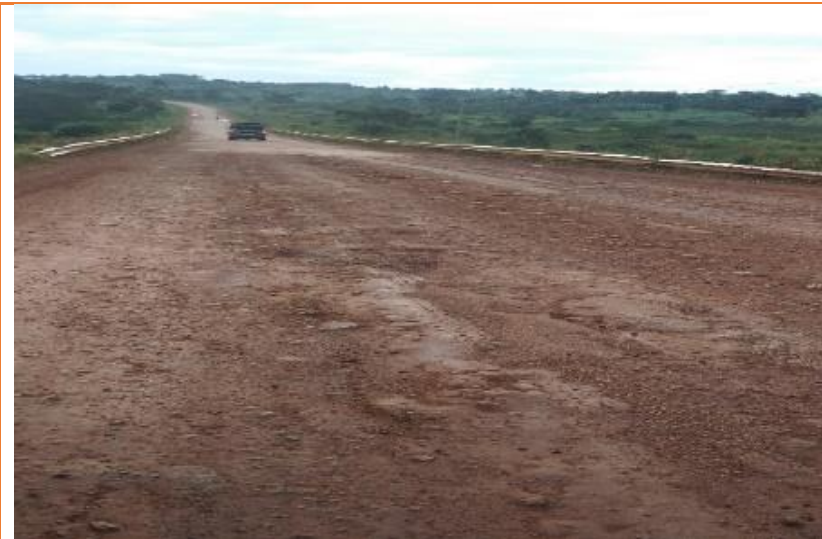
*Photograph 1-6: Ongoing rehabilitation works along Kiganda - Kitenga road at chainage 108+000 to 109+000.*

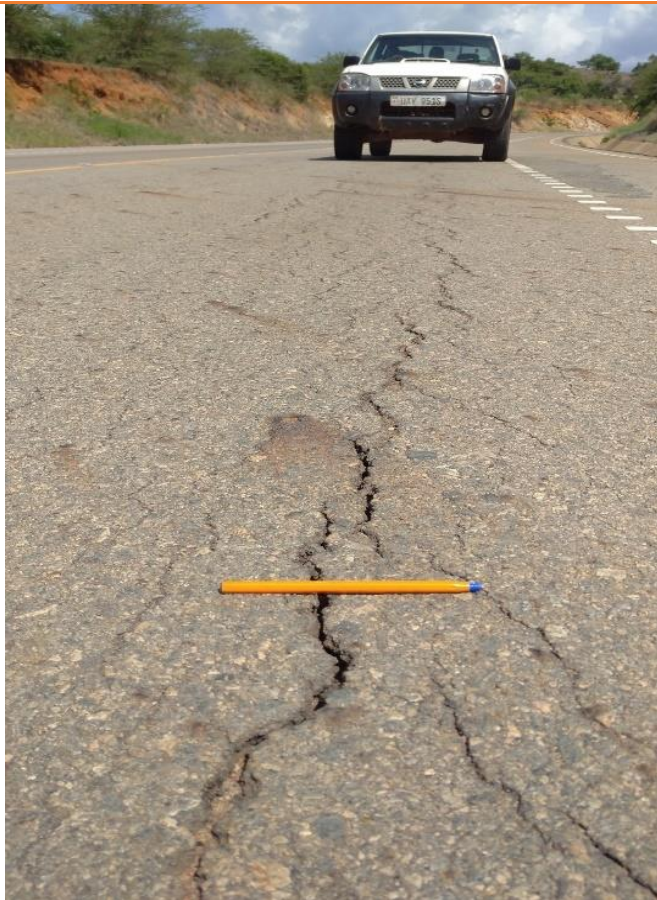
*Photograph 1-7: Wide cracks along Kabaale - Kaiso road at chainage 38+000 to 49+000.*

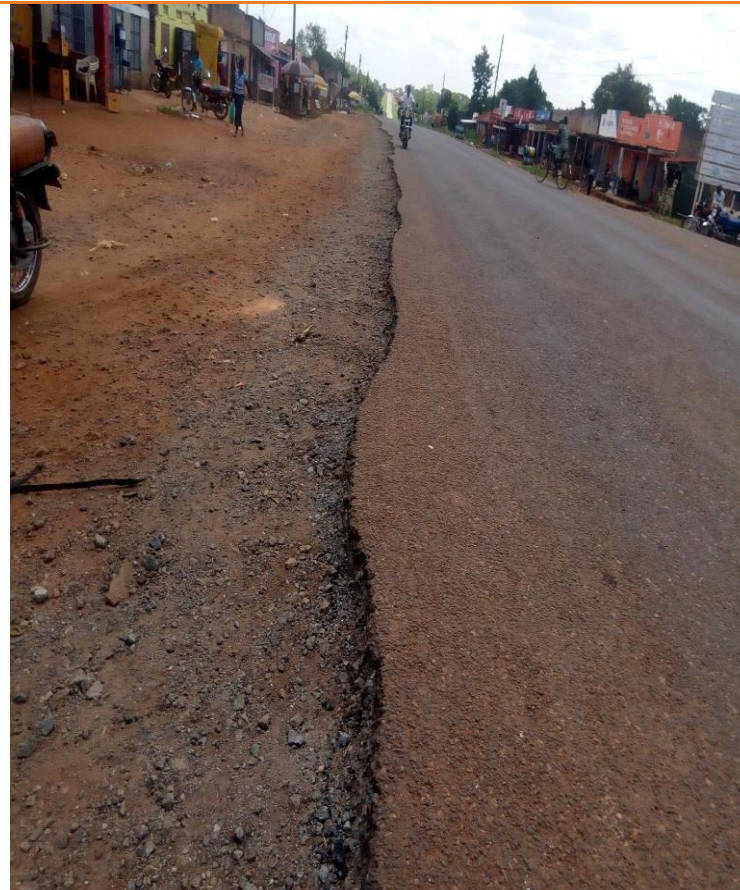
*Photograph 1-8: Width loss, edge loss/drop and surface deterioration along Gulu - Atiak - Nimule (Uganda/Sudan border) road.*

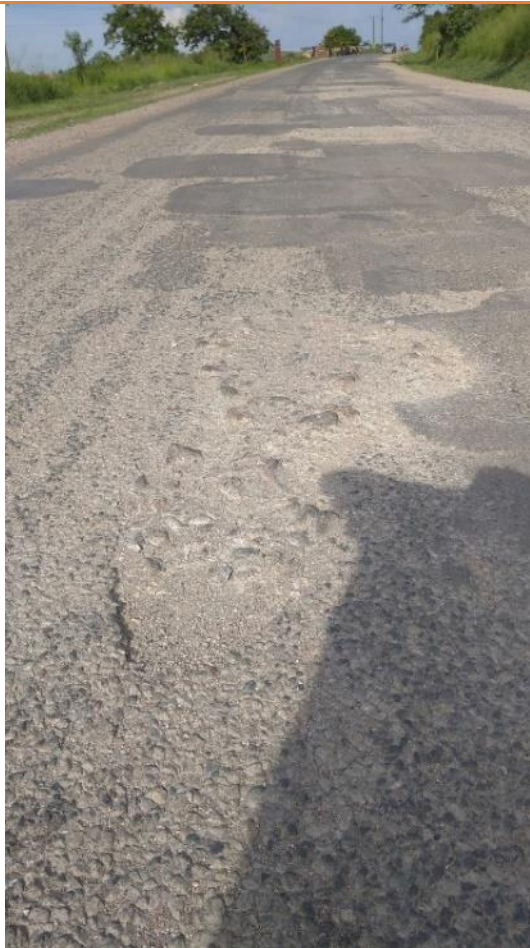
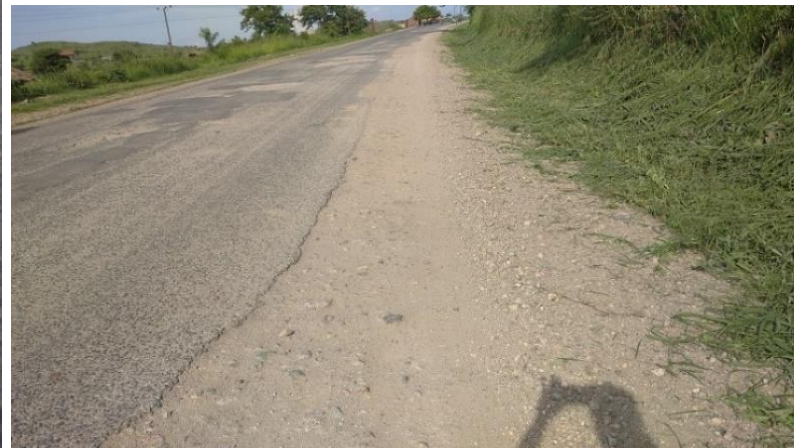
*Photograph 1-9: Severe width loss, Edge break, Wide Cracking and Potholes along Kikorongo - Bwera Mpondwe road.*

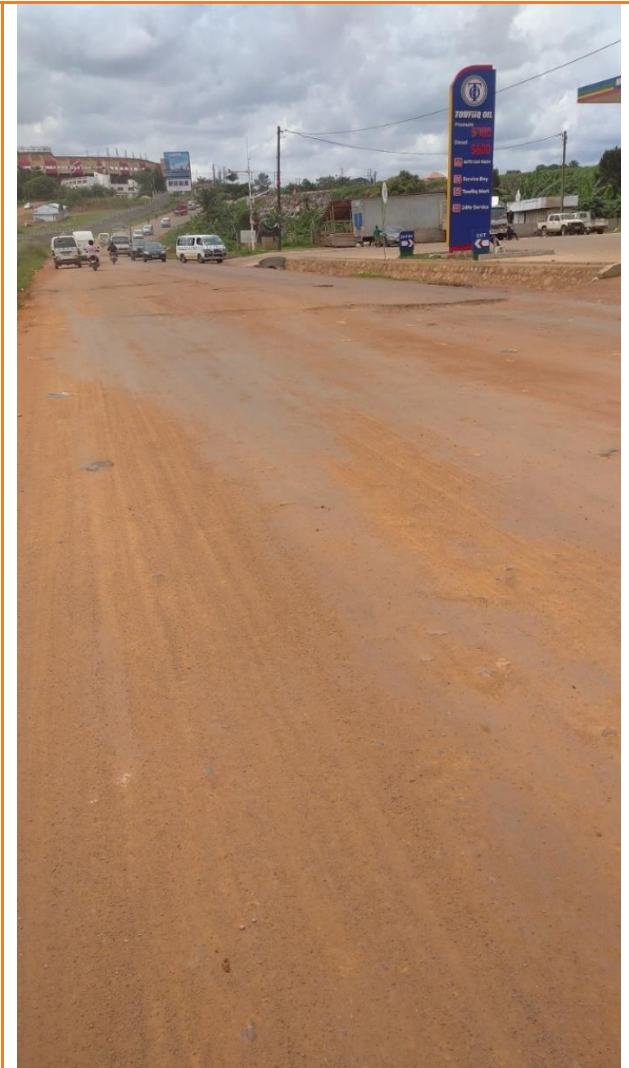
*Photograph 1-10: Wide cracks and Potholes along Namboole Access road.*

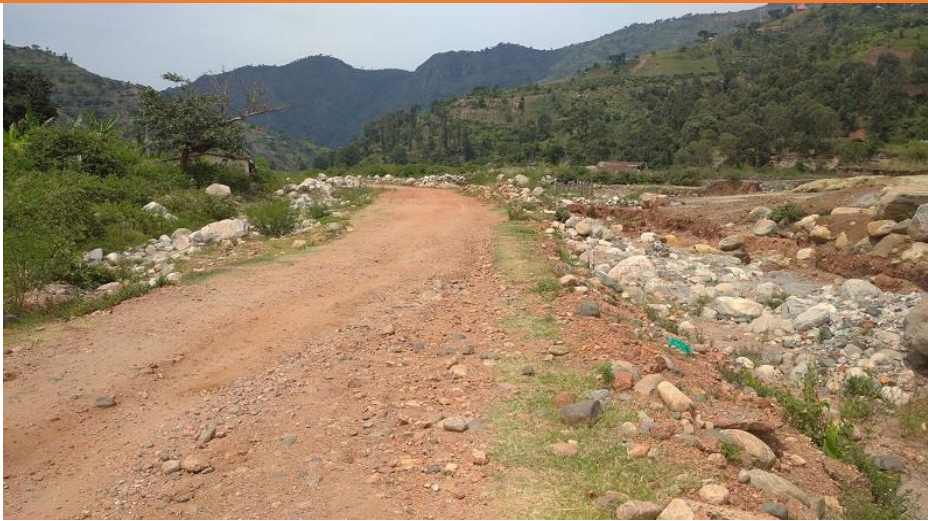
*Photograph 1-11: Pavement severely washed away due to overflow of River Mwamba along Kasese - Kilembe mines road.*

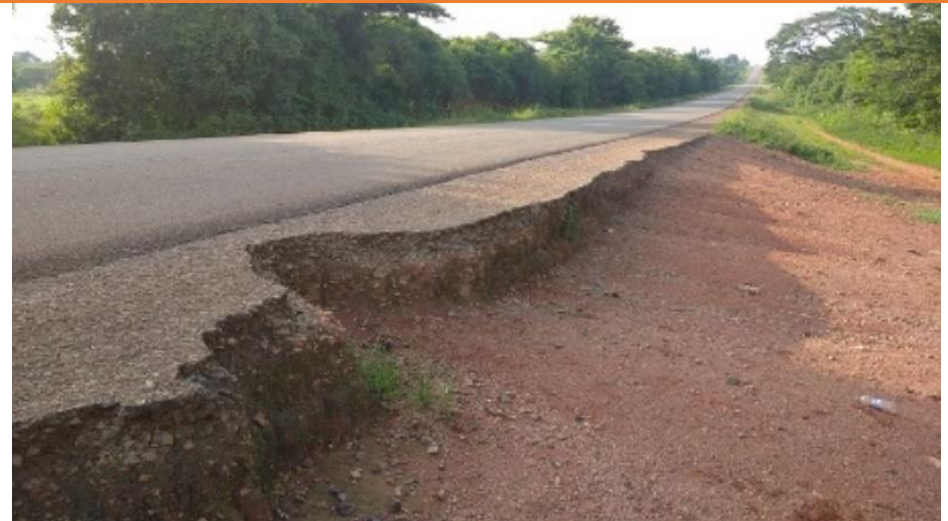
*Photograph 1-12: Severe edge drop/loss Lwamata - Hoima road at chainage 153+000 to 154+000.*

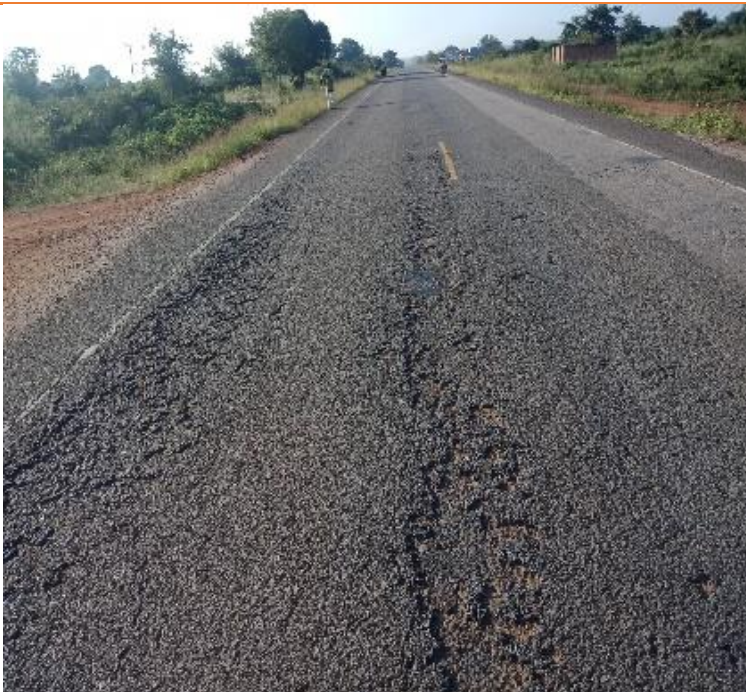
*Photograph 1-13: Severe surface deterioration, potholes and cracking along Soroti - Dokolo road.*

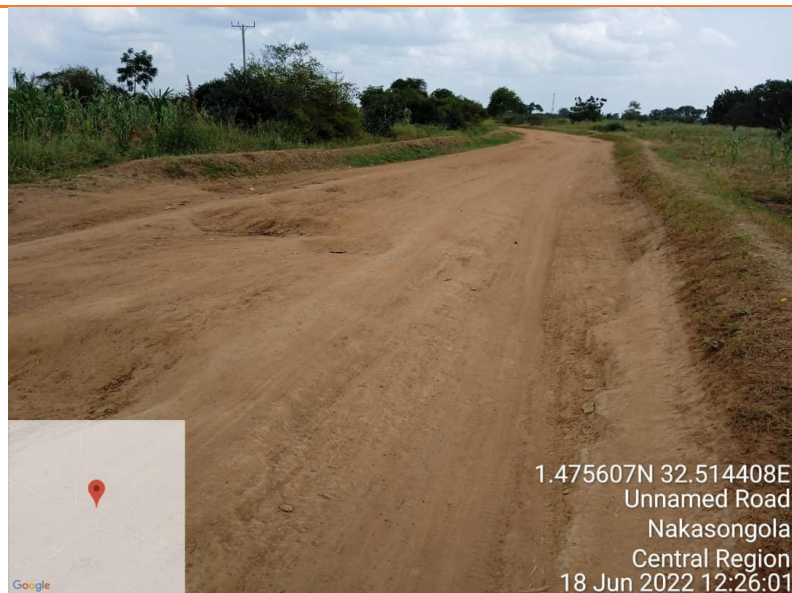
*Photograph 2-1: Severe potholes and gullies along Zengebe-Ferry-Access road.*

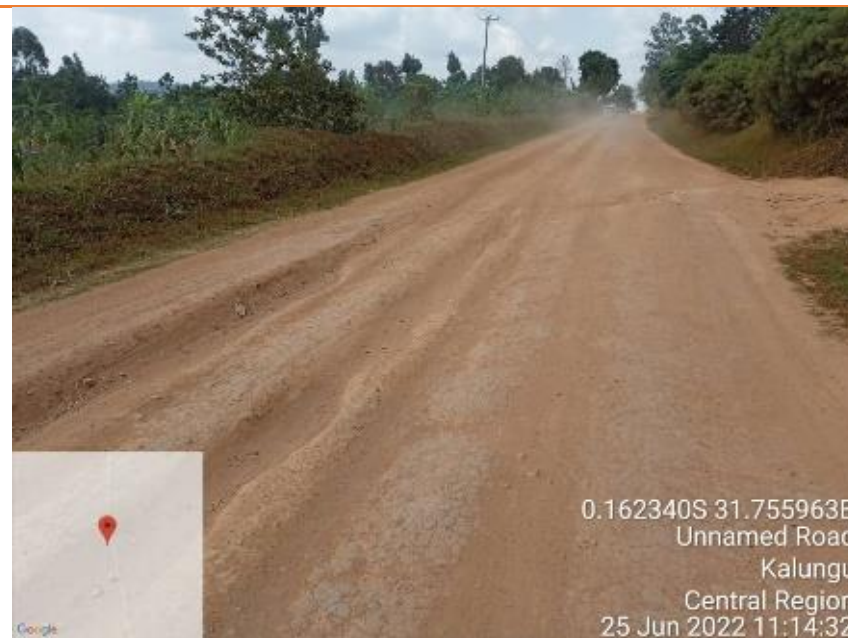
*Photograph 2-2: Severe rutting along Villa Maria - Kalungu road*

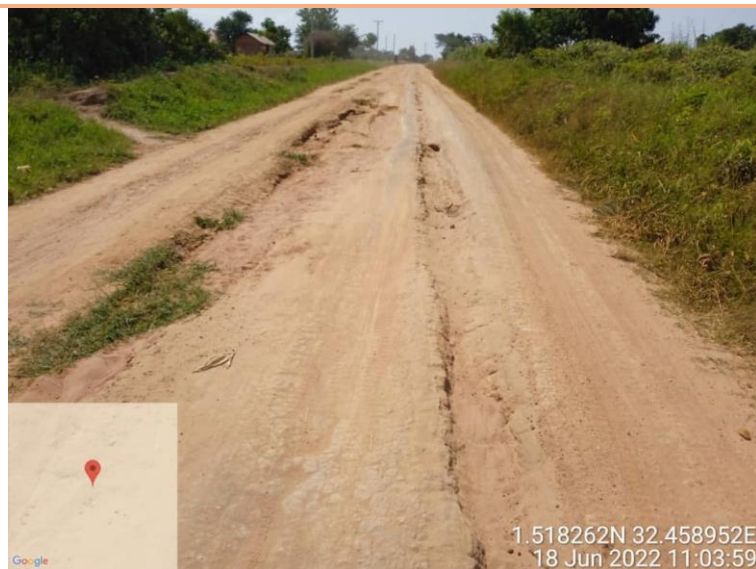
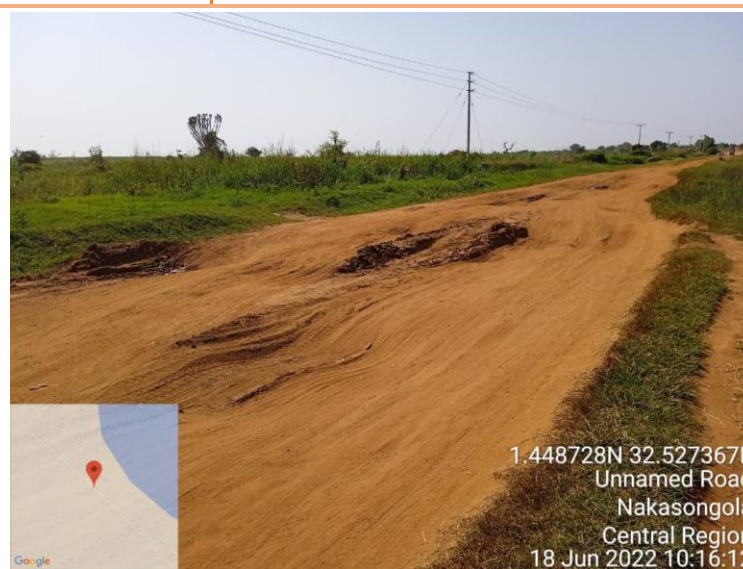
*Photograph 2-3: Deep erosion gullies along Lwampanga - Lwabyata road.*

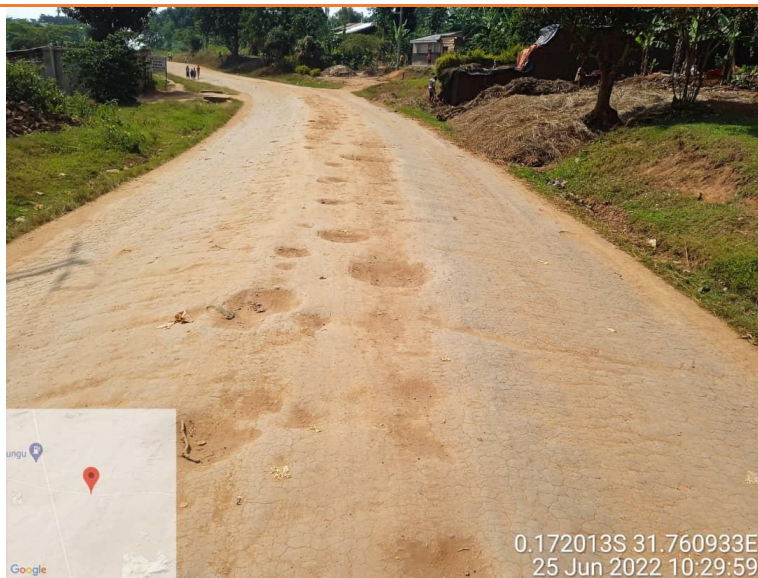
*Photograph 2-4: Potholes along Bukulula - Kalungu road.*

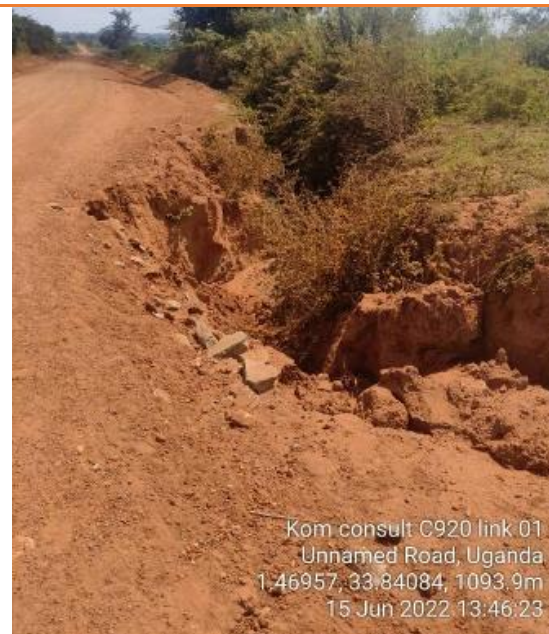
*Photograph 2-5: Defects along Kumi-Brooks corner road.*

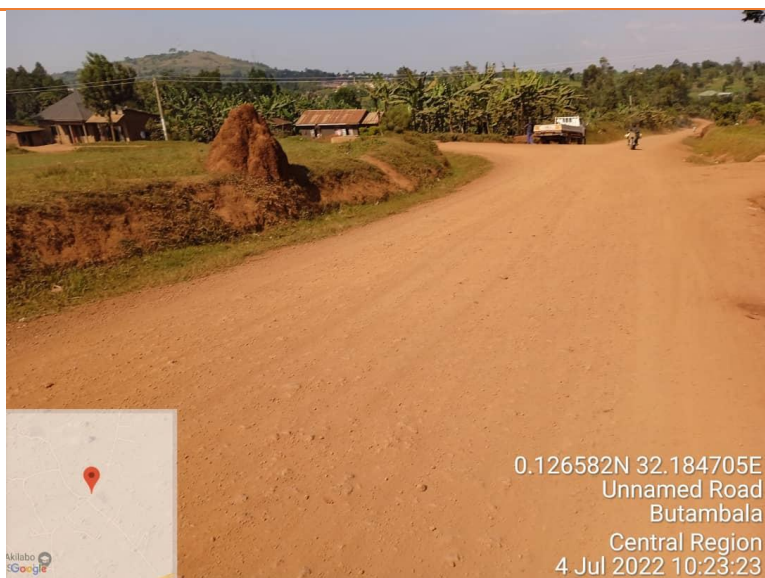
*Photograph 2-6: Kyabadaza - Kibibi road.*

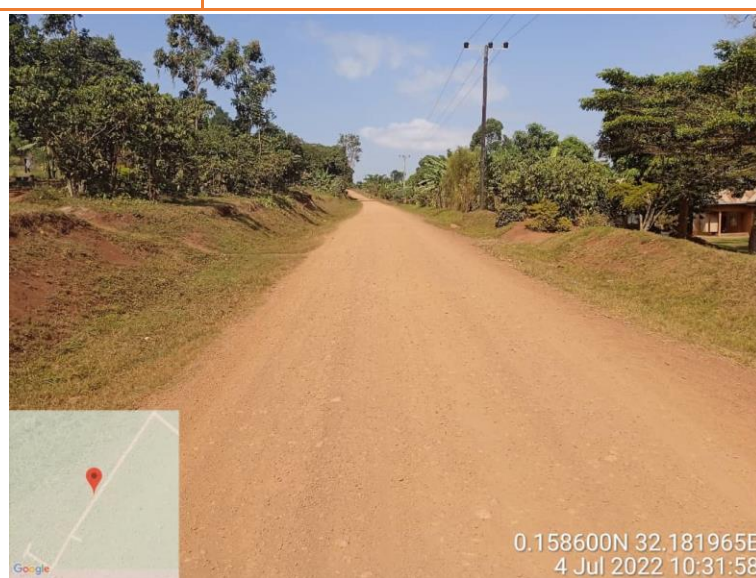
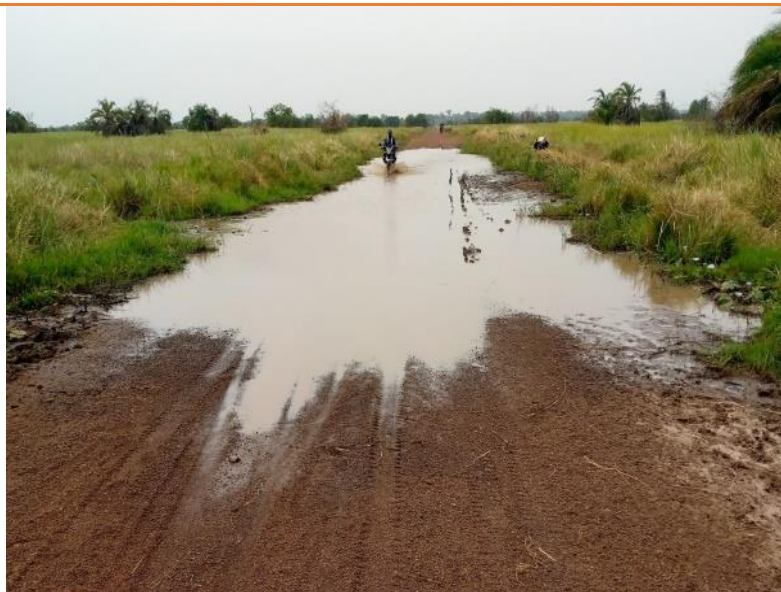
*Photograph 2-7: Flooding along Rhino camp-Ogoko - Inde road.*

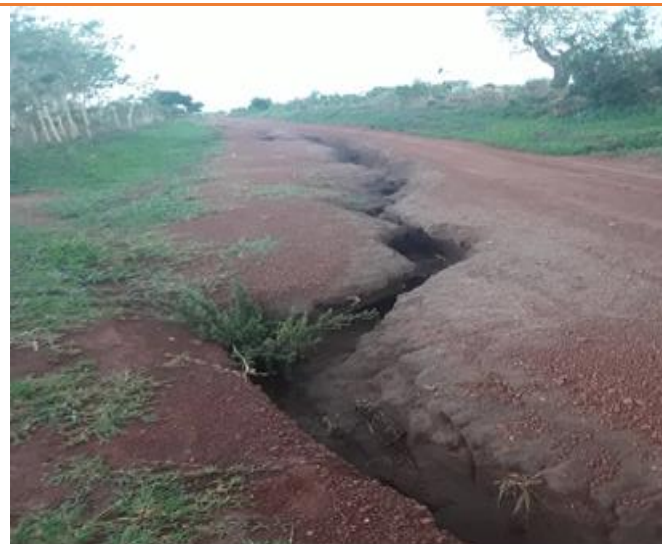
*Photograph 2-8: Erosion gullies along Ngai- Abok – Otwal - Aromo road.*

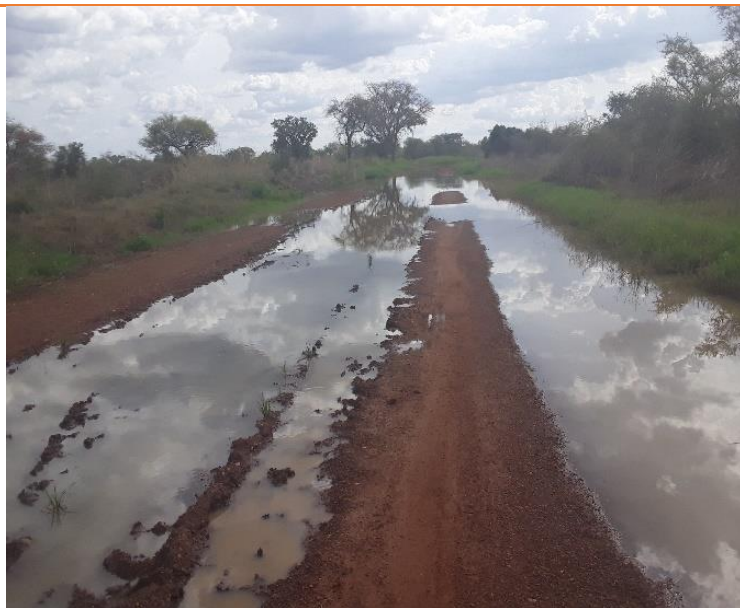
*Photograph 2-9: Flooding of River Nile along Tete - Nimule border road.*

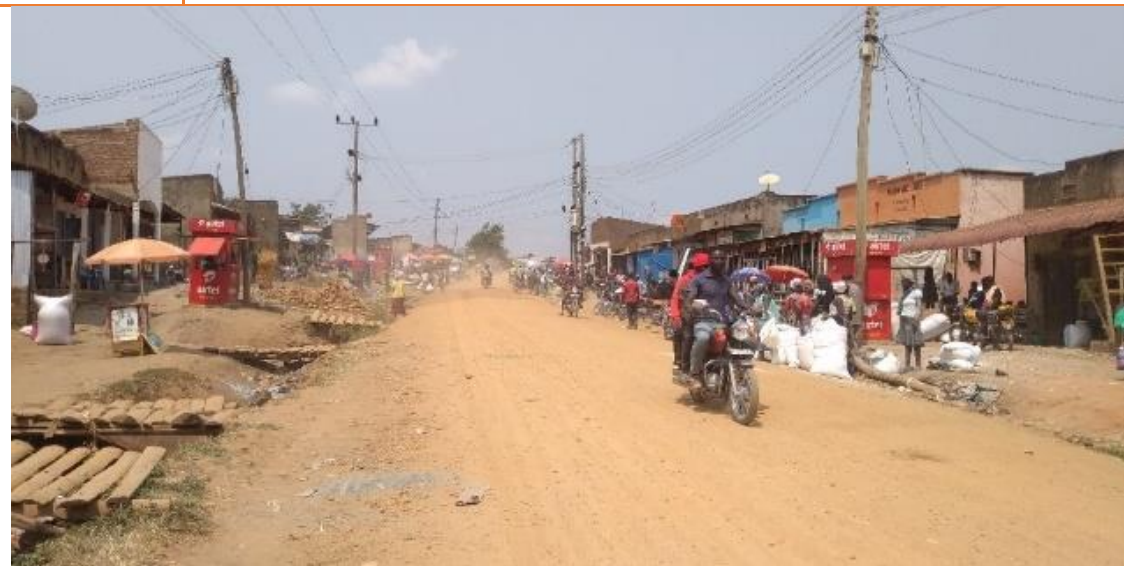
*Photograph 2-10: High road side friction along Katerera - Buhindagye road.*

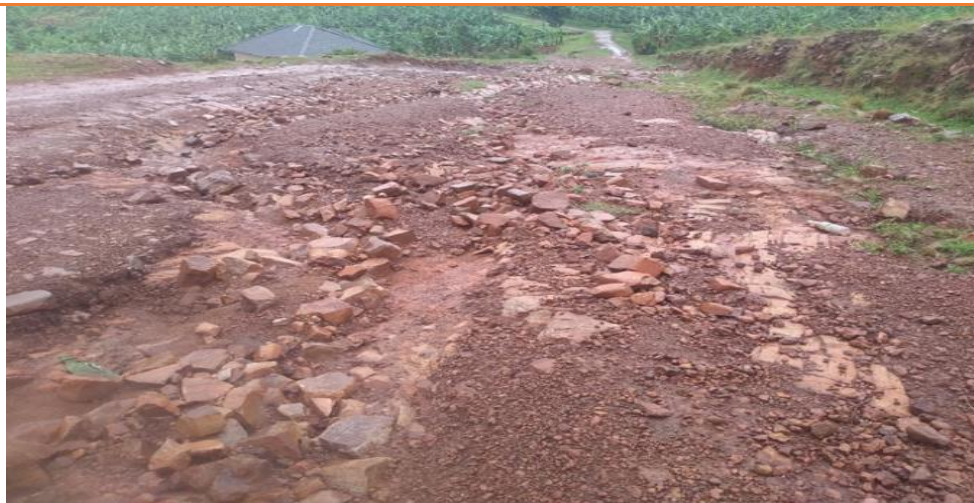
*Photograph 2-11: Poor material quality along Kityanza - Bugango access road.*

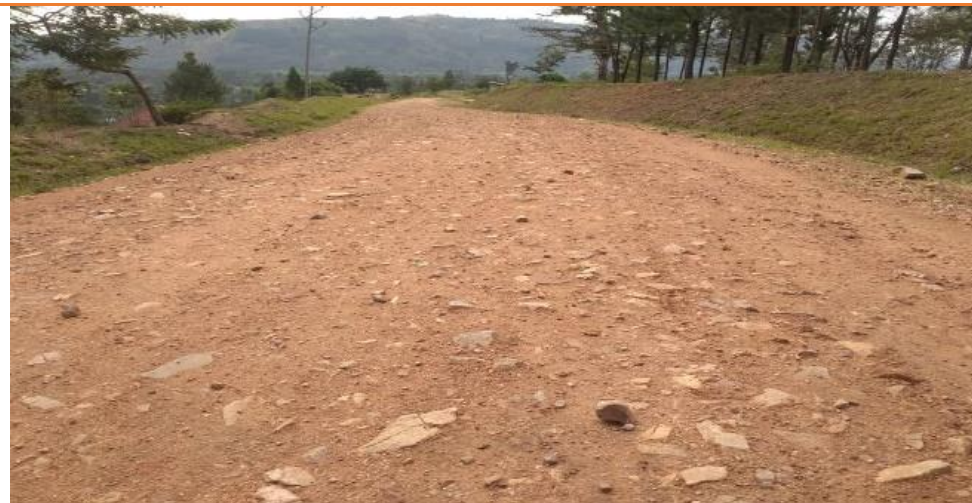
*Photograph 2-12: Poor material quality along Nkenda - Bugoye road*

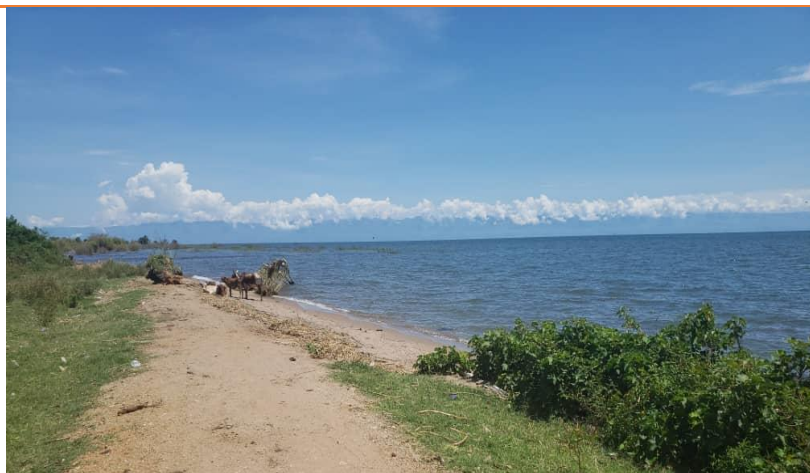
*Photograph 2-13: The end of Kaiso - Tonya cut off by the lake.*

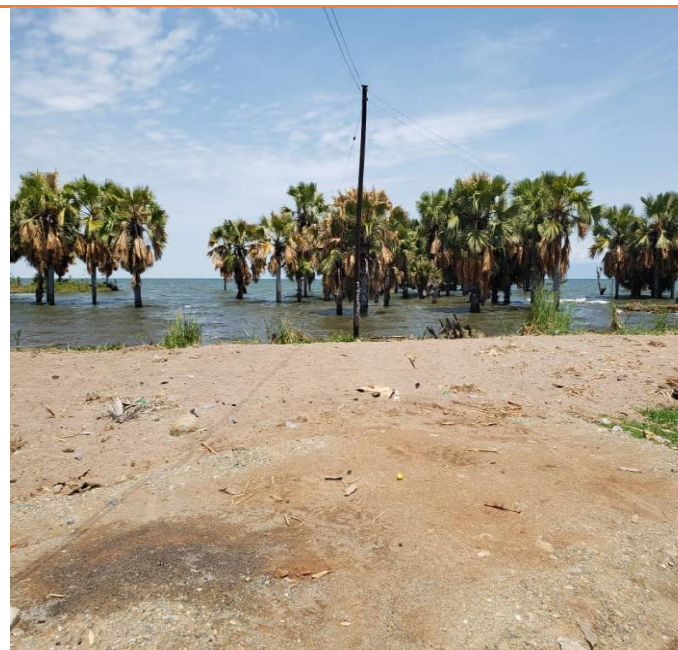
*Photograph 2-14: The end of Isunga - Bugwara road cut off by the lake.*

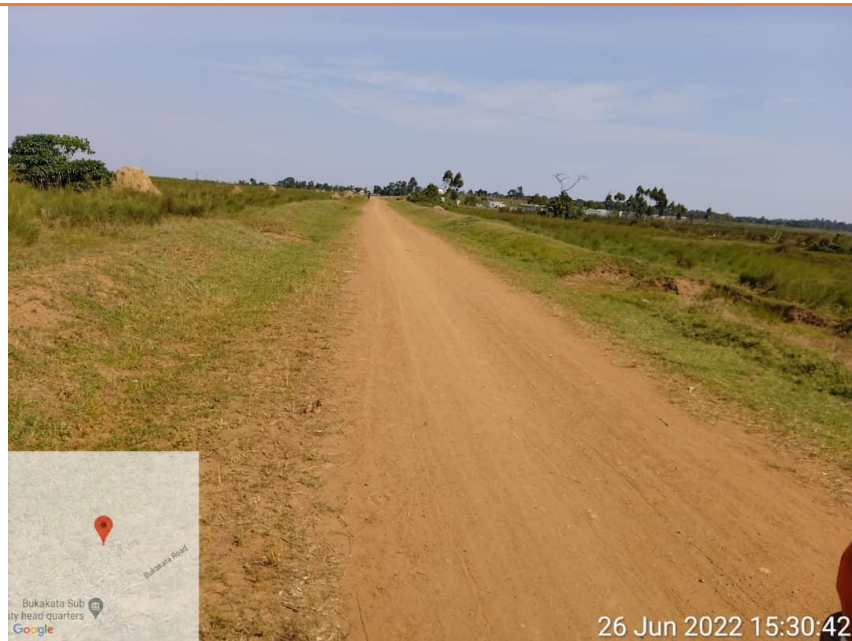
*Photograph 2-15: Mukoko - Birinzi - Ssunga road*

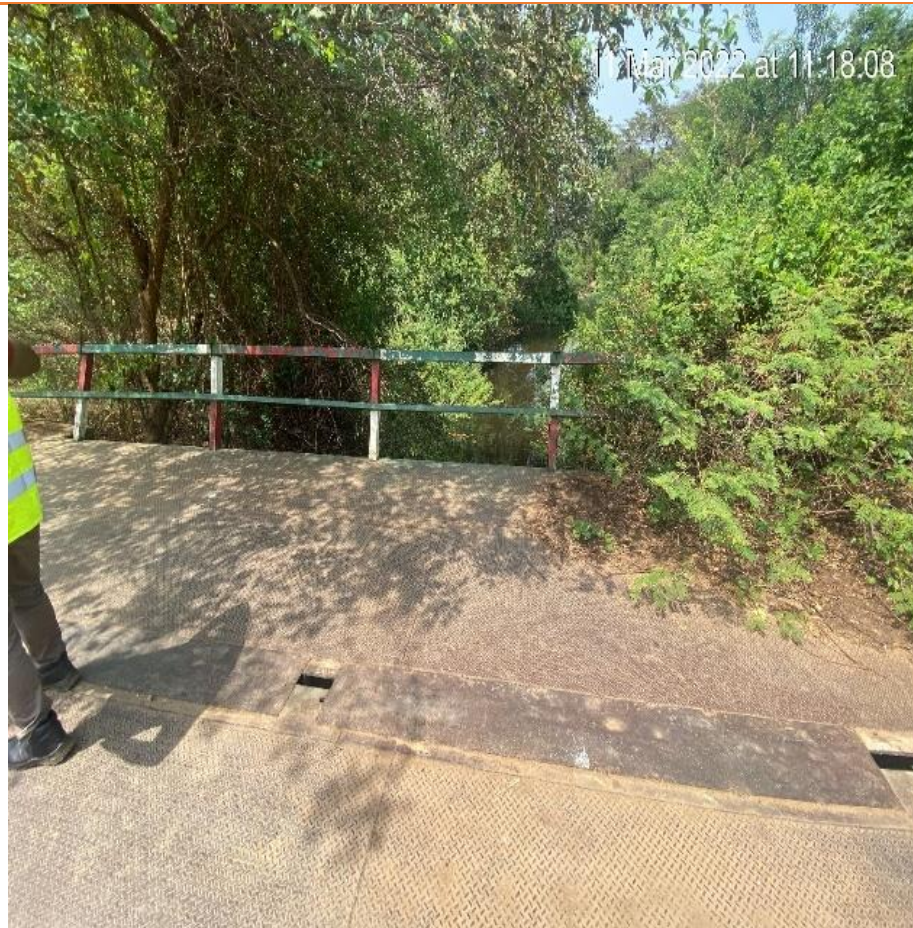
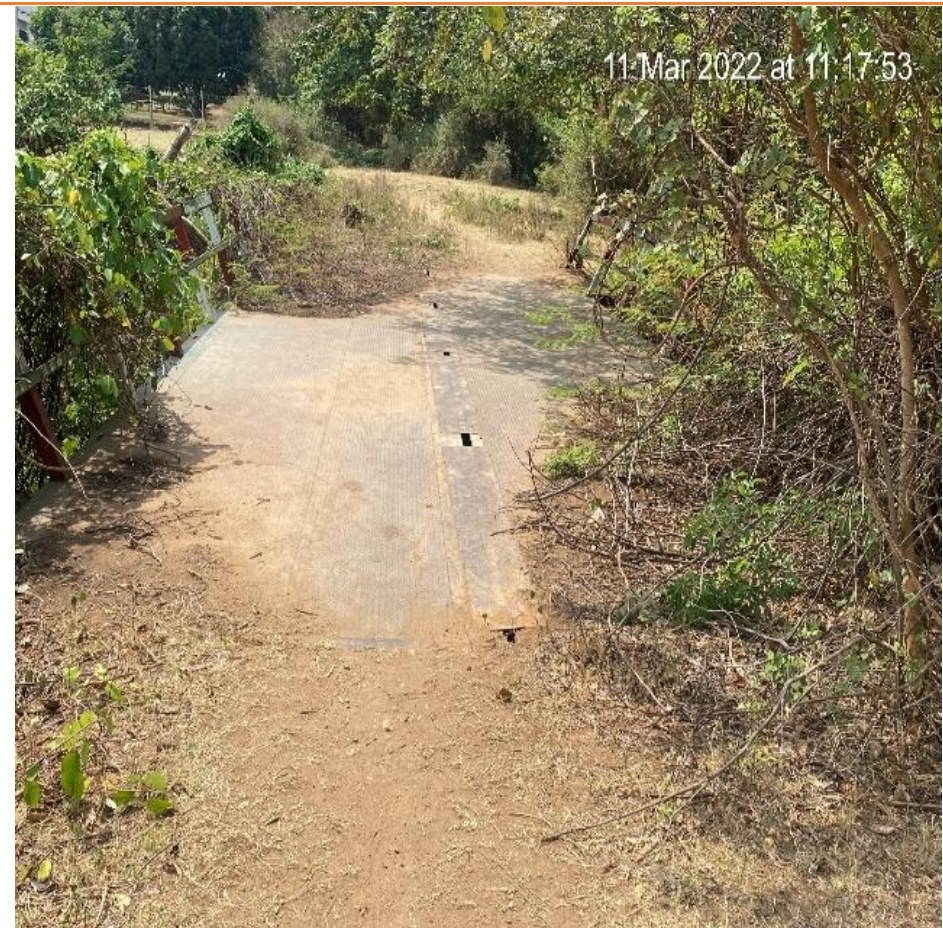
*Photograph 3-1: B275 Wambabya Bridge along Buseruka - Tonya road is no longer in use.*

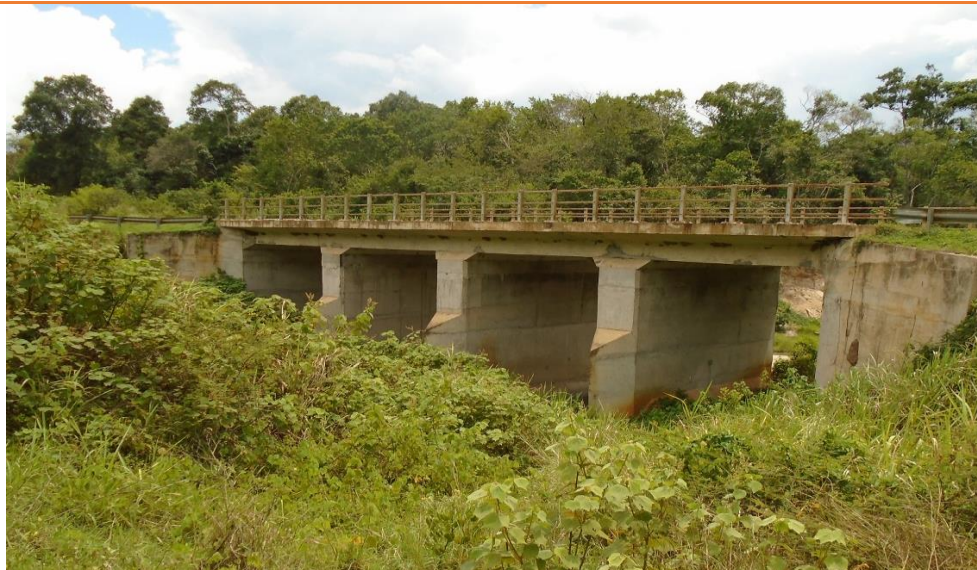
*Photograph 3-2: B071 Rwempunu bridge along Katunguru - Ishasha road with poor waterway condition.*

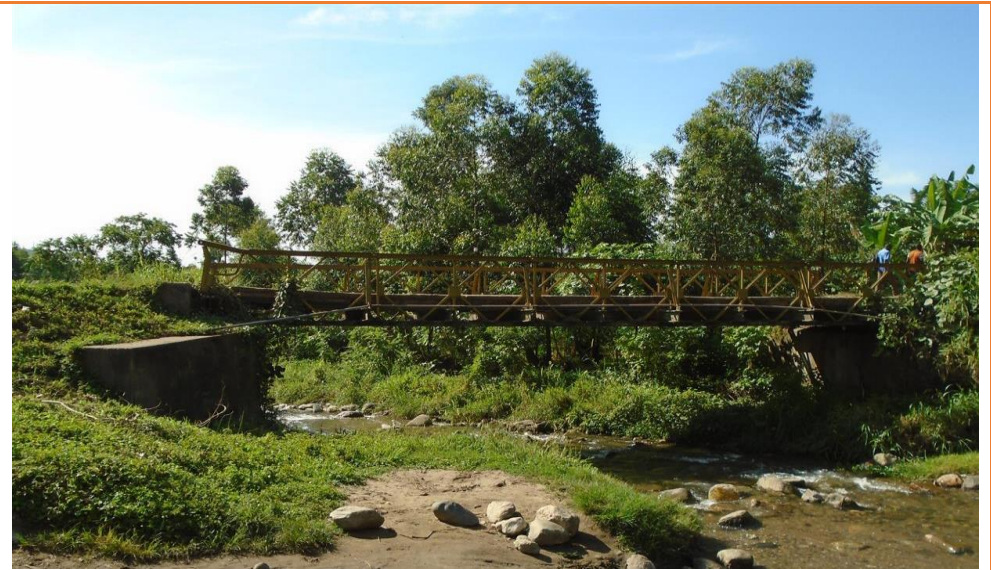
*Photograph 3-3: Ongoing replacement works on B082 Kanyampala Upper bridge along Kinyamaseke - Kisinga road.*

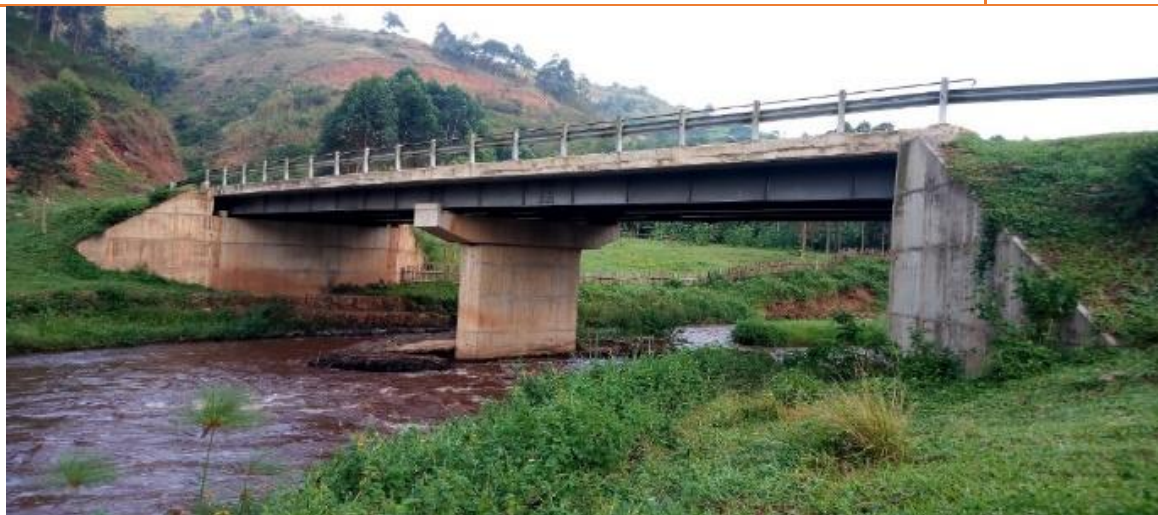
*Photograph 3-4: Waterway condition for B560 along Kisinga – Kyarumba - Kibirizi road.*

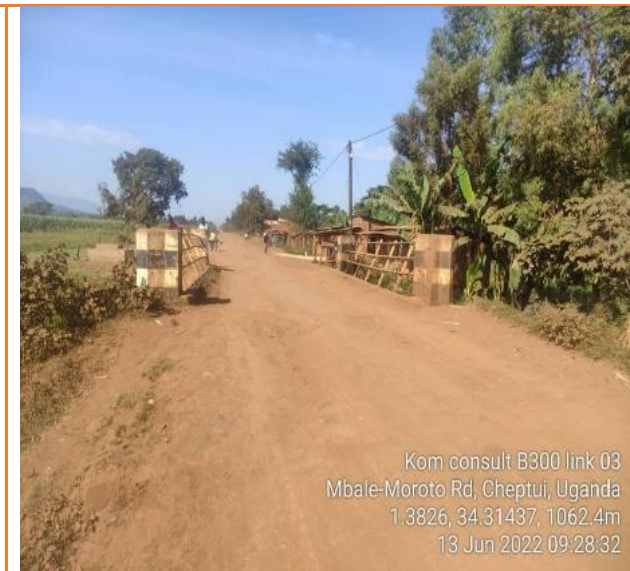
*Photograph 3-5: B158 Sipi bridge along Muyembe - Namalu road.*

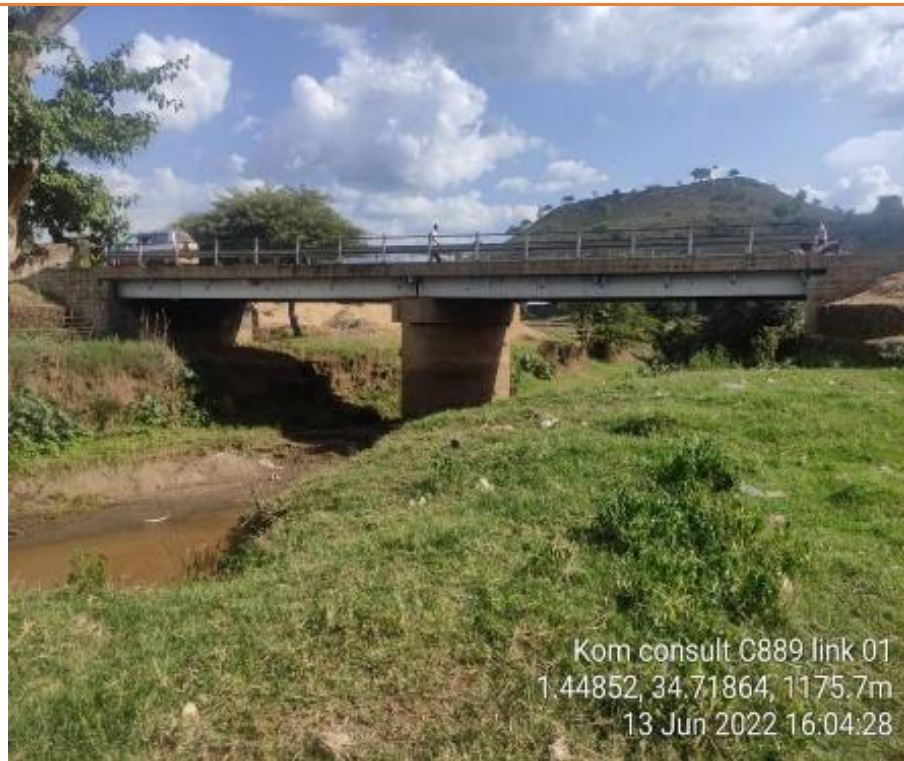
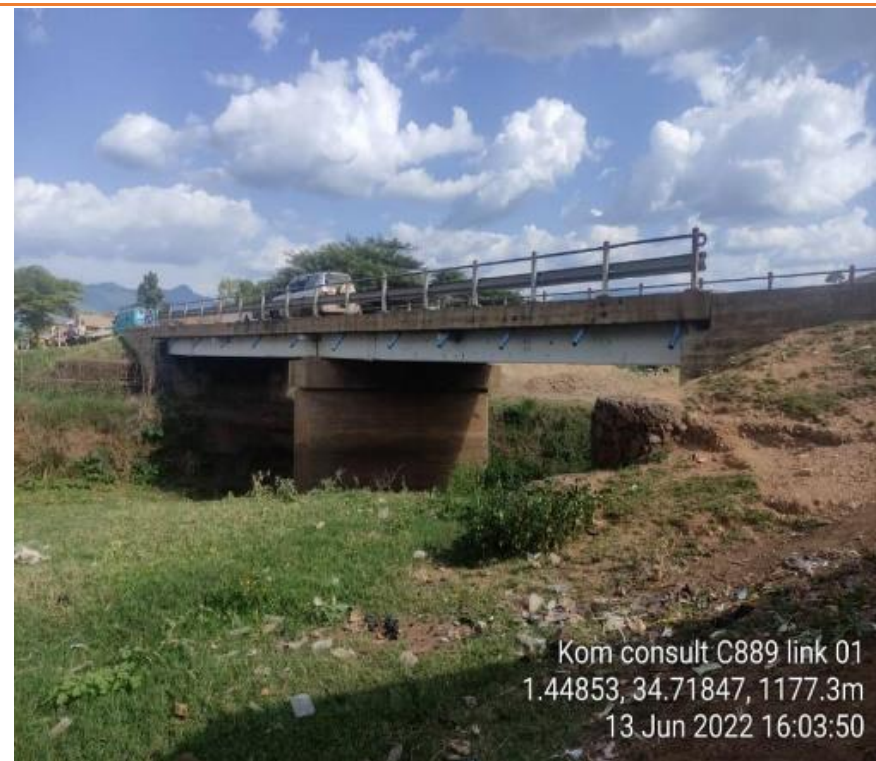
Photograph 3-6: B873 Girik bridge along Chepsikunya -Girik road.
