# 2020 Condition report

## Bridges and Major Culverts

Uganda National Roads Authority

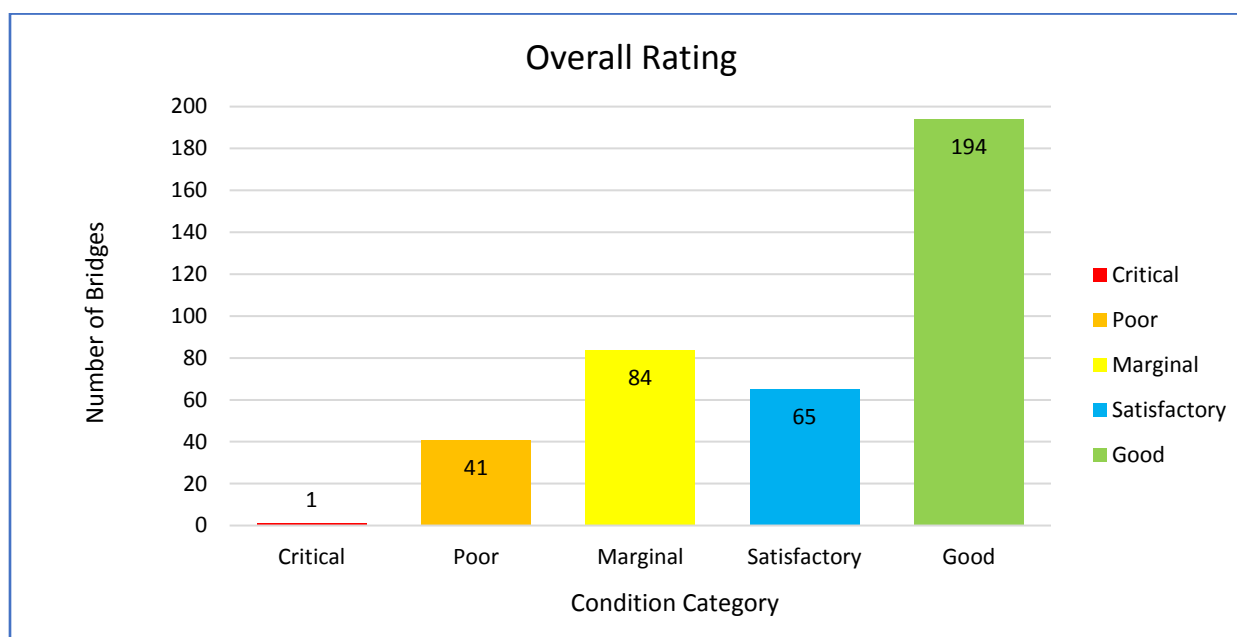
*Figure 3-3: Overall rating of bridges*

From Figure 3-3 above, it can be observed that the highest number of bridges (50%) is in good condition. The bridges in marginal condition are significant (17%) and timely maintenance is advised to prevent them from quickly deteriorating to a poor condition. Bridges in poor and critical condition are the least (11%) and urgent intervention is required.

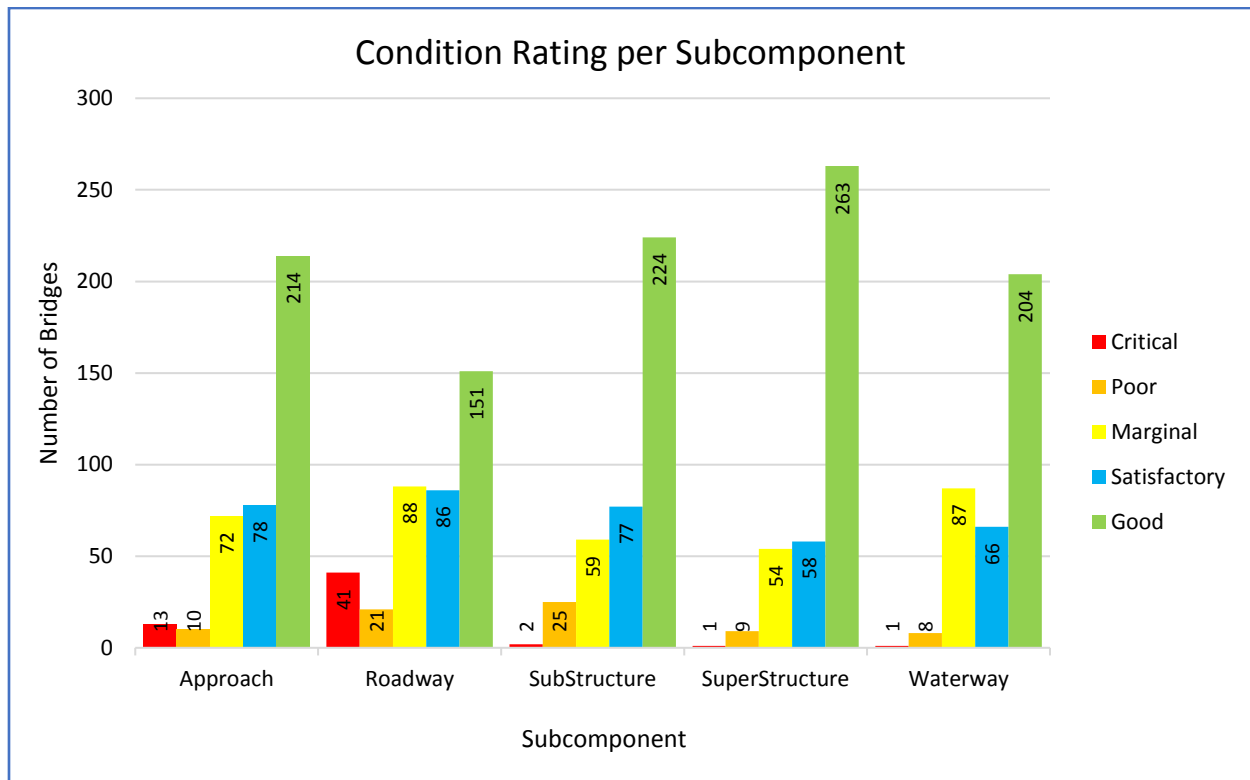
*Figure 3-4: Condition rating of bridges per subcomponent*

- The majority of bridges have subcomponents in good condition.
- An appreciable number of subcomponents have a marginal rating and timely maintenance is required.
- Subcomponents in poor and critical condition are minimal and urgent maintenance is required. Failure to do so possess a safety hazard and can lead to closure or collapse of a bridge.

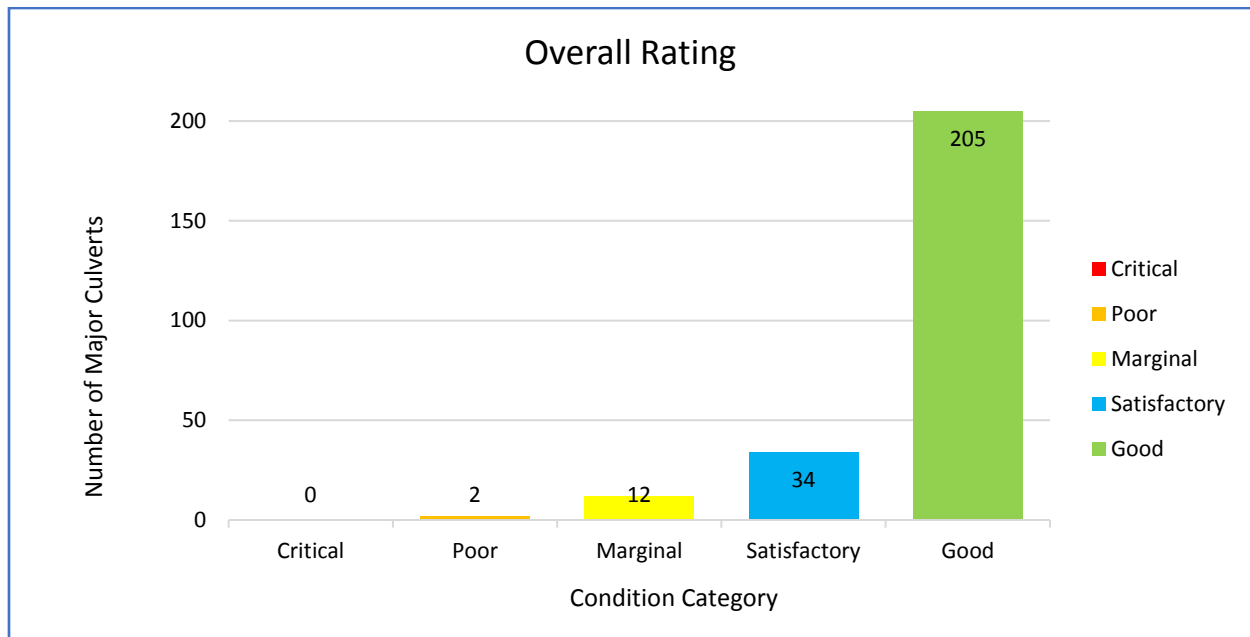
*Figure 3-5: Overall rating of major culverts*

From Figure 3-3 above, it can be observed that 205 (81%) major culverts are in good condition. 34 (13%) are satisfactory and 12 (5%) are in marginal condition. Only 2 (less than 1%) major culverts are in poor and critical condition.

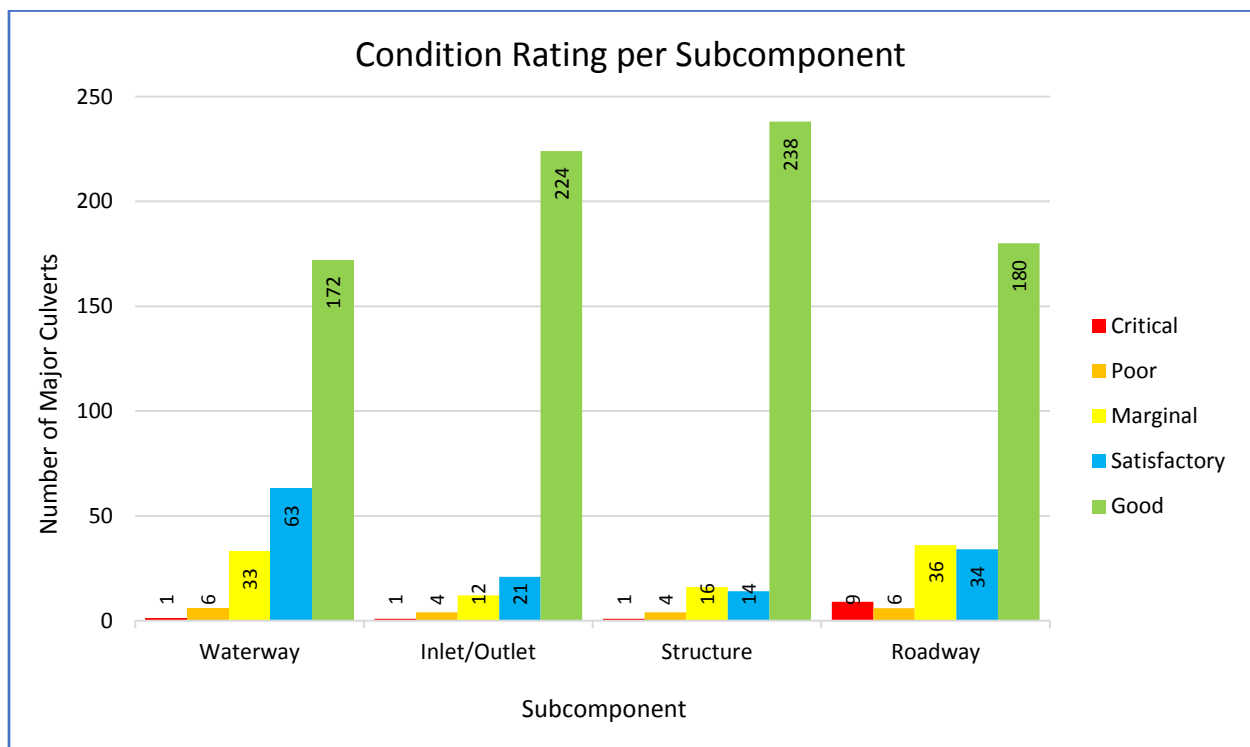
*Figure 3-6: Condition rating of bridges per subcomponent*

- The majority of major culverts have subcomponents in good condition.

- Subcomponents in poor and critical condition are minimal and urgent maintenance is required.

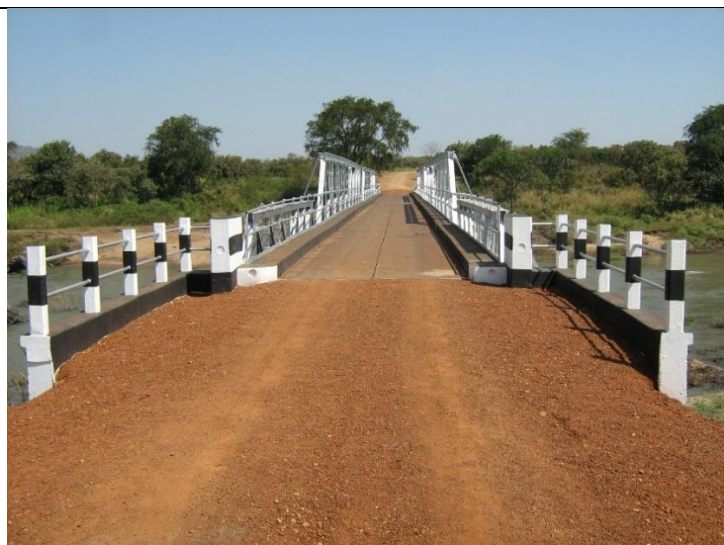
Aswa bridge along Atiak-Palabek in 2008

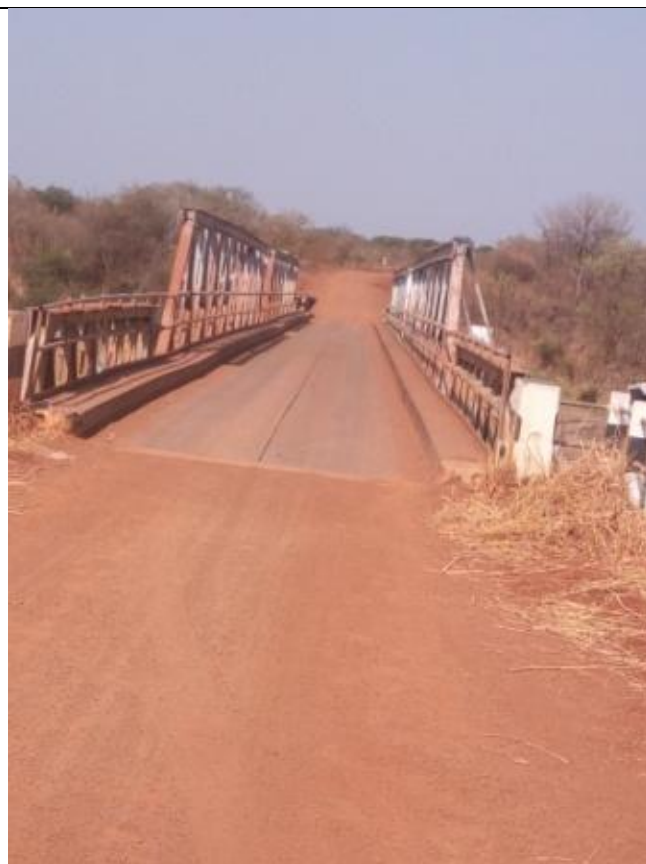
Aswa bridge along Atiak-Palabek in 2018

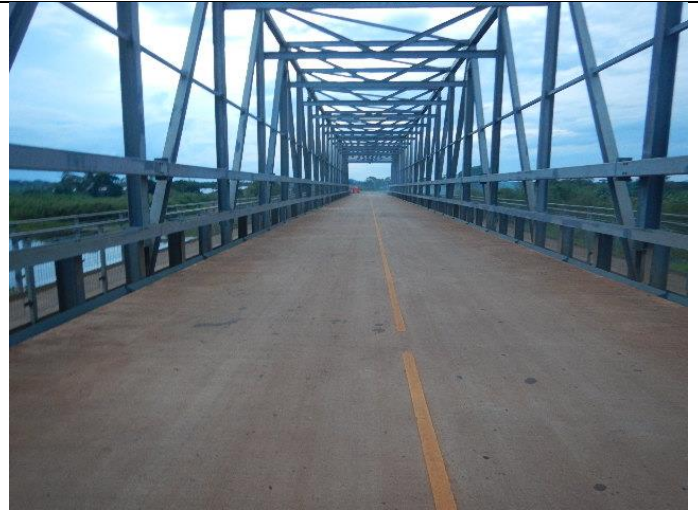
Kabaale Bridge in 2018

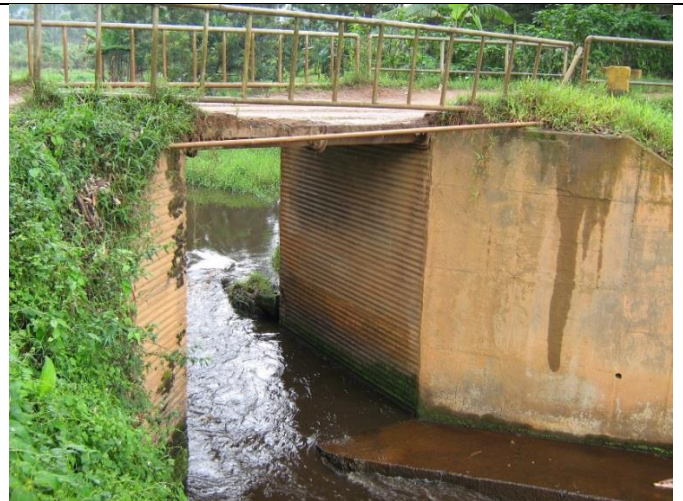
Culvert C171 in 2008. Structure was formerly Kitagata bridge

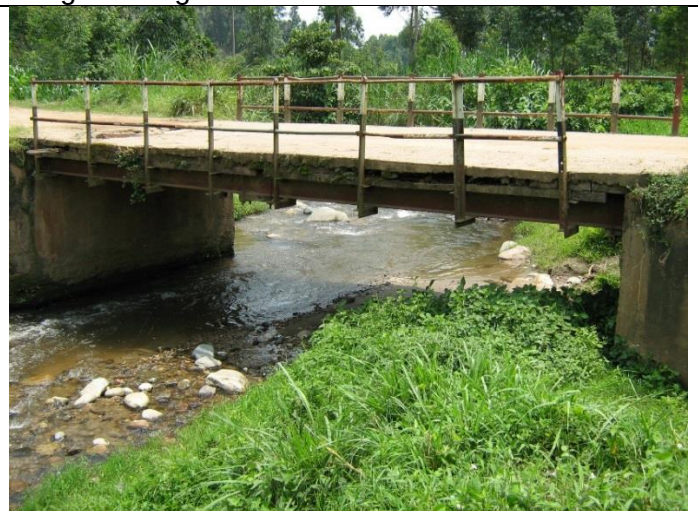
Culvert C193 in 2008. Structure was formerly Dungulwa bridge

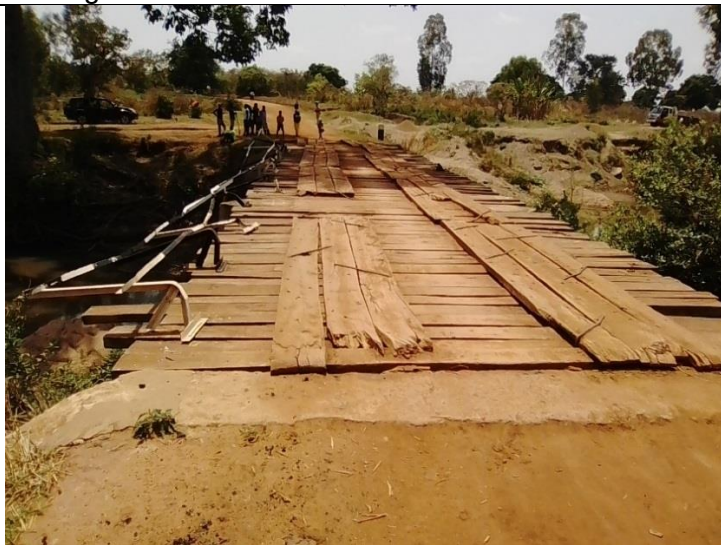
Kochi bridge along Keriri – Midigo in 2018

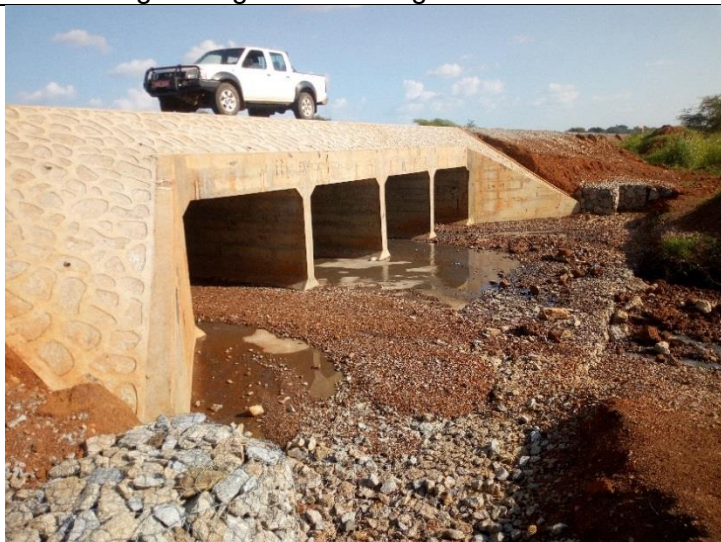
C520 along Kitgum - Madi Opei

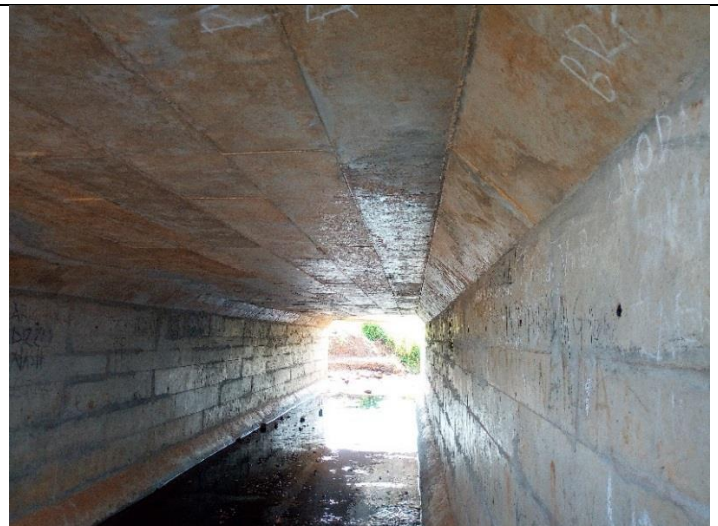
Newly constructed box culvert C520

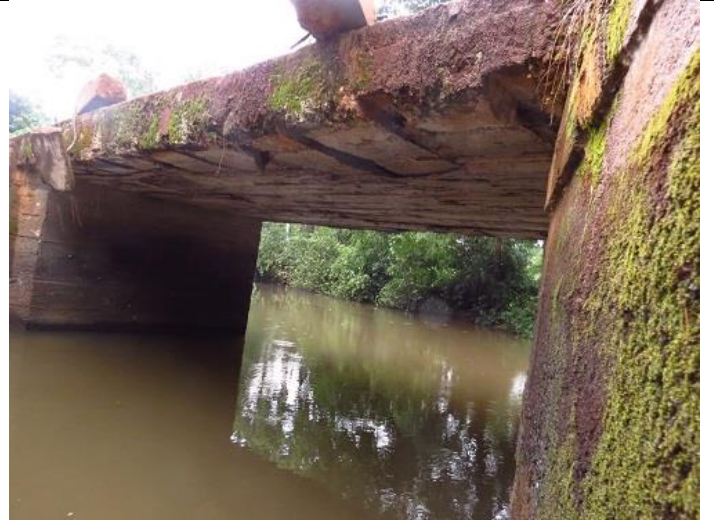
C404 along Bugambe-Kidoma is in poor condition

Underside of C404
