# 2020 Condition report

## Bridges and Major Culverts

Uganda National Roads Authority

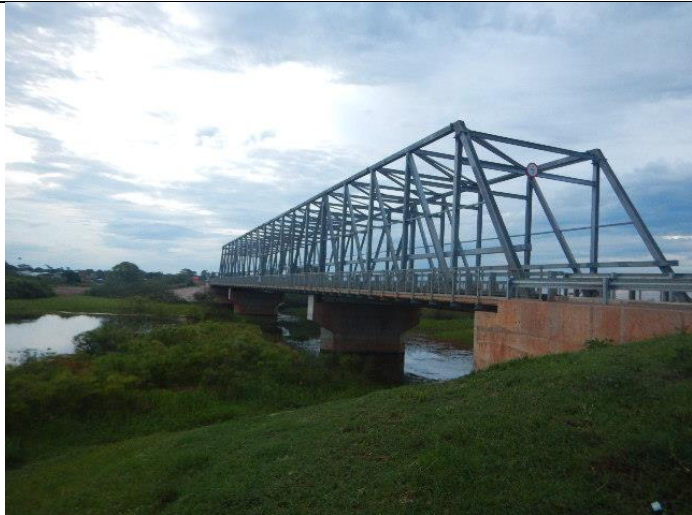
Kabaale Bridge along Kyankwazi – Ngoma in 2018

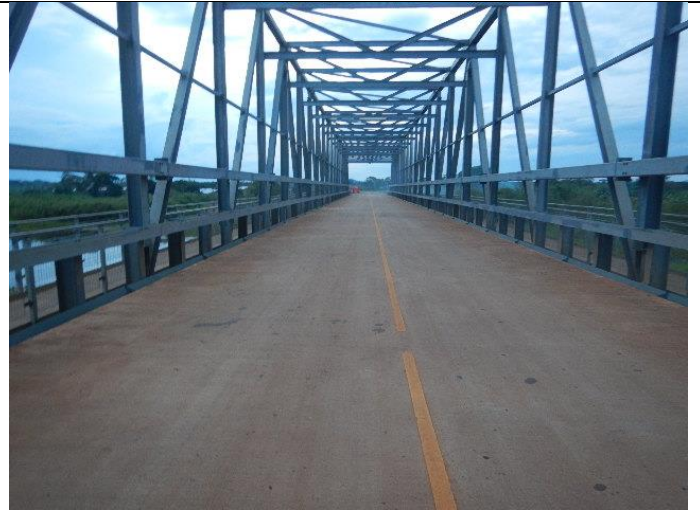
Kabaale Bridge in 2018

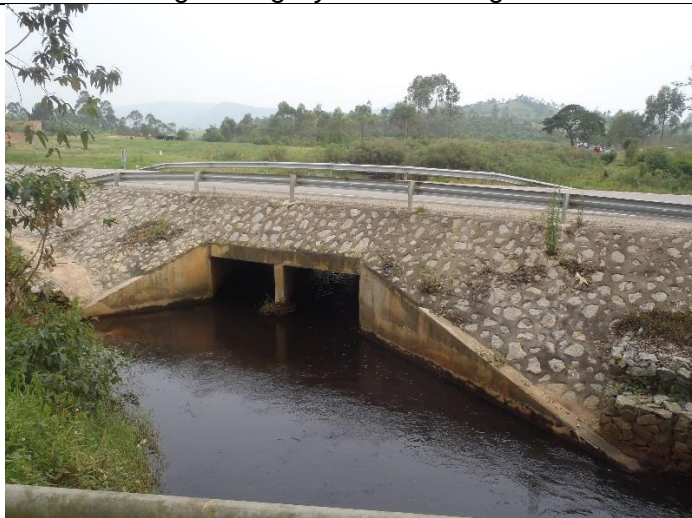
Culvert C171 along Kagamba – Ishaka in 2018

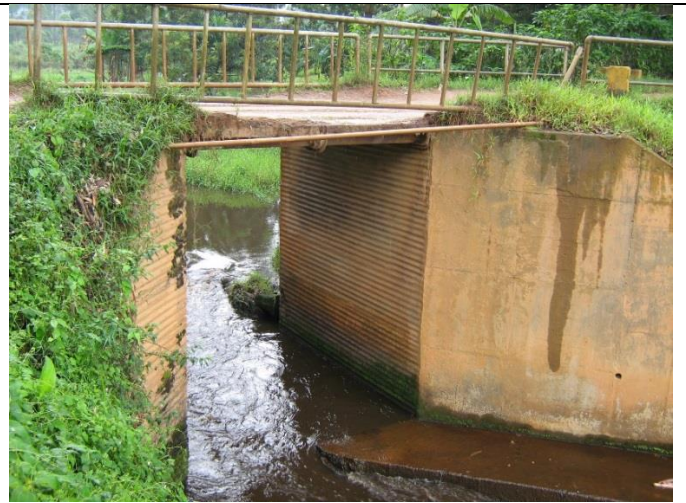
Culvert C171 in 2008. Structure was formerly Kitagata bridge

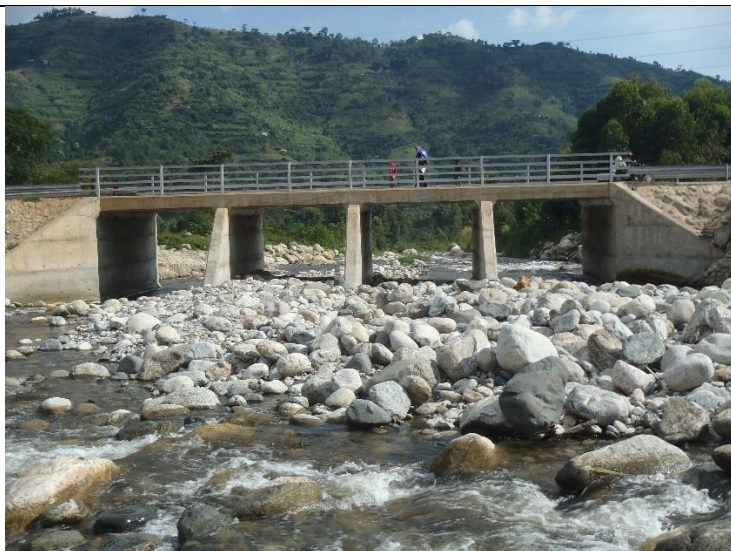
Culvert C193 along Kisinga-Kyarumba-Kibirizi in 2017

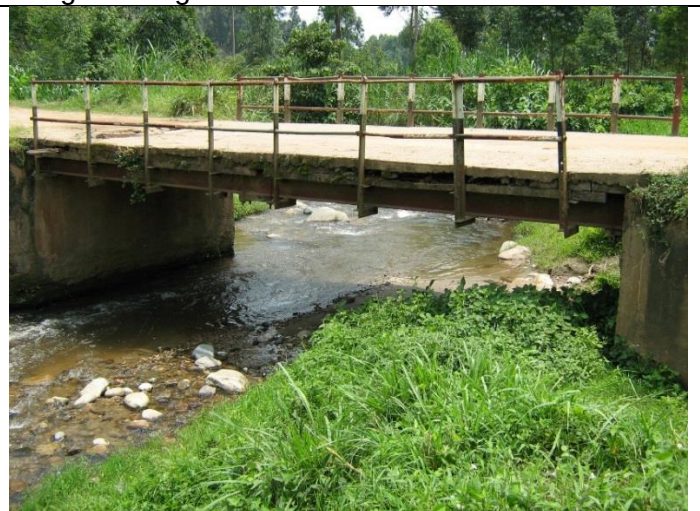
Culvert C193 in 2008. Structure was formerly Dungulwa bridge

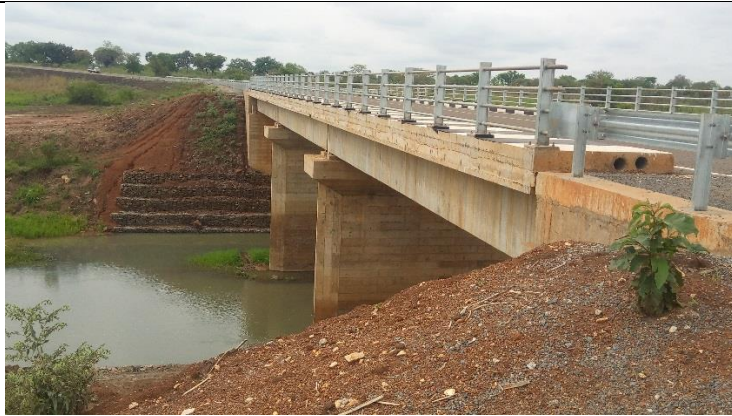
Newly rehabilitated Puranga bridge along Ngetta - Puranga in 2018

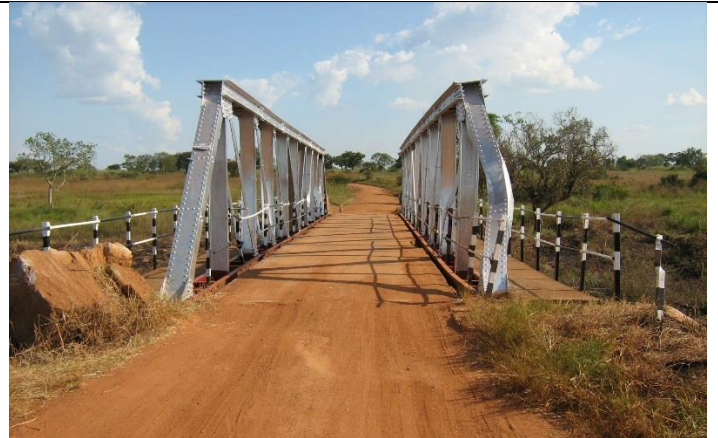
Old Puranga bridge in 2008 before rehabilitation

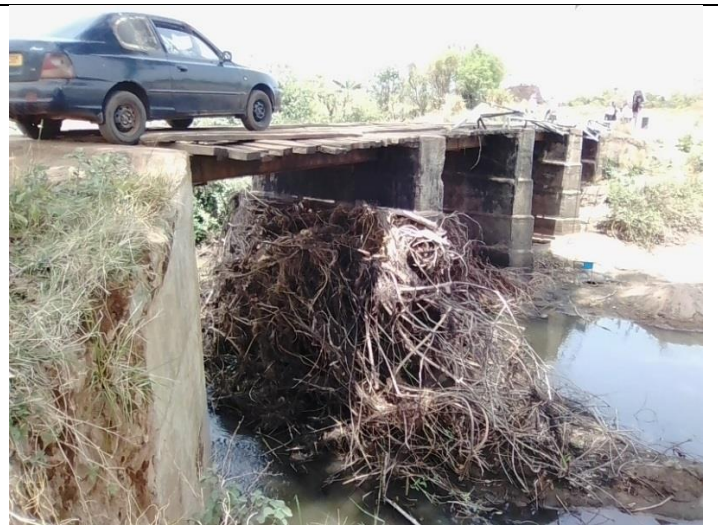
Poor condition of Kochi bridge

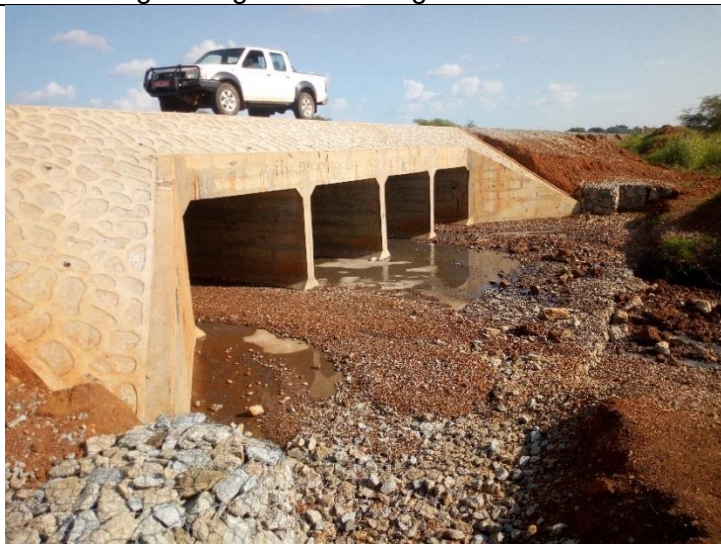
C520 along Kitgum - Madi Opei

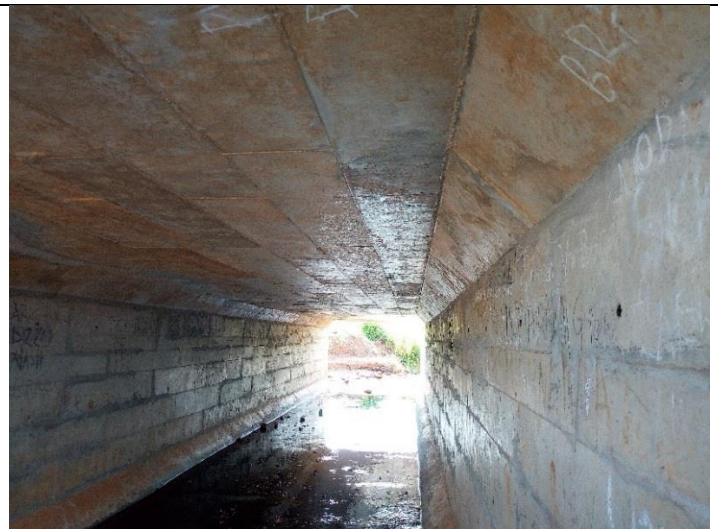
Newly constructed box culvert C520

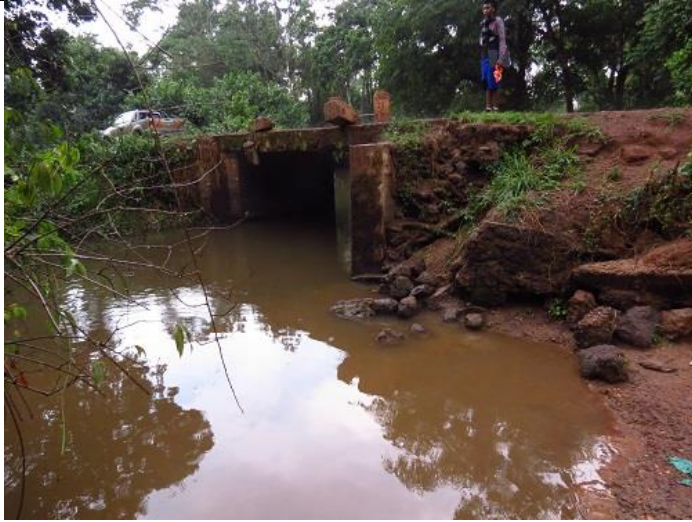
C404 along Bugambe-Kidoma is in poor condition
