# 2022 Condition report

## Bridges and Major Culverts

Uganda National Roads Authority

**Uganda National Roads Authority  
Network Planning Department**

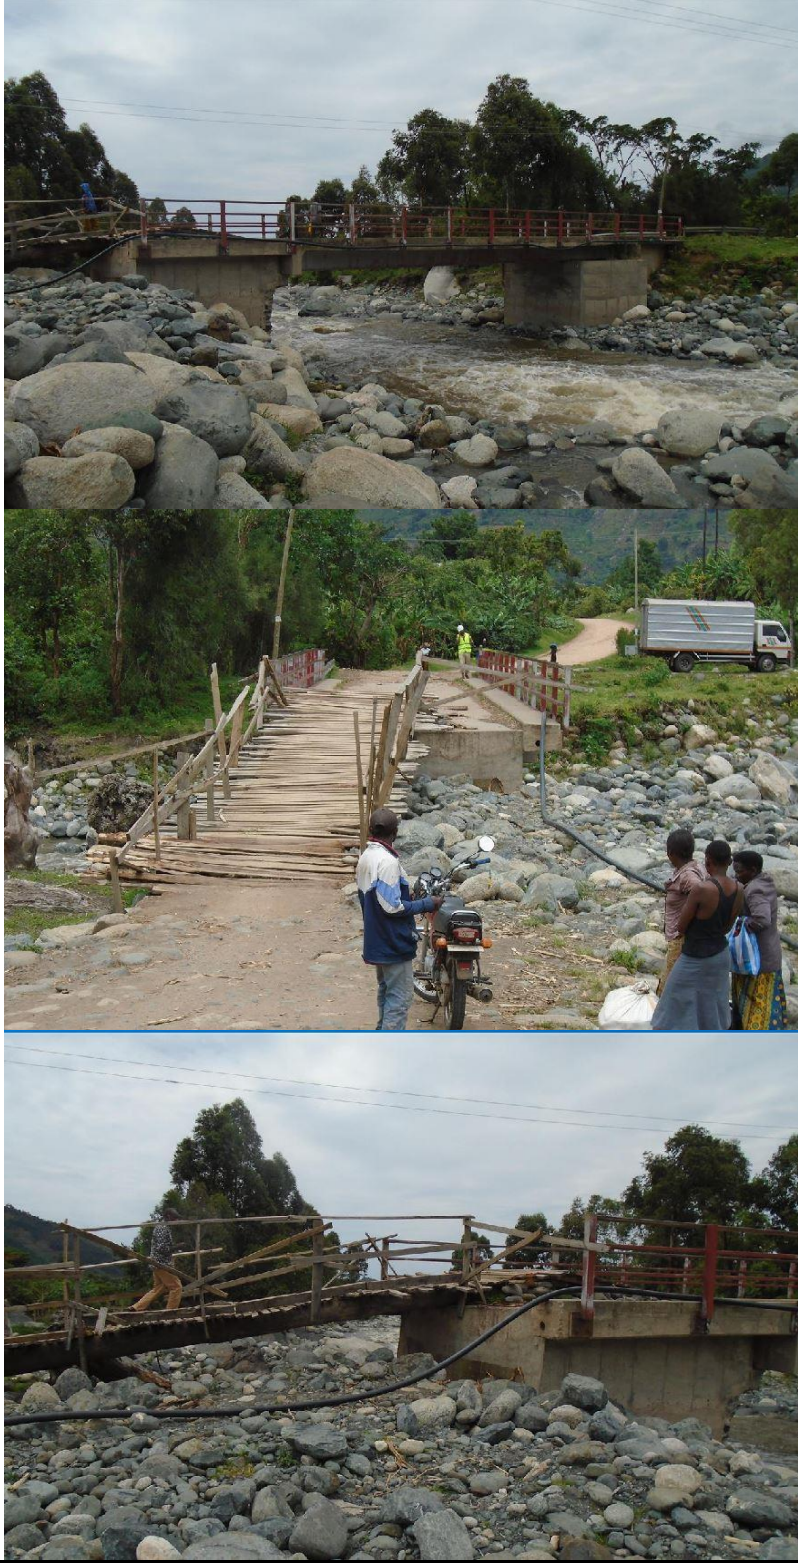
| Bridge No. | Bridge Name | Link ID | Link Name | Chainage (km) | Station | Overall Rating | Pictorial Evidence | Year of current assessment | Comment |
|---|---|---|---|---|---|---|---|---|---|
| B080 | Mubuku | C510_Link01 | Mubuku-Maliba-Nyakalingijo | 10.7 | Kasese | Poor | | 2022 | The approach to the bridge on one side is made of wood and is surrounded by boulders. |

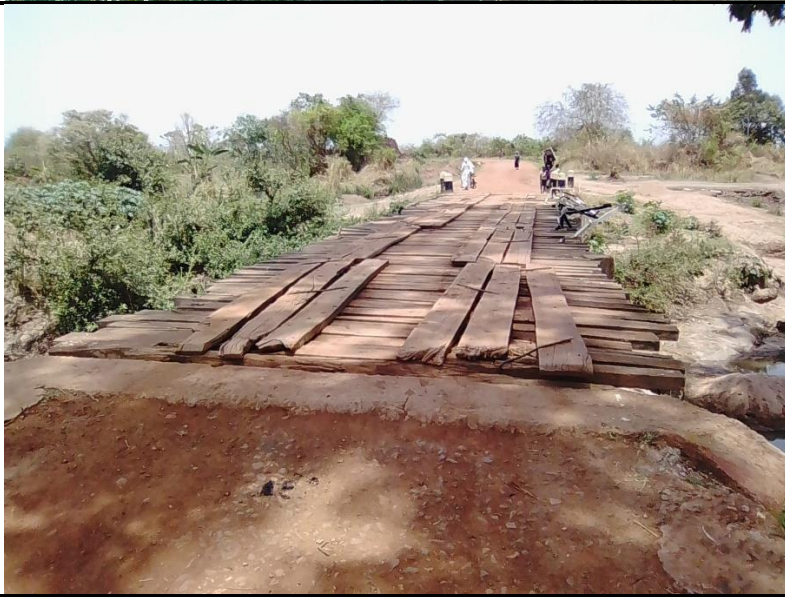
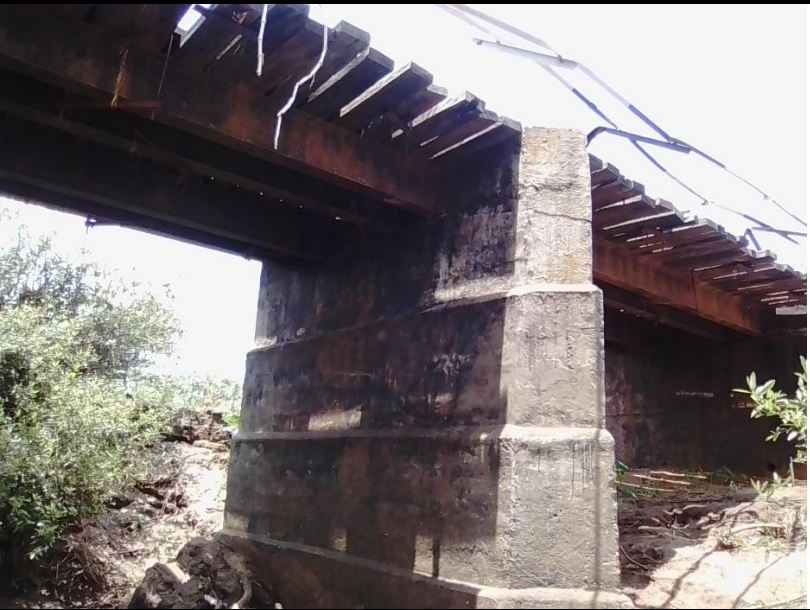
| B348 | Kochi | C758_Link01 | Keriri - Midigo | 6.7 | Moyo | Poor | | 2018 | Wooden Deck |
