### VISUAL CONDITION SURVEY (MOBICAP)

#### FIELD SURVEY REPORT

#### MPIGI AND SOUTH WESTERN PAVED NATIONAL ROAD NETWORK

**AUGUST 2025**

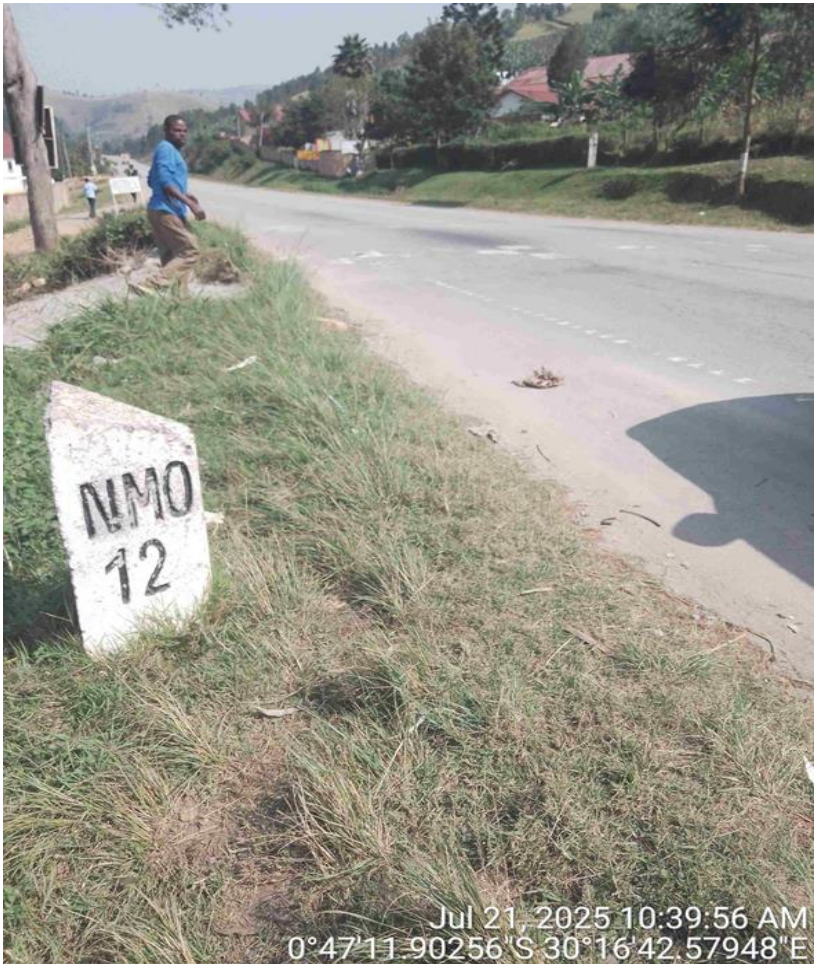
A002\_Link08 Mbarara (Bushenyi Junction) – Ntungamo

- Lyantonde - Mbarara (Bushenyi junction) 67.3km
  - Mbarara (Bushenyi Junction) – Ntungamo 61.8km
  - Ntungamo – Rubaale 14.9km
  - Rubaale - Muhanga – Kabale 59.4km
