Uganda National Roads Authority

# NATIONAL ROADS SITUATIONAL

## ANALYSIS REPORT

Network Planning Department

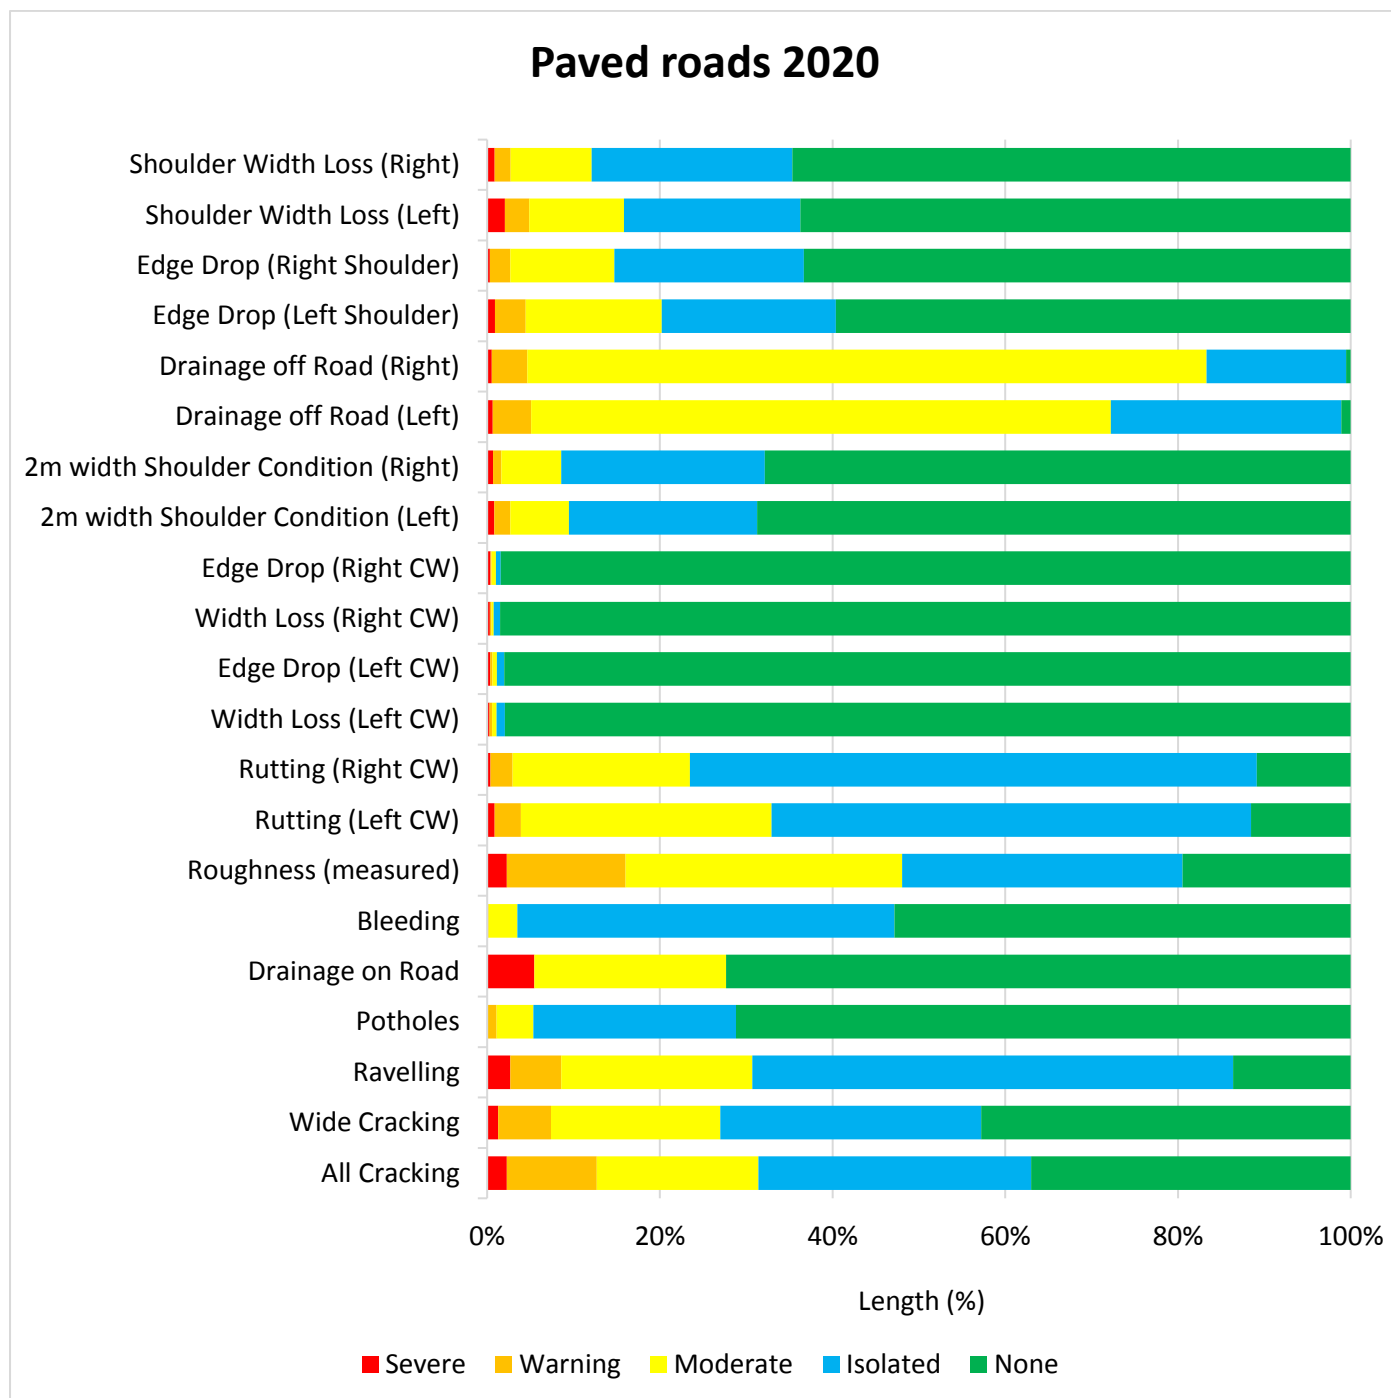
**Figure 5-1: Measured values and distress ratings of paved roads, 2020**

- Cracking
- Moderate to severe ‘All Cracking’ is noted on 31% of the paved roads with another 32% exhibiting isolated cracking and 37% exhibiting no cracking. There are moderate to severe ratings for wide cracks on 27% of the paved road network with 30% exhibiting isolated wide cracking. Wide cracking is a particular concern

because these cracks indicate the disintegration of the structural layers in the wheel paths. Wide cracks also initiate the formation of rutting. Preventive measures should be considered as soon as possible to delay further deterioration with the development of secondary distresses.

| Ravelling | <ul style="list-style-type: none"><li>■ Ravelling is the loss of aggregate material from the road surfacing. In seals, this manifests through stone loss, in asphalts through disintegration of the surfacing.</li><li>■ 9% of roads have severe to warning ravelling and immediate maintenance is required on these roads. Future maintenance of roads with moderate ravelling is crucial since it accounts for 22% of roads which could easily deteriorate to warning condition.</li></ul> |
| Potholes | <ul style="list-style-type: none"><li>■ 5% of roads are in a moderate to severe condition due to the occurrence of potholes. Isolated potholes occur on a further 23% of the network.</li></ul> |
| Roughness<br>(measured) | <ul style="list-style-type: none"><li>■ From IRI surveys, 16% of the road network has severe to warning roughness. These roads typically require some form of rehabilitation.</li><li>■ 32% of the road network is in a moderate condition regarding roughness. Although some of these roads might not require immediate attention it is crucial to monitor the condition continuously and apply the right treatment at the right time to delay further deterioration.</li></ul> |
| Shoulder<br>condition | <ul style="list-style-type: none"><li>■ The 2m width is available to the road user as emergency stopping area. There are isolated problems on 23% of the road network and 9% in moderate to severe condition.</li></ul> |
| Drainage<br>on road | <ul style="list-style-type: none"><li>■ This refers to surface drainage and ability of road to drain water from the surfacing. Generally not a problem with only 22% in moderate condition and 5% in severe condition.</li></ul> |

Drainage off road ■ Referring to condition of side drainage, mitre drains and cross drainage underneath the road. 5% of the paved road network in a warning to severe conditions, 73% in warning state and 21% with isolated drainage problems.

In summary, the paved network is in good condition. From a pavement management perspective, roads appear to be structurally sound, but cracking, roughness and rutting indicate some structural deterioration (rated as severe to warning). A preventive maintenance regime of timely patching, crack sealing, diluted emulsions and resurfacings will contribute significantly to delay the structural deterioration by preventing water from entering the pavement structures.

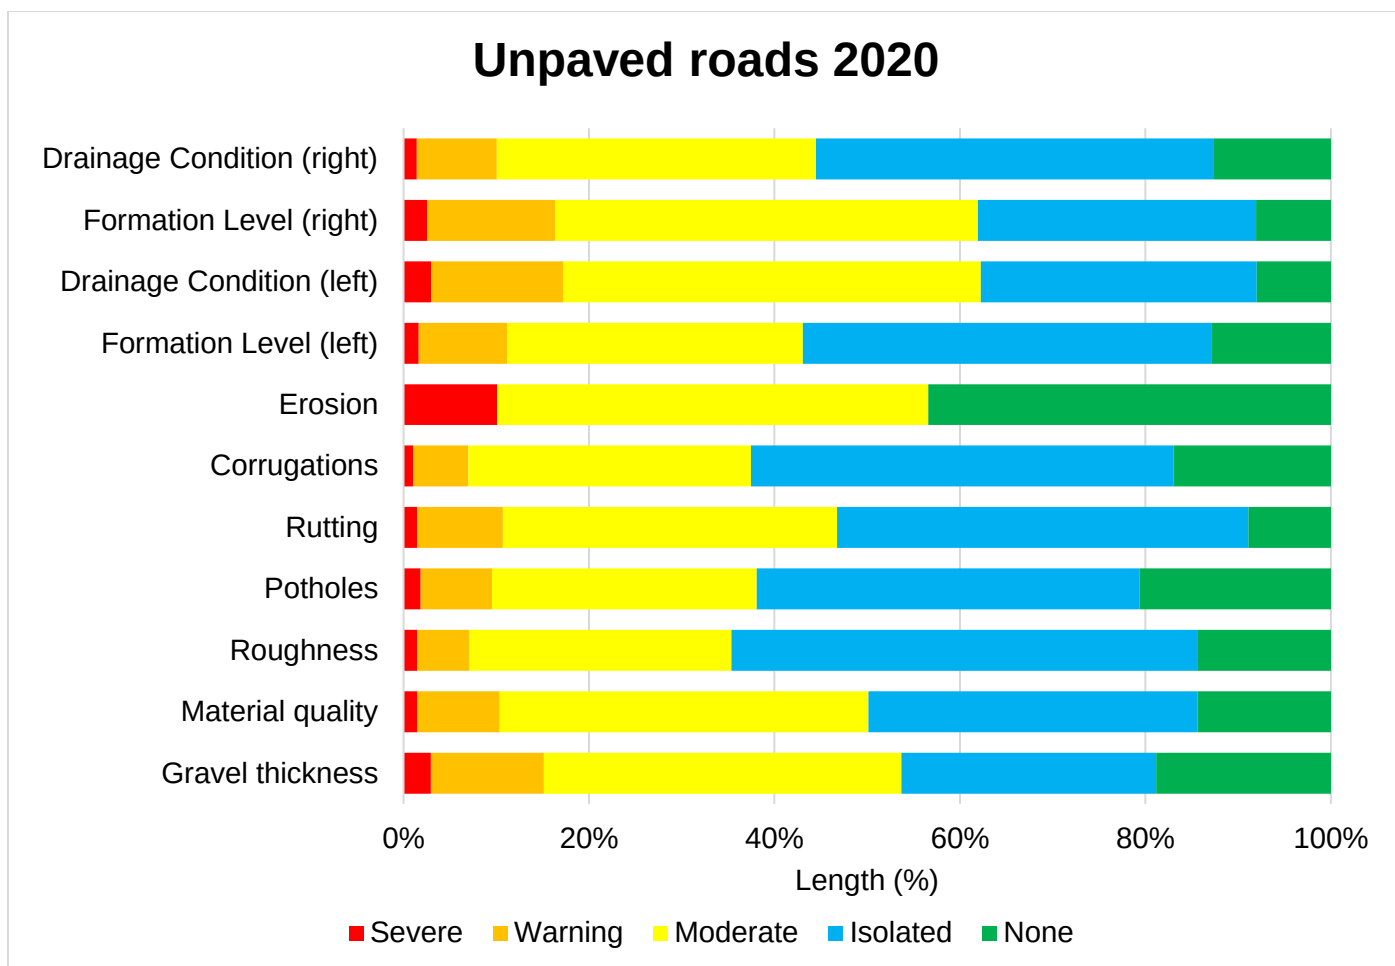
**Figure 6-1: Distress, characteristic and condition ratings of unpaved roads, 2020**

- Gravel thickness
  - The gravel thickness ratings indicate the need for re-gravelling on 15% of the unpaved road network, with 3% having no gravel, another 12% having less than 50mm gravel wearing course and severe exposure of the sub grade. A further 39% is in the moderate

| Material quality | <p>condition state, with subgrade exposed in local areas (average of 50 to 100mm gravel thickness).</p> <ul style="list-style-type: none"> <li>■ 2% of roads having severe material quality exhibiting poorly distributed range of particle sizes and/or zero or excessive plasticity, 9% of roads was rated with warning material quality (poor particle size distribution). A further 40% exhibits cracking, loose material or stones clearly visible, thus rated as material quality of moderate state.</li> </ul> |
| Roughness | <ul style="list-style-type: none"> <li>■ The roughness ratings on the unpaved network indicate 35% of the road network to be warning to moderate condition. This will result in high road user costs.</li> </ul> |
| Potholes | <ul style="list-style-type: none"> <li>■ The high occurrence of potholes especially in severe to moderate states (39%) and 41% in isolated state is indicative of inadequate maintenance.</li> </ul> |
| Rutting | <ul style="list-style-type: none"> <li>■ Roads with rutting in a moderate to severe condition accounts closely to 46% of the network. These roads are in need of blading and re-graveling.</li> </ul> |
| Erosion | <ul style="list-style-type: none"> <li>■ Erosion was rated serious on 10% of road network. There is a need to repair erosion more regularly.</li> </ul> |
| Drain condition and formation level | <ul style="list-style-type: none"> <li>■ Drainage condition and formation level indicate the ability of roads to drain water away, transversely underneath and longitudinally next to them. Roads with severe or warning formation levels, would act as a canal, this is the case for 14% of the unpaved road network. 39% of the unpaved roads have moderate formation levels indicating that the drainage is level with ground level.</li> <li>■ Furthermore, the drainage condition is warning to severe for 13% the network with moderate drainage conditions existing on 40% of the network.</li> </ul> |

In summary, the unpaved network is in fair condition. From a road user's perspective, material quality and possibly non-sufficient maintenance regime contribute to the development of rough roads with potholes, rutting and corrugations. From an unpaved roads management perspective, gravel thickness problems, low formation levels and poor drainage conditions result in erosion, wetting of the gravel layers and subgrade which result in potholes and rutting. A well planned gravelling programme should be supported by an effective maintenance regime of blading (to maintain cambers and limit roughness), cleaning of side drains, mitre drains and cross drainage.

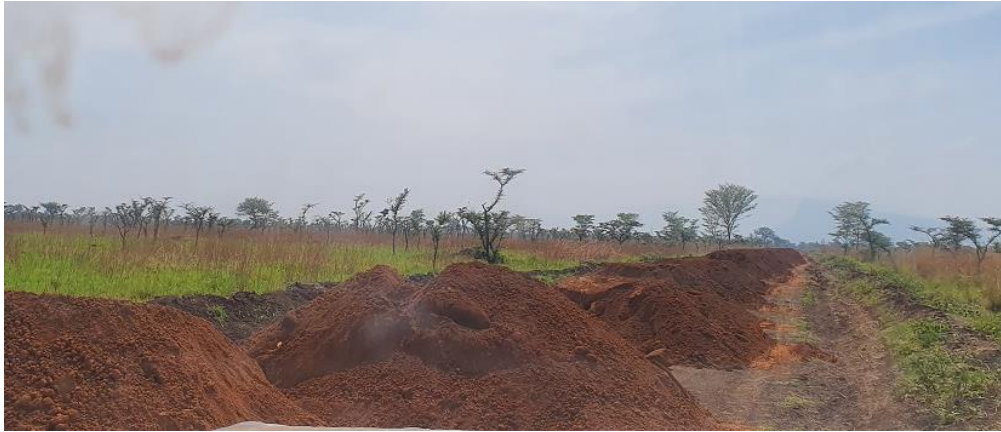
Construction along Apeitolim-Iriri Road in North Eastern region

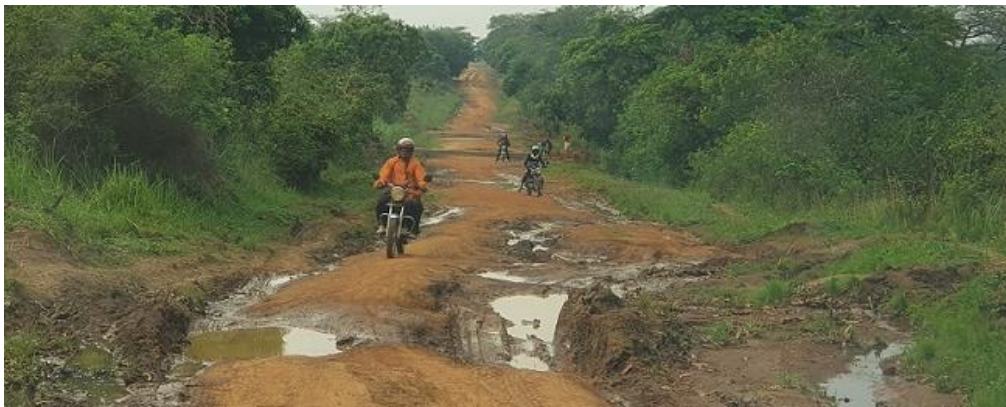
Section of Okude – Amuria with poor drainage in North Eastern region

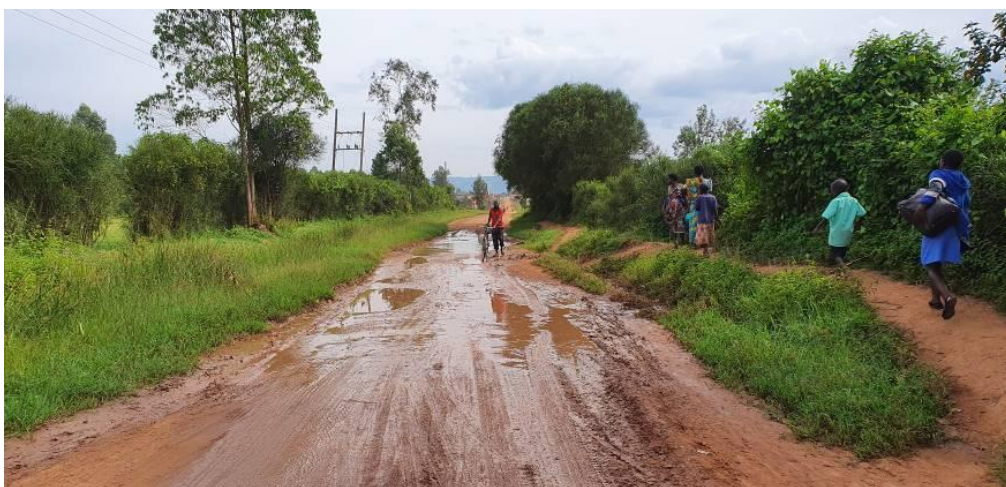
Section of Ruzinga (Bugamba) Chitwe in Southern region with poor drainage.

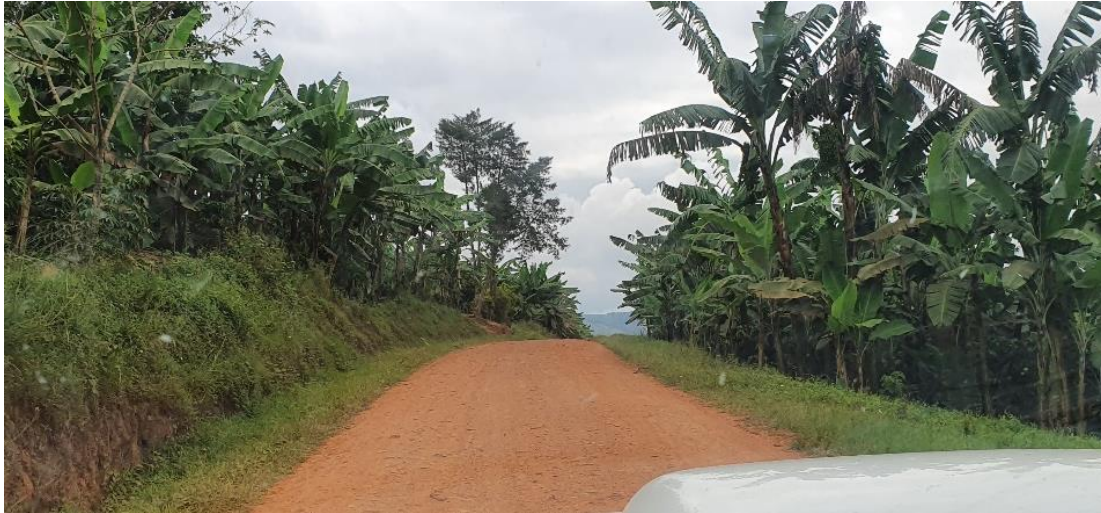
Fair road section along Ruti- Mwizi-Kabuyanda-Kikagati in Southern region

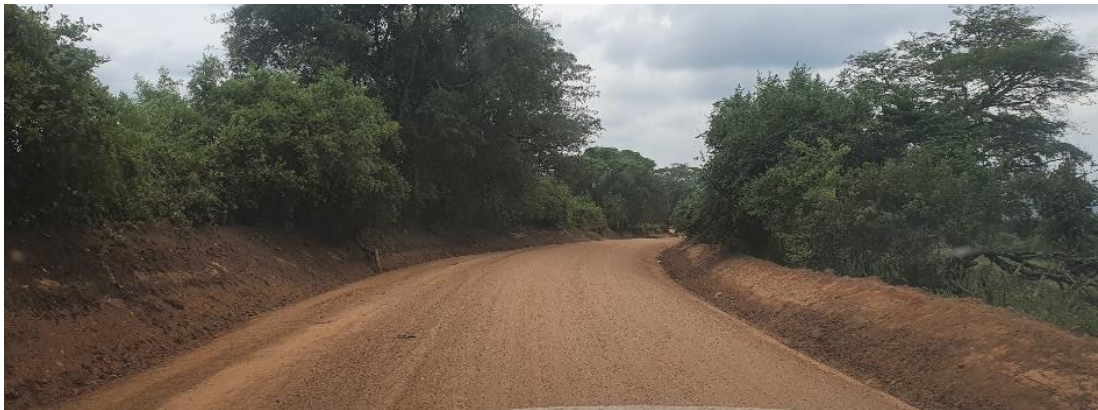
Isingiro-Kityanza in Southern region in good condition.

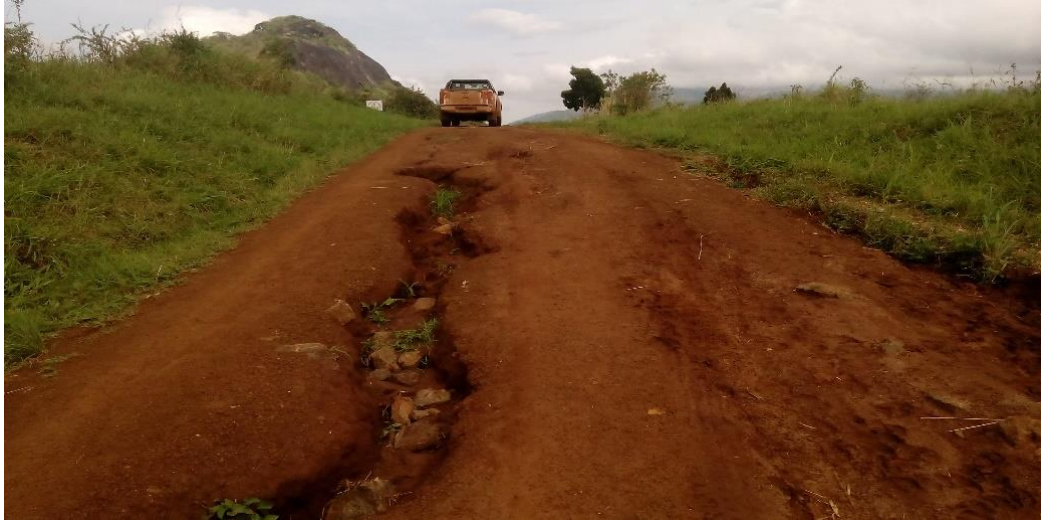
Section along Paloga-Potika Link with gullies.

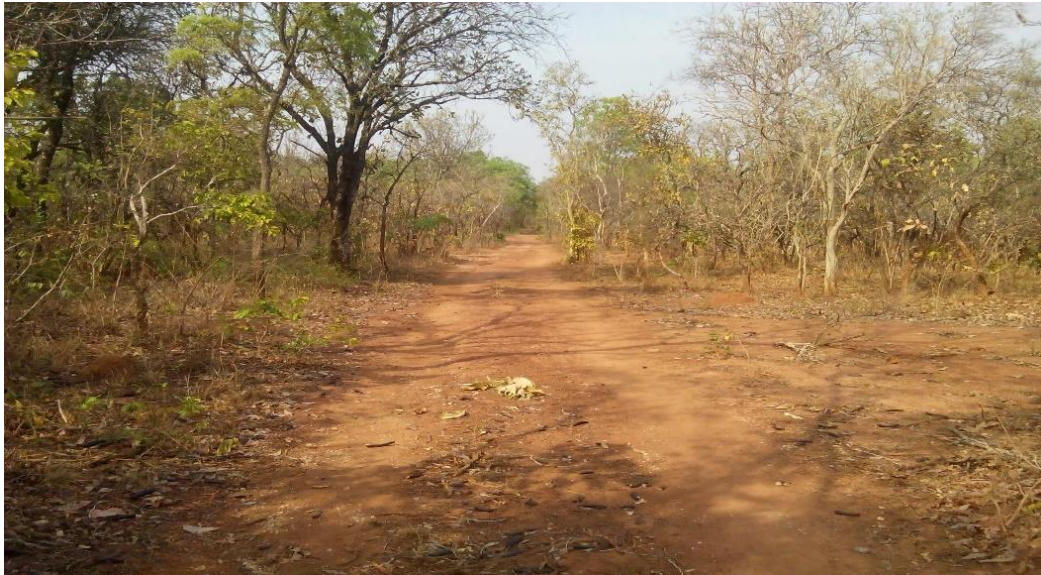
Section along Yuku –Lobe Spur link which is not maintained.

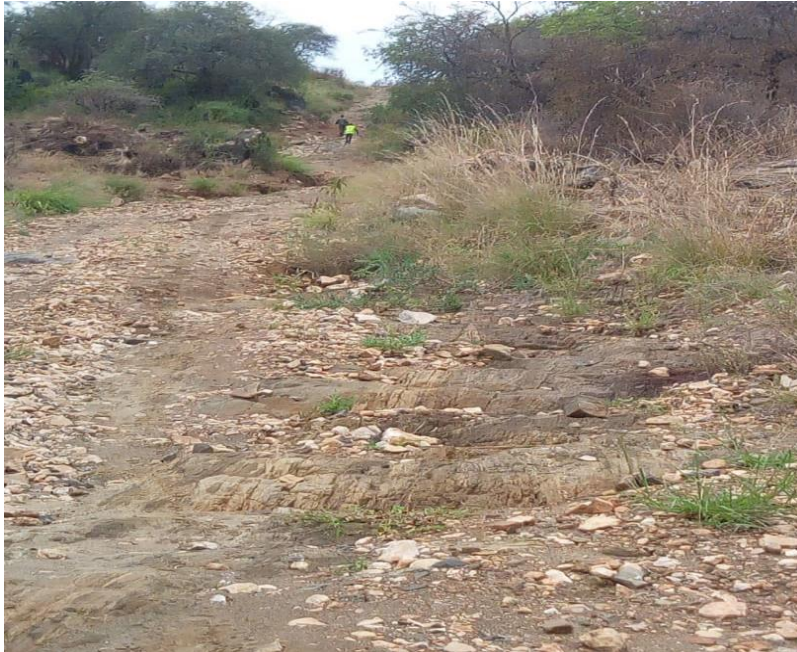
Hard to reach section along Kotein-Kenya Border in the North East

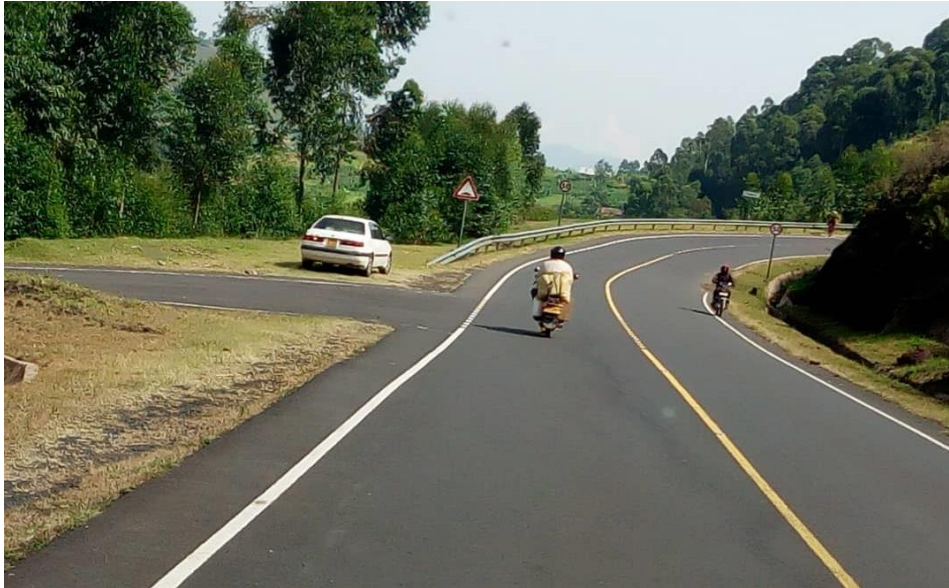
Kabale-Kisoro road in good condition

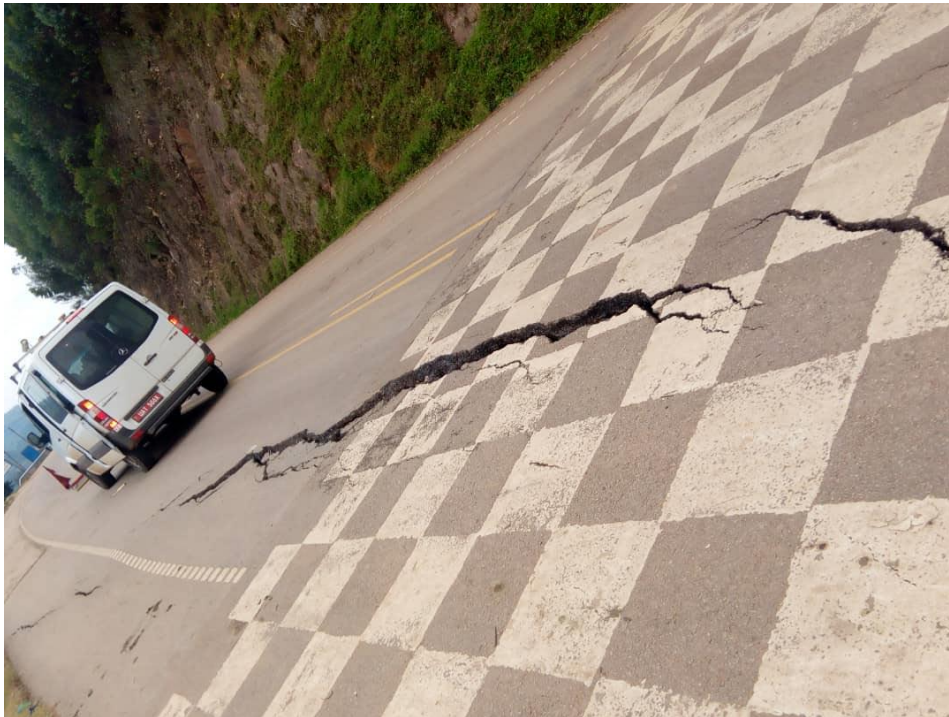
The most dominating mode of failure of paved roads is cracking with a significant portion of the northern corridor route affected all the way from Malaba/Busia to Katuna. This shall require periodic maintenance very soon.

Severe cracking on a section along Kabale-Katuna (A002\_11) at 20+300

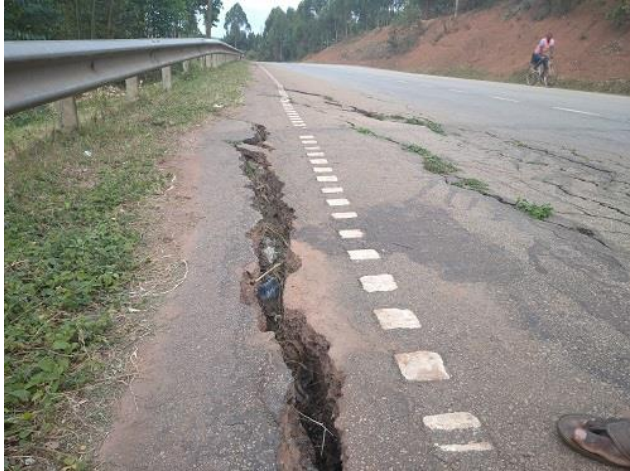
Shear Cracks along sections of Rubale-Muhanga-Kabale (A002\_Link010) at 391+300

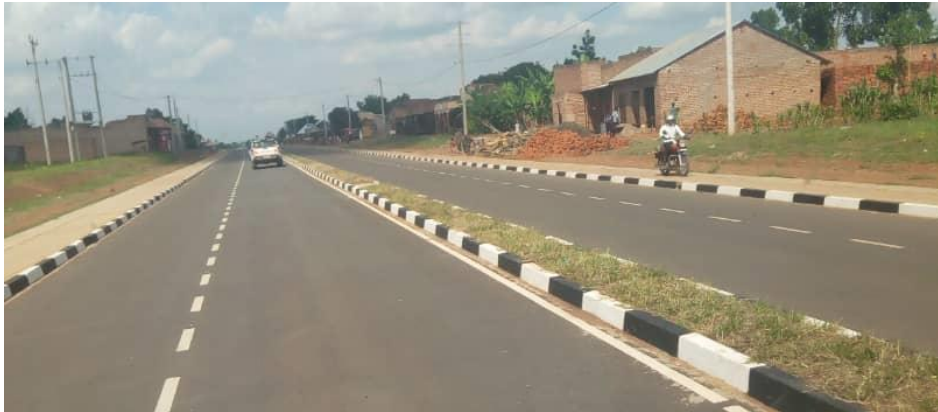
Section along Pallisa- Kumi road through a trading centre. The road is in very good condition.

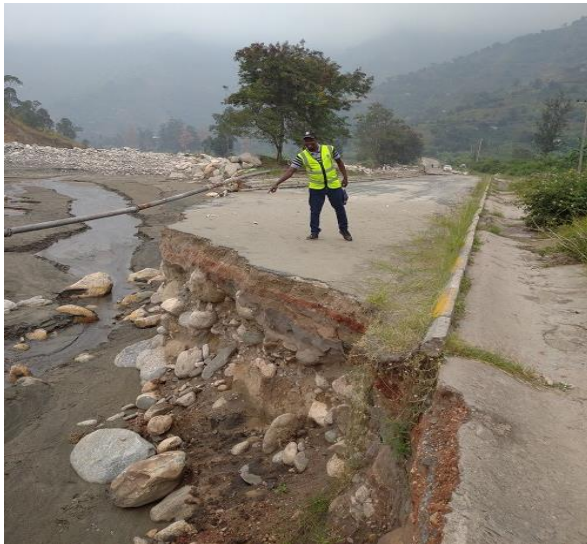
Kasese-Kilembe mines at CH 8+700km. Road cut off due to heavy downpour which caused river to change path
