Uganda National Roads Authority

# NATIONAL ROADS SITUATIONAL

## ANALYSIS REPORT

2022

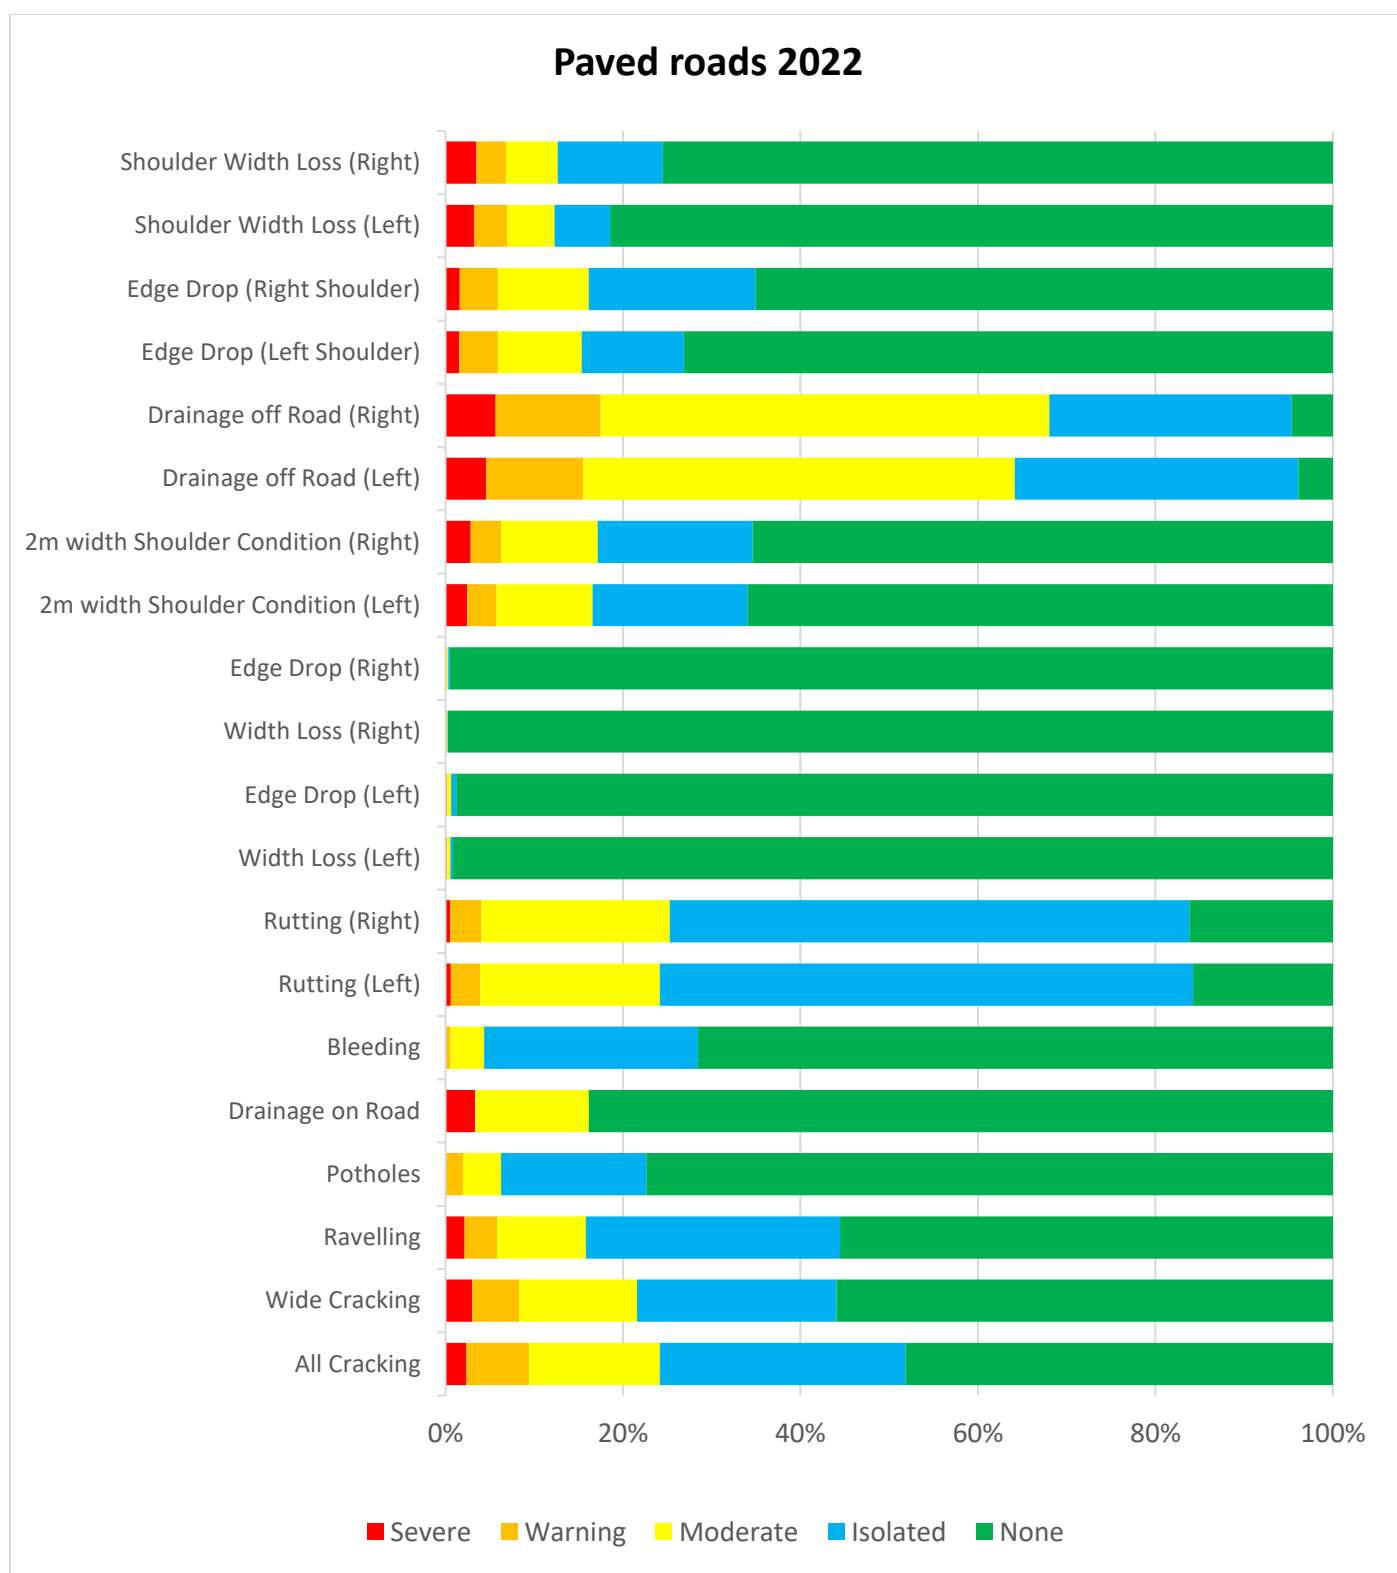
**Figure 4-1: Measured values and distress ratings of paved roads, 2022**

Generally, the paved road network is in good condition. However, from a pavement management perspective, the roads appear to be structurally sound but an increase in cracking, ravelling, potholes and bleeding indicates a deterioration. A preventive maintenance regime of timely patching, crack sealing, diluted emulsions and resurfacings will contribute significantly to delaying the structural deterioration by preventing water ingress into the pavement structures.

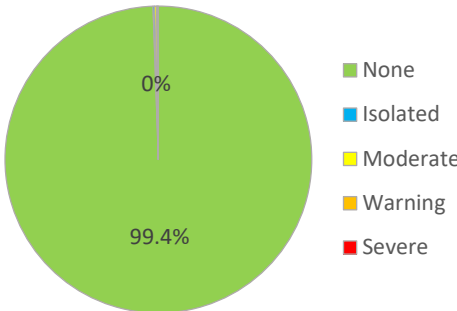
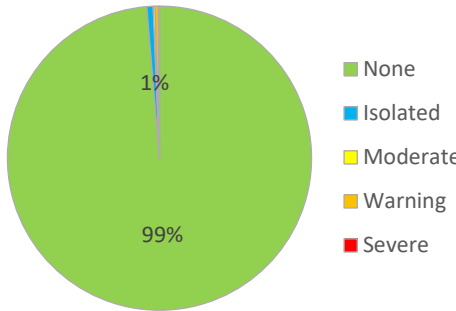
| No change in the extent of width loss on the paved network | | | | | | | | | | | | | | | | | | | | | | |

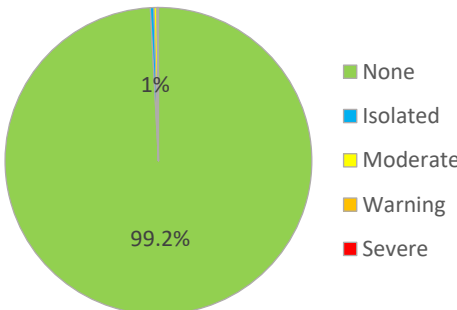
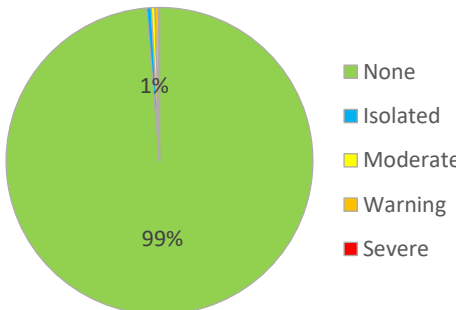
| No change in the extent of edge drop on the paved network | | | | | | | | | | | | | | | | | | | | | | |

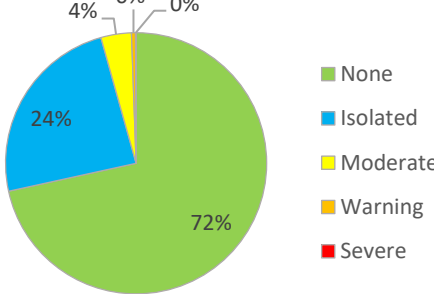
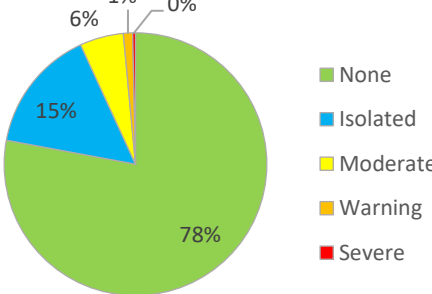
| There has been a reduction in the condition of road with no bleeding from 78% in 2021 to 72% n 2022. The percentage length with isolated bleeding has also increased from 15% in 2021 to 24% in 2022. This also indicates a deterioration in the condition of the paved roads. | | | | | | | | | | | | | | | | | | | | | | |

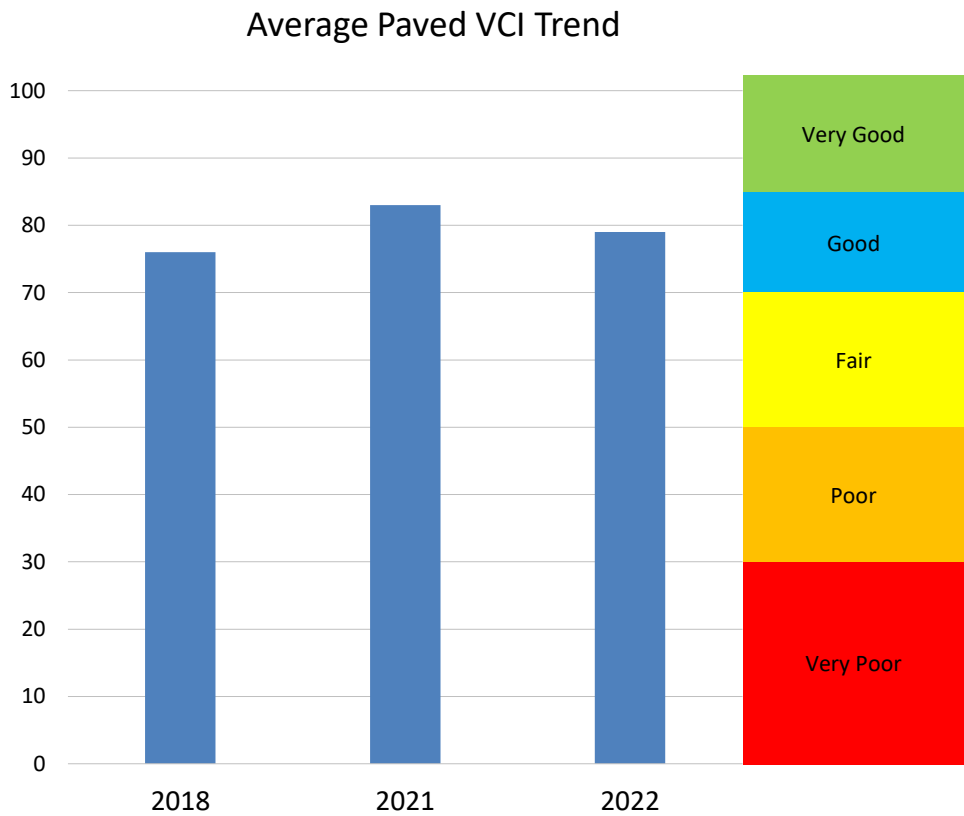
**Figure 4-2: Average Paved VCI comparison**

The average paved road VCI based on the 2022 data is 79% which categorises the road network in the “good” condition category. In 2021, the average paved road VCI was 83% indicating a decline of 4%. The graph below shows the comparison in VCI over the years.

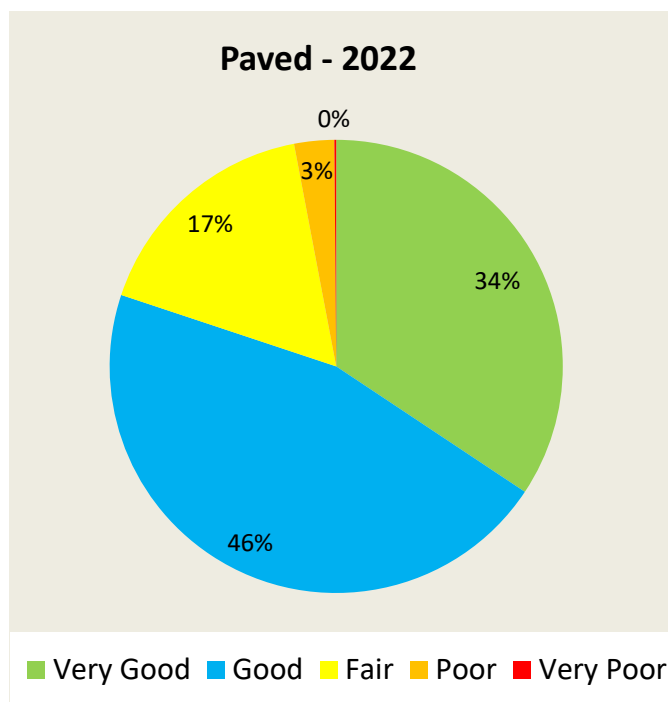
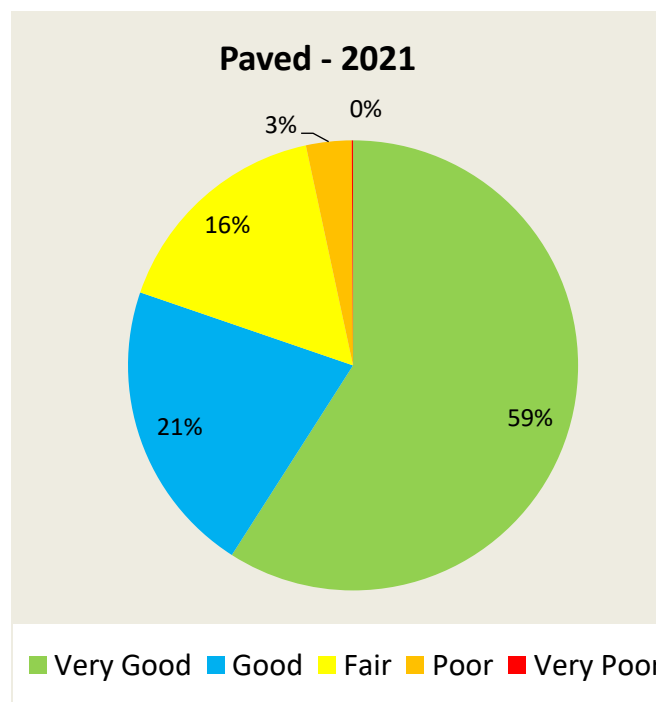
**Figure 4-3: Paved VCI for 2022**

Figures 4-2 and 4-3 above show that the percentage of roads in very poor, poor and moderate condition has generally remained constant. The roads in very good condition have reduced from 59% in 2021 to 46% in 2022 and those in good condition have increased from 21% in 2021 to 46% in 2022. This shows a decline in the performance of the roads in very condition. However, the total roads in good and very good condition have remained constant at 80%.

Generally, the paved road network is in good condition with only 3% in poor and very poor condition, indicating a need for rehabilitation. The roads in fair condition indicate a need for preventive maintenance (see Appendix 2 for details). Timely maintenance is encouraged to preserve current asset.

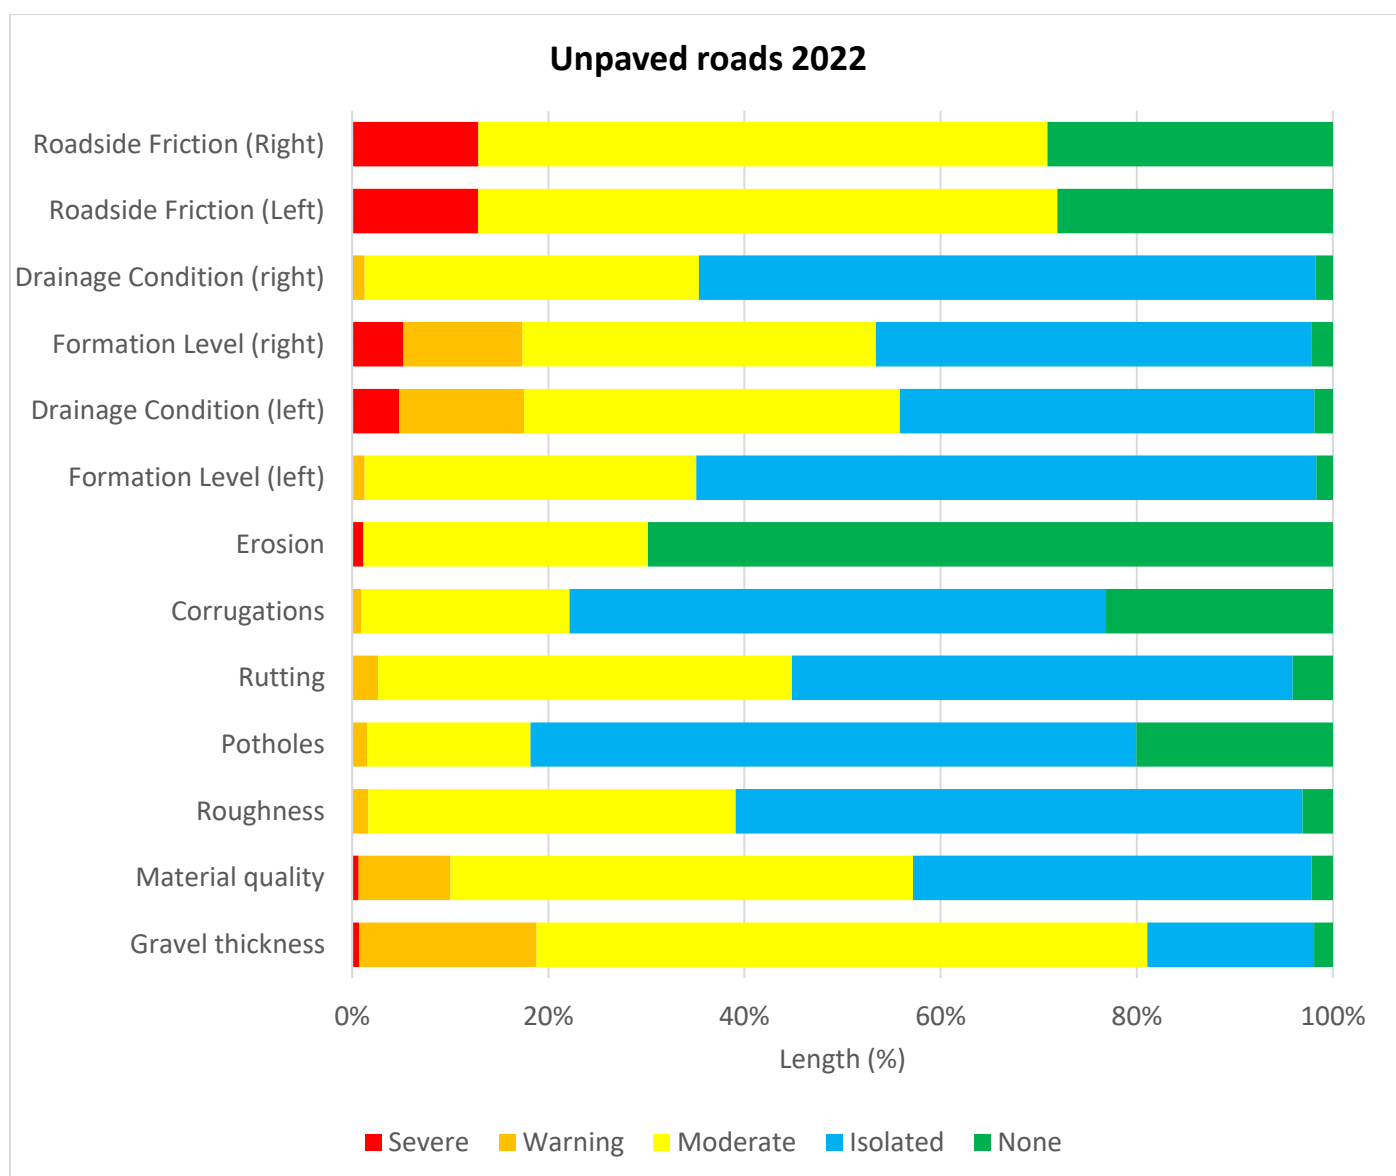
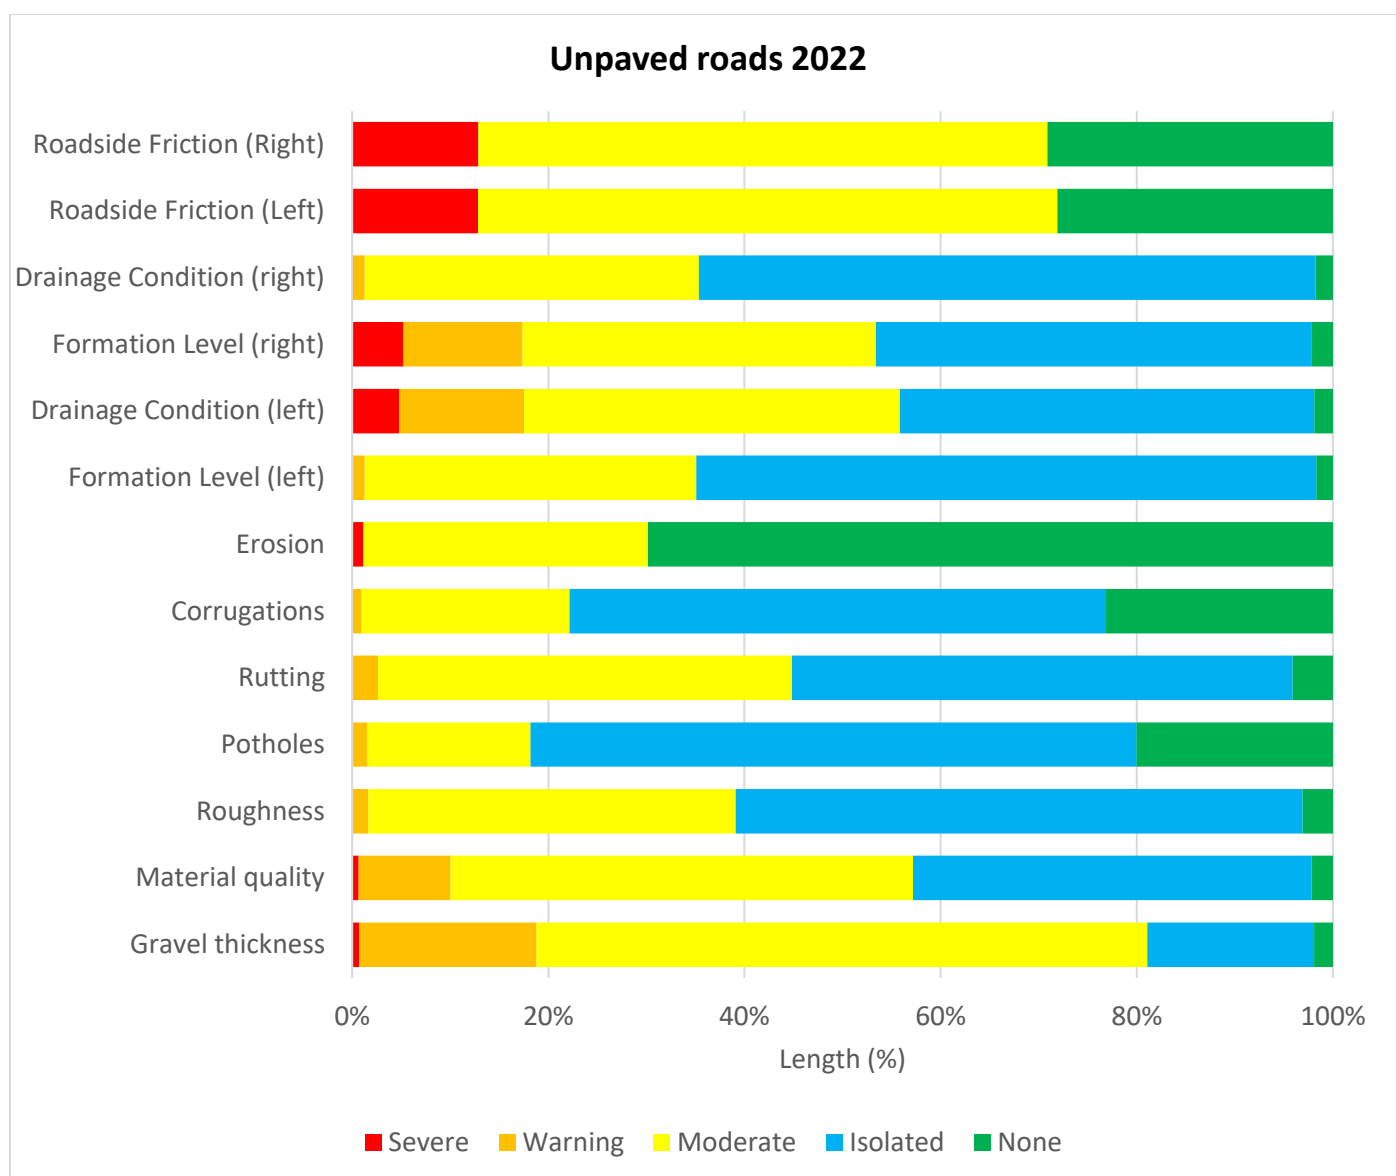
**Figure 5-1: Distress, characteristic and condition ratings of unpaved roads, 2022**

In summary, the unpaved network is in fair condition. From a road user's perspective, material quality and possibly non-sufficient maintenance regime contribute to the development of rough roads with potholes, rutting and corrugations. From an unpaved roads management perspective, gravel thickness problems, low formation levels and poor drainage conditions result in erosion, wetting of the gravel layers and subgrade which result in potholes and rutting. A well-planned re-gravelling programme should be supported by an effective maintenance regime of blading (to maintain cambers and limit roughness), cleaning of side drains, mitre drains and cross drainage.

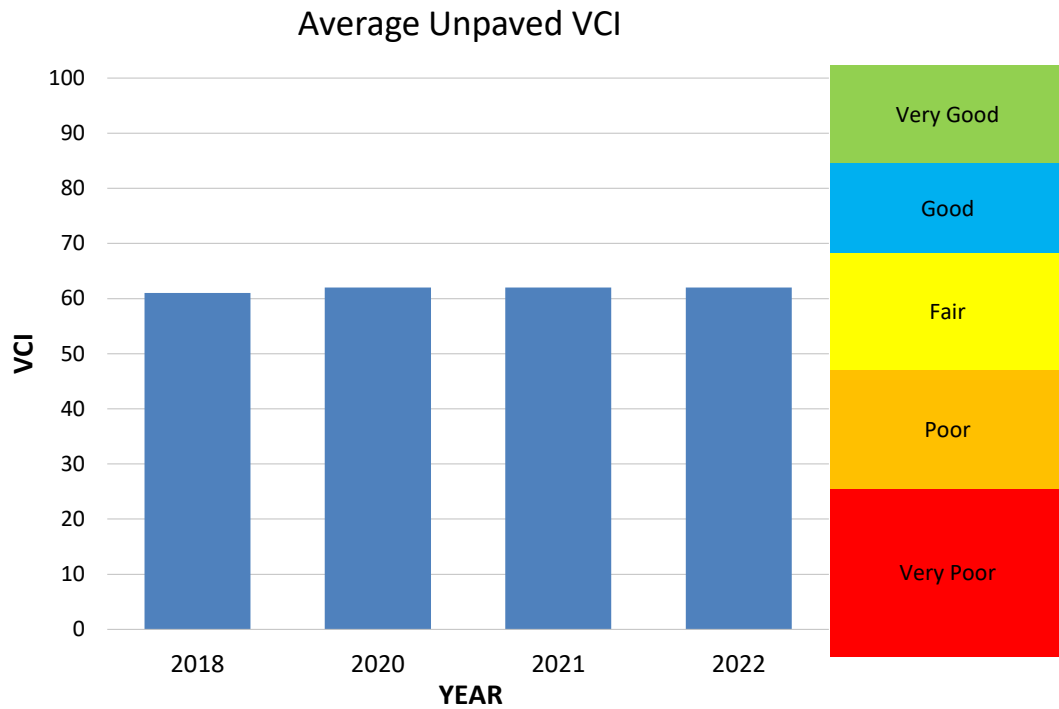
**Figure 5-2: Average Unpaved VCI comparison (2018-2022)**

The average unpaved road VCI based on the 2022 data is 62% which categorises the road network in the “fair” condition category, this has remained constant compared to the average VCI calculated on the 2021 visual assessment data. The graph below shows the trend of VCI for the unpaved road network.

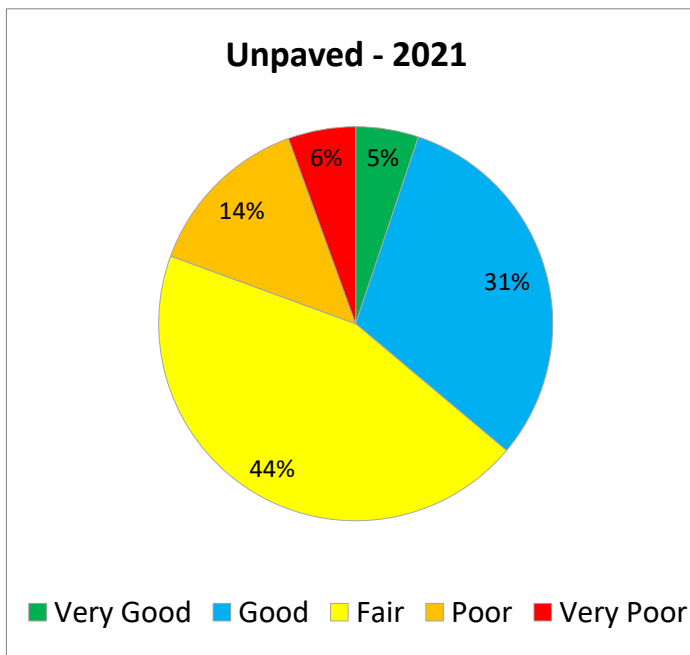
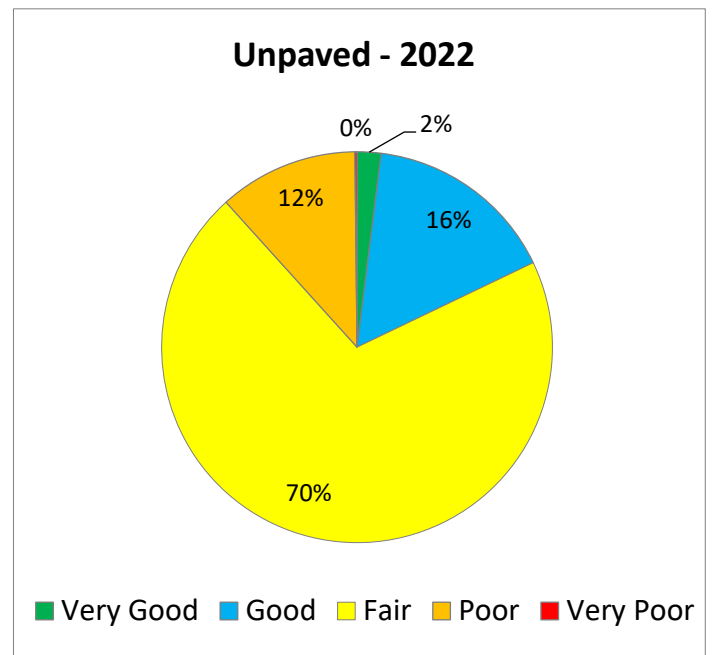
**Figure 5-4: Unpaved VCI distribution for 2022**

The figures show that the percentage of roads in very poor and poor condition has reduced from 20% in 2021 to 12% in 2022. The roads in fair condition have increased from 44% in 2021 to 70% in 2022. The condition of roads in good and very good condition has decreased from 36% in 2021 to 18% in 2022.

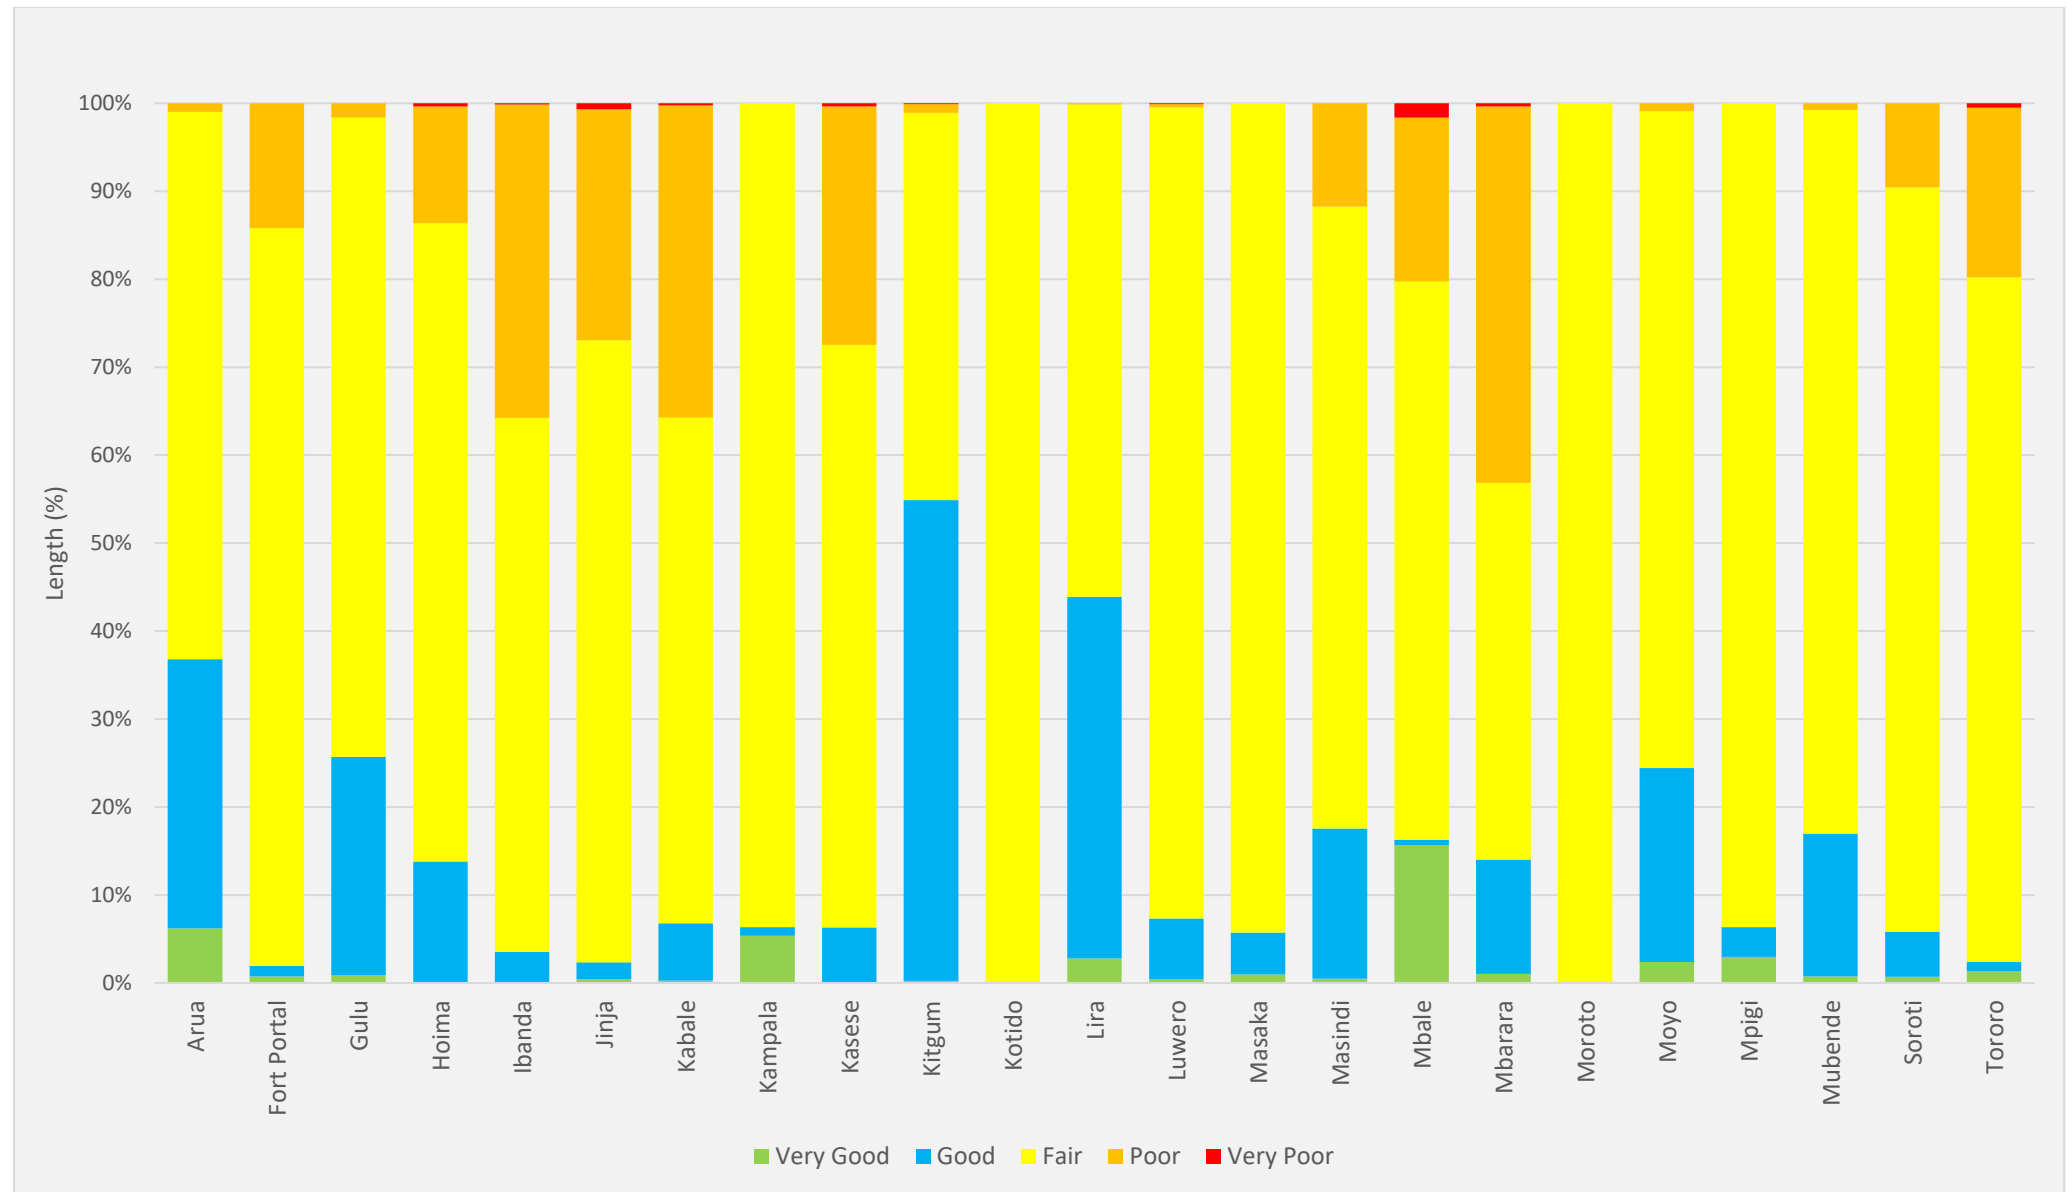
Figure 5-6: Condition rating of the unpaved road network per station

Figure 5-6 above indicates the performance of the unpaved road network by station. Most stations maintain the road network in good to fair condition. Mbale (16%), Arua (6%) and Kampala (5%) stations have the highest percentage of roads in very good condition while Mbale (2%), Jinja (1%) and Tororo (1%) stations have the highest percentage of roads in very poor conditions (see Appendix 6 for details).

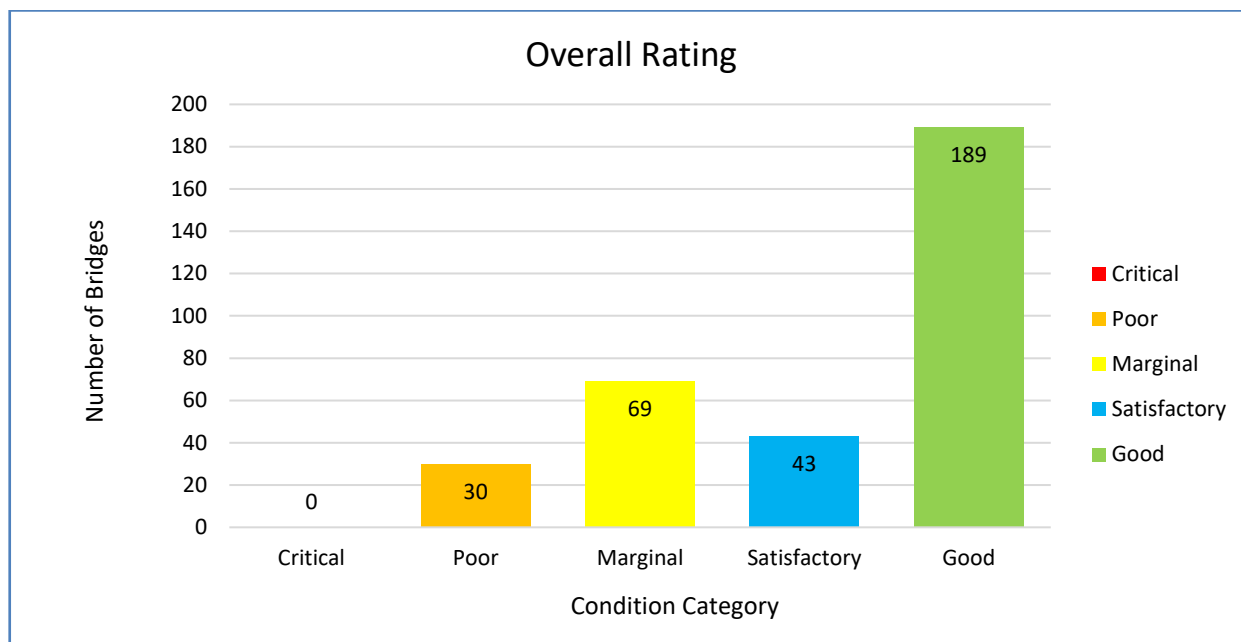
**Figure 6-1: Overall rating of bridges**

From Figure 6-1 above, it can be observed that the highest number of bridges is in good condition (189No.) and 43No bridges are in satisfactory condition. The bridges in marginal condition are significant (69No.) and timely maintenance is advised to prevent them from quickly deteriorating to a poor condition. Bridges in poor and critical condition are the least (30No.) and urgent intervention is required.

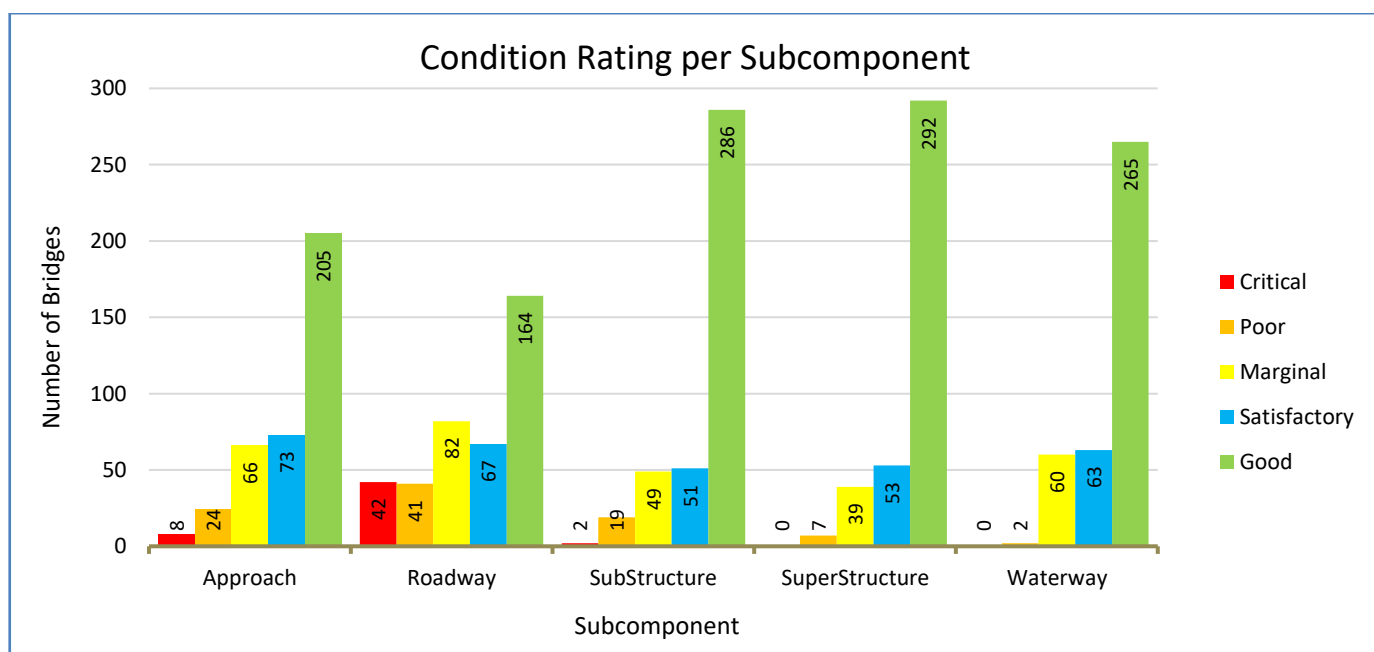
**Figure 6-2: Condition rating of bridges per subcomponent**

From the figure above, it is observed that;

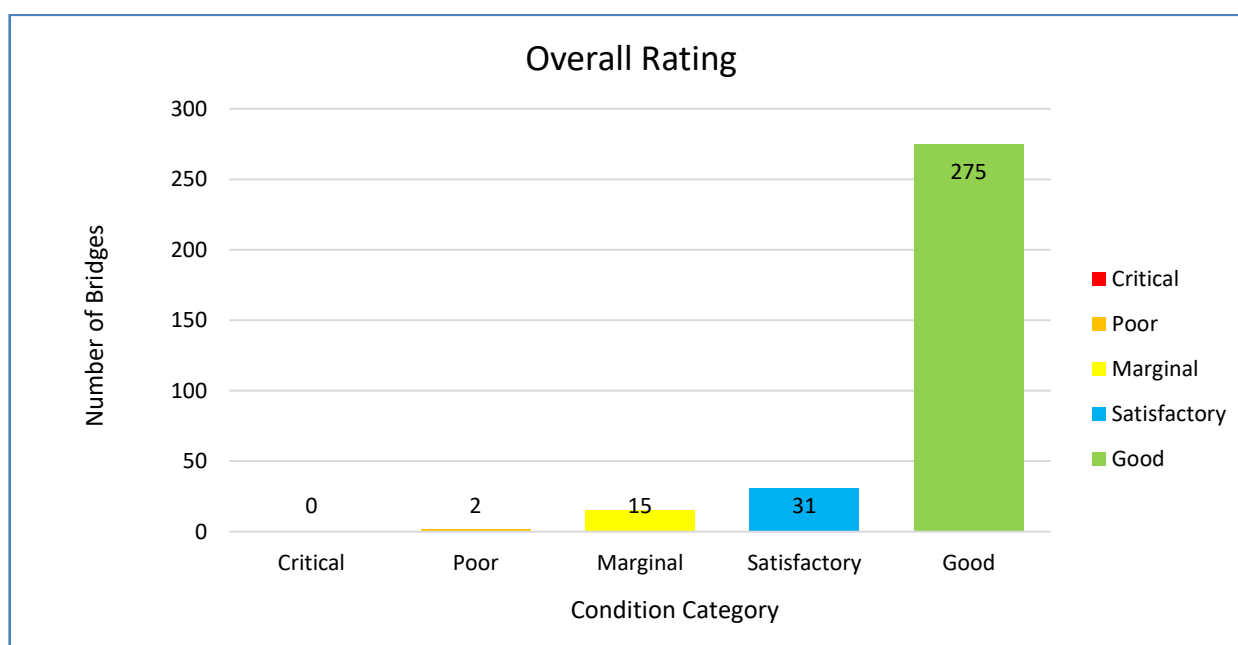
**Figure 6-3: Overall rating of major culverts**

From Figure 6-3 above, it can be observed that 275No. major culverts are in good condition. 31No. are satisfactory and 15No. are in marginal condition. Only 2No. major culverts are in poor and critical condition.

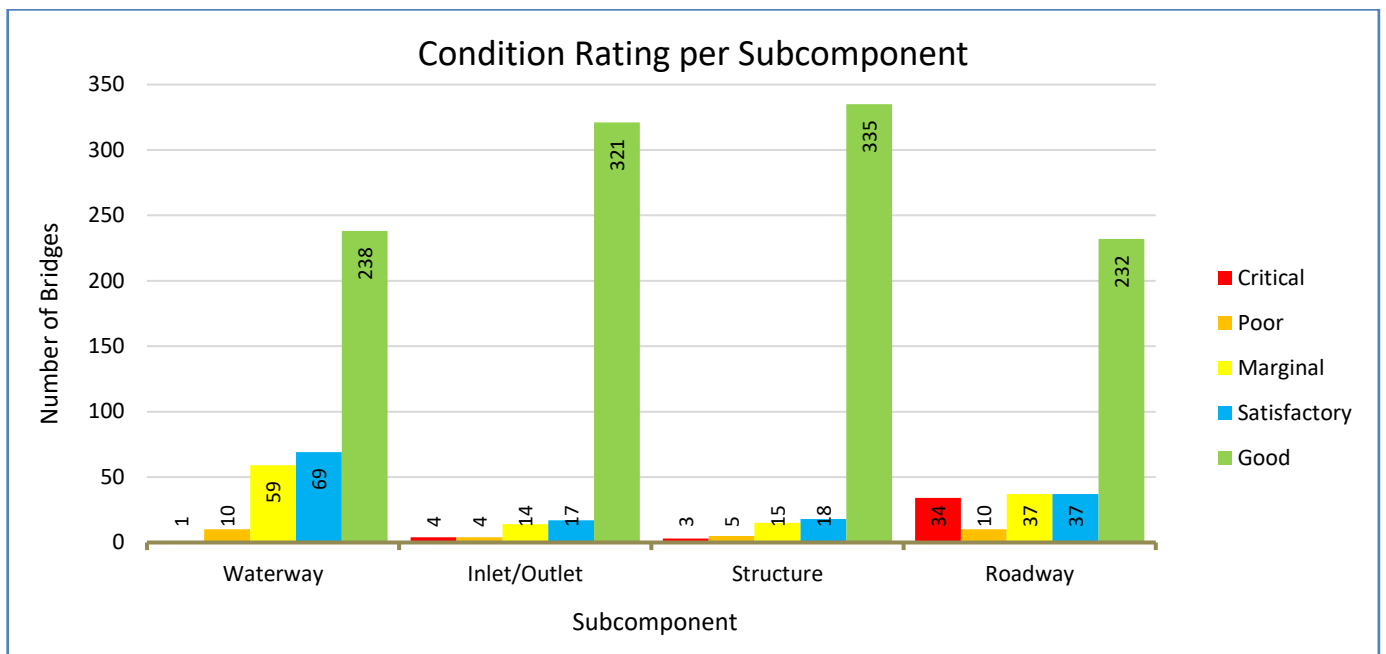
**Figure 6-4: Condition rating of major culverts per subcomponent**

From the figure above, it is observed that;
