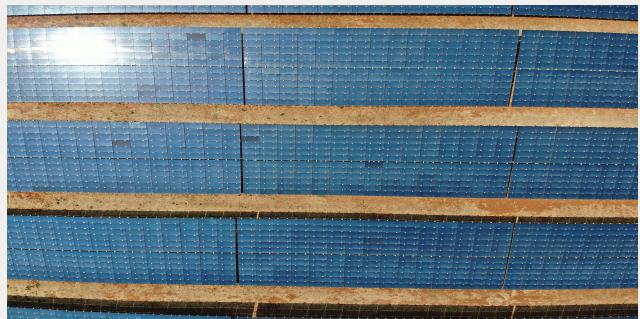
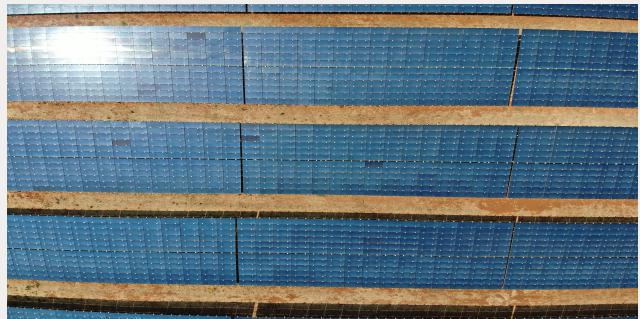
1.Broken_Glass

Module No.	(10, 6)
Table No.	B1/T67

Minimum Temperature	28.88999939(°C)
Maximum Temperature	41.86999893(°C)
Average Temperature	37.9(°C)
Delta(Δ) Temp.(°C)	(°C)

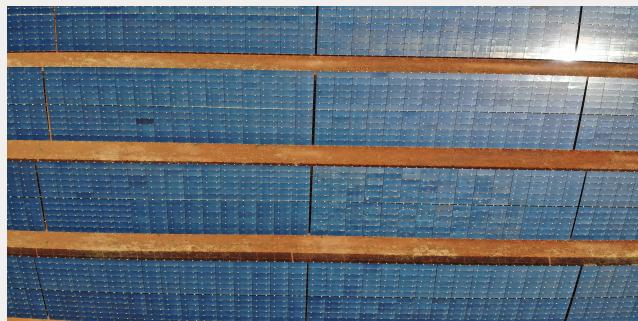
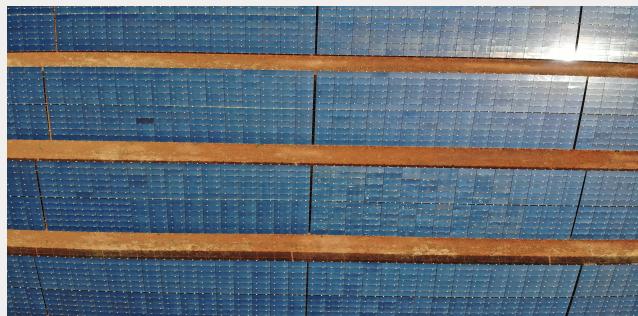
2.Broken_Glass

Module No.	(12, 15)
Table No.	B1/T24

Minimum Temperature	33.72000122(°C)
Maximum Temperature	52.54999924(°C)
Average Temperature	43.41(°C)
Delta(Δ) Temp.(°C)	(°C)

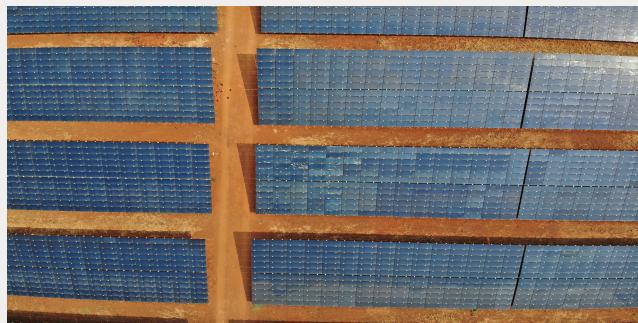
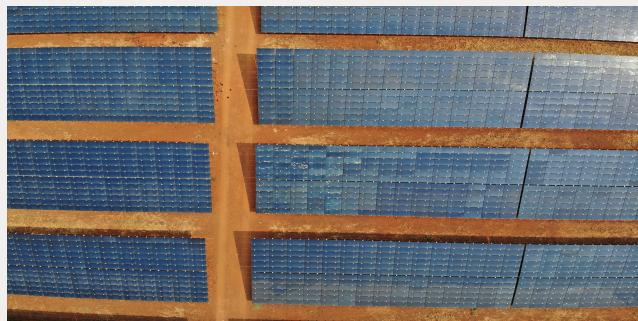
4.Broken_Glass

Module No.	(11, 13)
Table No.	B1/T11

Minimum Temperature	33.70999908(°C)
Maximum Temperature	43.90000153(°C)
Average Temperature	40.01(°C)
Delta(Δ) Temp.(°C)	(°C)

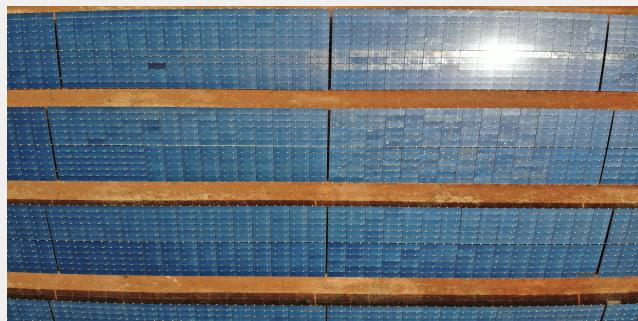
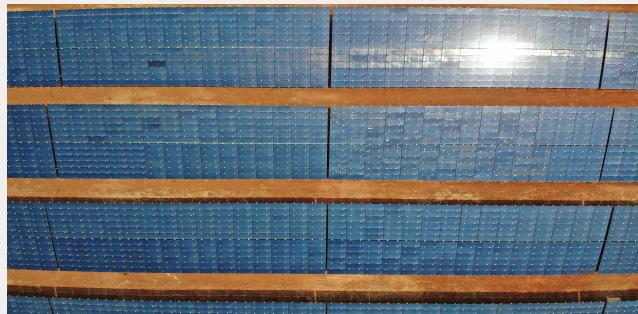
6.Broken_Glass

Module No.	(4, 15)
Table No.	B1/T11

Minimum Temperature	36.11999893(°C)
Maximum Temperature	46.54000092(°C)
Average Temperature	42.34(°C)
Delta(Δ) Temp.(°C)	(°C)

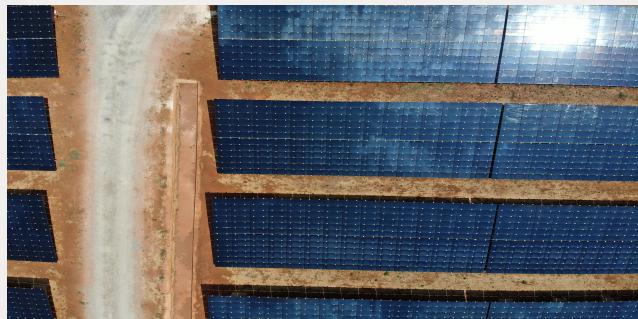
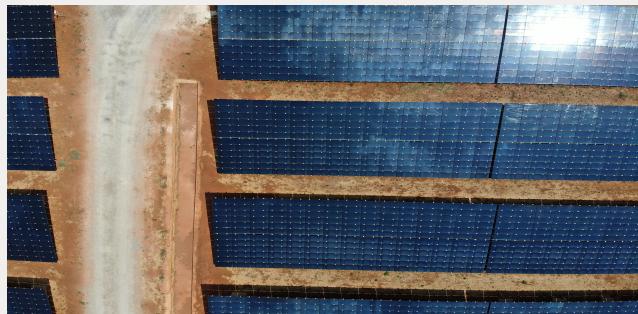
7.Broken_Glass

Module No.	(8, 6)
Table No.	B1/T11

Minimum Temperature	30.45999908(°C)
Maximum Temperature	46.95000076(°C)
Average Temperature	43.08(°C)
Delta(Δ) Temp.(°C)	(°C)
