# Catastrophic Failures and Explanations

Department of Materials and Metallurgical Engineering  
Bangladesh University of Engineering and Technology, Dhaka

## MORBI BRIDGE TRAGEDY!

## Skybound Giant's Last Dance, The Hindenburg Disaster

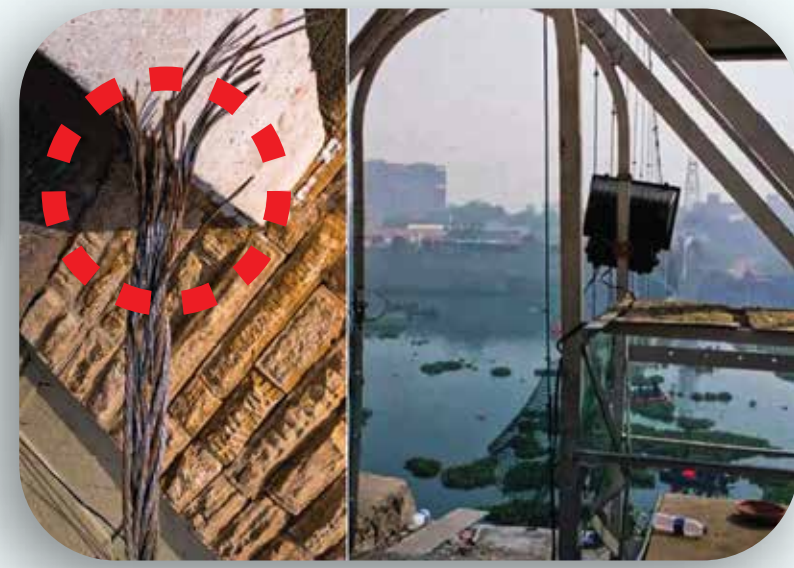
Corrosion resulted, in cable from little oiling

Aeroelastic flutter and allowable capacity assurance

Fatigue failure in the suspension system

| <b>Corrosion Protection:</b> | regular inspections, coatings, or corrosion-resistant materials |
| <b>Wind-resistant Design &amp; Quality :</b> | Aerodynamic shapes or damping systems, can prevent excessive twisting & quality control tests, safe occupancy limits. |

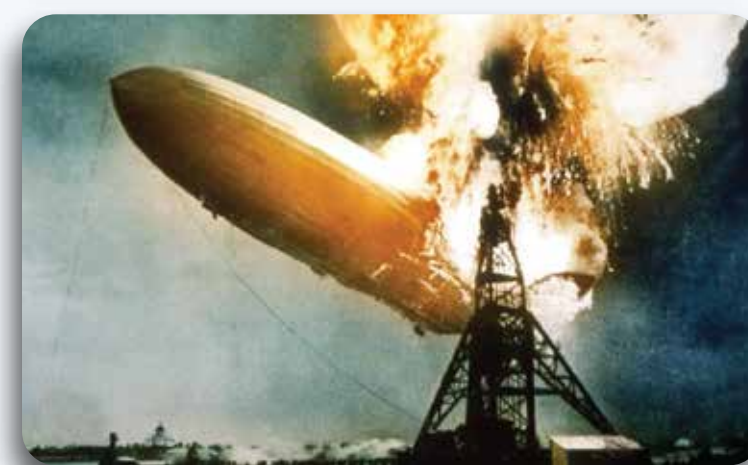
- Used inappropriate aluminum (Al) alloy as outer material
- Employed hydrogen gas (H<sub>2</sub>) as the fuel element within the airship
- Possible hypothesis

- Fire-resistant materials:** Incorporating non-flammable metals and synthetic fabrics
- Fuel optimization:** Substituting hydrogen with helium for improved safety
- Electrical system refinement:** Implementing spark-resistant technology
- Innovative docking methods:** Implementing better landing system
