# System Failure Case Studies

DECEMBER 2007 Volume 1 Issue 10

## **POWERLESS**

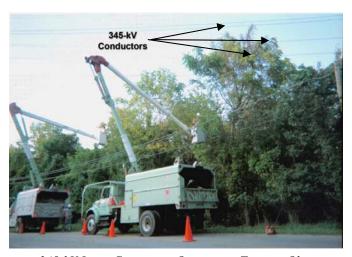
FirstEnergy failed to follow its own tree trimming policies (also known as vegetation management), which resulted in the failure of the three 345-kV transmission lines and one 138-kV line in its Ohio service area.

345-kV Lines Contacting Overgrown Trees in Ohio.

Furthermore, FirstEnergy rewrote its operator procedures and training programs to reflect the new systems, created a certification program to ensure operators fully understand their networks and systems as well as improve their reactions to emergency situations. It established new communication protocols for computer system repair and maintenance downtimes between their operations and IT staffs. An emergency response plan was created that focused on controlled load reductions of up to 1,500 megawatts for the Cleveland-Akron area. Tree trimming procedures and compliance were tightened.
