# **Consultancy Services for the Plant Audit in various Pump Stations and Reservoirs (OP18REFCS03)**

Technical Report for VILLAMOR Pump Station (Excluding Electrical Testing)  
reference: OP18REFCS03-GHD-VIL-REP-G001A

**Title:**  
Preliminary Report for Villamor Pump Station

**Theme:**  
Plant Audit and Asset Management

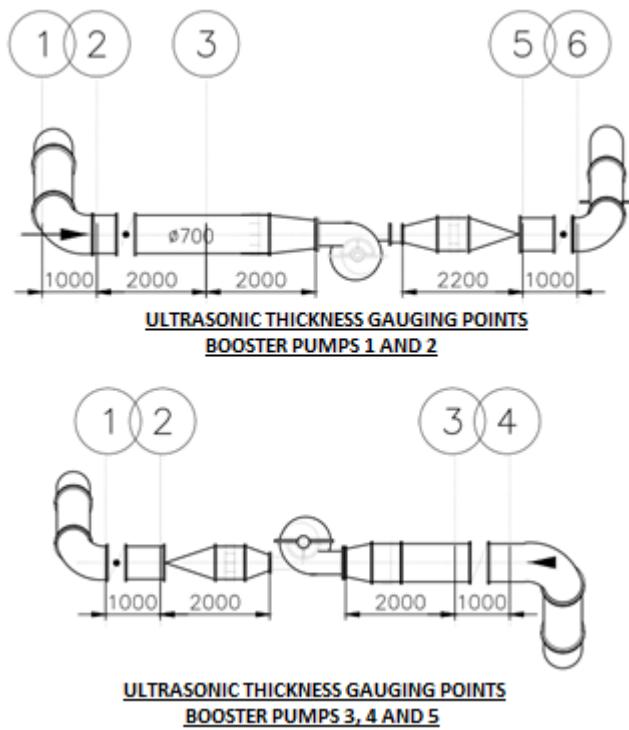
Figure 3.1: Positions and distances of UTG - Booster Pump

- Thickness at elbow is less than that of the straight line;
- Thickness of storage line is likely to be higher than that of the discharge line;
- BP1 has a value of 3.92 as min at the elbow, which requires attention from time to time.

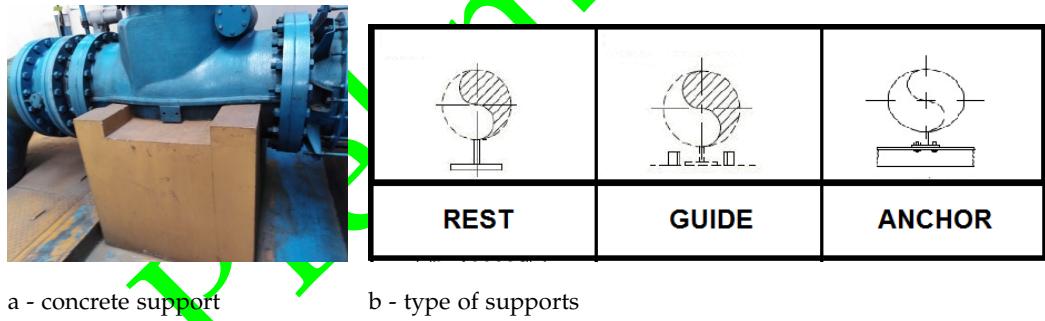
**Figure 3.7:** Piping support

flow is high and fluid momentum is great. However, from the visual inspection of the concrete support for check valves and how the valve seats on it, the supports function like anchors (fixed).

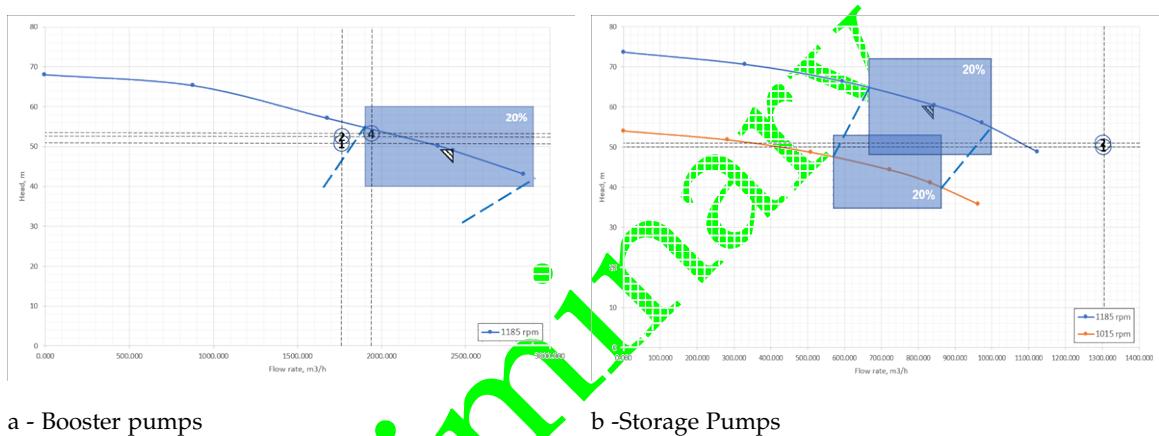
**Figure 3.10:** Efficiency curves

As shown in Figure 4.10-b, the storage pumps operate at an overflow condition and are beyond the tolerance of 20% Best Efficiency Point (BEP). Both pumps only run at 1015 rpm at the time of testing, but delivers an overflow and so deviate greatly from the curve. In this operating conditions, the pump might incur higher power consumption aside from the increase of deterioration rate of its components. Specifically, it will produce high cavitation and high vibration thus associated to the so called operate-to-destruction. This is similar to underflow as it will increase the temperature rise rate and produce noisy operations, cavitation surge and even high vibration scenarios.

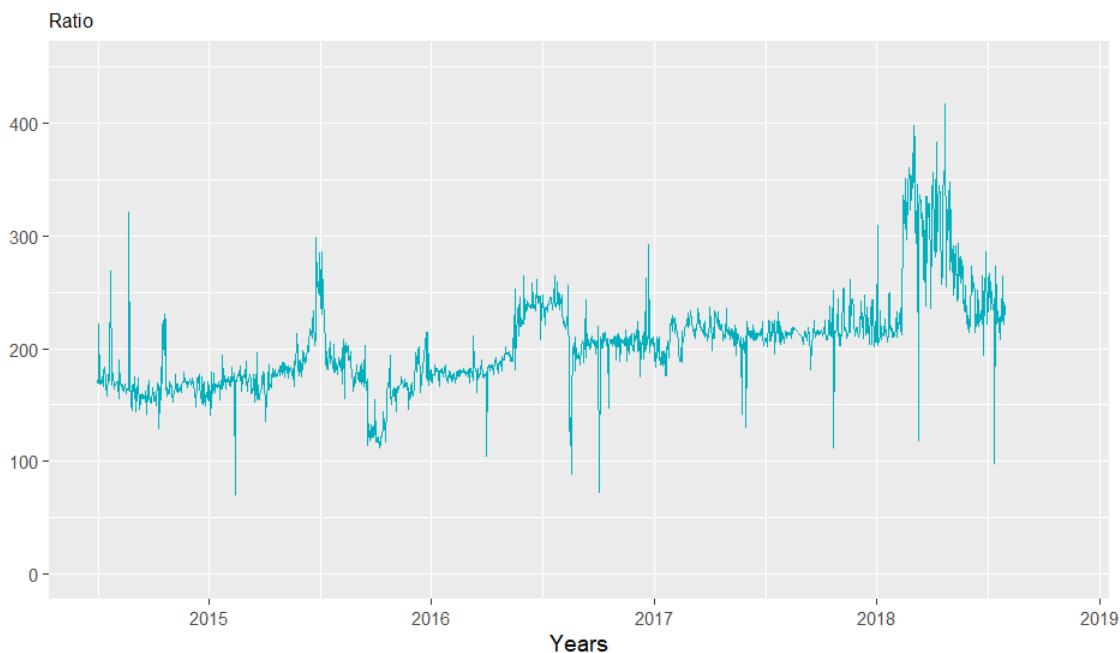
**Figure 3.14:** Time series ratio between production and power

- There has been a few number of peaks at which the ratio between power and production were significantly high compared to average value. These peaks seem to be repeated at least one in a year. The reason causing that peaks are unknown;
- There are a number of outliers which should not be an actual cases;
- There was a high peak in ratio in the first quarter of 2018. The ratio has reached between 300 and 400 for 3 months period, inferring an abnormal operation.

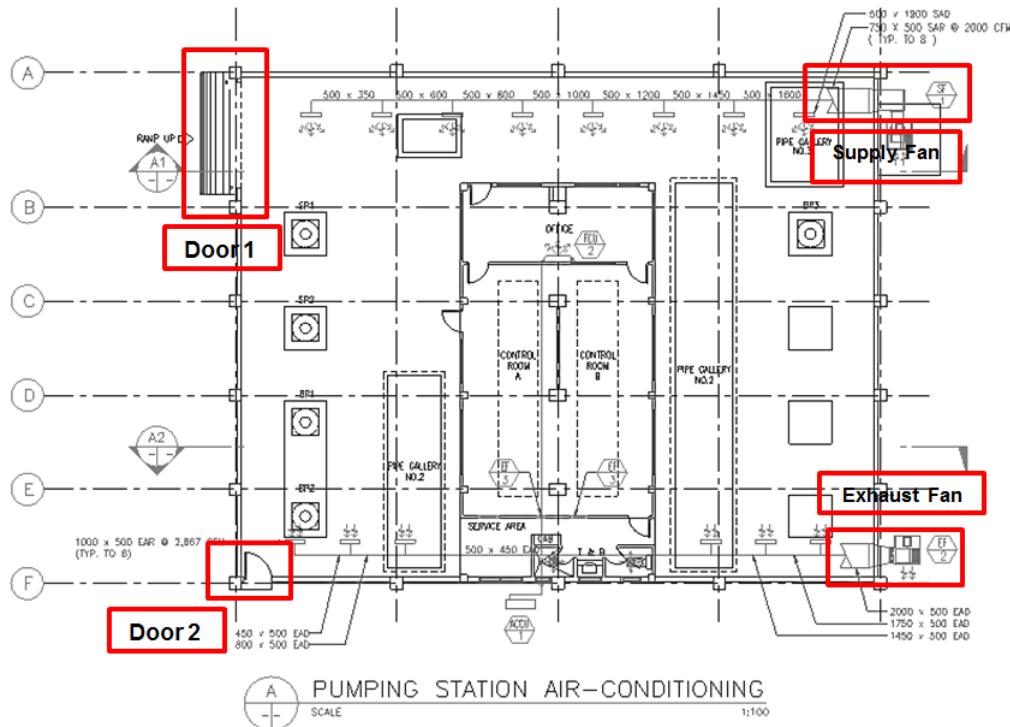
Figure 3.16: Existing ventilation layout

Natural ventilation through Door 1 and Door 2 is not sufficient to attain the minimum Air Changes requirement of the Pump House and so Mechanical Ventilation is utilized most of the time.

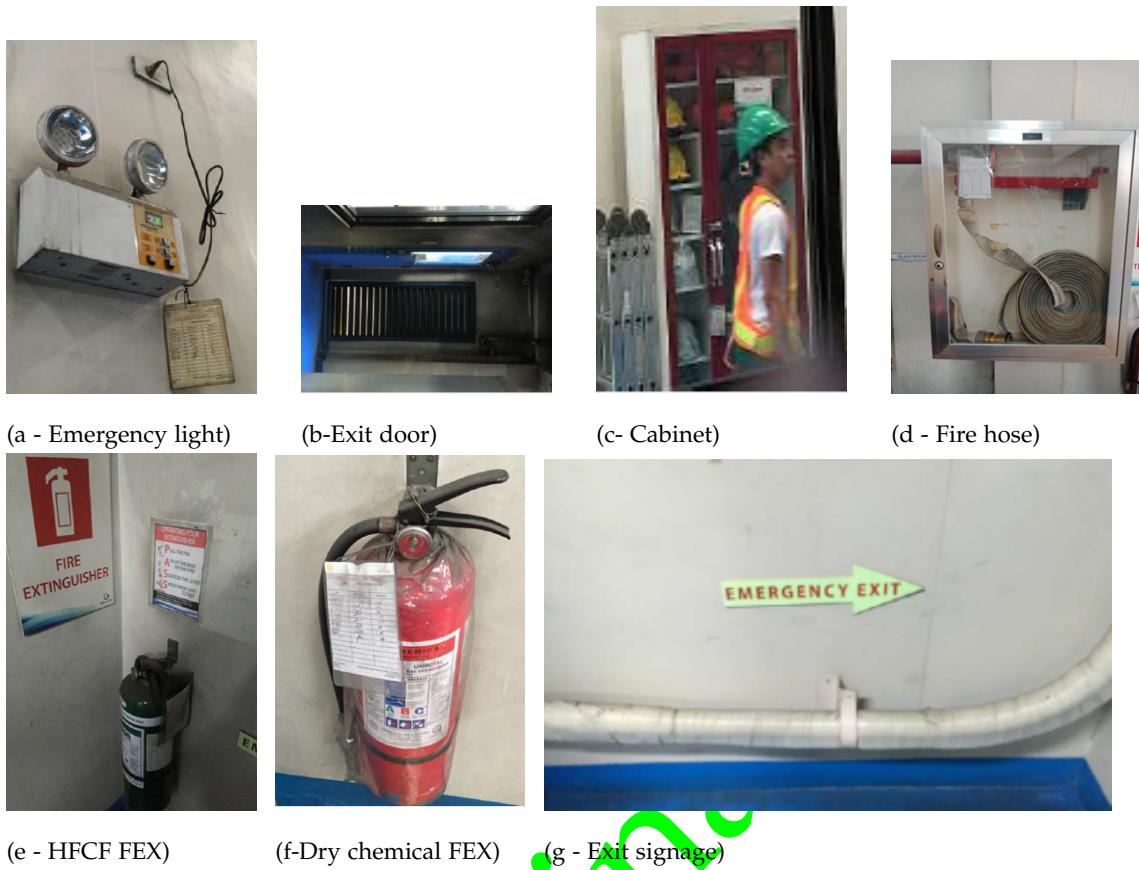
**Figure 3.19:** Existing safety devices**Table 3.27:** FDAS analysis.

- Most of the smoke detector devices, manual call point, buzzer and the FACP were not functioning. These were established during the conducted testing of FDAS and devices;

- Test the batteries for voltage output;

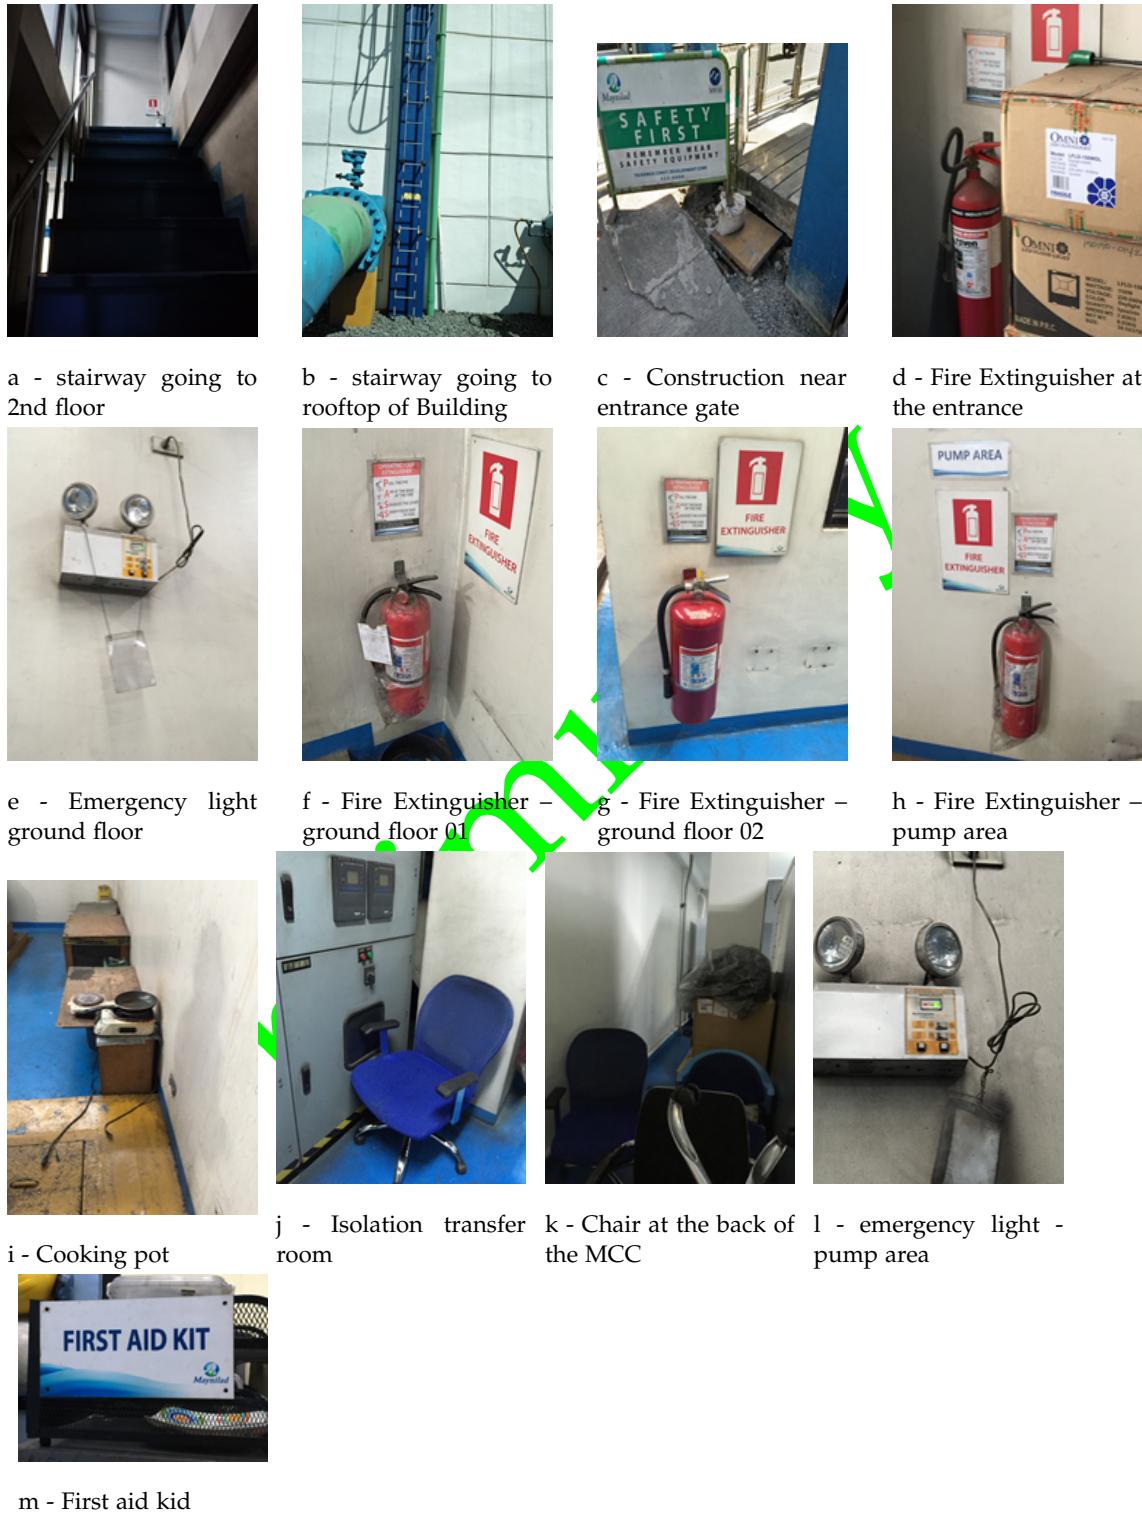
**Figure 3.21:** Protective devices.

7	Fire Extinguisher - ground floor tag 02	0	4	No tag	FEX workability/functionality should be determined
8	Fire Extinguisher - Pump Area	0	4	No tag	FEX workability/functionality should be determined
9	Cooking pot-Pump Area	0	4	Cooking activity being done in Pump Area	Unsafe Cooking activity should be done in designated Area like pantry
10	Isolation Transfer Room - Ground floor	0	4	Chair obstruction in front of Switchgear	Unsafe Switchgear shall be free from all obstruction.
11	Chairs stores at the back of MCC	0	4	Chair obstruction on the rear of the Motor control Starter	Unsafe Switchgear shall be free from all obstruction
12	Emergency Light - Pump Area	0	4	With Power indicator Not charging	Inspection tag says EL is ok
13	First Aid Kit- Engineer's Area	0	4	First Aid kit not found only with signage	Unsafe Area should be dedicated to First Aid Alone and not to mix with other office materials

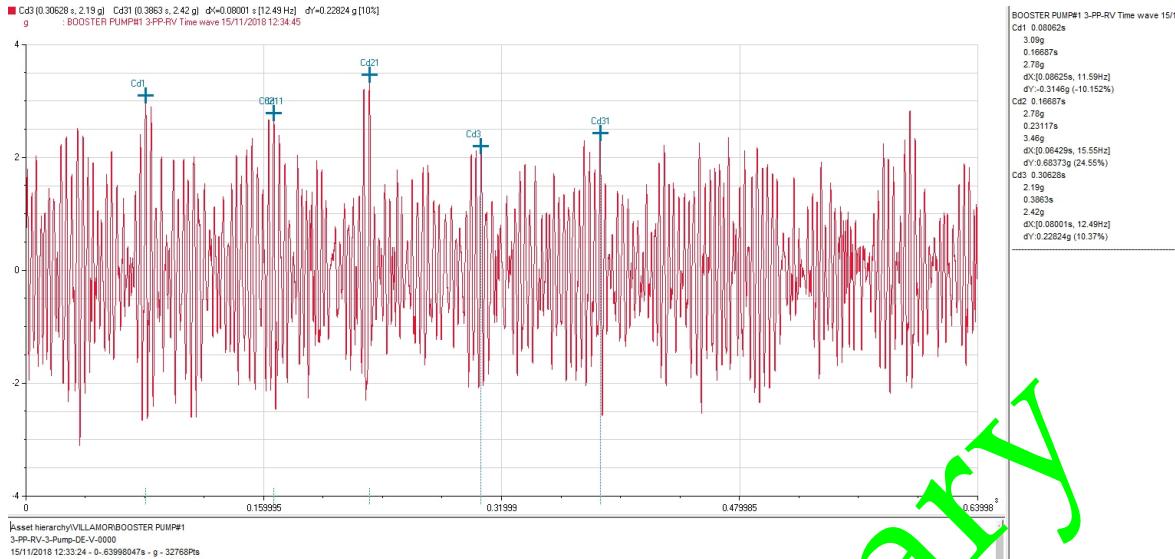
#### Non-periodic pulsation due to pump cavitations

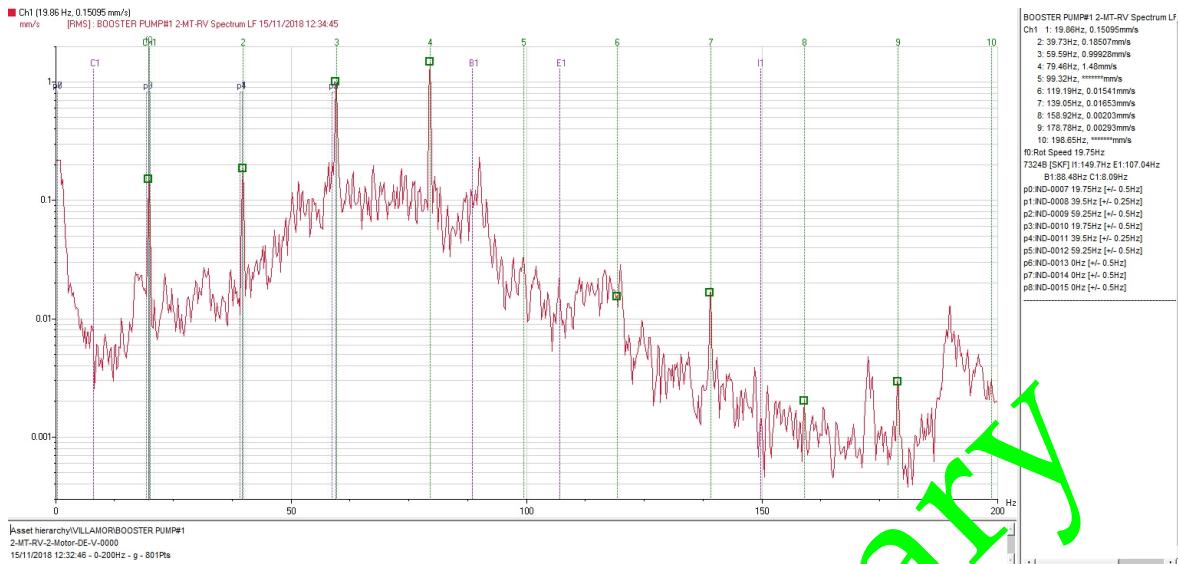
Pedestal Looseness at 1x, 2x, 3x, 4x peak

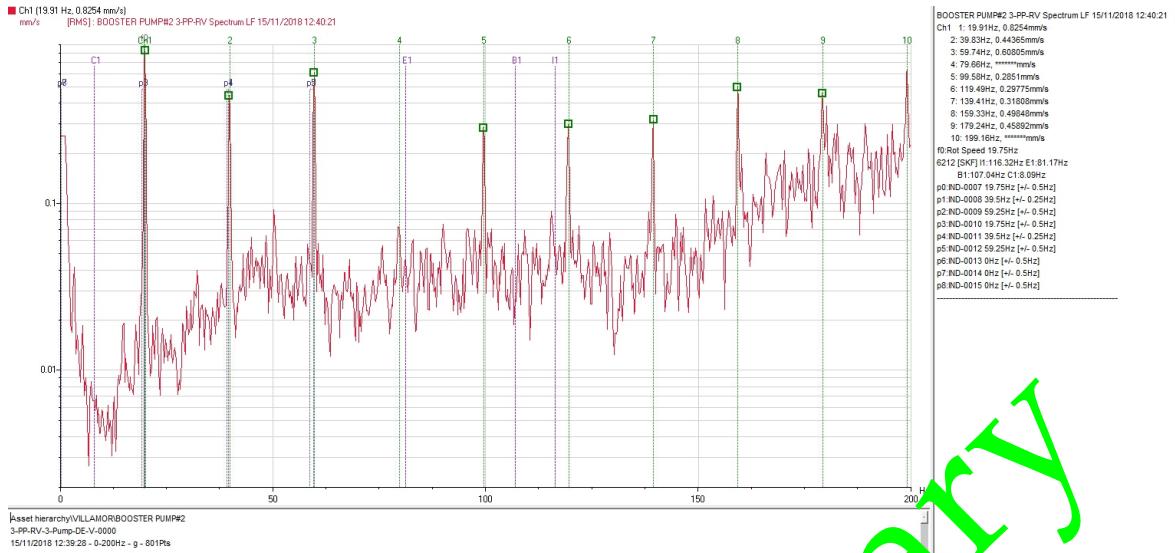
Highest vibrations measured at Pump IB Bearing Vertical with Overall Velocity of 0.7mm/s and dominant peak at 1x Blade Passing Frequency (119.25Hz) caused by Pump Cavitation.

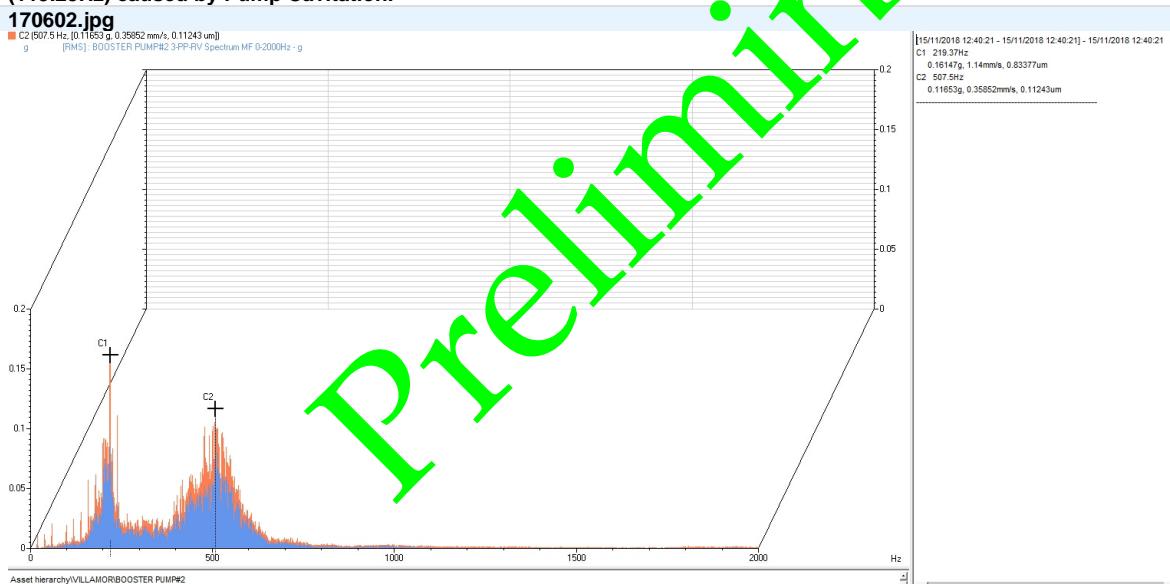
Elevated Base of Spectrum at high frequency range is an indication of Pump Cavitations  
b0648.jpg

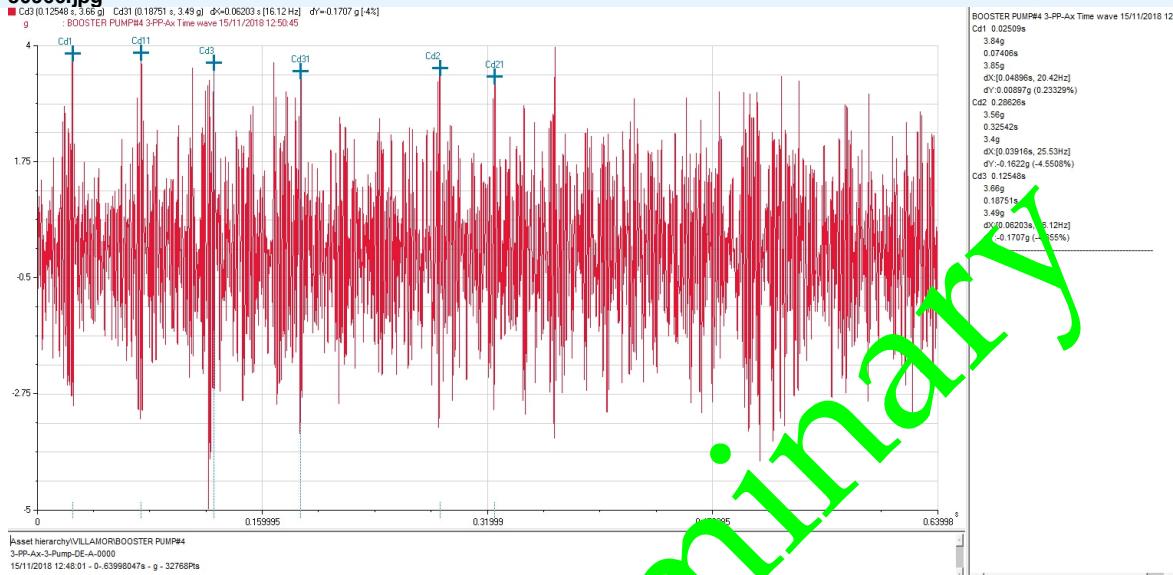
50966.jpg

Location	<b>VILLAMOR\</b>	
Designation		
Equipment	<b>BOOSTER PUMP#4</b>	
Designation		
Abbreviation	<b>BP#4</b>	
Serial No		
Model		
Periodicity (d)	Normal 60	Alarm 15
<b>Previous Advice</b>	<b>Condition</b>	<b>Rotation Speed</b>
		Fixed speed

Schedule Pump reconditioning to visualize Pump Impeller blades profile and pitch for damages. Check as well its wear ring clearances

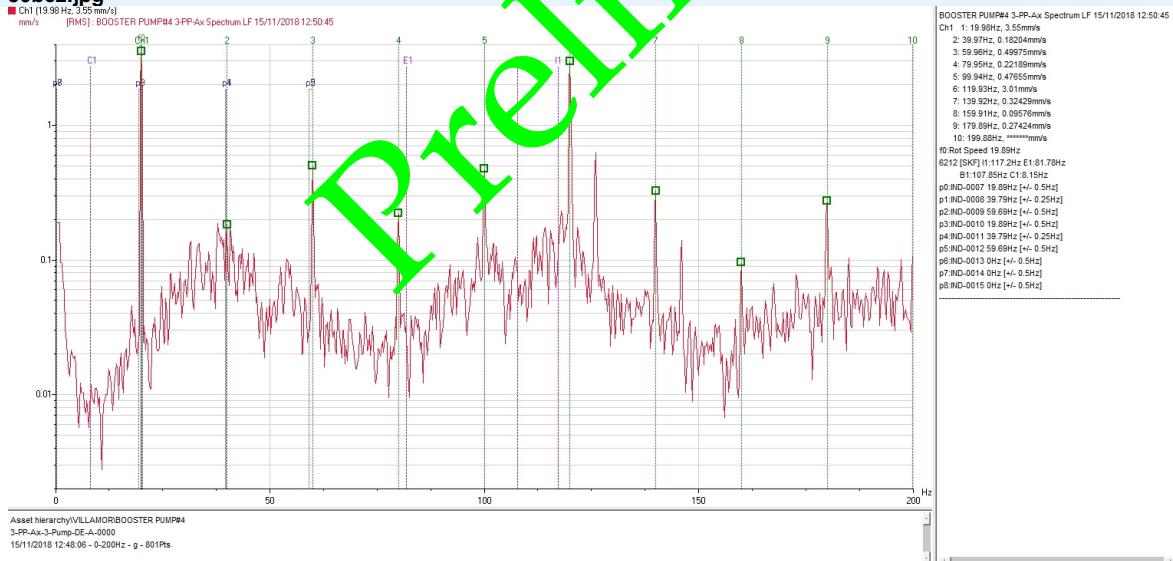
1x RPM peak and 1x Blade Passing - an indications of Misalignment and Cavitations

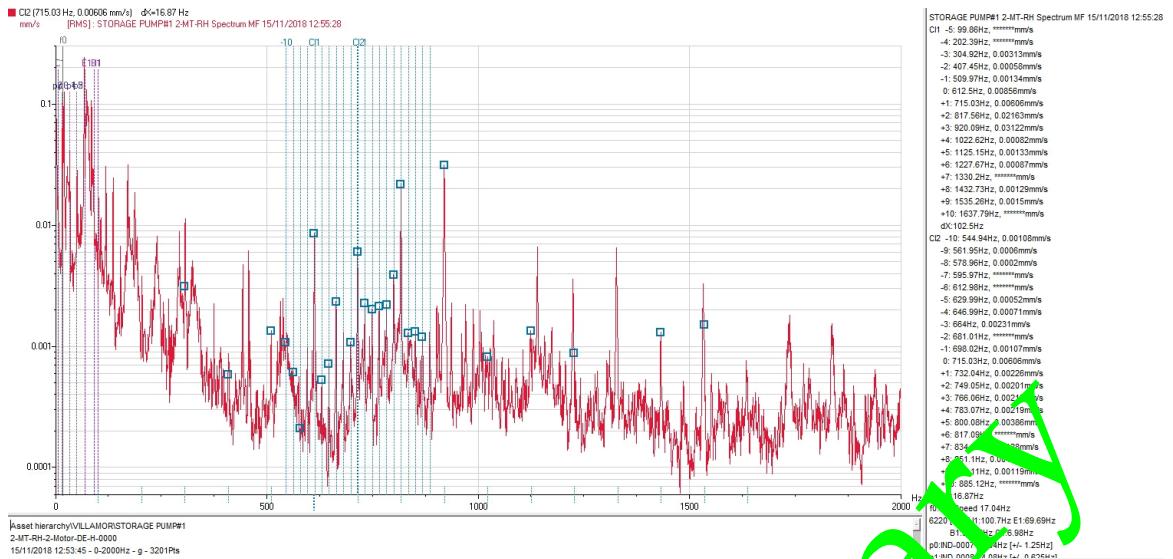
### Early Stage Motor DE Bearing Defect

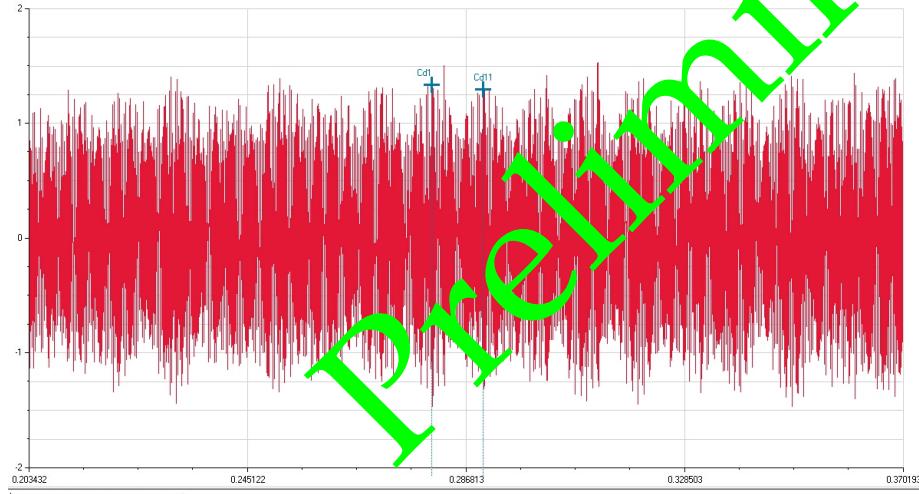
■ Cd1 [0.38941 s, 1.33 g] Cd11 [0.29021 s, 1.29 g],  $\Delta\omega=0.0098$  s [101.99 Hz],  $\Delta\gamma=0.0416$  g [3%]

■ RMS : STORAGE PUMP#1 2-MT-RH Time wave 15/11/2018 12:55:28

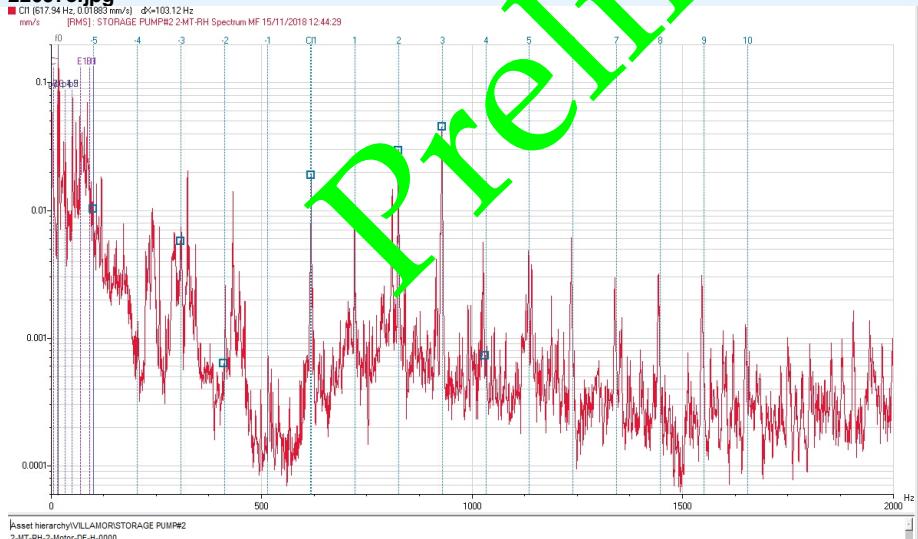
22097e.jpg

Location	<b>VILLAMOR\</b>	
Designation		
Equipment	<b>STORAGE PUMP#2</b>	
Designation		
Abbreviation	<b>SP#2</b>	
Serial No		
Model		
Periodicity (d)	Normal 60	Alarm 15
Previous Advice	Condition	Rotation Speed

STORAGE PUMP#2 2-MT-RH Spectrum MF 15/11/2018 12:44:29  
C11 -5: 100.37Hz, 0.0128mm/s  
-4: 203.89Hz, \*\*\*\*\*mm/s  
-3: 307.4Hz, 0.0057mm/s  
-2: 410.91Hz, 0.0006mm/s  
-1: 514.42Hz, 0.0002mm/s

Regrease bearings periodically. Continue monitor evolution
