# **Consultancy Services for the Plant Audit in various Pump Stations and Reservoirs (OP18REFCS03)**

Technical Report for PAGCOR Pump Station  
reference: OP18REFCS03-GHD-PAG-REP-G001A

**Title:**  
Preliminary Report for Pagcor Pump Station

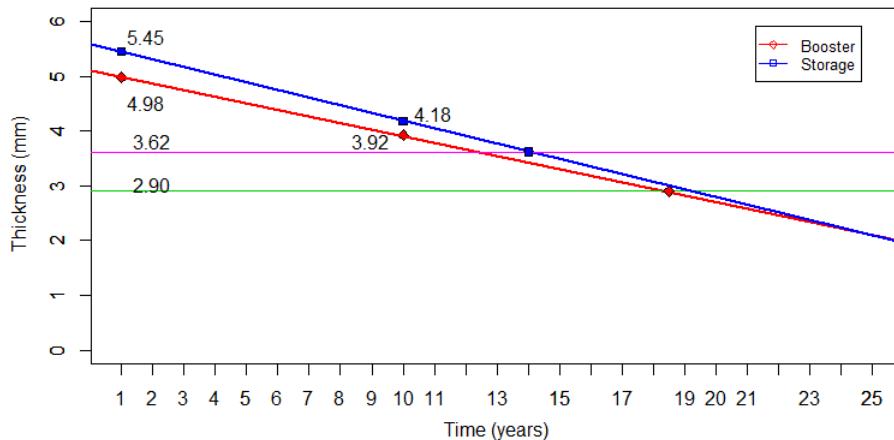
**Figure 4.5:** Thickness prediction

A simplest way to predict the remaining duration till thickness of pipe reaching alarming level (minimum allowable thickness). This prediction is shown in Table 4.5

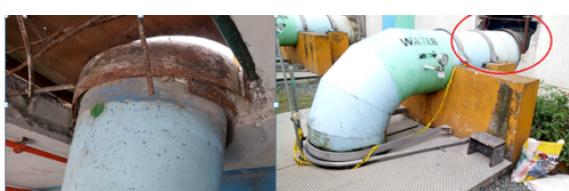
a - wall opening

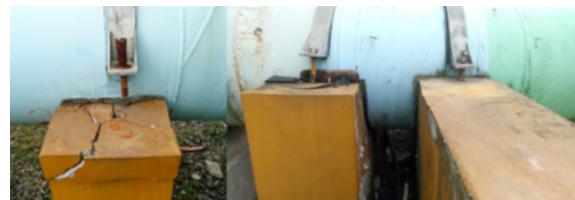
b - Support damage

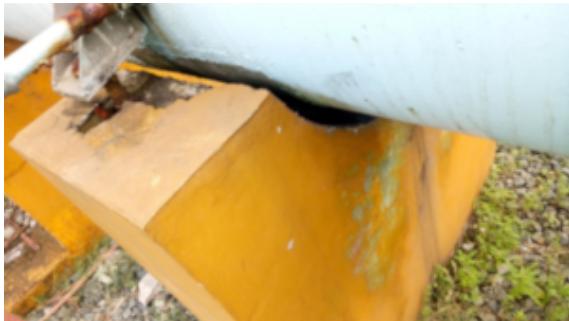
c - Gap between saddle support and pipe

Piping movements parallel to the central axis also have been observed. As shown in Figure 4.7-b, a gap has been observed between several counter supports and the elbow. The counter supports are supposed to handle elbow thrust as immense water volumes pass thru the elbow.

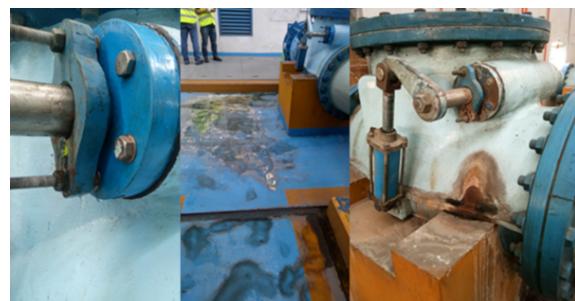
d - common leakage

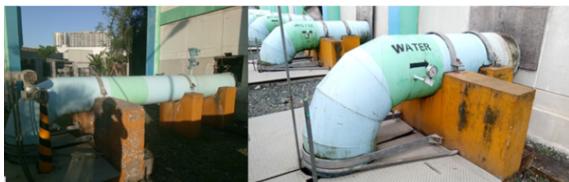
#### a - Piping supports

For the booster pumps, there are two saddle supports located near to each other and are positioned just outside the pump house after the suction elbows as shown in Figure 4.7-a. For the storage pumps, the three saddles are located farther, one before the discharge elbow and the other still outside the pump house and just after the check valve.

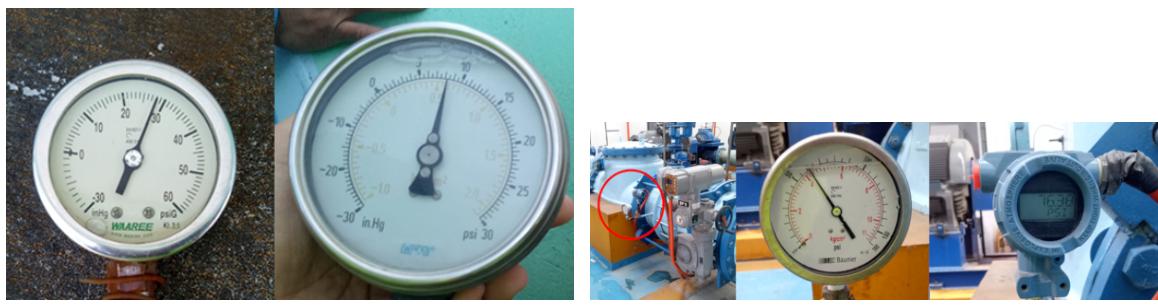
a - Defective

**Figure 4.8:** Defective/discrepancy pressure gauges

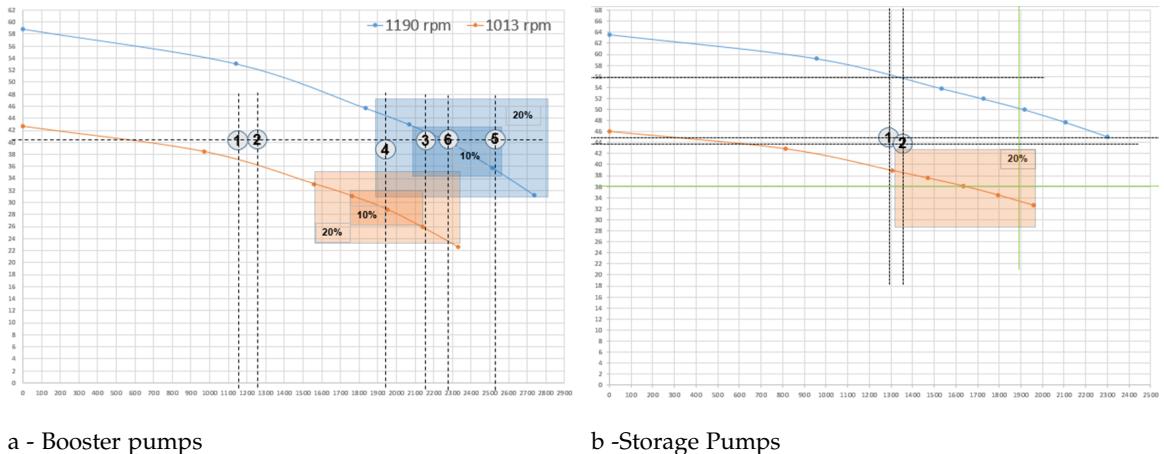
**Figure 4.10:** Efficiency curves

Figure 4.10-a shows that BP1 and BP2 deviates away from the curve. In this case, BP1 and BP2 possibly operates at underflow condition, and at higher friction loss. The pump operates at lower efficiency based on the plot curve, and backed up to have an efficiency of 78.6% and 71.7%, respectively. This also constitutes to the “fair” condition of the pump with possible cavitation at the suction head. Moreover, BP3, BP5, and BP6 have efficiencies higher than 85%. As shown at the shaded region, these pumps operate under the 10% tolerance BEP range, thereby operating at considerably good operation point although BP5 has overflow-measured flow. In the contrary, these pumps were diagnosed to have a “fair” pump condition state. This is due to pump possible cavitation from the suction and carried throughout the discharged side of the pumps. In the other hand, BP4 has an efficiency of 74.2% and deviates slightly away to the curve with the operating point of BP4 is under the 20% tolerance BEP range. The pump operates at lower head and possibly in underflow condition. The pump have a diagnosis of having a good pump health that means lower vibration and possible cavitation occurred / occurring within pump impellers

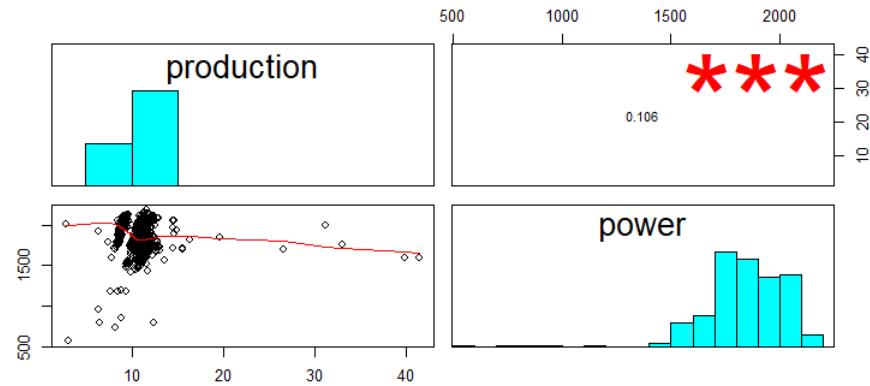
**Figure 4.11:** Correlation between production and power consumption

Figure 4.11 shows the statistical correlation between production and power. It can be seen from the correlation graph and correlation value that there is little correlation among these two values. This is against the hypothesis that when production increase, power consumption shall also increase. However, it is not the case as observed from the graph. This infers that the pump system might have incurred a certain level of deterioration leading to its low reliability over time.

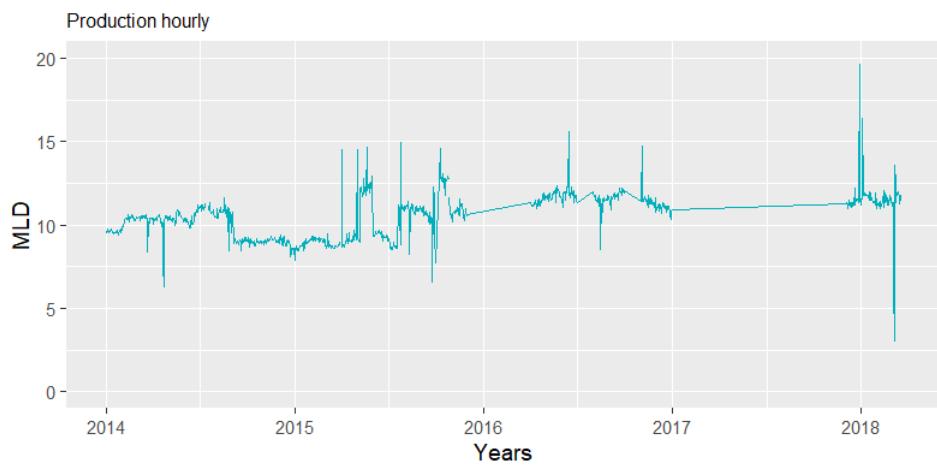
**Figure 4.12:** Time series production/hour

Figure 4.12 shows a trend in time series production since 2014. It can be seen from the graph that the production has kept decreasing slightly over the year.

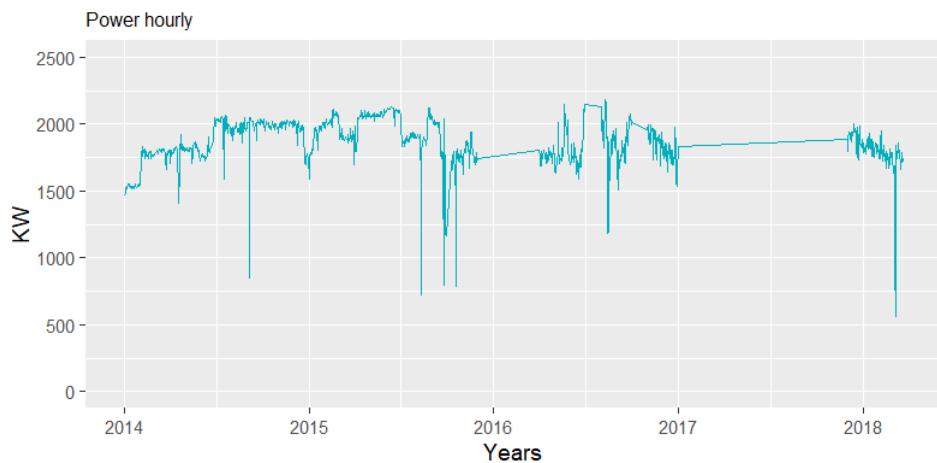
**Figure 4.13:** Time series power/hour

Figure 4.13 shows a trend in time series power consumption since 2014. It can be seen from the graph that the power has kept increasing over the year.

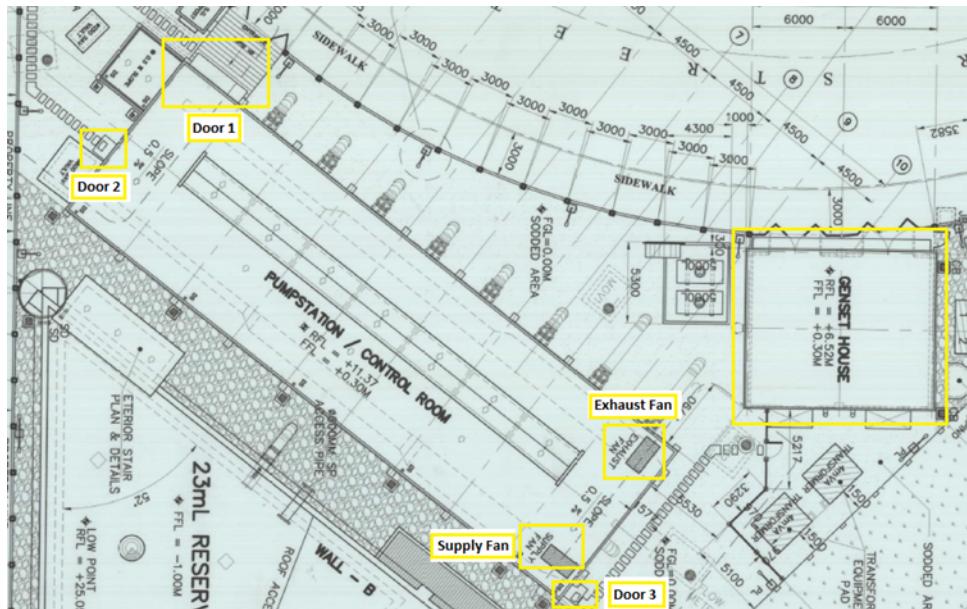
**Figure 4.16:** Existing ventilation layout

There are two ways of ventilation available, natural and mechanical. Natural ventilation is possible through the entrance door in front of Guard House (Door 1) and the other one beside the office (Door 2) which are both always open. Other door, situated at the farthest side of SP1 (Door 3) can also be used as a means of natural ventilation but it is normally closed and not

utilized (Figure 4.16). Thus, mechanical ventilation is the main option as the plant installed supply and exhaust fan for the pump house running most of the time, specifically during hot dry days and when there are on-going maintenance activities. An air conditioned office is also available for the operator monitoring the plant daily operation.

It was realized that natural ventilation through Door 1 and Door 2 is not sufficient to attain the minimum air changes requirement of the Pump House and so mechanical ventilation is utilized most of the time.

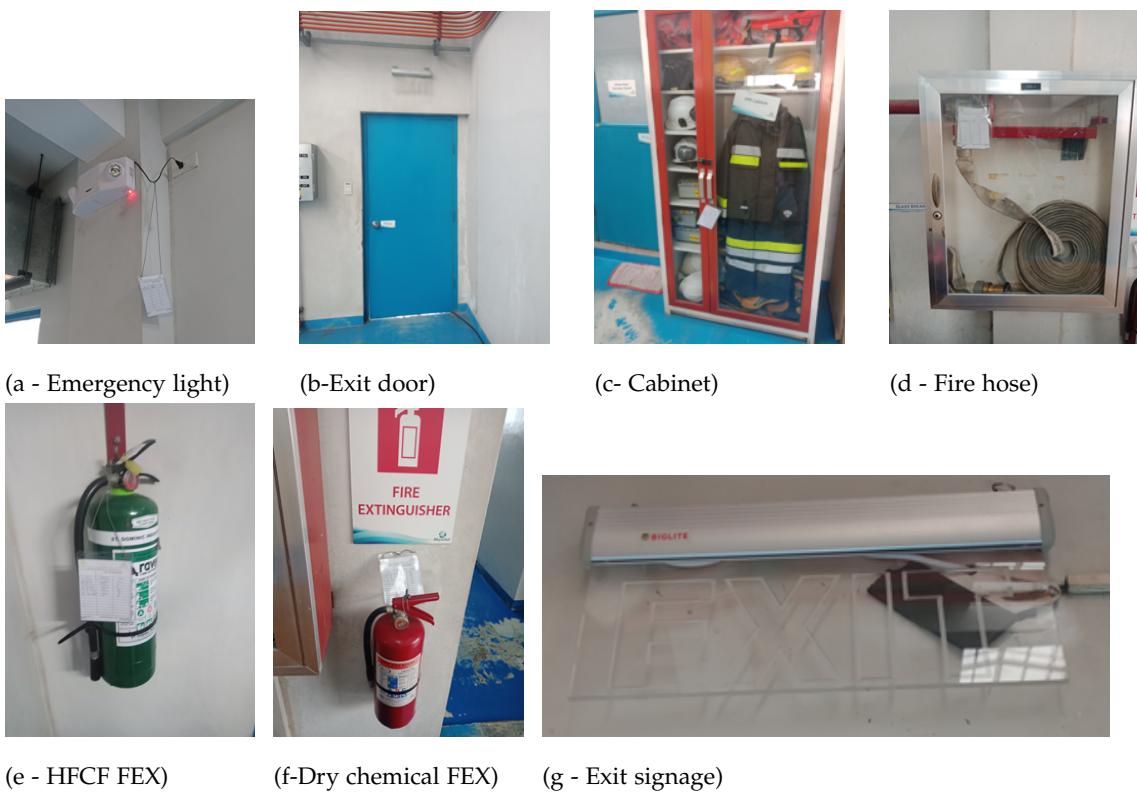
**Figure 4.19:** Existing safety devices

No.	Assets	CS	IT	Facts	Remarks
1	Exit light 01 (Fig. 4.19-g)	0	4	Not function No light indication	Unsafe risk to the safety of people in the event of power a power outage
2	Exit light 02 (Fig. 4.21-h)	0	4	Not function No light indication	Unsafe risk to the safety of people in the event of power a power outage
3	Exit light 03 (Fig. 4.19-b)	0	4		Unsafe risk to the safety of people in the event of power a power outage
4	Exit light 04 (Fig. 4.21-i)	0	4		Unsafe risk to the safety of people in the event of power a power outage
5	Exit light 05 (Fig. 4.21-j)	0	4		Unsafe risk to the safety of people in the event of power a power outage
6	Emergency light tag 01 (Fig. 4.19-a)	0	4	No updated Last update is 30/Aug/2018	Unsafe Failure to inspect emergency light can make it ineffective
7	Emergency light tag 02 (Fig. 4.21-a)	0	4	No tag	Unsafe Failure to inspect emergency light can make it ineffective
8	Emergency light tag 03 (Fig. 4.21-b)	0	4	No tag	Unsafe Failure to inspect emergency light can make it ineffective

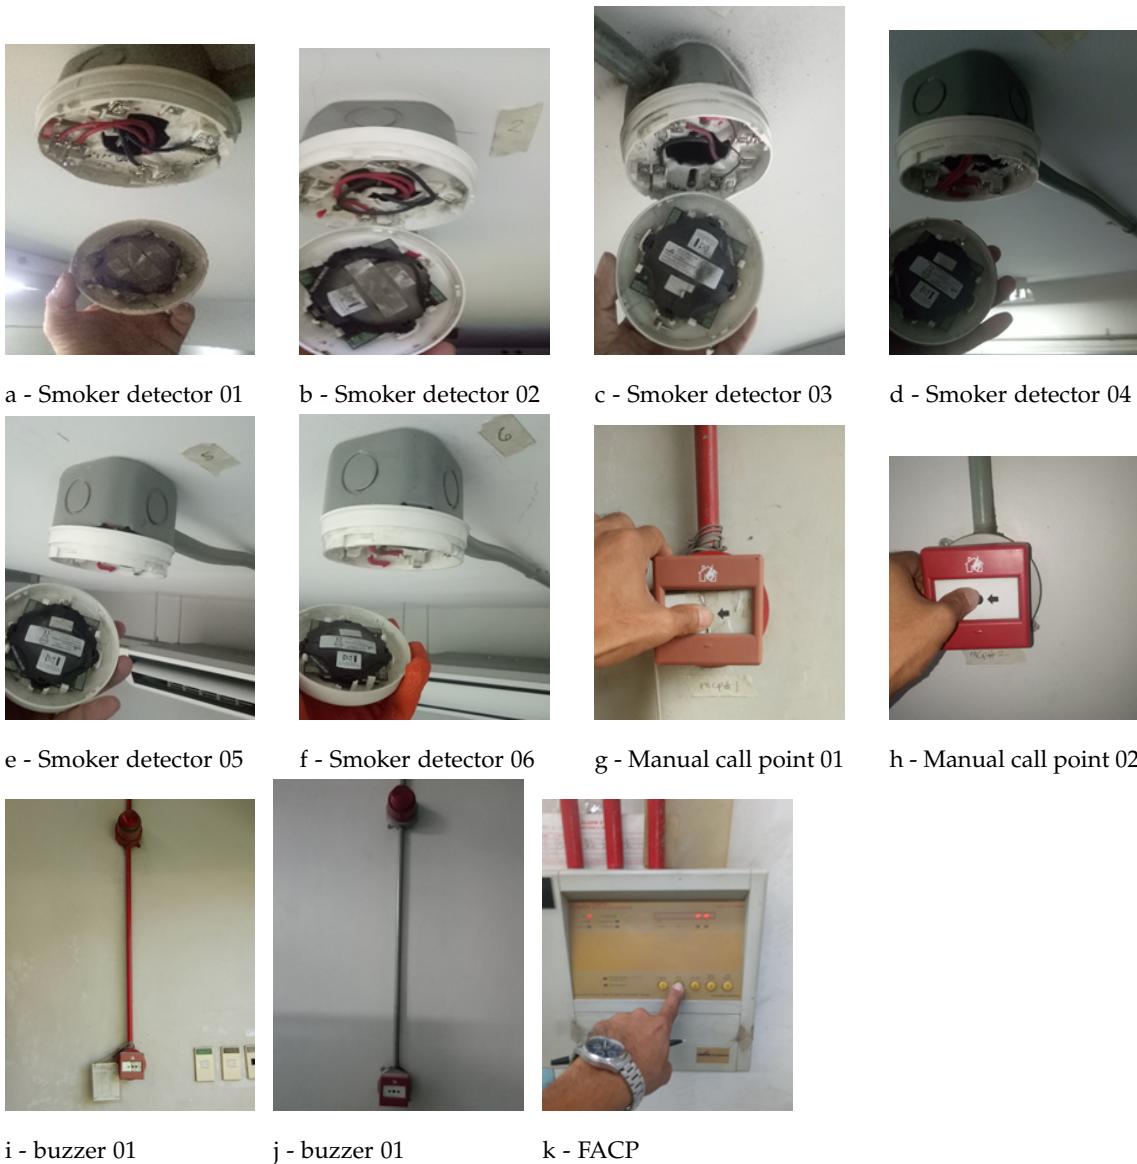
**Figure 4.20:** FDAS assets

9	MCP#1 (Fig. 4.20-g)	0	4	No updated	Unsafe Failure to inspect manual call point can make it ineffective in case of fire
10	Fire extinguisher 01 (Fig. 4.21-c)	0	4	Missing	Unsafe Failure to replace or locate fire extinguisher can delay response to
11	Fire extinguisher 02 (Fig. 4.21-d)	0	4	Missing	Unsafe Failure to replace or locate fire extinguisher can delay response to
12	Fire extinguisher 03 (Fig. 4.21-e)	0	4	Missing	Unsafe Failure to replace or locate fire extinguisher can delay response to
13	Fire extinguisher 04 (Fig. 4.21-f)	0	4	No inspection tag	Unsafe Failure to inspect fire extinguisher can make it ineffective in case of fire.
14	PPE cabinet tag (Fig. 4.21-g)	0	4	Not updated Last update is 7-30-2018	Unsafe Failure to inspect PPE cabinet may not ensure completeness of content and PPE may have damage that can make these equipment ineffective

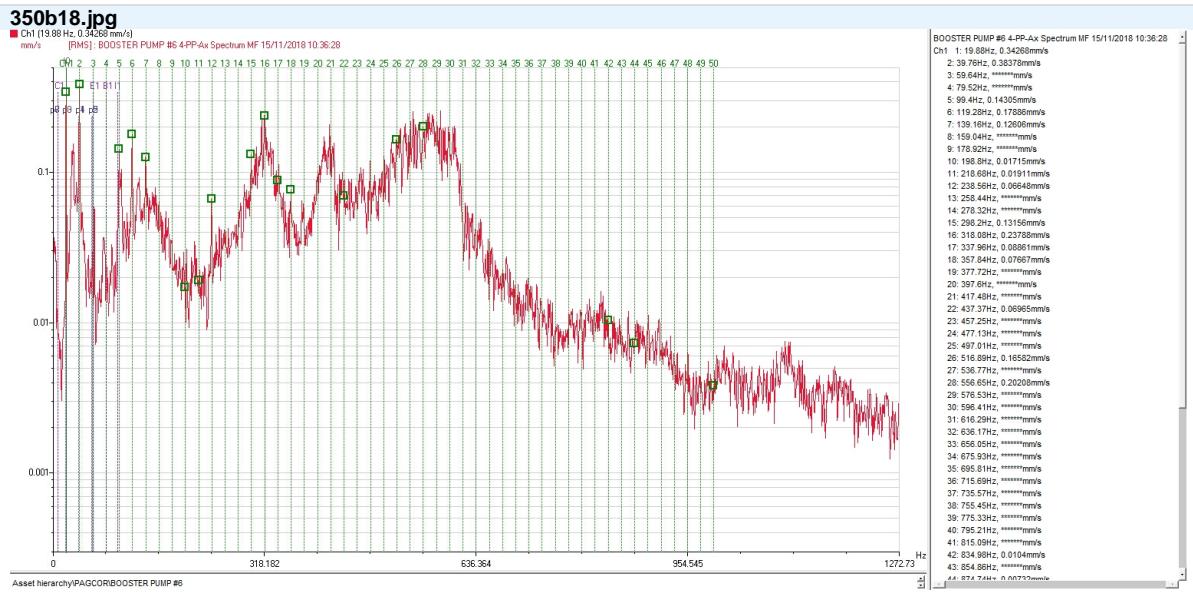
**Elevated base or humps at High frequencies are an indications of combination Noise from Pump Cavitations and Lubrication issues at Pump OB Bearing**
