Consultancy Services for the Plant Audit in various Pump Stations and Reservoirs (OP18REFCS03)

Technical Report for Ayala South Vale (ASV) Pump Station
reference: OP18REFCS03-GHD-ASV-REP-G001A

Preliminary Report for Ayala South Vale (ASV)
Pump Station

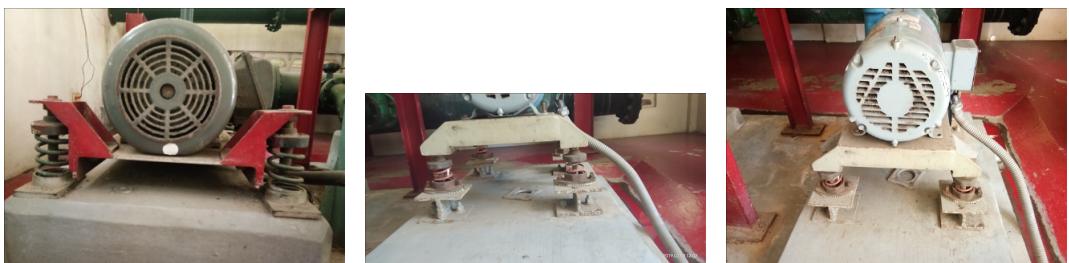
Figure 4.3: Spring Mounted Baseplates

The four booster pump units in this station are bolted onto spring-mounted base-plates (Figure 4.3) typical of small Goulds pumps installations. Designed to allow displacement under applied loads associated with thermal expansion of piping, such as those employed in small chilled water or hot water systems, said spring-mounted base-plates typically sit or slide on a smooth floor. However, the station designers choose to bolt the spring mounts onto concrete blocks, which defeats the purpose of the spring-mount design. (Refer to Goulds Pumps Installation, Operation and Maintenance Instructions.)

If possible, it is best to inquire the station designers to re-examine the assumptions or reasons behind this unusual mounting design.

a - Southvale service pump baseplate b - Sonera service pump baseplate c - Deflection Spring Mounting Assembly

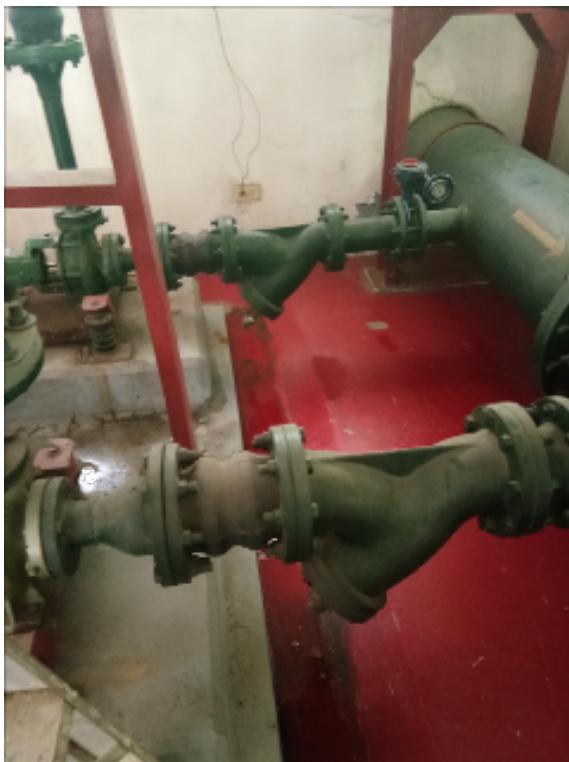
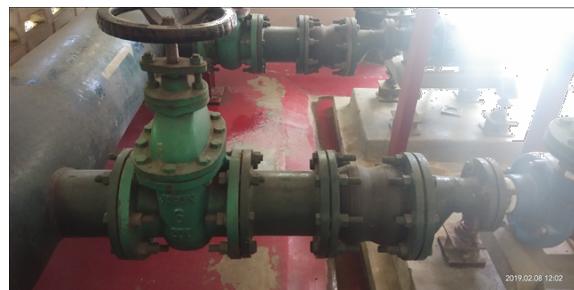
Figure 4.4: Suction side

a -Southvale service pump suction

b - Sonera service pump suction

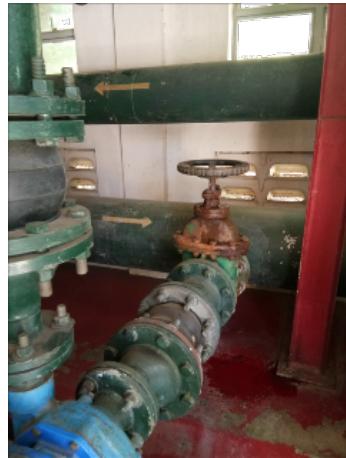
Figure 4.6: defective valve

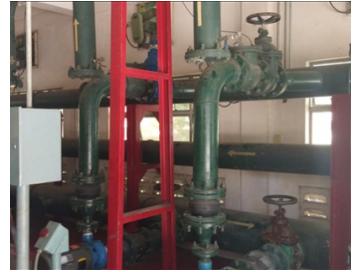
Figure 4.7: over-head valve location

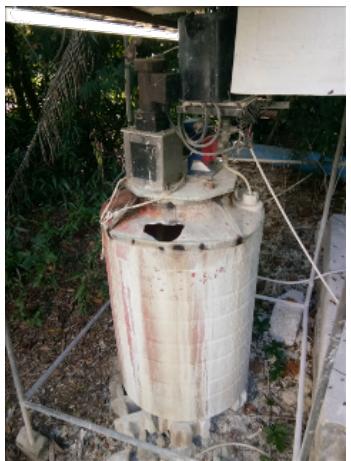
Figure 4.9: Other deterioration

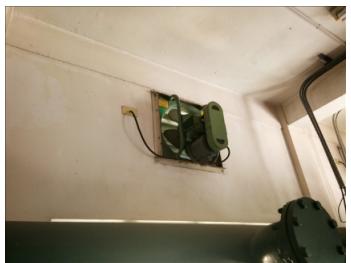
**Figure 4.10:** exhaust fan

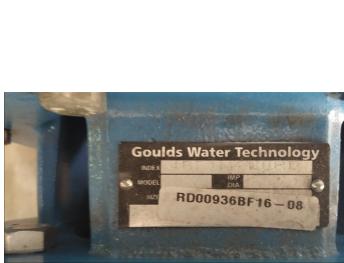
**Figure 4.11:** blank nameplate

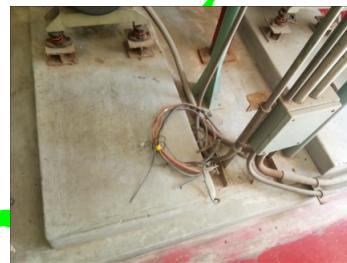
**Figure 4.12:** wire clutters

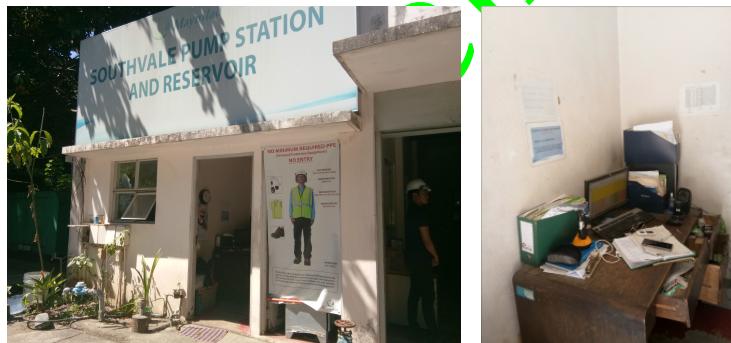
a - High solar load during the day

b - Operator's desk

- Development of documentation code and naming for appropriate filing and library/referencing;
- Refurbish operator's office (Figure 4.16 - b) and include necessary organizing items such as file cabinet

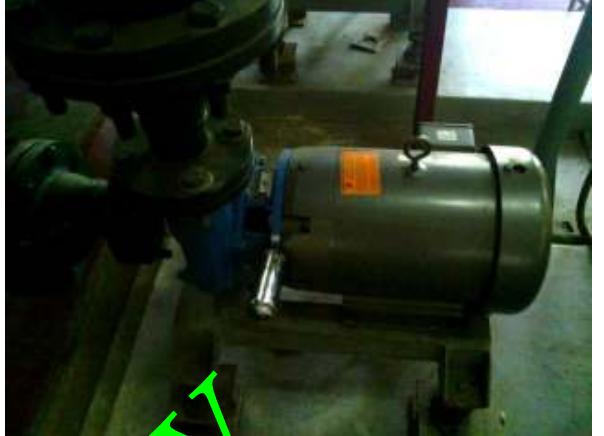
Location	SOUTHVALE PUMP\		Fixed speed

Designation	SOUTHVALE PUMP STATION					
Equipment	BOOSTER PUMP UNIT 2					
Designation						
Abbreviation	BP#2					
Serial No						
Model						
Periodicity (d)	Normal 60	Alarm 15				
Previous Advice	Condition	Rotation Speed				
Date 15/02/2019 14:59:51	FAIR	Health is not acceptable for a long time service.		Speed 50 Hz / 1750 rpm Author u1 System Serial FALCON - 11407 Sensor connector		
Condition DfCnd						
Diagnosis & Recommendation	Parameters sheet					
Diagnosis						
Motor NDE Bearing Inner Race Fault						
Fair state for component 'Electric motor'.						
Motor NDE Bearing Inner Race Fault - Stage 2 out of 4						
Recommendations						
Continue monitor and trend Motor NDE Brdg						
Continue monitor and trend Motor NDE Brdg.

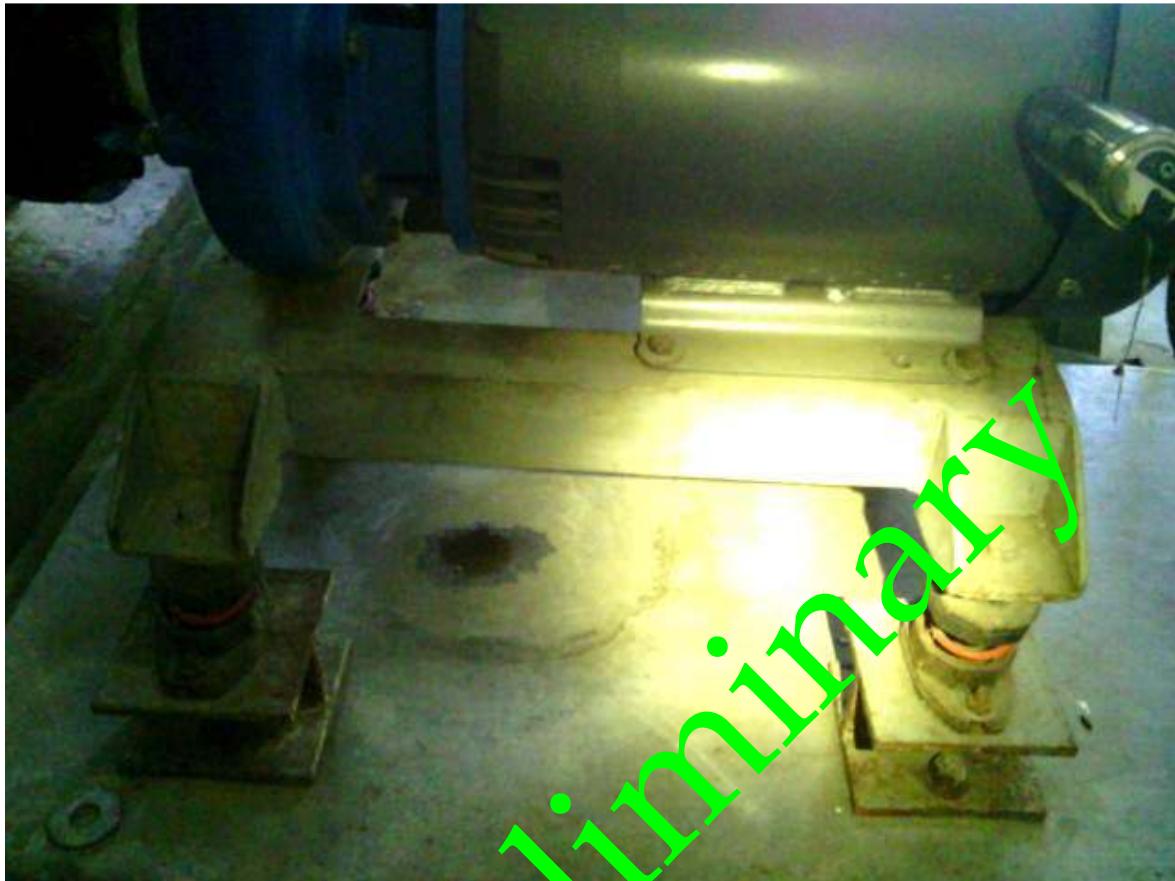
corrosion

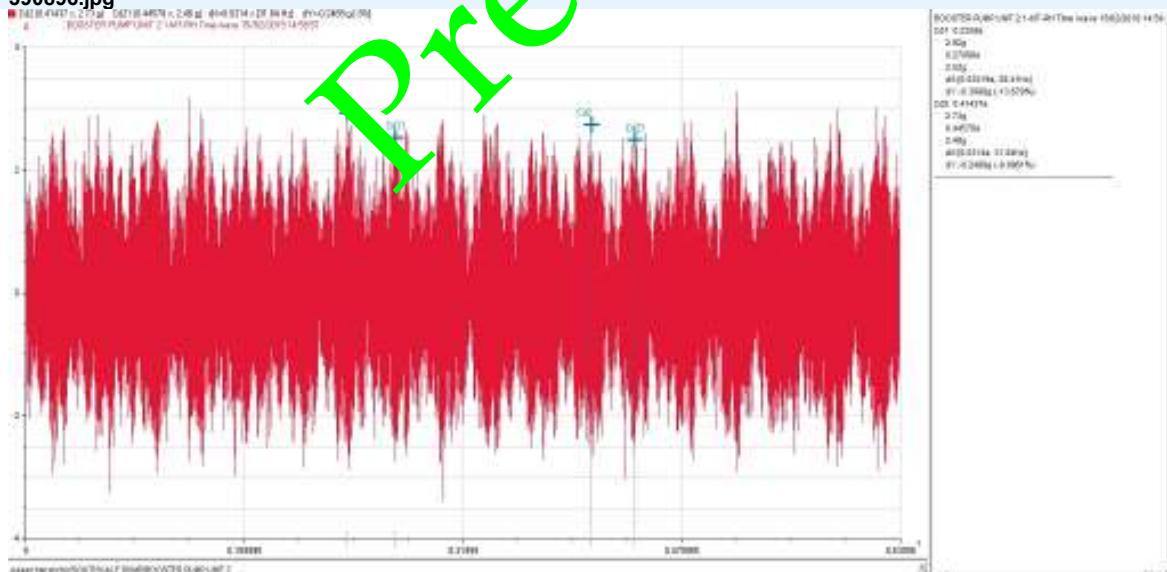
Motor NDE Bearing noise with Ringing rate at shaft rate

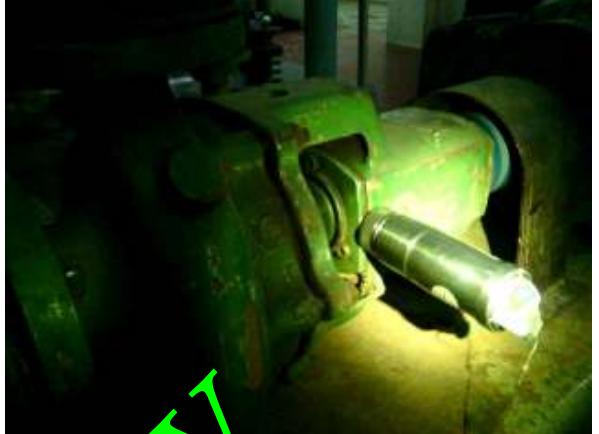
Location	SOUTHVALE PUMP\		Fixed speed

Designation	SOUTHVALE PUMP STATION					
Equipment	BOOSTER PUMP UNIT 4					
Designation						
Abbreviation	BP#4					
Serial No						
Model						
Periodicity (d)	Normal 60	Alarm 15				
Previous Advice	Condition	Rotation Speed				
Date 15/02/2019 15:18:55	CRITICAL	<i>Measurement observed shows that vibration levels could generate damages!</i>	Speed 2 Hz / 3545 rpm Author u1 System Serial FALCON - 11407 Sensor Connector			
Condition DfCnd						
Diagnosis & Recommendation	Parameters sheet					
Diagnosis						
<i>Rotating Looseness and Misalignment</i> Overall state still acceptable for the component 'Electric motor'. Overall state NOT acceptable for the component 'Pump'. Highest vibration measured at Pump IB Bearing Vertical with Overall Velocity of 6.07mm/s, with Defect Factor of 5.18 due to 1x Rate Repetitive Impact caused by Rotating Looseness at Pump Bearings, Rubbing and Misalignment

Recommendations						
<i>Schedule Reconditioning of Pump</i> Schedule reconditioning of Pump Bearings. Check Pump bearings fit for shaft wear or Pump housing wear. Rectify those first prior bearing replacement. Realign shaft/coupling using precision laser alignment tool upon installation of pump onsite.

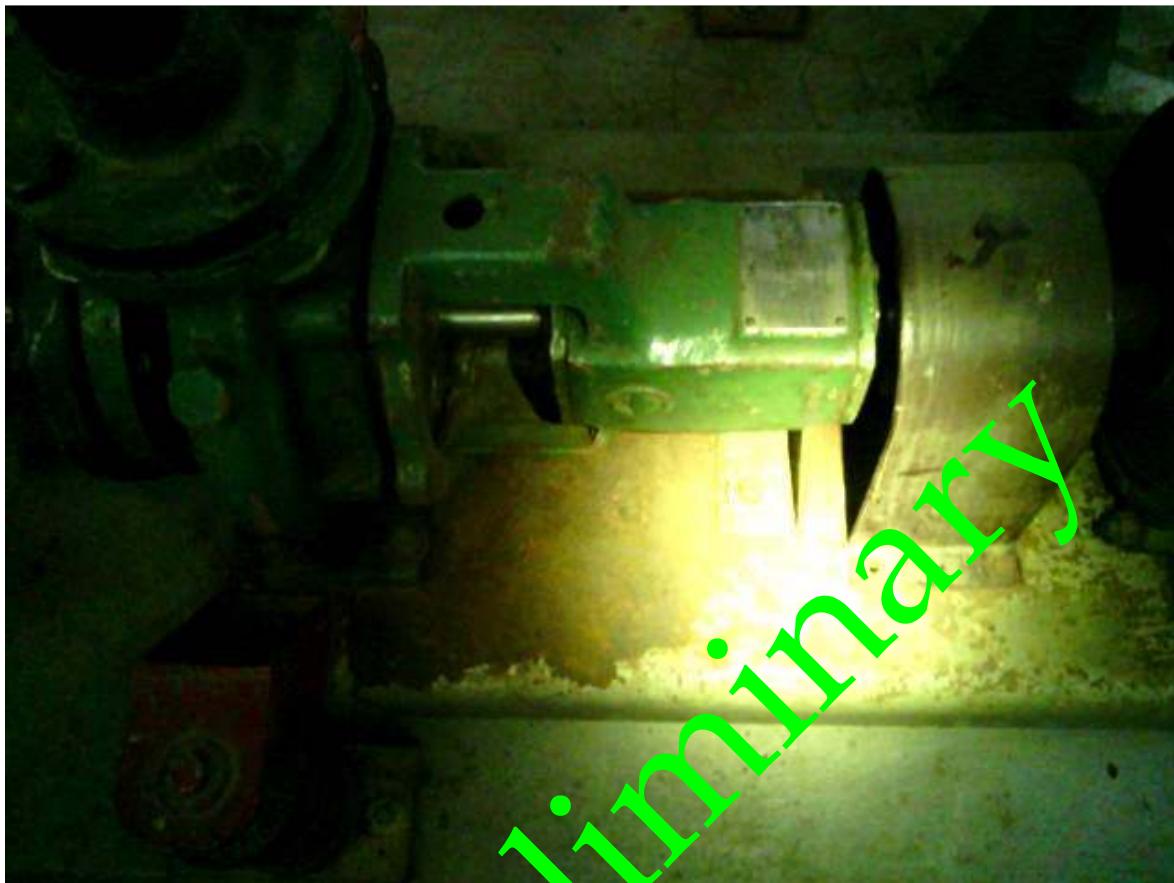
corrosion
