Consultancy Services for the Plant Audit in various Pump Stations and Reservoirs (OP18REFCS03)

Technical Report for R1P Pump Station (FDAS and Electrical Audit)
reference: OP18REFCS03-GHD-R1P-REP-G002A

Title:
Preliminary Report for R1P Pump Station

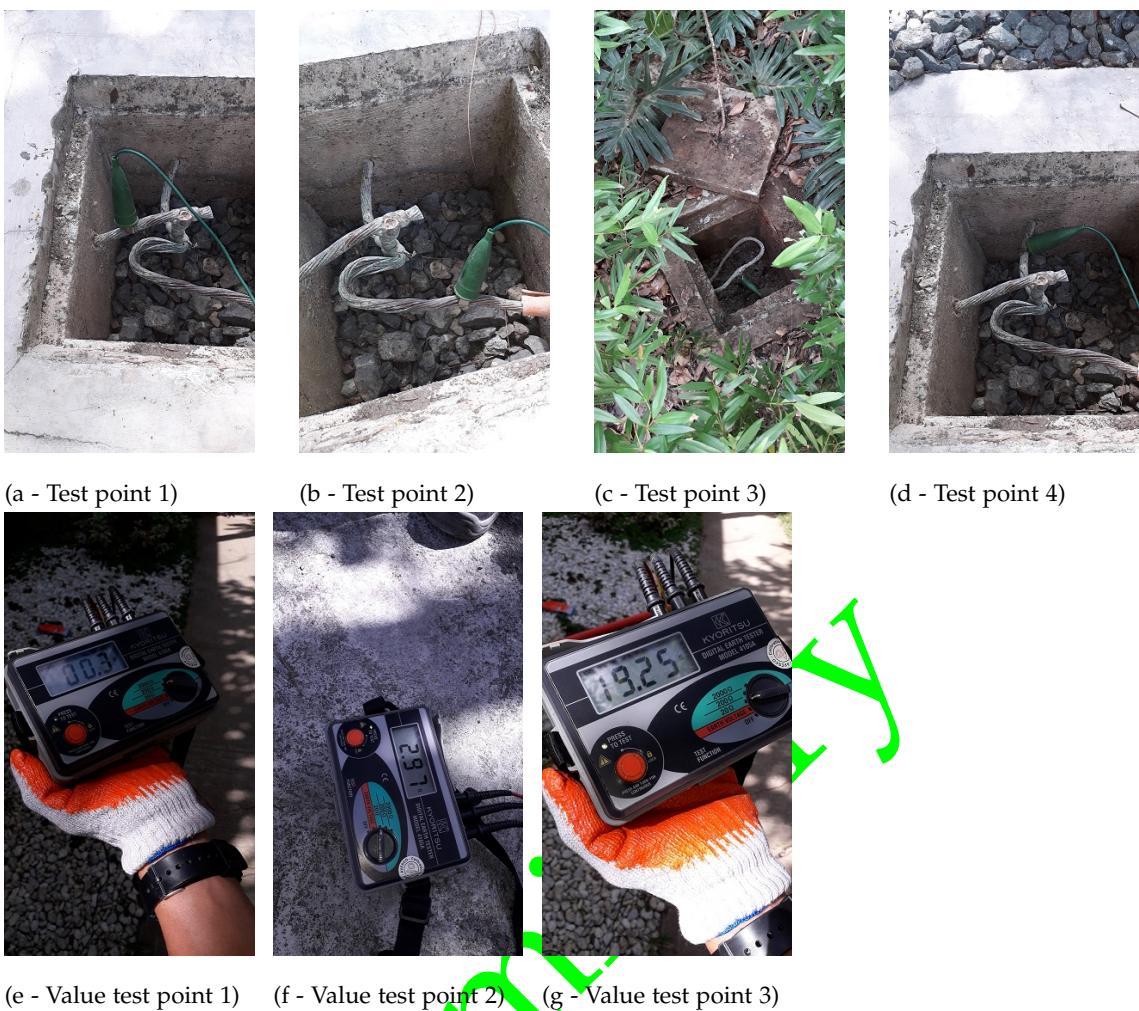
Figure 2.10: Visual inspection on electrical safety and grounding

Locations	Asset/Room	Resistance	Findings	Recommendations	Effects	Risks
LIGHTNING ARRESTER	TEST POINT 1 BARE COPPER WIRE	2.99Ω	(1) Within the 5 ohms limit as per NFPA and IEE standards; (2) However, values are already within the marginal level of acceptability	(1) Checking and retightening of loose grounding terminal connections; (2) Replacement of corroded copper wires improper lugs for grounding terminations	Overheating on conductors and possible nuisance tripping of ground fault protection or relays	Damage to equipment or accessories
LIGHTNING ARRESTER	TEST POINT 1 GROUND ROD	2.97Ω	(1) Within the 5 ohms limit as per NFPA and IEE standards; (2) However, values are already within the marginal level of acceptability	(1) Checking and retightening of loose grounding terminal connections (2) Replacement of corroded copper wires improper lugs for grounding terminations	(1) Overheating on conductors and possible nuisance tripping of ground fault protection or relays	Damage to equipment or accessories

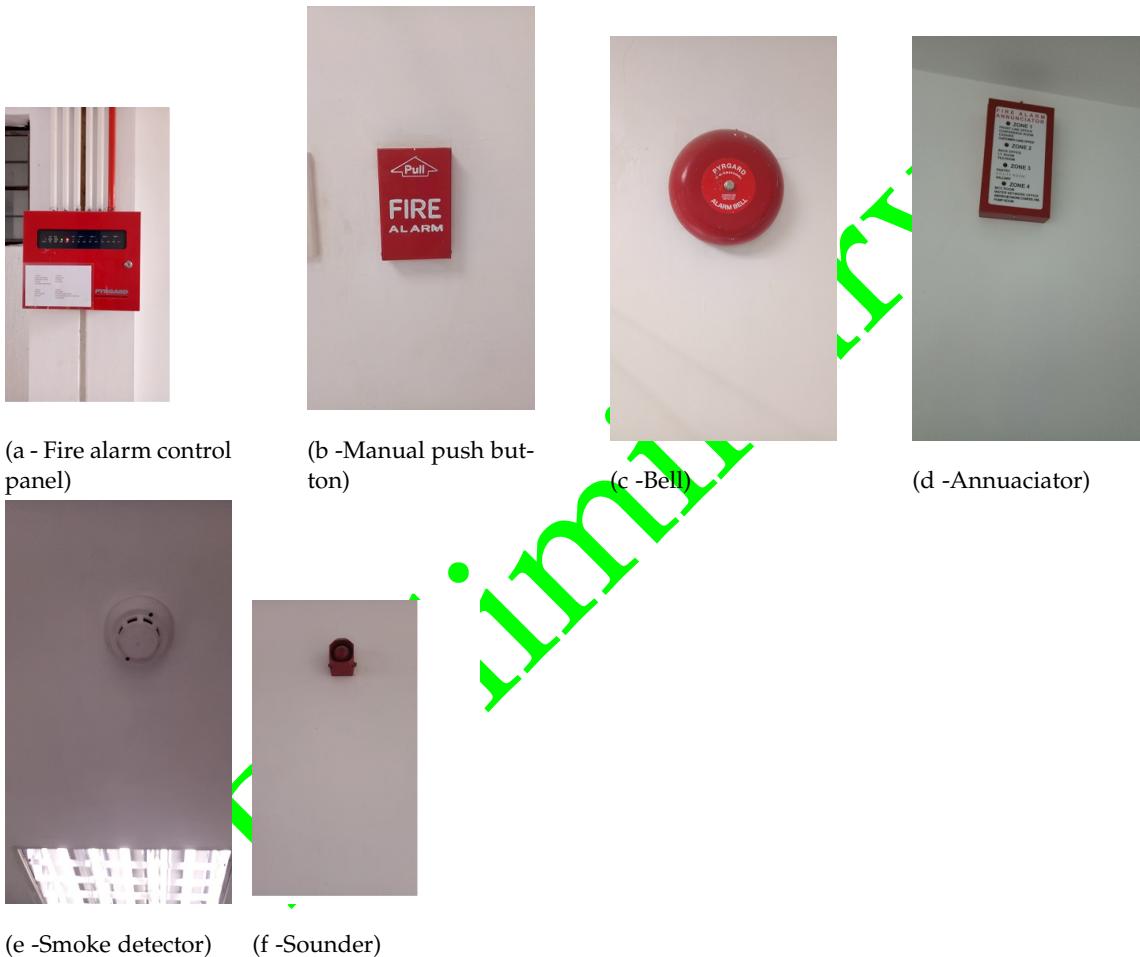
Figure 2.11: As-found devices and panels

Summary of data and information from FDAS audit is presented in Table 2.18 with visual images on as-found devices and panels (Figure 2.11 and Figure 2.12).

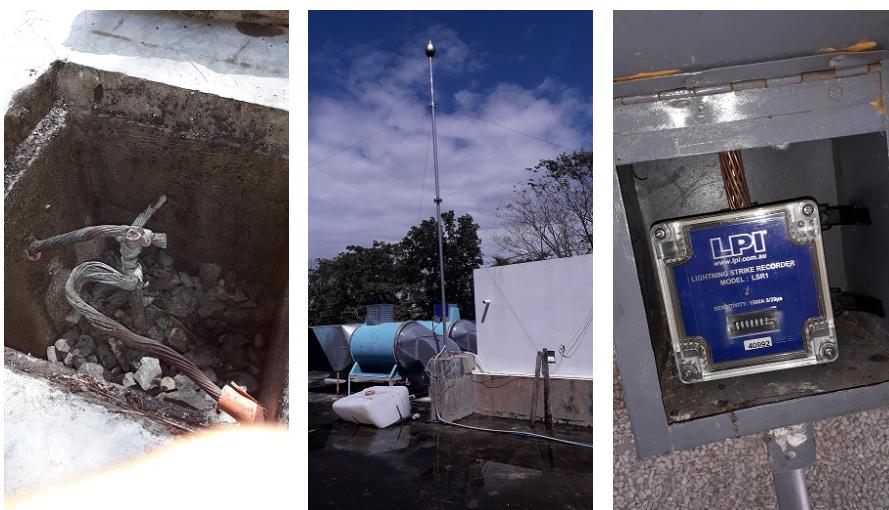
Figure 2.13: Lightning devicesLong term Recommendations

(a - Bare copper wire)

(b -Lighting arrester rod)

It is advisable to continue monitoring the lighting system with future tests possible to detect the statistical trend that the system will fail to provide adequate level of services.

- ✓ According to the standard, an inspection should be undertaken during the construction of the structure, after the installation, after alterations or repairs, and when it is known that the structure has been struck by lightning;

- ✓ It is also recommended that inspections take place “periodically at such intervals as determined with regard to the nature of the structure to be protected”, taking into account the local environment, such as corrosive soils and corrosive atmospheric conditions and the type of protection measures employed;

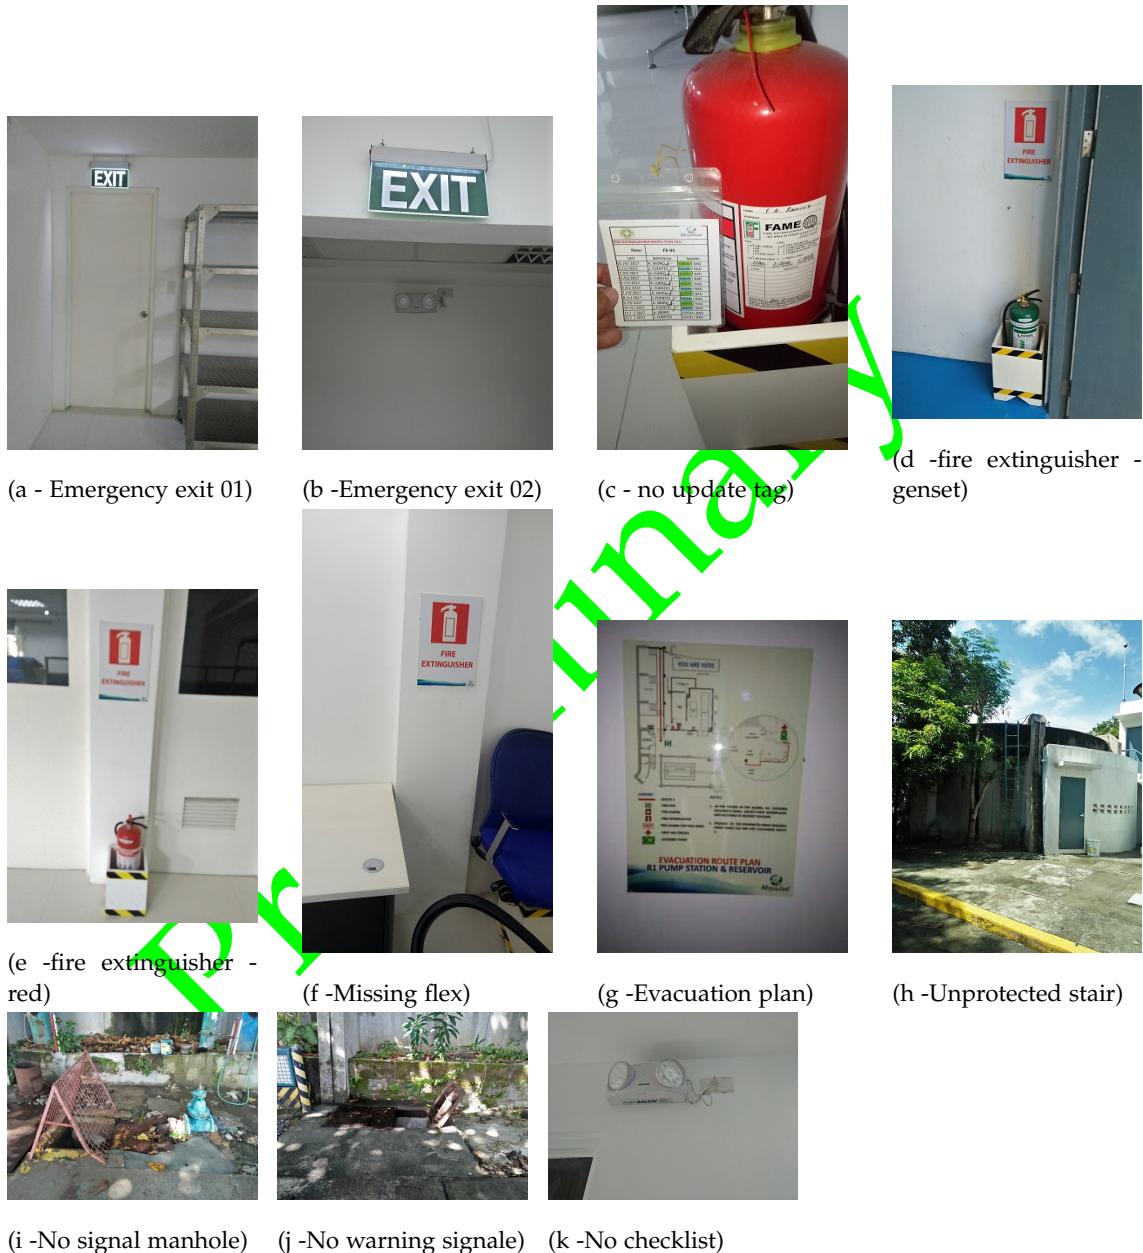
Figure 2.14: Safety

The pump station in general is well maintained and the area station where the operator stays is free from all obstructions. There were some marginal findings of safety issues but otherwise the station is well managed. The station has observed good housekeeping and cleanliness of the pump station.

(i -No signal manhole) (j -No warning signale) (k -No checklist)
