Consultancy Services for the Plant Audit in various Pump Stations and Reservoirs (OP18REFCS03)

Technical Report for R1P Pump Station (FDAS and Electrical Audit)
reference: OP18REFCS03-GHD-R1P-REP-G002A

Title:
Preliminary Report for R1P Pump Station

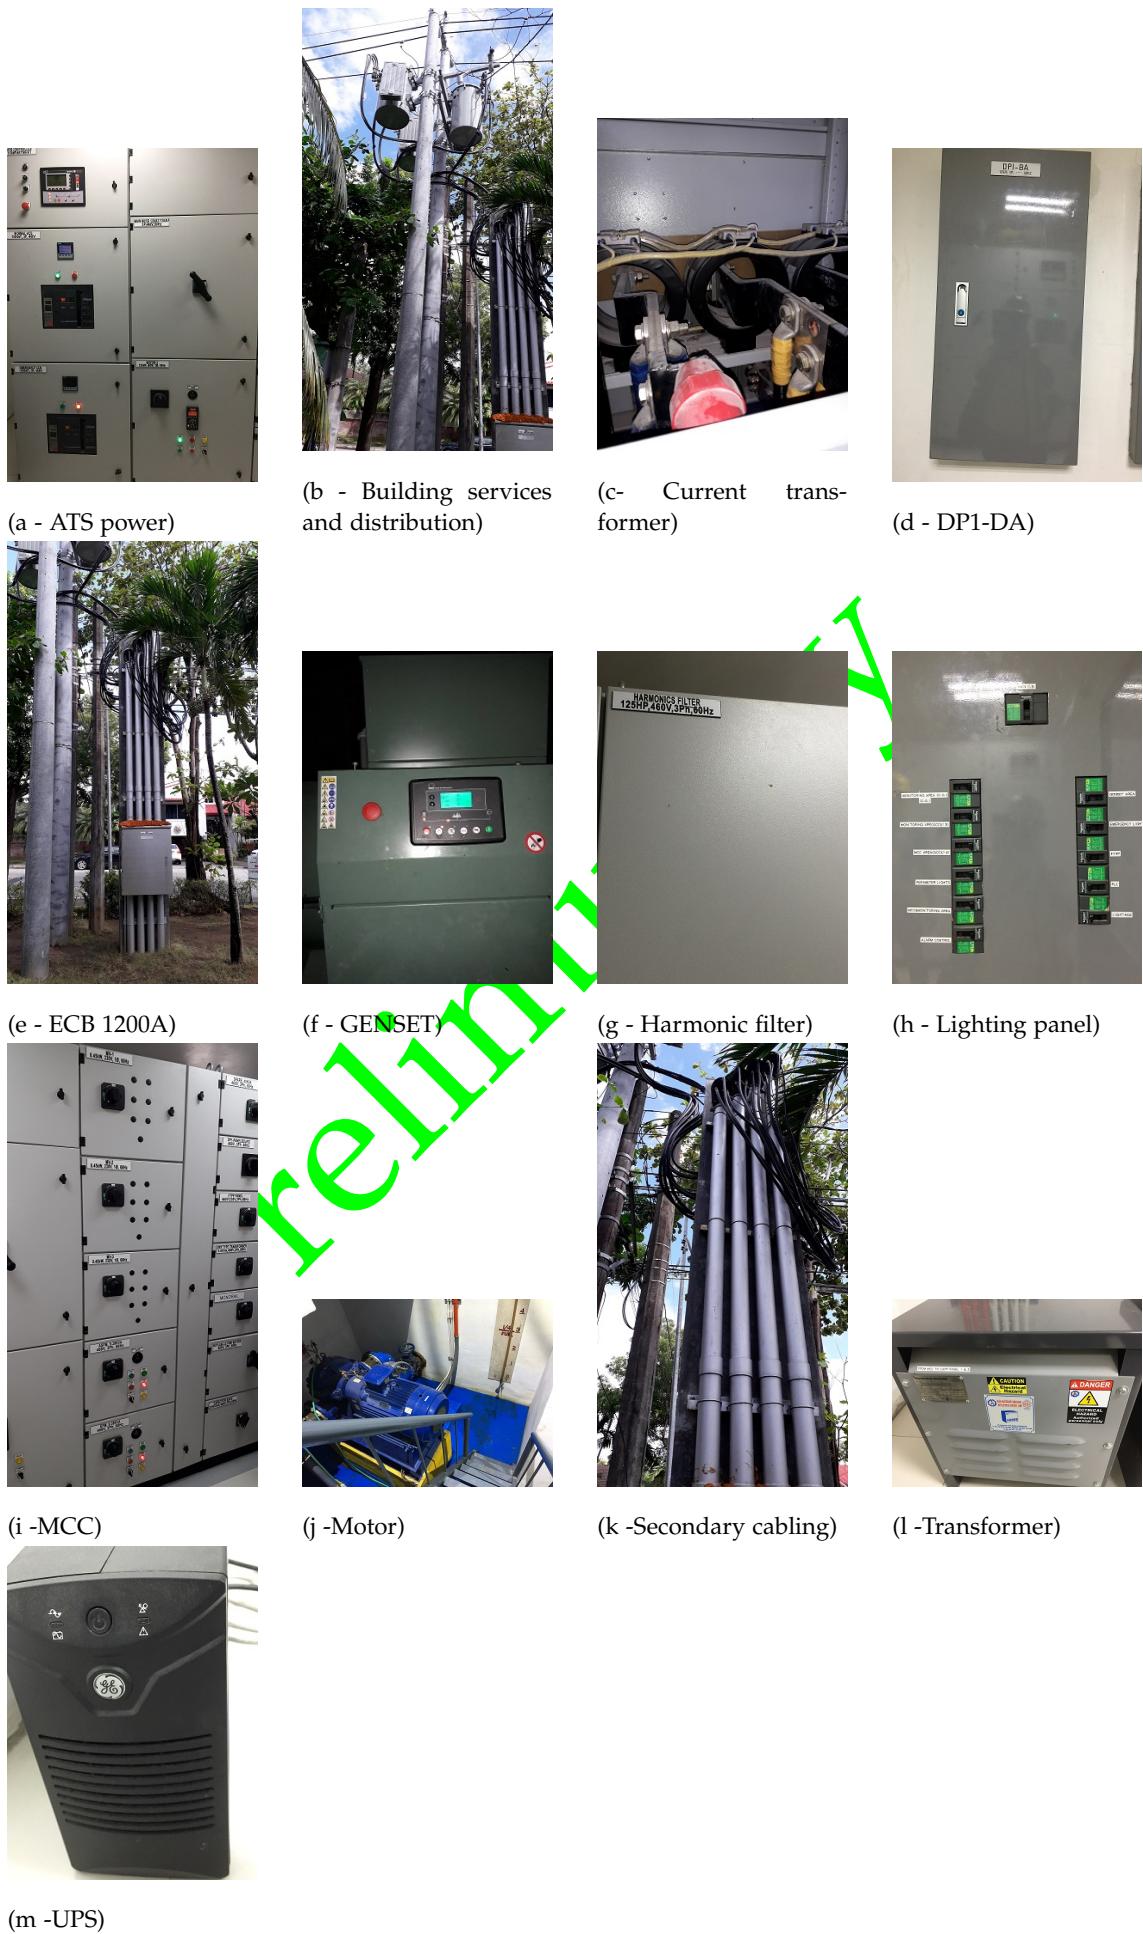
Figure 2.1: Existing electrical assets

Item	Description	Model	Brand	Status	Remarks
Item	Description	Model	Brand	Status	Remarks
1	Main Switch/Switchboard	MDP 460V/MDP230V	Local Fabrication	1	Functioning
2	Distribution Transformer	5kVA, 460V/230	Mega Masterlink	1	Functioning
3	Distribution Transformer	15kVA, 460V/230	Mega Masterlink	1	Functioning
4	Distribution Transformer	50kVA, 460V/230	Mega Masterlink	1	Functioning
5	Maynilad Owned Load Break Switch (LBS)	n/a	N/a	0	Low voltage installation
6	Power Cables (secondary side of DT to the Elect. Loads)	THHN cables		1	
7	Motor Control Center	230V and 460V MCC	Local Assembly	1	Complete with nameplates
8	Capacitor Bank	225 kVAR	Local Assembly	1	Functioning
9	TVSS	n/a	N/a	0	Not found
10	Power Meter	Digital	Siemens Sentron	1	Functioning
11	Filters and Reactors	125HP 460V 3ph	Danfoss	1	Functioning
12	Instrument Transformers	Current and Voltage		1	wiring acceptable
13	Electrical Protective Relays	n/a	n/a	0	Not found

14	Motor and Switches	Induction Motor	Teral	1	Functioning
15	Transfer Switch	Automatic	Gensys Controller	1	Functioning
16	Uninterruptible Power System (UPS)	Verify capacity	GE	1	Functioning
17	Distrbutioin Panelboards and assoc. appurtenances	DP and LPB	locally fabricated	1	Breakers are Schneider brand
18	Ground-Fault Circuit Interrupter (GFCI) or ELCB or (RCD)	n/a	n/a	0	Not found
19	Lighting and Lighting Control System	Verify wattage	Fixture w/ Diffuser	1	Functioning fixtures
20	Emergency Generator	Standby Genset	Cumper	1	Well maintained
21	Building Service and Distribution	utility owned	3 x 250kVA	1	Y-Y connection

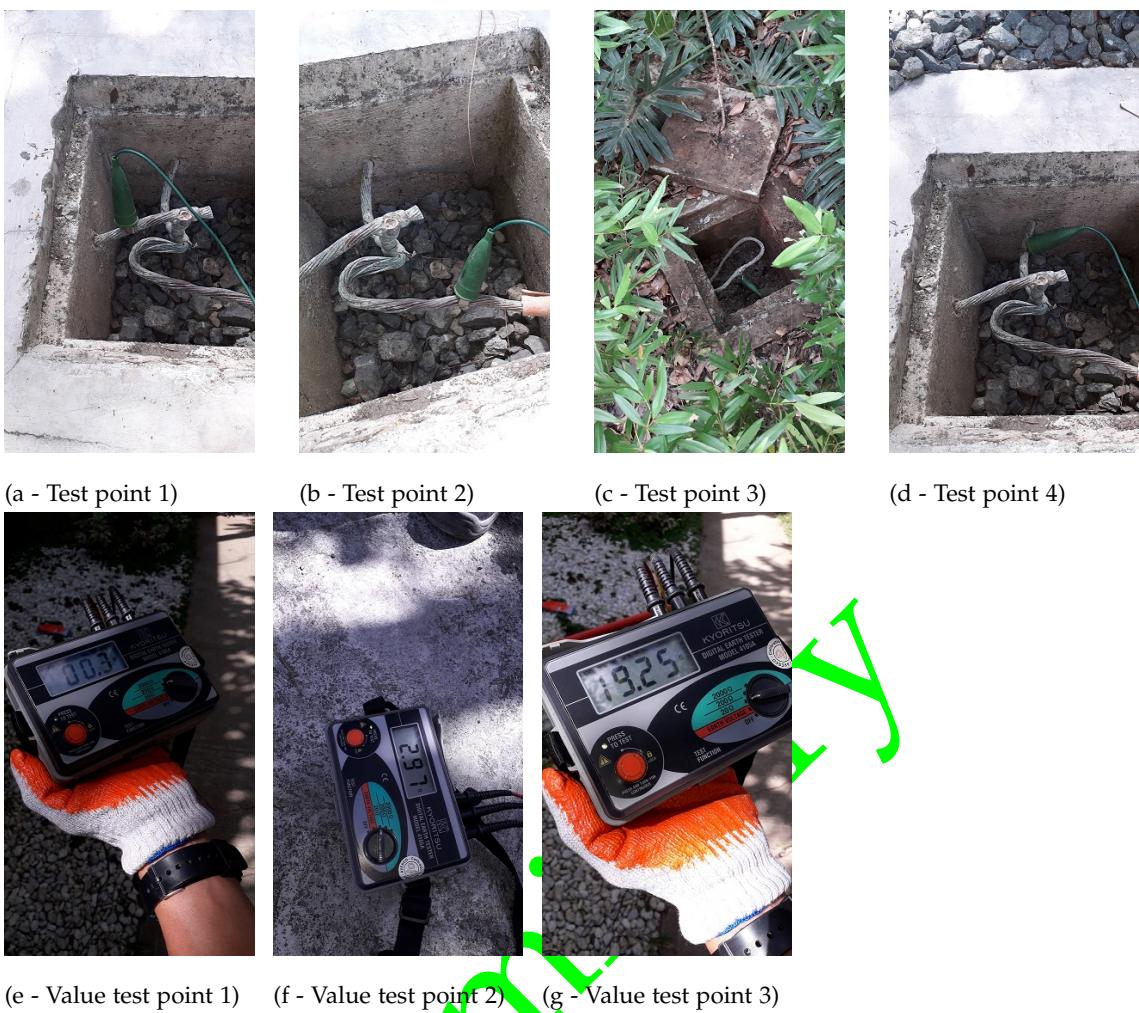
Figure 2.13: Visual inspection on electrical safety and grounding

Locations	Asset/Room	Resistance	Findings	Recommendations	Effects	Risks
LIGHTNING ARRESTER	TEST POINT 1 BARE COPPER WIRE	2.99Ω	(1) Within the 5 ohms limit as per NFPA and IEE standards; (2) However, values are already within the marginal level of acceptability	(1) Checking and retightening of loose grounding terminal connections; (2) Replacement of corroded copper wires improper lugs for grounding terminations	Overheating on conductors and possible nuisance tripping of ground fault protection or relays	Damage to equipment or accessories
LIGHTNING ARRESTER	TEST POINT 1 GROUND ROD	2.97Ω	(1) Within the 5 ohms limit as per NFPA and IEE standards; (2) However, values are already within the marginal level of acceptability	(1) Checking and retightening of loose grounding terminal connections (2) Replacement of corroded copper wires improper lugs for grounding terminations	(1) Overheating on conductors and possible nuisance tripping of ground fault protection or relays (2) Replacement of corroded copper wires improper lugs for grounding terminations	Damage to equipment or accessories

- the current unbalance occurred in the absence of voltage unbalance, hence it is recommended to look for the cause of current unbalance which could be faulty insulation or a phase shorted to ground. Correcting the current unbalance helps prevent overheating and deterioration of motor-winding insulation and other equipment. Thermal scanning of motor is recommended;

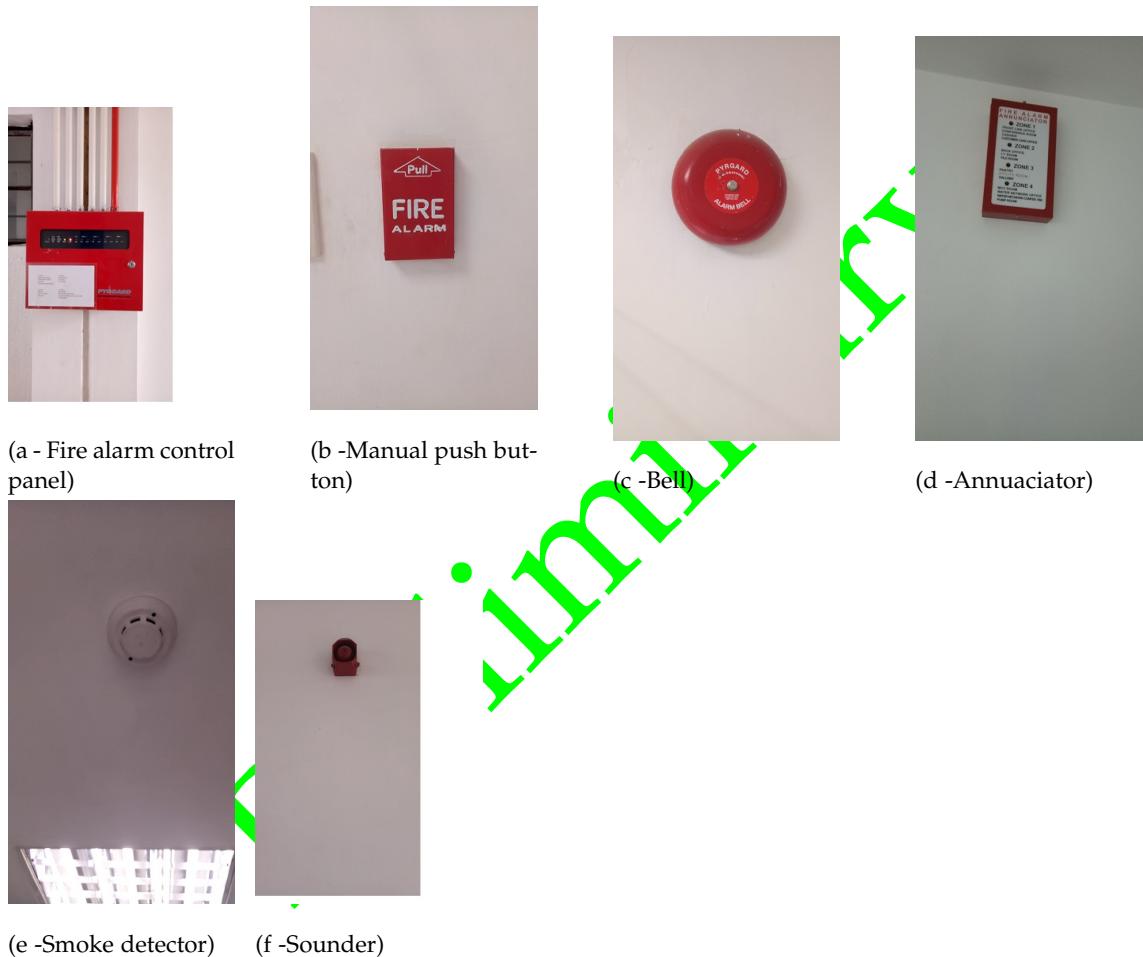
Figure 2.16: As-found devices and panels

Summary of data and information from FDAS audit is presented in Table 2.25 with visual images on as-found devices and panels (Figure 2.16 and Figure 2.17).

No ground fault circuit interrupter (GFCI) or earth leakage Circuit breaker (ELCB) protection was installed in the panel for FDAS for this PS.

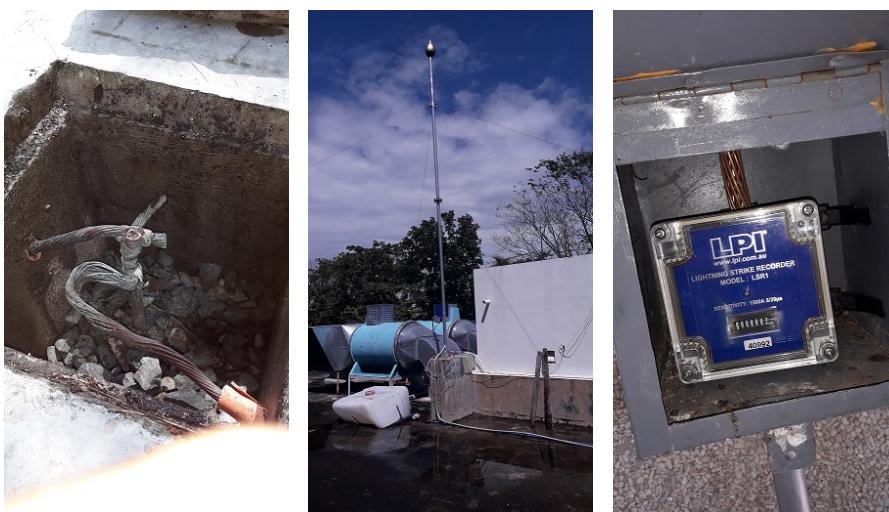
Figure 2.18: Lightning devicesLong term Recommendations

(a - Bare copper wire) (b -Lighting arrester rod) (c -Strike counter)

It is advisable to continue monitoring the lighting system with future tests possible to detect the statistical trend that the system will fail to provide adequate level of services.

- ✓ According to the standard, an inspection should be undertaken during the construction of the structure, after the installation, after alterations or repairs, and when it is known that the structure has been struck by lightning;

- ✓ It is also recommended that inspections take place “periodically at such intervals as determined with regard to the nature of the structure to be protected”, taking into account the local environment, such as corrosive soils and corrosive atmospheric conditions and the type of protection measures employed;

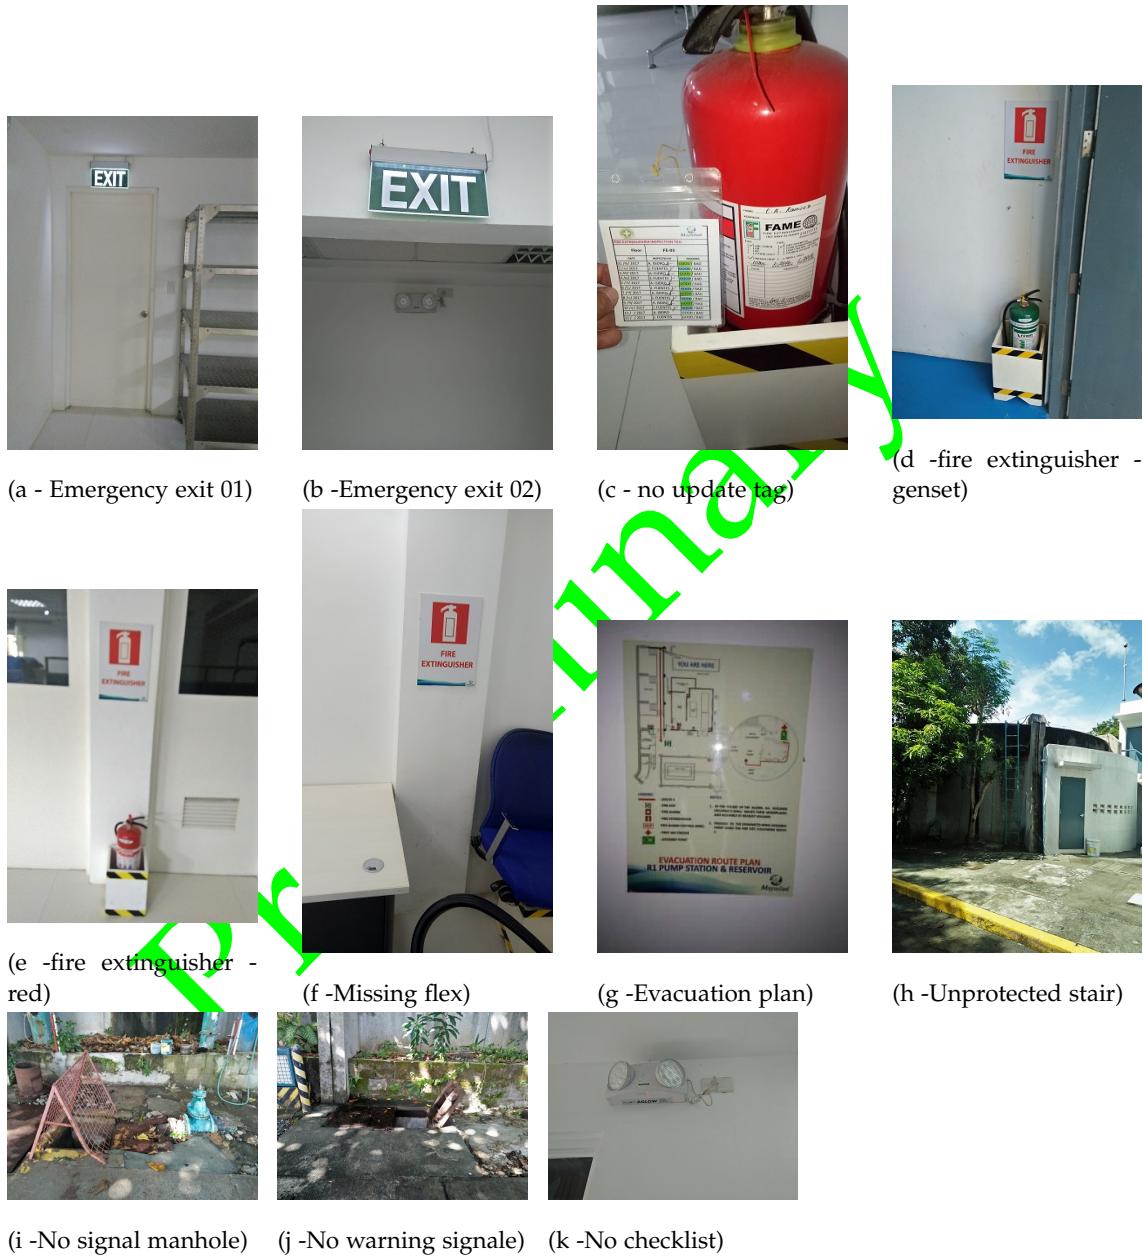
Figure 2.19: Safety

Items	Visual inspection on	Status	Remarks
1	Evacuation Plan	1	Posted
2	Fire Extinguishers	1	Green FEX(HCFC) and Red FEX dry chemical
3	Fire Exits	1	All doors have exit signages
4	Fire Hose Cabinet	0	Not found
5	Fire Sprinkler System	0	No sprinkler system
6	Emergency Exit Signages	1	Found in every door
7	Emergency Lights	1	Emergency lights are functioning (Aglow) Mosy has no inspection tag
8	Ppe Cabinet	0	Not found

(i -No signal manhole) (j -No warning signale) (k -No checklist)
