# **Consultancy Services for the Plant Audit in various Pump Stations and Reservoirs (OP18REFCS03)**

Technical Report for R1P Pump Station  
reference: OP18REFCS03-GHD-R1P-REP-G001A

**Title:**  
Preliminary Report for R1P Pump Station

**Theme:**  
Plant Audit and Asset Management

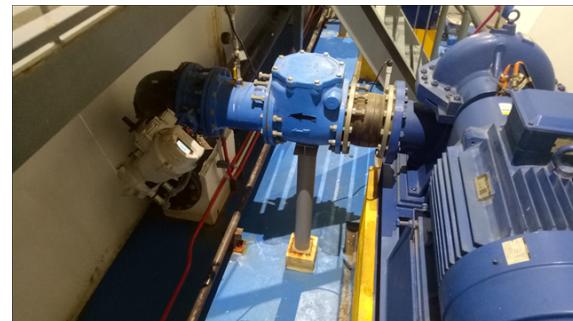
**Figure 4.5:** Pump discharge

The distance of the main discharge header and the pump discharge flange was small and so the design opted for higher pump centerline elevation to allow space for the placement of check valve. As a consequence of increasing the pump centerline elevation, existing pipe connecting the reservoir and the old pump had to reach the new pump centerline and so a series of two elbows was used. (Figure 4.5)

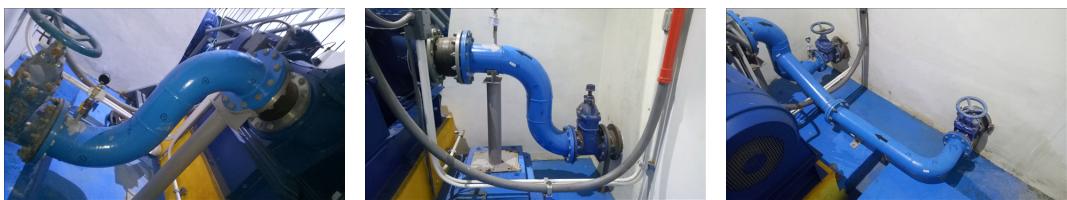
**Figure 4.6:** suction pipe design

The water leaves the reservoir and passes thru two successive elbows finally a rubber bellow-type flexible coupling before it enters the pump intake. High turbulence of entering water is expected. Further inconsistency in flow profile may be expected and vacuum spots may occur within the suction piping. (Figures 4.6 - a, 4.6 - b, 4.6 - c)

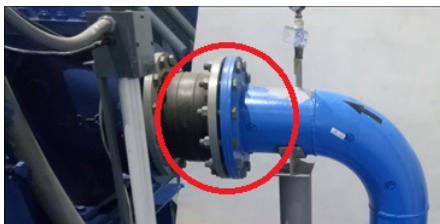
**Figure 4.7:** Abrupt connection

The abrupt connection between the short 200 mm short pipe (just after the elbow) and the 250 mm bellow-type flexible coupling is unideal and will promote turbulence near the pump inlet and further reduce pump performance and life.(Figure 4.7)

It can be said that such a minor details in the pipe suction design will prove to be a great factor in pump performance and longevity. Pumps, and especially centrifugal pumps, work most efficiently when the fluid is delivered in a surge-free, smooth, laminar flow. Any form of turbulence reduces efficiency and increases wear and tear on the pump's bearings, seals and other components. There should be at least 5 pipe diameters' worth of straight piping connecting to the pump. Never connect an elbow, reducer, valve, or strainer within this final run of pipework. If an elbow is directly connected to the pump flange, the fluid is effectively centrifuged towards the outer curve of the elbow and not directed into the centre of the impeller. This creates stress on the pump's bearings and seals which could lead to wear and premature failure.

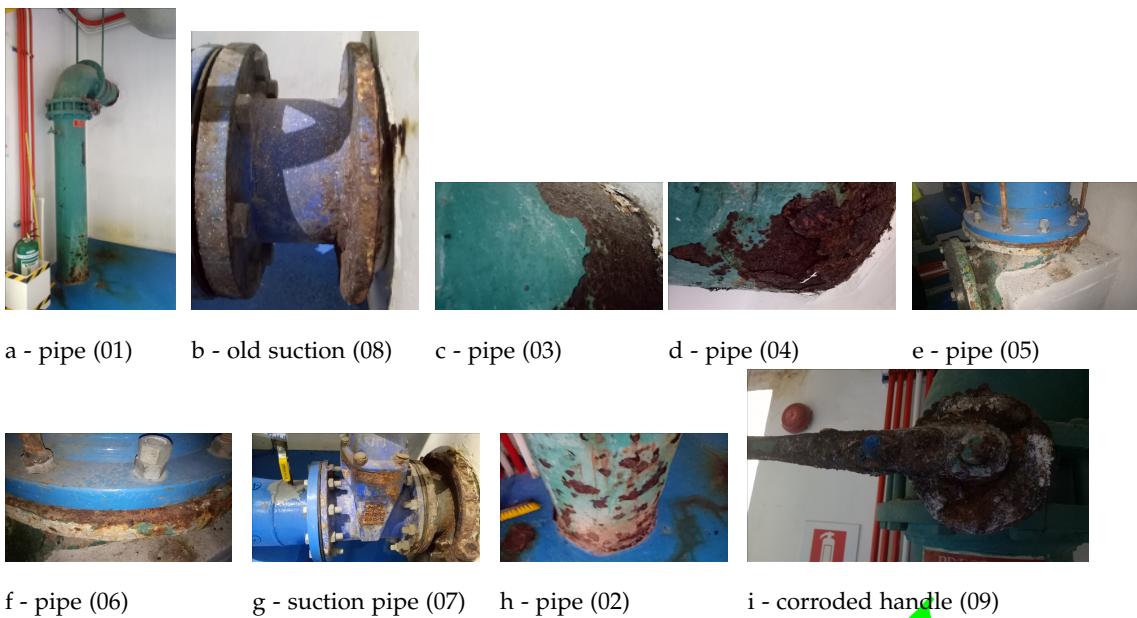
**Figure 4.8:** Examples of deterioration on pipes and connections

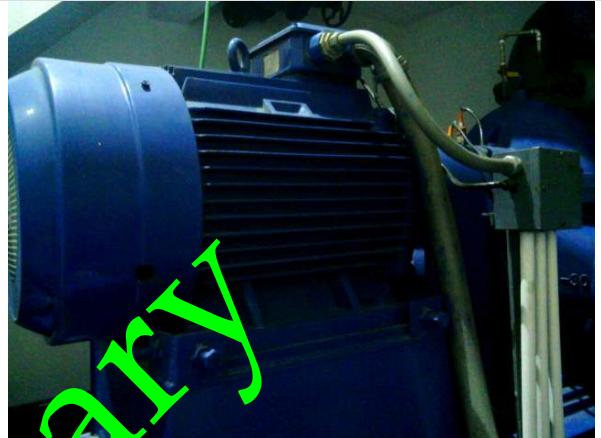
Location	AYALA ALABANG\
Designation	Ayala Alabang R1 Pump Station
Equipment	<b>BOOSTER PUMP UNIT 1</b>
Designation	
Abbreviation	BP#1
Serial No	
Model	
Periodicity (d)	Normal 60      Alarm 15

Previous Advice	Condition	Rotation Speed	
Date	GOOD			Speed 22.4 Hz / 1343 rpm
14/02/2019 11:38:36	Health is good for a long time service without restriction			Author u1
Condition	DfCnd			System - Serial FALCON - 11407
				Sensor Connector
<b>Diagnosis &amp; Recommendation</b>				
<b>Diagnosis</b>				
Vibrations are within acceptable levels				
Good overall state for component 'Electric motor'.				
Overall state still acceptable for the component 'Pump'.				
<b>Recommendations</b>				
Continue monitor vibrations periodically				
Continue monitor vibrations periodically

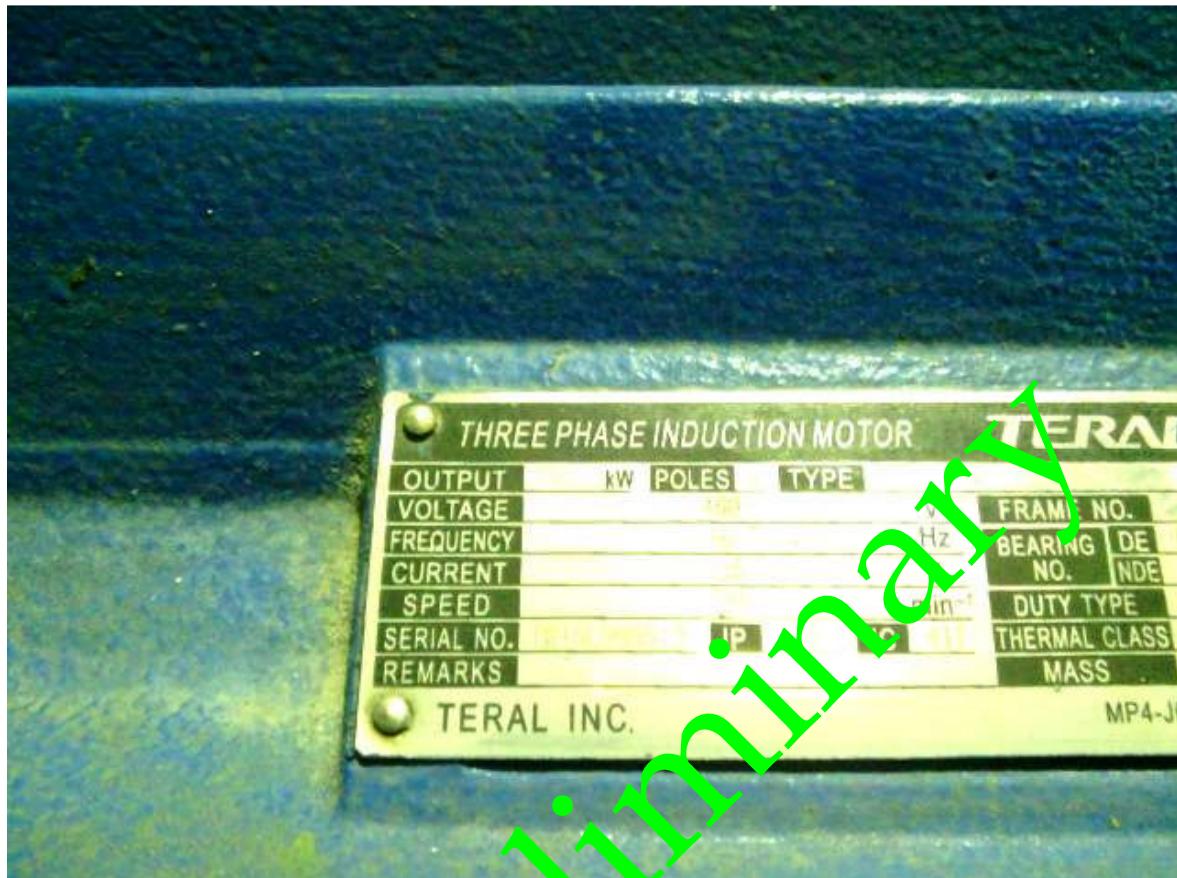
Location	AYALA ALABANG\	
Designation	Ayala Alabang R1 Pump Station	
Equipment	<b>BOOSTER PUMP UNIT 2</b>	
Designation		
Abbreviation	BP#2	
Serial No		
Model		
Periodicity (d)	Normal 60	Alarm 15
<b>Previous Advice</b>		
<b>Condition</b>		
<b>Rotation Speed</b>		
Date	GOOD	
14/02/2019 11:57:25	Health is good for a long time service without restriction.	
Condition		
DfCnd		
<b>Diagnosis &amp; Recommendation</b>		
<b>Diagnosis</b>		
Vibrations are within acceptable levels		
Good overall state for component 'Electric motor'.		
Good overall state for component 'Pump'.		
<b>Recommendations</b>		
No action required		
No action required

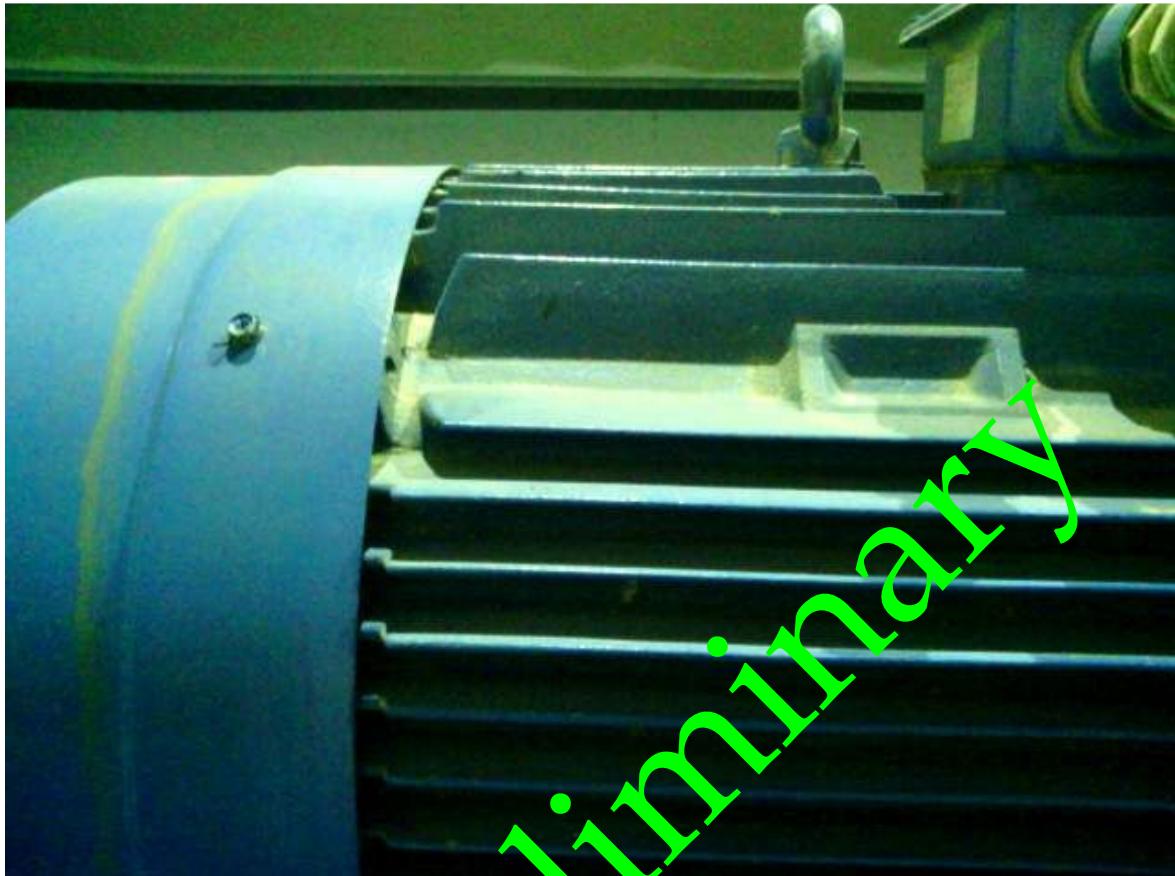
dusty
