Consultancy Services for the Plant Audit in various Pump Stations and Reservoirs (OP18REFCS03)

Technical Report for PAGCOR Pump Station
reference: OP18REFCS03-GHD-PAG-REP-G001A

Title:
Preliminary Report for Pagcor Pump Station

Theme:
Plant Audit and Asset Management

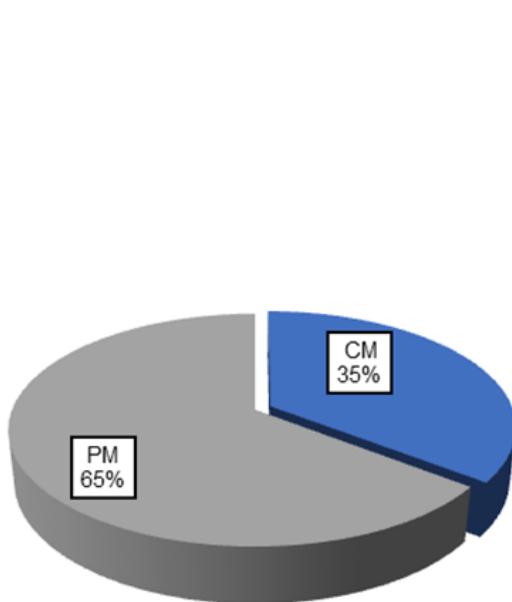
**Figure 2.2:** PI and CI – 2017

The statistics infers that there are numerous major CIs that did incurred in just one year. CI also infers that there are loss in Revenue, Reputation, and Regulatory (3Rs) that Maynilad could have been suffered. This 3Rs has not been addressed in the historical data.

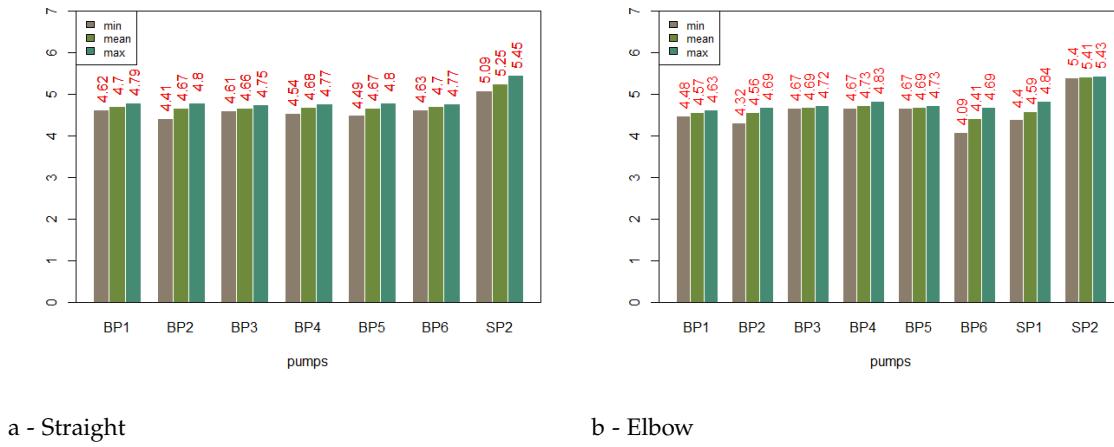
- Suction Piping System - The extrados thickness is less than the remaining thickness values measured.

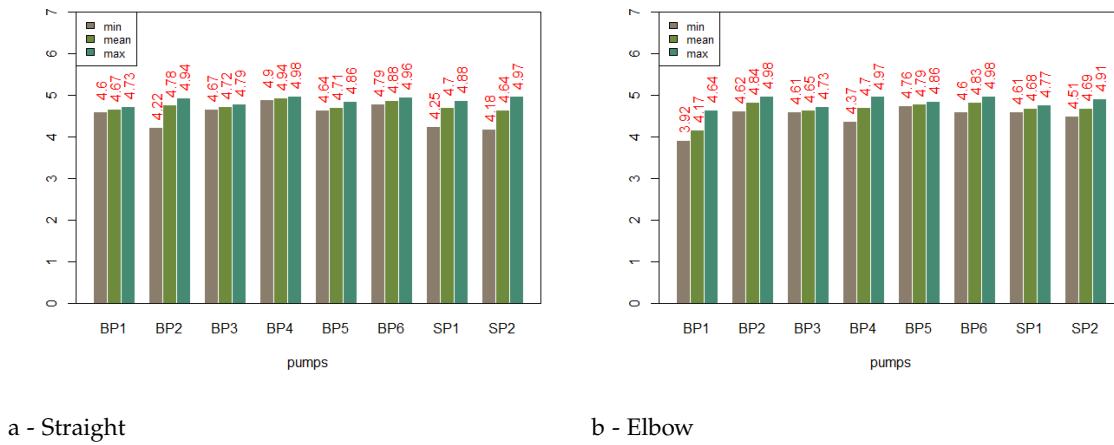
- Discharge Piping System - The average extrados thickness is 4.346 mm, with a minimum of 3.94 at the entry area to the center of the extrados. Localized thinning is observed to be higher at the upper half of the discharge line (as seen in 4m mark, 12-3-9 o'clock position). Then extends to the elbow entry up to the center of extrados. This may be caused by possible cavitation carried over from the pump to the discharge side and then amplified by the backflows in the elbow.

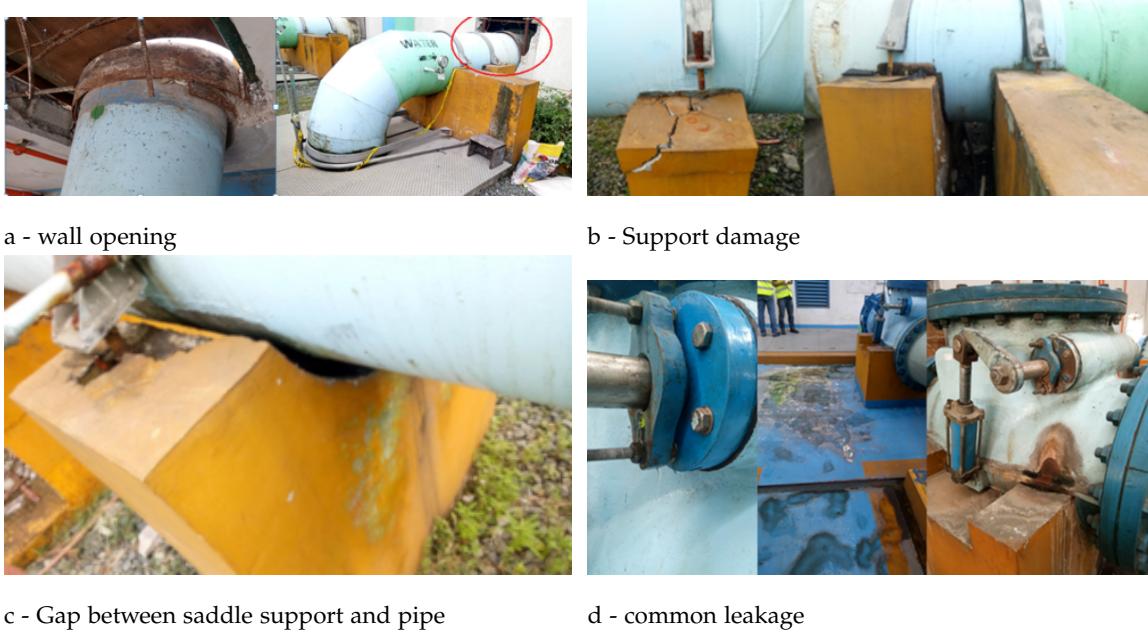
Figure 4.6: Ground settlement impacts and leakages

between the concrete saddle supports and the straight pipe beneath as shown in 4.6-c.

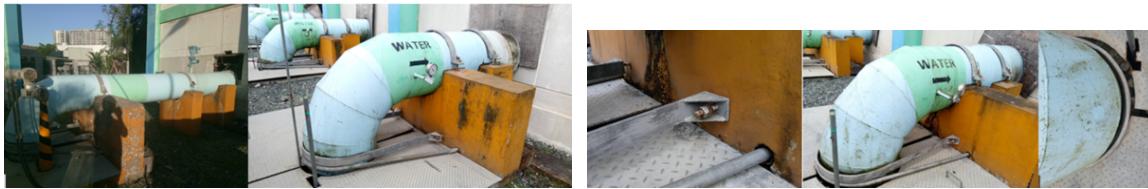
Piping movements parallel to the central axis also have been observed. As shown in Figure 4.7-b, a gap has been observed between several counter supports and the elbow. The counter supports are supposed to handle elbow thrust as immense water volumes pass thru the elbow.

a - Piping supports

b - Piping counter supports

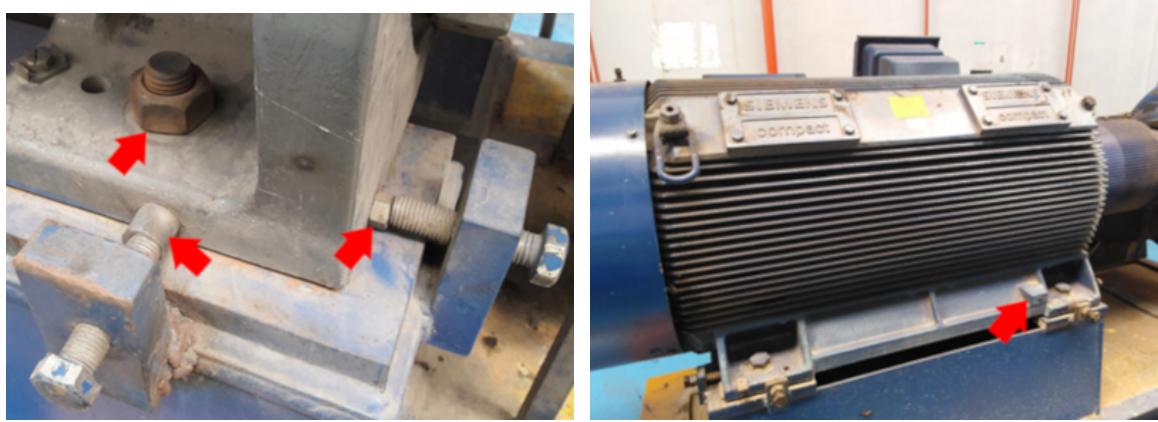
a - Motor alignment bolts

b - Motor alignment supports

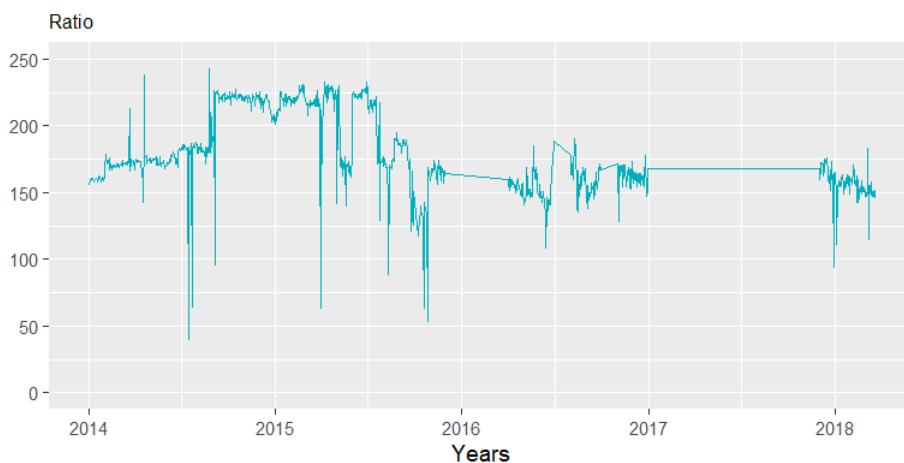
Figure 4.14: Time series ratio between production and power

Figure 4.14 shows time series of ratio between power and production. As the production decreases and power increase, the ratio keeps increasing over time.

- Efficiency of the pump system has decreased due to more frequent breakdown of pumps;
- Pumps might have been operated in a non-optimal operational scheme/sequence;

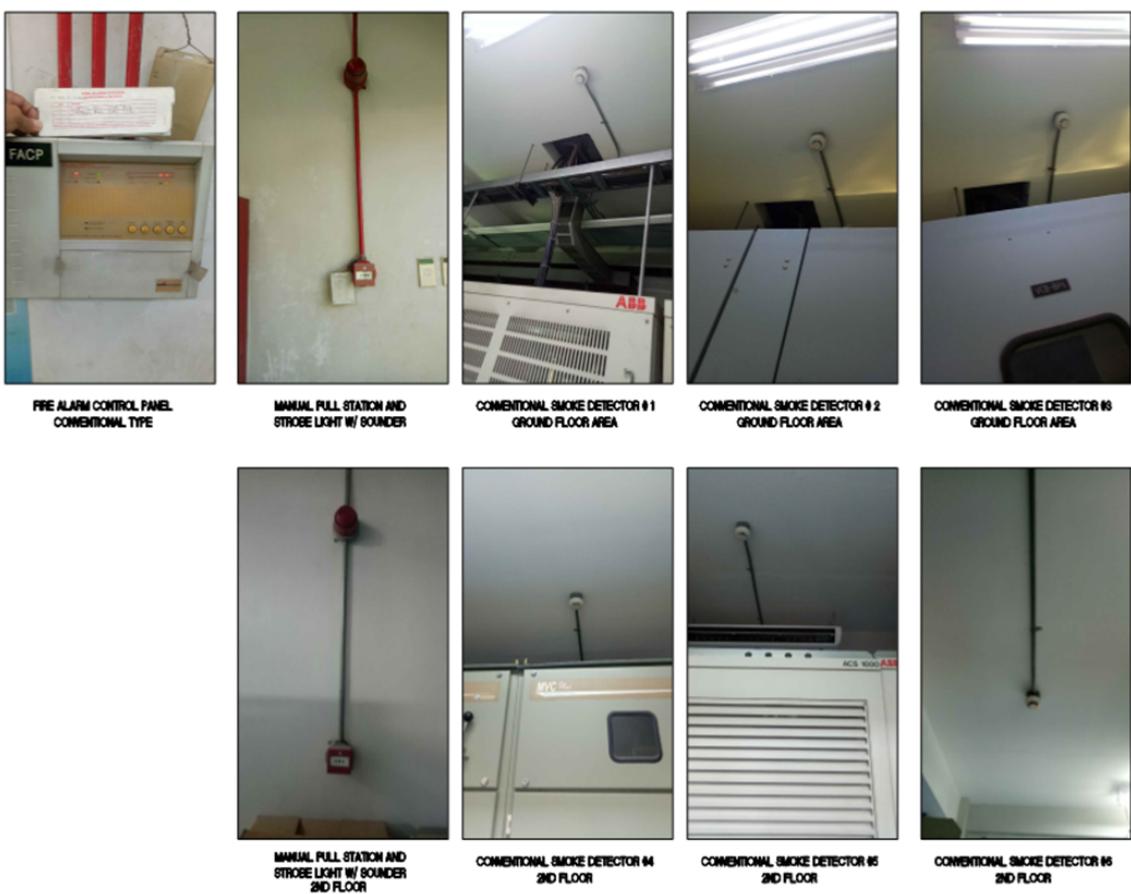
- **Fire Alarm control Panel (FACP):** System failure of FDAS and devices due to communication failure and not functioning devices installed within the system.

Figure 4.17: As-found devices and panels

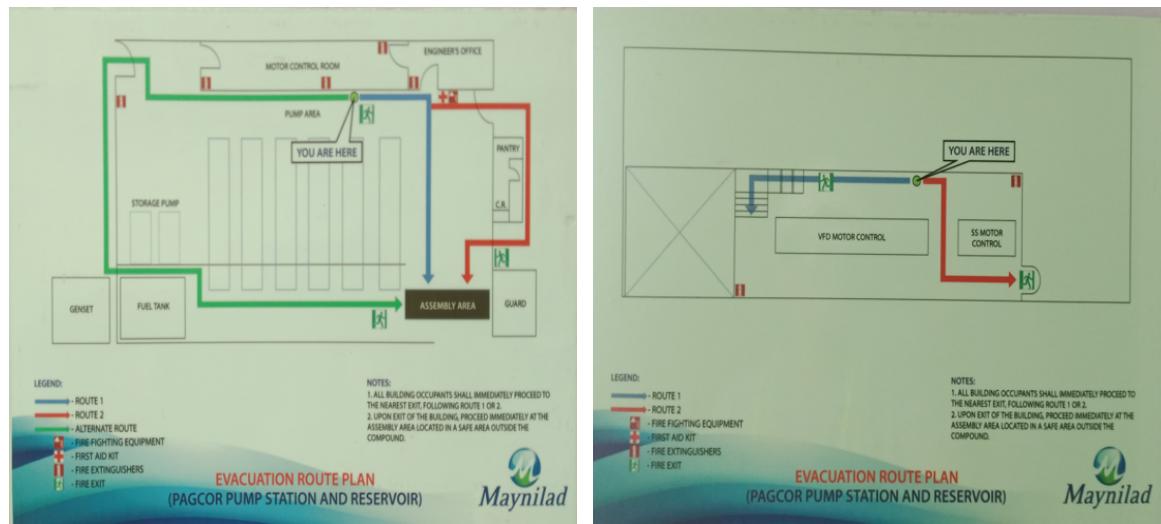
(a - 1st floor)

- Most of the smoke detector devices, manual call point, buzzer and the FACP were not functioning. These were established during the conducted testing of FDAS and devices;
- Lacking smoke / heat detector devices at substation room and genset room, engineer's office, pantry and guardhouse. In every close room there should be a device installed to

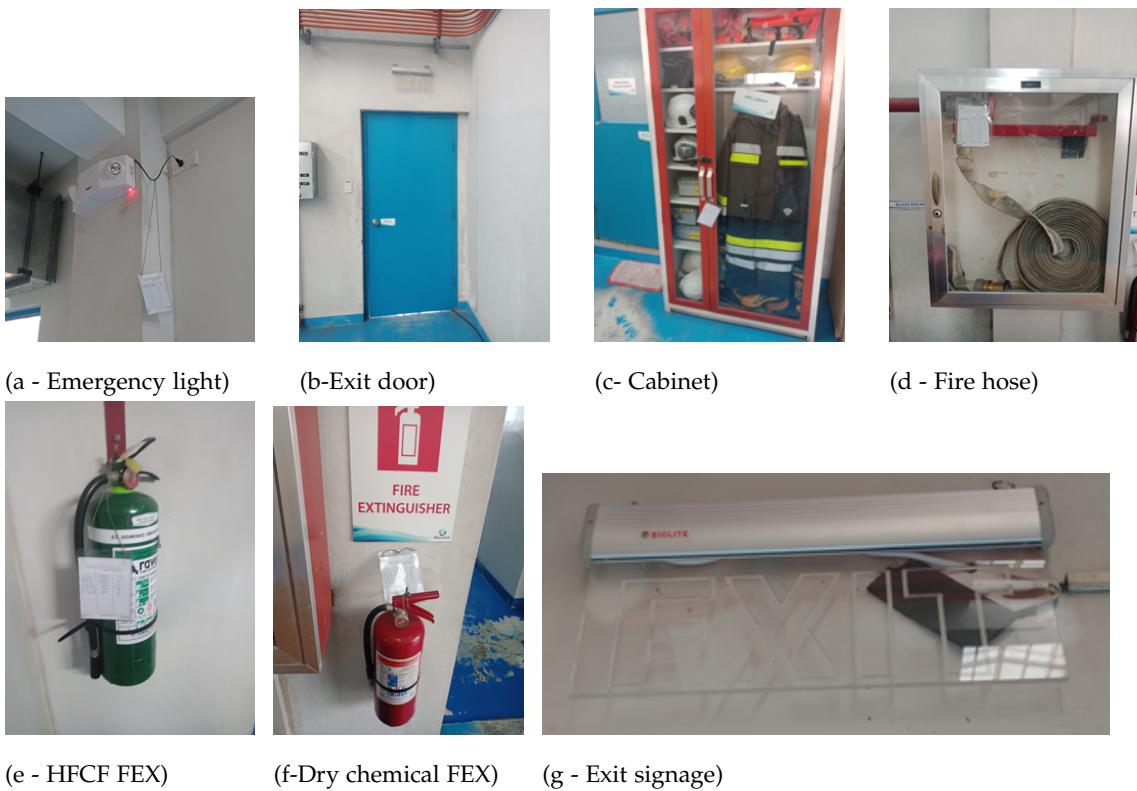
Figure 4.19: Existing safety devices

No.	Assets	CS	IT	Facts	Remarks
1	Exit light 01 (Fig. 4.19-g)	0	4	Not function No light indication	Unsafe risk to the safety of people in the event of power a power outage
2	Exit light 02 (Fig. 4.21-h)	0	4	Not function No light indication	Unsafe risk to the safety of people in the event of power a power outage
3	Exit light 03 (Fig. 4.19-b)	0	4		Unsafe risk to the safety of people in the event of power a power outage
4	Exit light 04 (Fig. 4.21-i)	0	4		Unsafe risk to the safety of people in the event of power a power outage
5	Exit light 05 (Fig. 4.21-j)	0	4		Unsafe risk to the safety of people in the event of power a power outage
6	Emergency light tag 01 (Fig. 4.19-a)	0	4	No updated Last update is 30/Aug/2018	Unsafe Failure to inspect emergency light can make it ineffective
7	Emergency light tag 02 (Fig. 4.21-a)	0	4	No tag	Unsafe Failure to inspect emergency light can make it ineffective
8	Emergency light tag 03 (Fig. 4.21-b)	0	4	No tag	Unsafe Failure to inspect emergency light can make it ineffective

Based on the status of devices, recommendations are with intervention types shown in Table 4.30. Chapter 5 further illustrates the recommendation with the conceptual design.

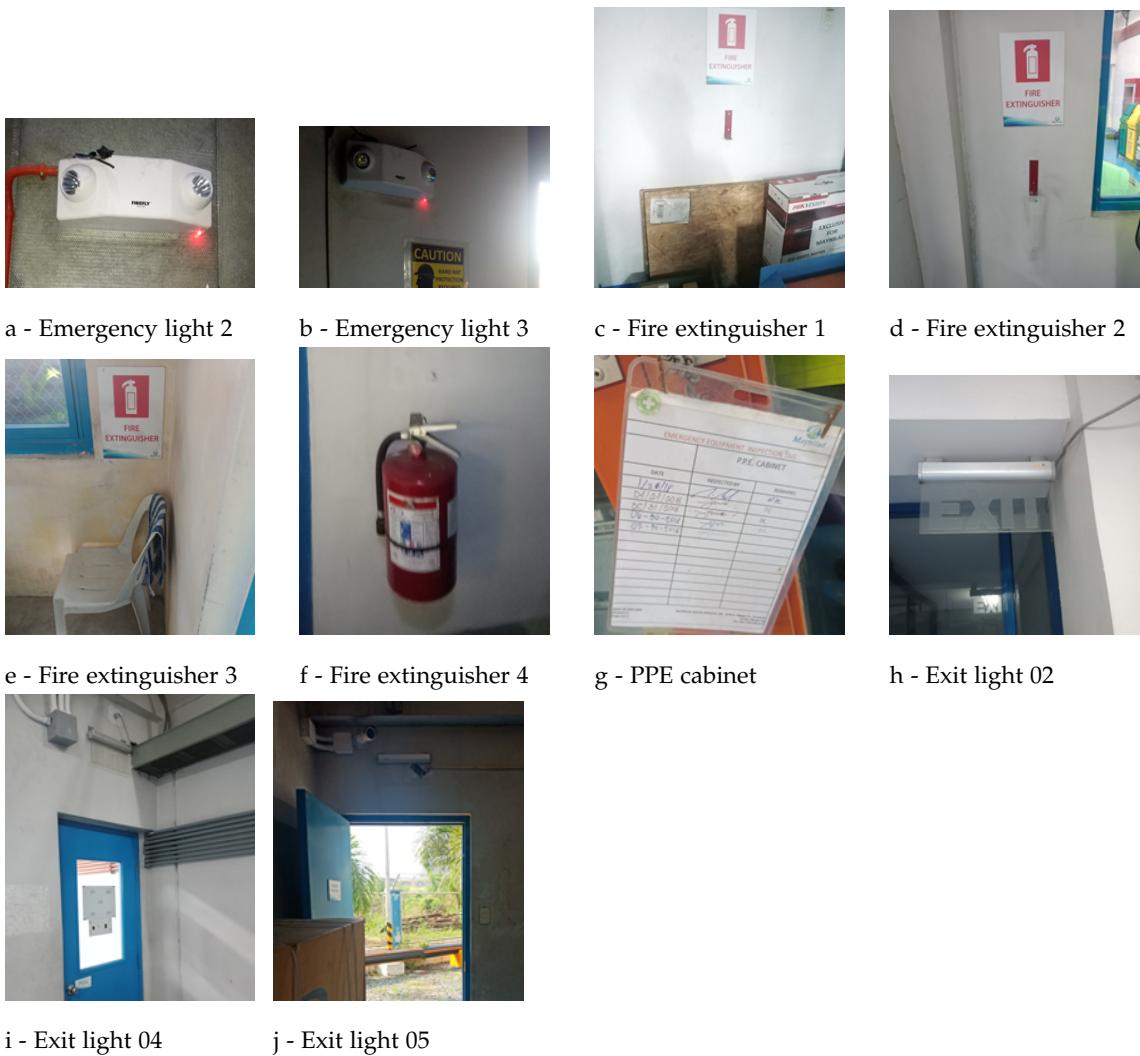
9	MCP#1 (Fig. 4.20-g)	0	4	No updated	Unsafe Failure to inspect manual call point can make it ineffective in case of fire
10	Fire extinguisher 01 (Fig. 4.21-c)	0	4	Missing	Unsafe Failure to replace or locate fire extinguisher can delay response to
11	Fire extinguisher 02 (Fig. 4.21-d)	0	4	Missing	Unsafe Failure to replace or locate fire extinguisher can delay response to
12	Fire extinguisher 03 (Fig. 4.21-e)	0	4	Missing	Unsafe Failure to replace or locate fire extinguisher can delay response to
13	Fire extinguisher 04 (Fig. 4.21-f)	0	4	No inspection tag	Unsafe Failure to inspect fire extinguisher can make it ineffective in case of fire.
14	PPE cabinet tag (Fig. 4.21-g)	0	4	Not updated Last update is 7-30-2018	Unsafe Failure to inspect PPE cabinet may not ensure completeness of content and PPE may have damage that can make these equipment ineffective

Figure 4.21: Protective devices.

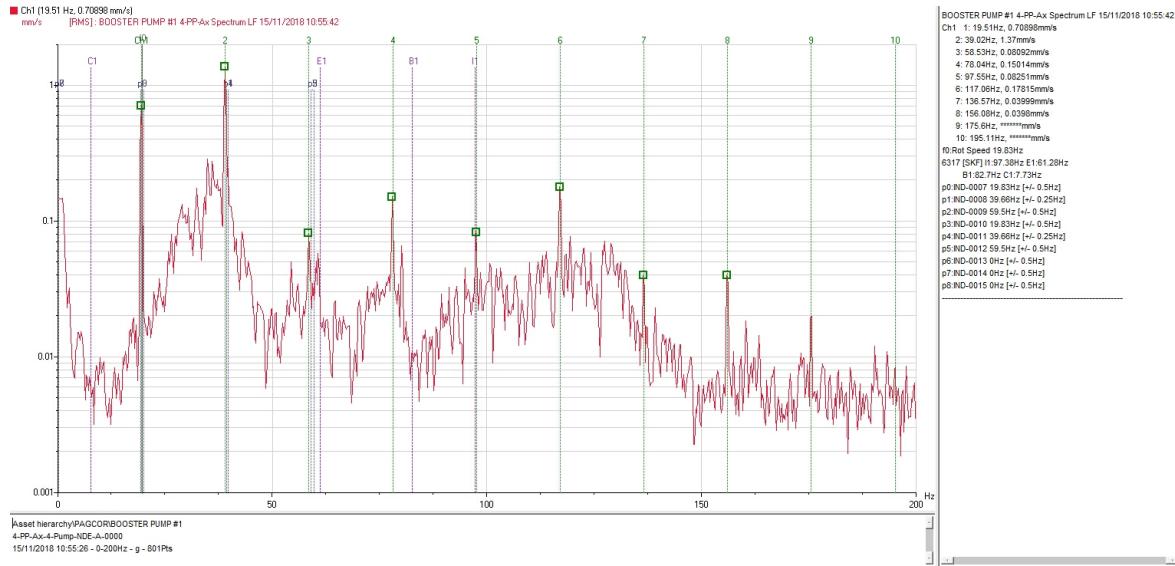
2x Peak is an indication of slight misalignment

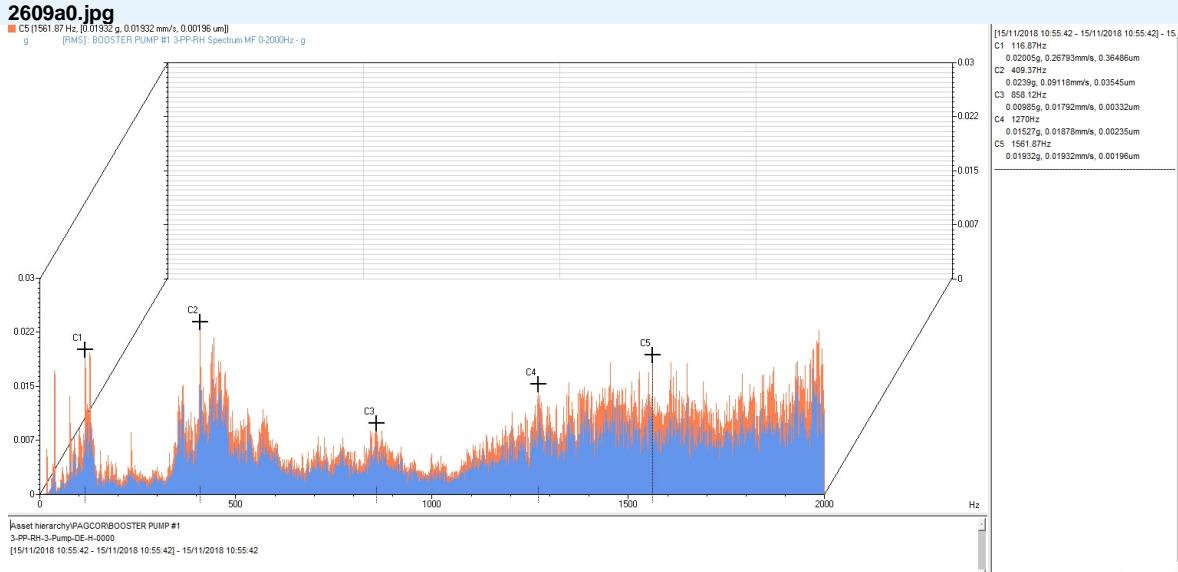
Elevated base or humps are an indications of Noise from Pump Cavitations and Bearing Noise

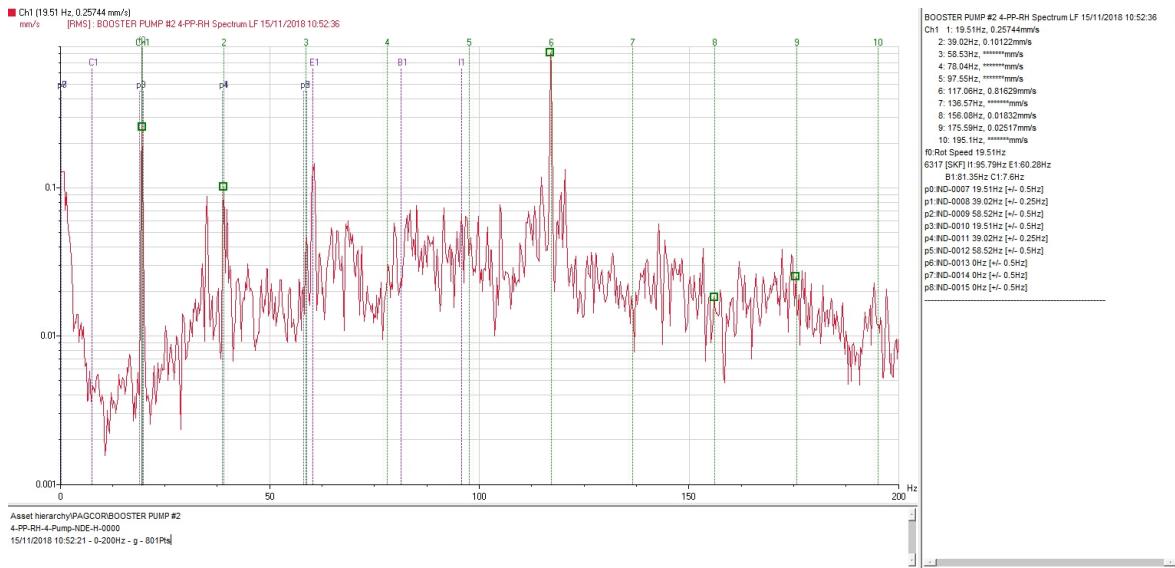
1x BPFO peak - Bearing Outer Race Fault

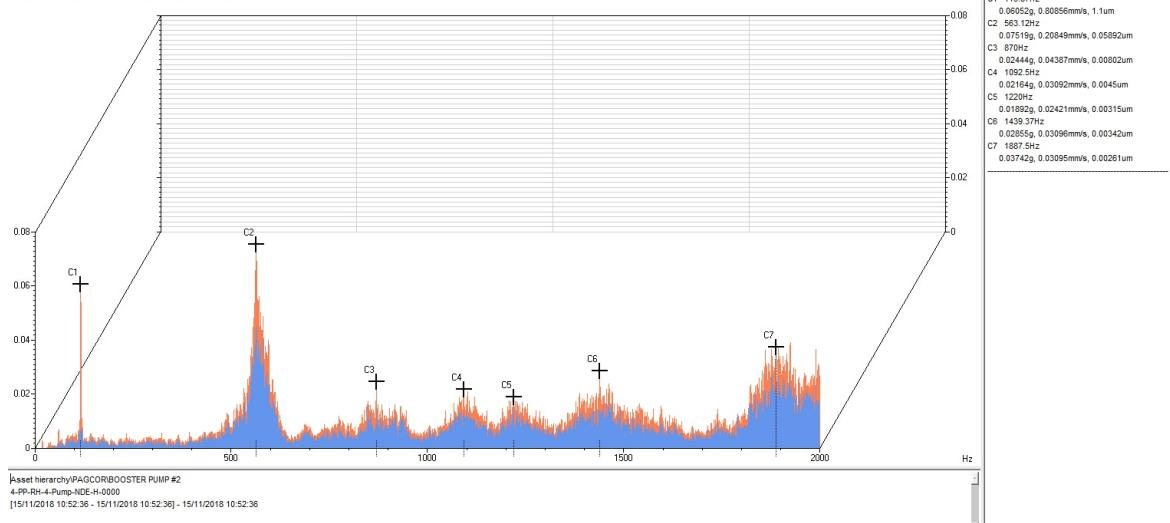
Noise generated at High frequencies due to lubrications problem

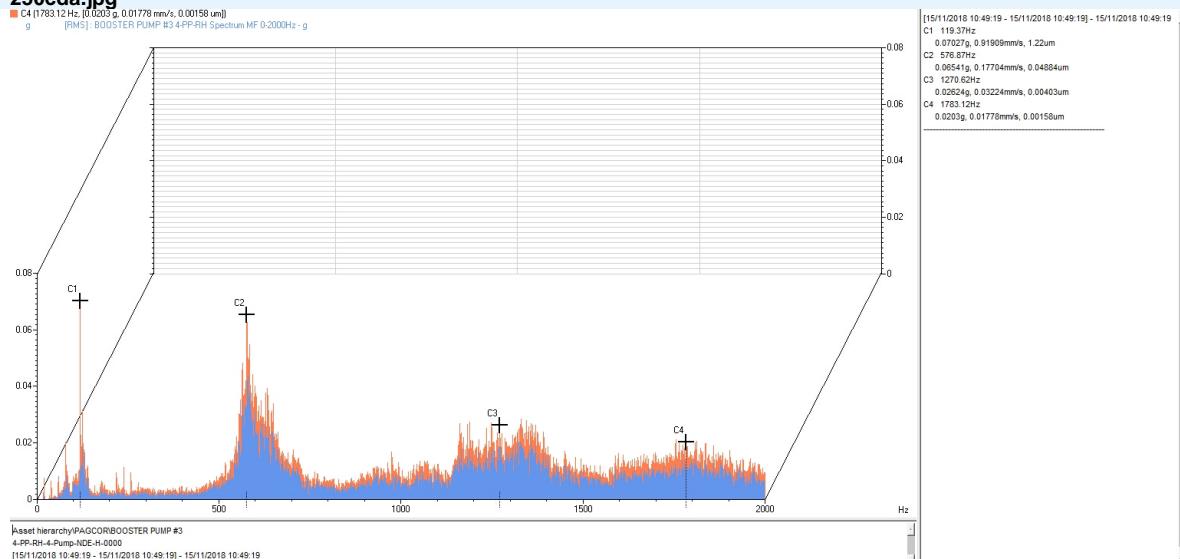
1x Blade Passing Frequency peak and elevated base or humps are an indications of pump cavitations Fault
2709f6.jpg

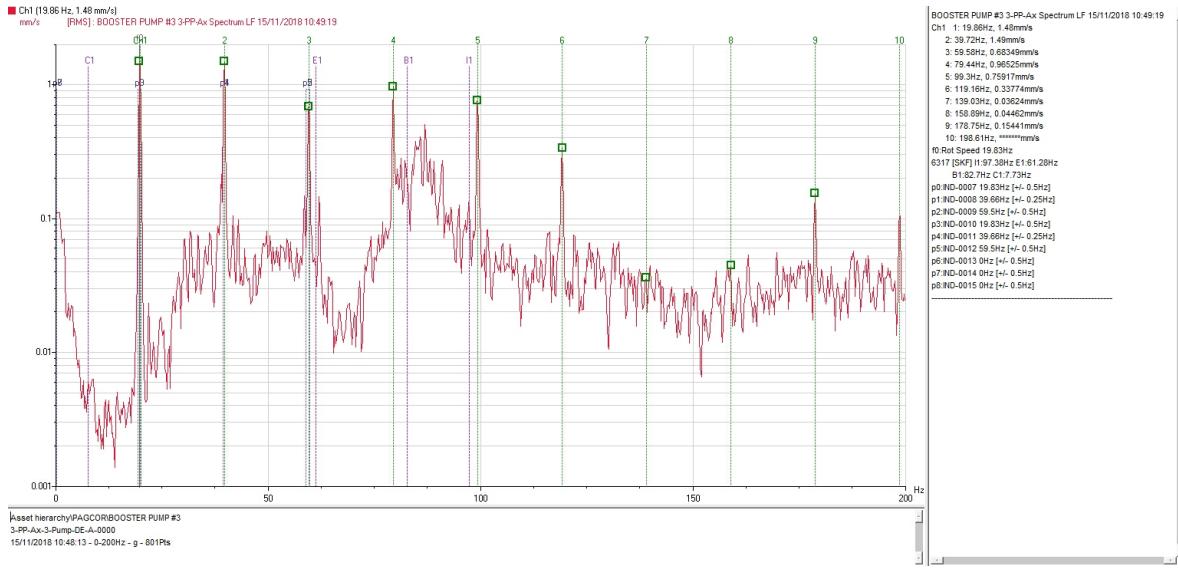
1x, 2x peak are an indications of slight Misalignment. Magnitude is minimal, but still need to verify actual alignment conditions.

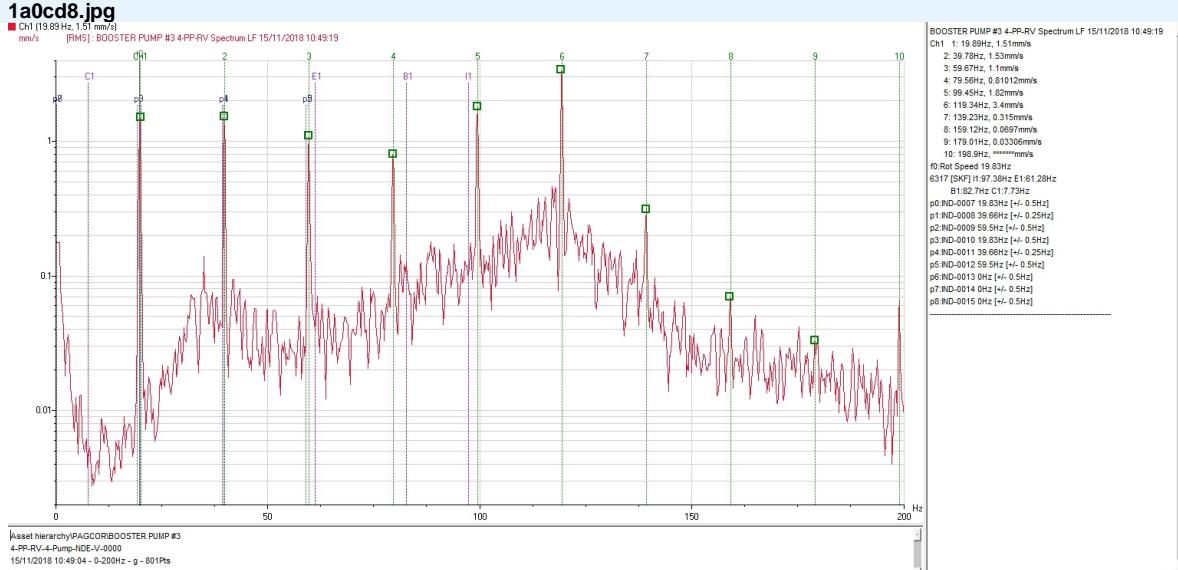
Dominant peak at Blade Passing Freq due to cavitations

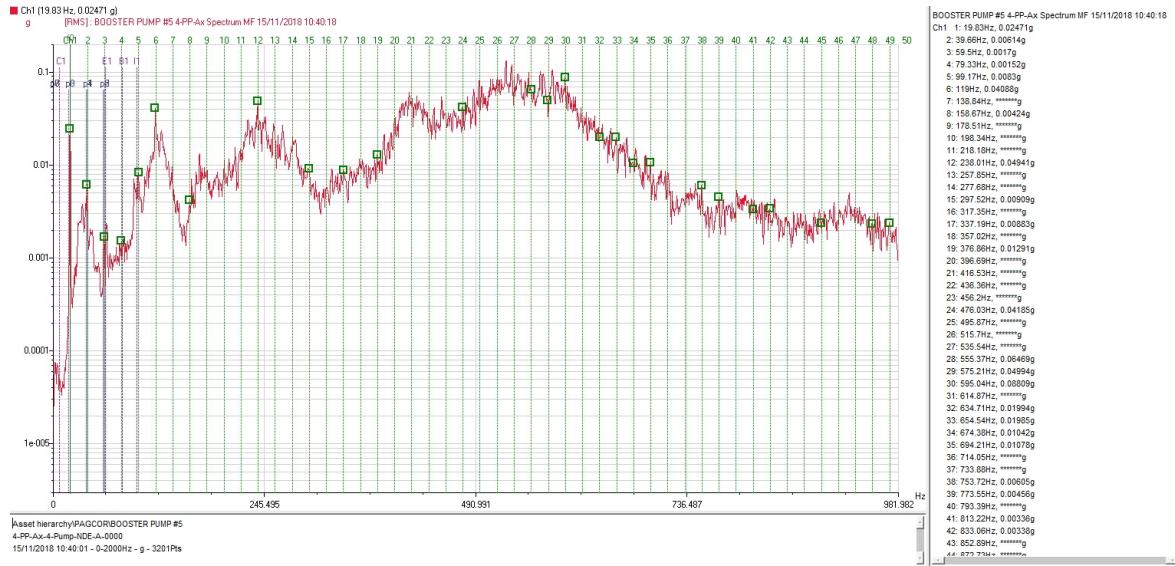
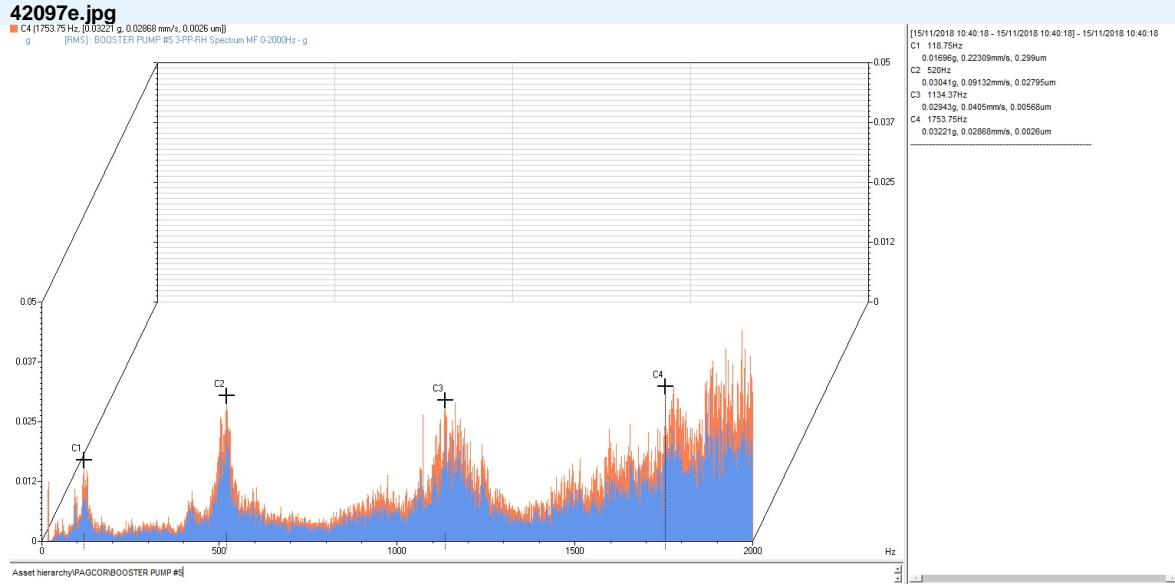
Elevated base or humps at High frequencies are an indications of combination Noise from Pump Cavitations and Lubrication issues

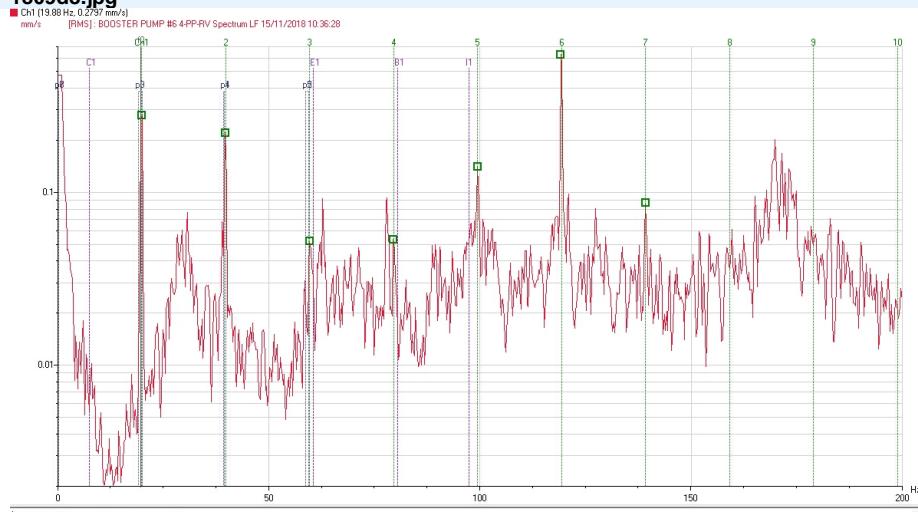
Elevated base or humps at High frequencies are an indications of combination Noise from Pump Cavitations and Lubrication issues at Pump OB Bearing

Monitor Slight cavitations, Regrease Pump OB Bearing with fresh greases

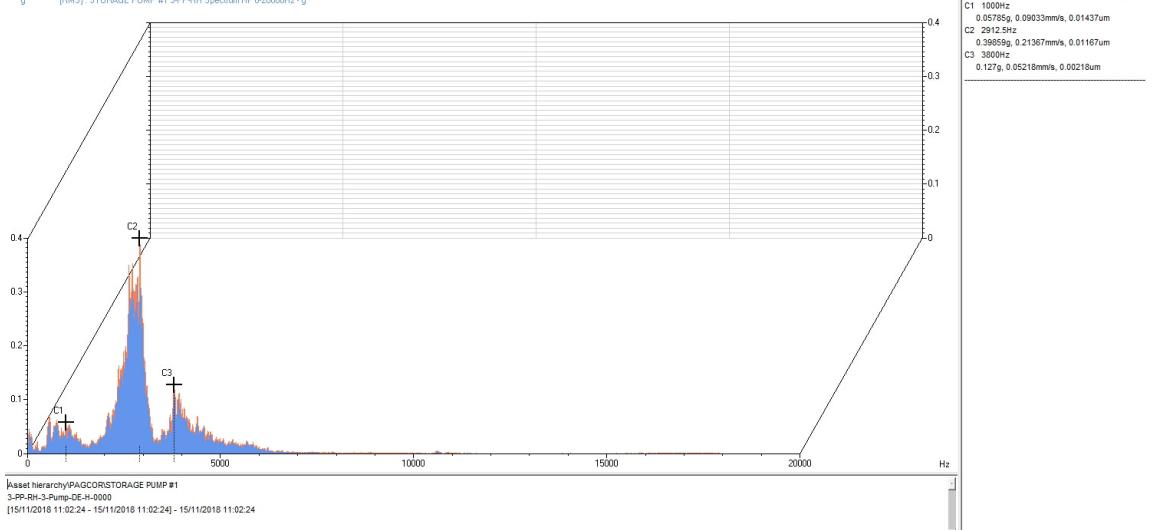
Elevated base or humps are an indications of Noise from Pump Cavitations

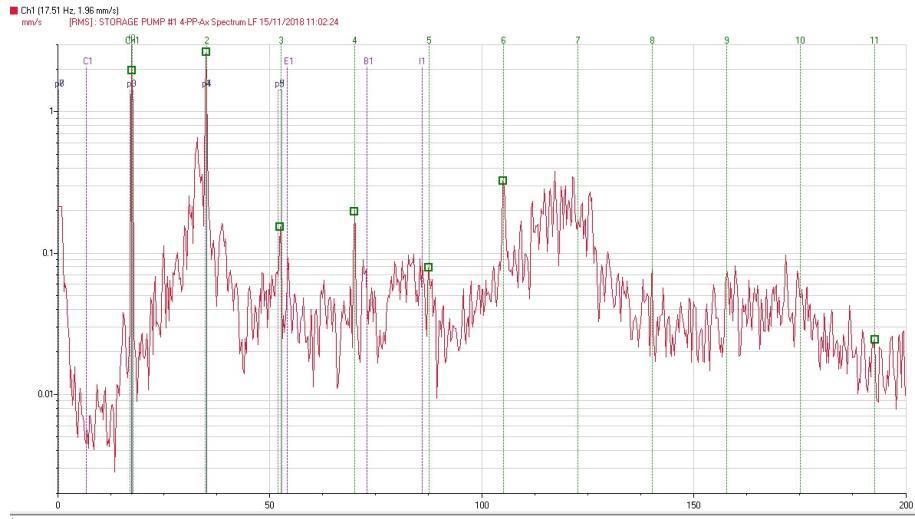
1x and 2x Peak at FFT - are an indications of Misalignment

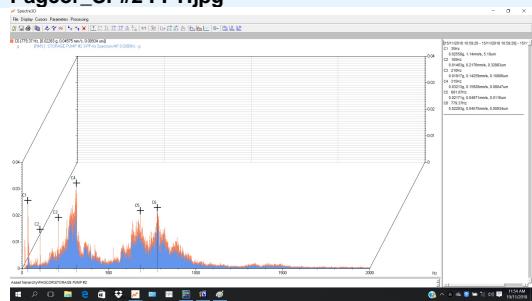
Elevated base or humps are an indications of Noise from Pump Cavitations

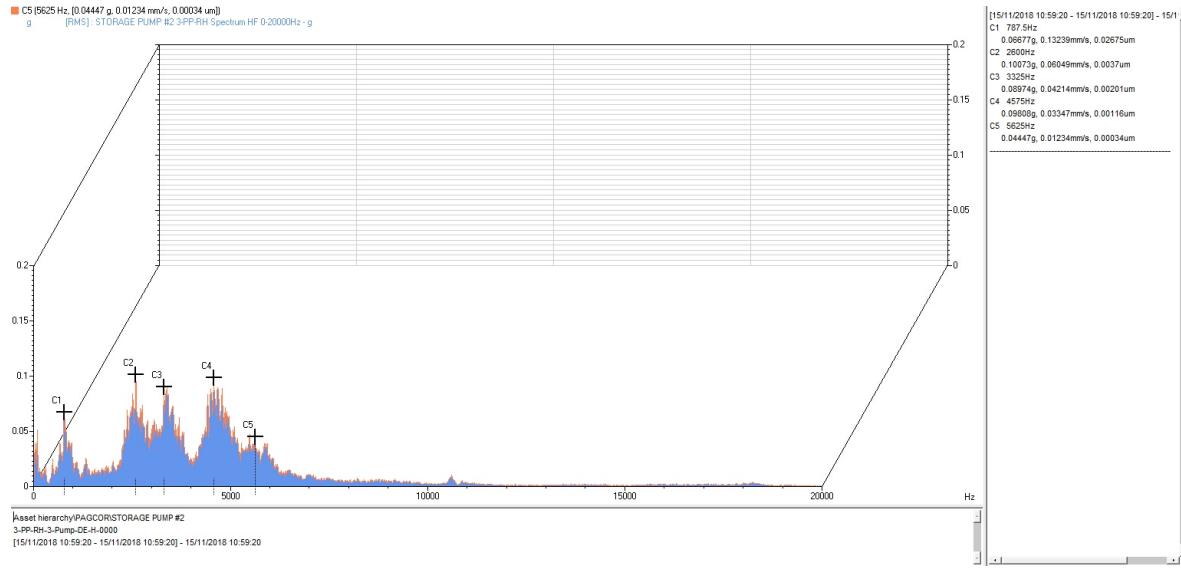
Elevated base or humps are an indications of Noise from Pump Cavitations

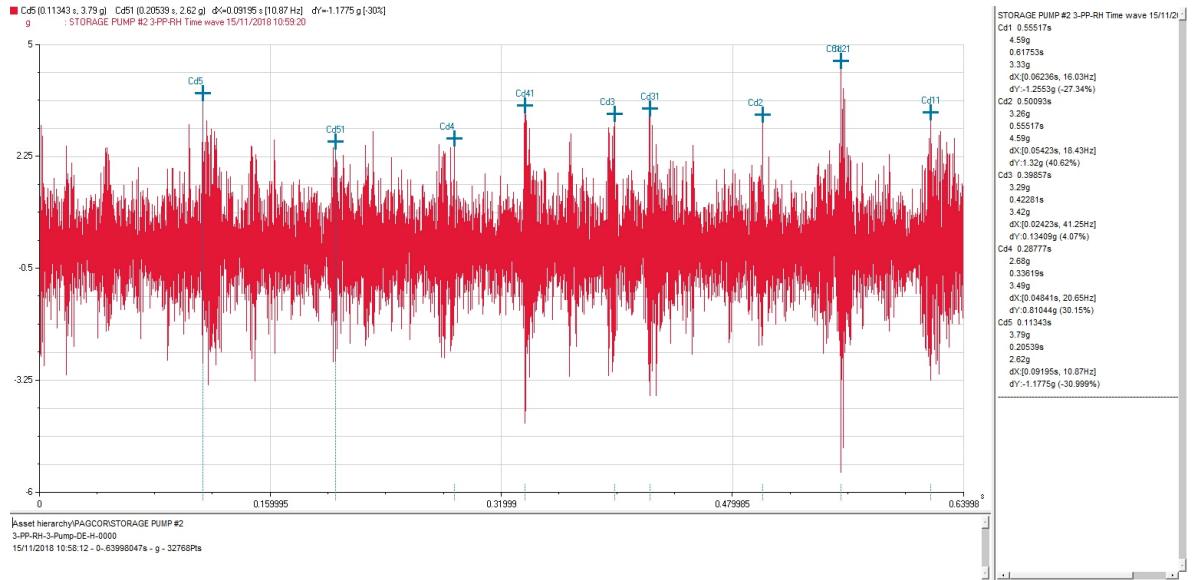
Non Periodic Pulsation due to cavitations
