Consultancy Services for the Plant Audit in various Pump Stations and Reservoirs (OP18REFCS03)

Technical Report for Ayala South Vale (ASV) Pump Station
(Mechanical and WEM)

reference: OP18REFCS03-GHD-ASV-REP-G001B

Title:
Preliminary Report for Ayala South Vale (ASV)
Pump Station

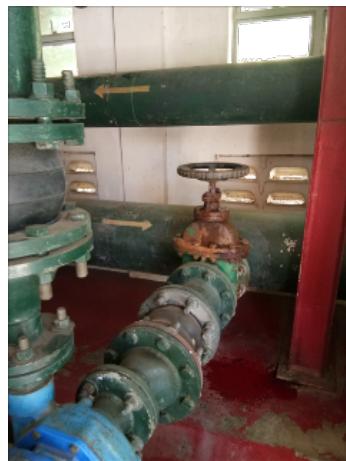
Figure 4.6: defective valve

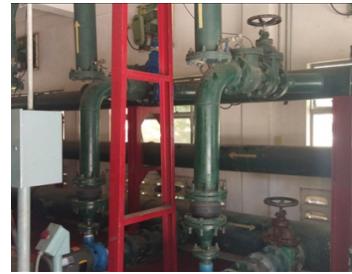
Figure 4.7: over-head valve location

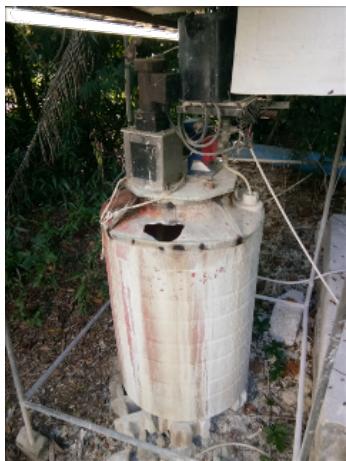
Figure 4.9: Other deterioration

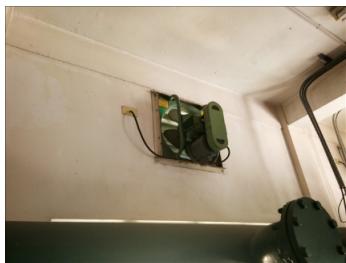
**Figure 4.10:** exhaust fan

- Defective valves – valves have already locked up either due to age and/or corrosion (Figure 4.6).
- Valve not easily accessible - located above head level and require ladder to access (Figure 4.7)
- Clogged tapping point - during testing, clogged pressure tapping points and pressure gauges on the same line were found.
- Inconveniently placed gauges (Figure 4.8)
- Cluttered Electric wires (Figure 4.12)
- Minor Deteriorations (Figure 4.9)
- Exhaust fan not easily accessible for cleaning or repair (Figure 4.10)
- Inconvenient blank nameplate (Figure 4.11)

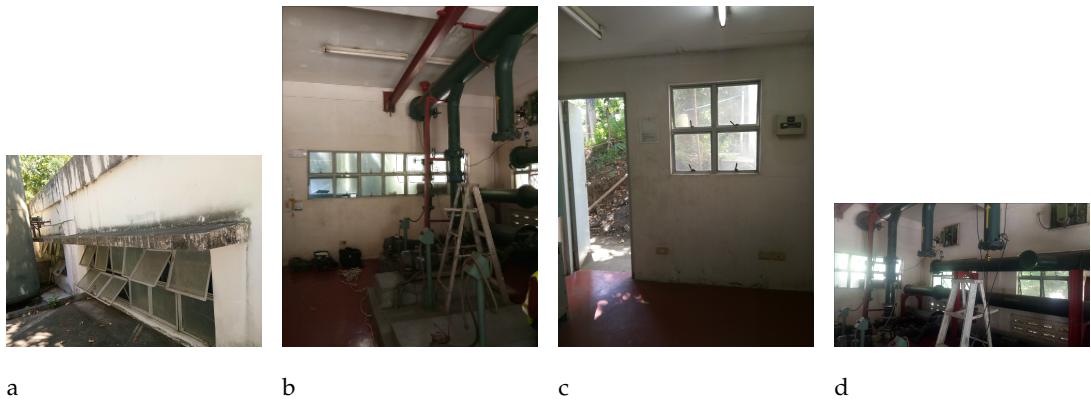
Figure 4.18: Pump house openings

Illumination levels measured are above recommended minimum. The pump station is mostly solar lit during the day thru door and windows (Figure 4.18). Lightings can

The pump room relies on natural ventilation via the access door and room windows. The MCC room beside the pump room is also naturally ventilated and has windows installed. The open access doors and windows serve double purpose to both promote air change in the rooms and also provide natural lighting inside (Figure 4.18)

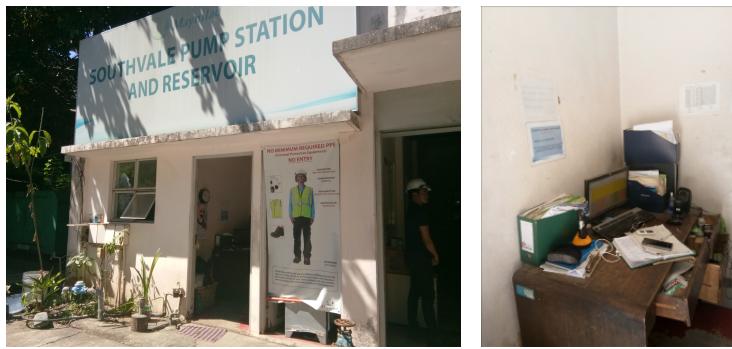
a - High solar load during the day

b - Operator's desk
