Consultancy Services for the Plant Audit in various Pump Stations and Reservoirs (OP18REFCS03)

Technical Report for Ayala South Vale (ASV) Pump Station
(Electrical and FDAS Audit)

reference: OP18REFCS03-GHD-ASV-REP-G002A

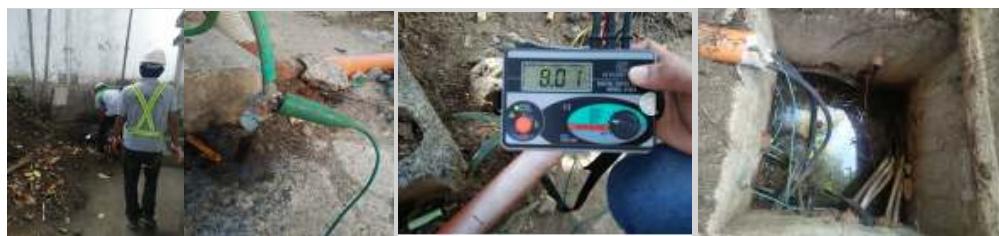
Figure 3.18: Visual inspection on electrical safety

The study has been conducted in accordance with the ITP. Figure 3.18 shows the grounding points and activities conducted during the test.

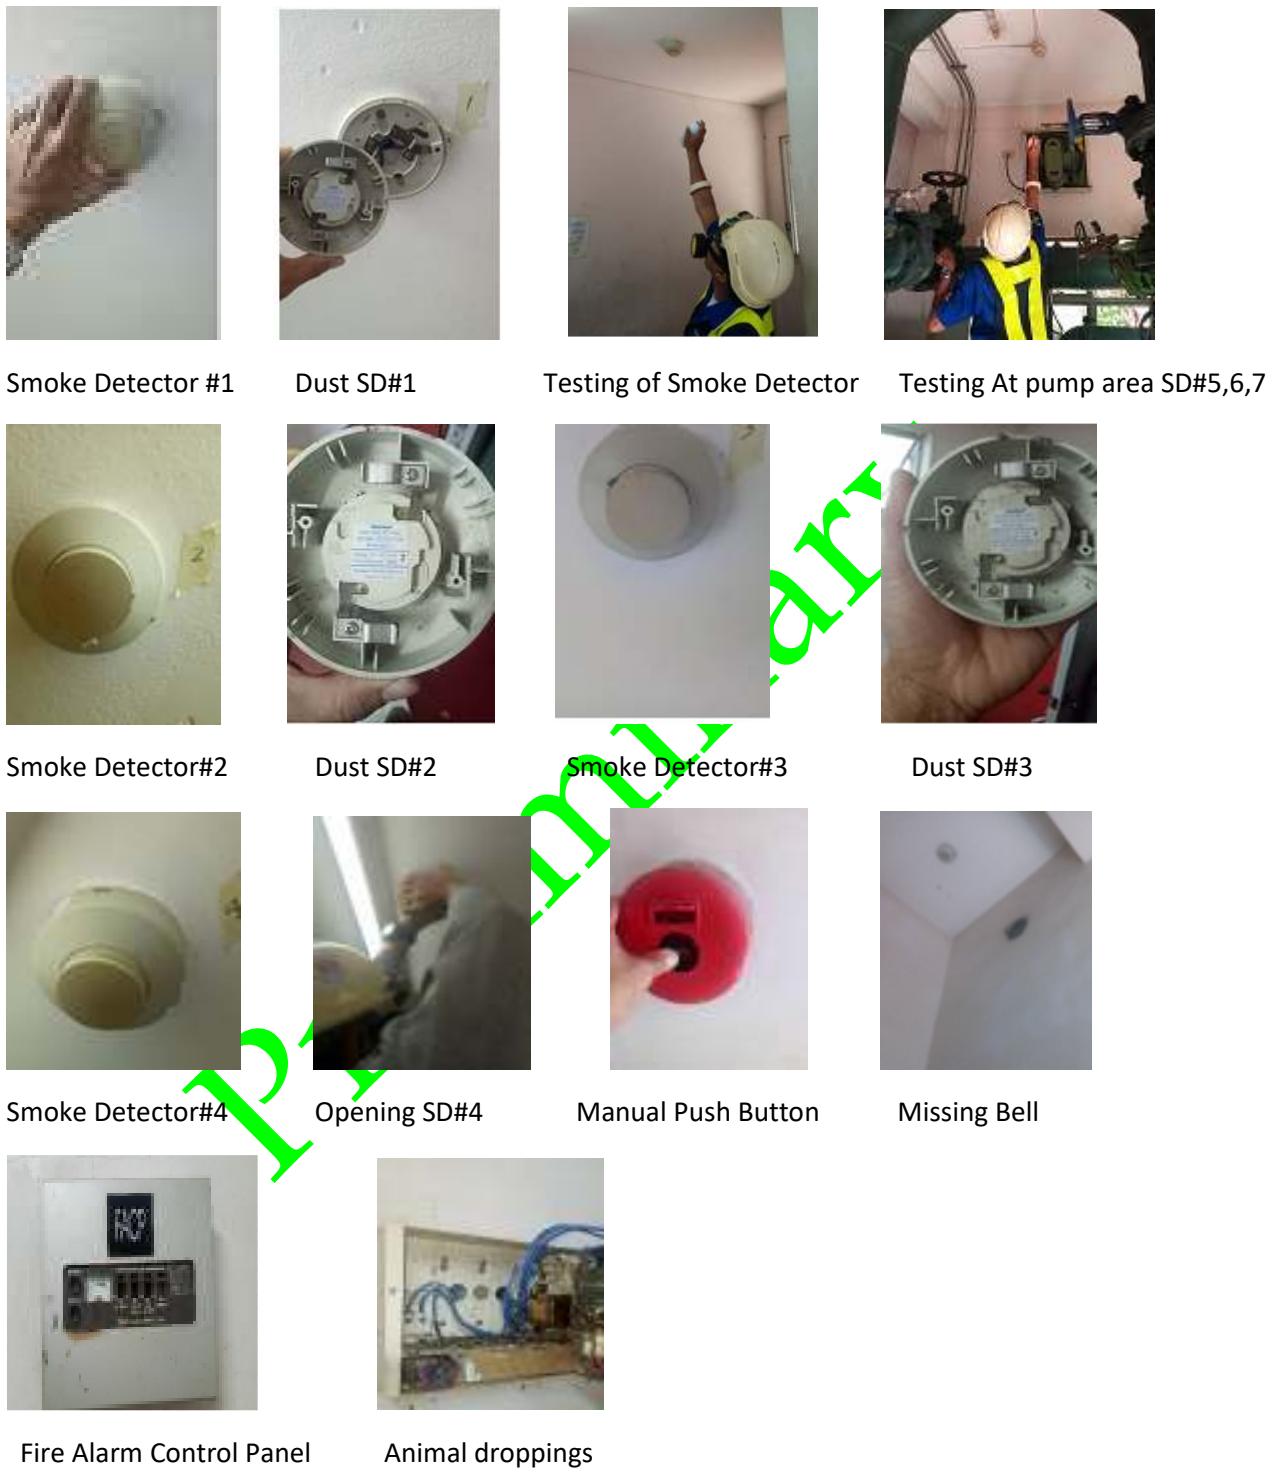
Figure 3.24: Visual inspection on FDAS and safety devices

ITEM	DESCRIPTION	YES	NO	Findings During Testing	Test Results
1.	Smoke Detector #1		X	-With dust inside and outside -Spray Smoke Detector Maximum 3 times	-No response on smoke tester -Repeat spray again but no response in the device -Repeat clean -After 3x spray no response on smoke tester
Analysis: After spraying of smoke tester, removal of the device from base to Reset contact point and cleaning did not show any improvement on the device. Hence device is declared not functioning and there is communication failure between device and FACP panel.

6.	Missing Bell		X	- Bell is missing. Only wiring is visible	-No test to be performed
7.	FACP			- with accumulated dust and dirt -with insect and rat "droppings" -No light indicator -No response on sounder, system reset, fire report and battery test when toggle pressed -evidence of rusty enclosure	Measured supply voltage. Value 205 volts Measured output voltage. Value: 0 volts
Analysis : FACP is not functioning

- The smoke detectors are not stand alone type and is dependent on the Fire Alarm control panel for proper operation;
- The FACP, though still have input voltage has no output voltage and is recommended for replacement together with all the devices. All devices in the system should be compatible to be able to operate. Replacement of FACP alone does not guarantee that the existing smoke detectors will operate;
- After replacement of battery, push test/ "hush" button. This will decrease the sensitivity for approximately 8 minutes. During this time, the RED LED will flush every 10 seconds. This will indicate that the device is functioning;
- Owing to the years, the wires and other auxiliaries have deteriorated and must be replaced by a new FDAS system.
