Consultancy Services for the Plant Audit in various Pump Stations and Reservoirs (OP18REFCS03)

Technical Report for Ayala South Vale (ASV) Pump Station
(Electrical and FDAS Audit)

reference: OP18REFCS03-GHD-ASV-REP-G002A

Preliminary Report for Ayala South Vale (ASV)
Pump Station

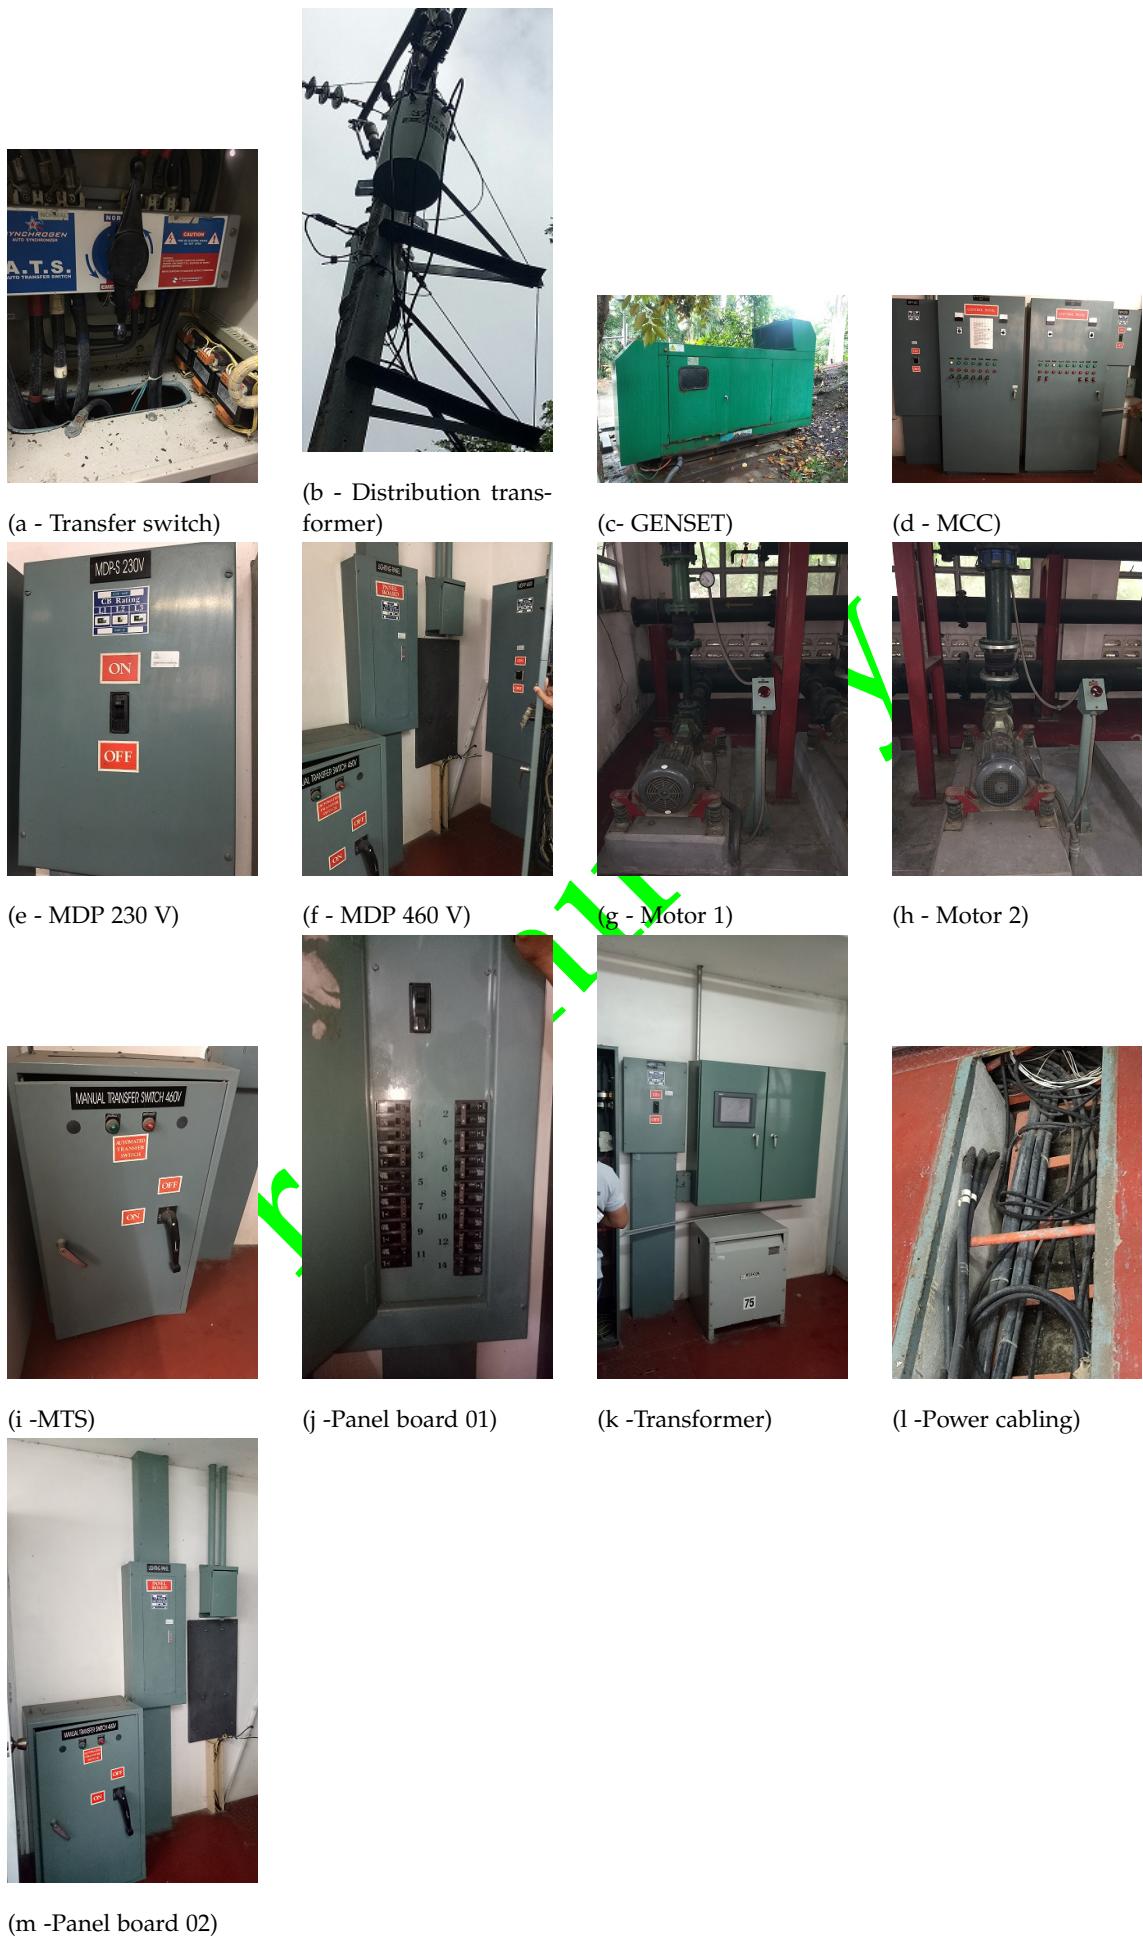
Figure 2.1: Existing electrical assets

Item	Description	Model	Brand	Status	Remarks
1	Main Switch/Switchboard	MDP 460V/MDP230V	Local Fabrication	1	Still being used
2	Distribution Transformer	75kVA, 460V	Wescor	1	Still being used
3	Maynilad Owned Load Break Switch (LBS)	n/a	N/a	0	Low voltage installation
4	Power Cables (secondary side of DT to the Elect. Loads)	THHN cables	Not visible	1	cable visually not maintained
5	Motor Control Center	230V and 460V MCC	Local Assembly	1	With defective components
6	Capacitor Bank	n/a	n/a	0	Not found
7	TVSS	n/a	N/a	0	Not found
8	Power Meter	Analog V and A	Not visible	1	Pointer still moving and has reading
9	Filters and Reactors	n/a	n/a	0	Not found
10	Instrument Transformers	Current and Voltage	n/a	1	wiring acceptable
11	Electrical Protective Relays	n/a	n/a	0	Not found
12	Motor and Switches	Nameplate blurred	nameplate blurred	1	Nameplate already blurred
13	Transfer Switch	Automatic	Synchrogen	1	Functioning as Manual Transfer

Transfer Switch	Manual	n/a	1	Not functioning; not used
14	Uninterruptible Power System (UPS)	n/a	n/a	0	Not found
15	Distribution Panelboards and assoc. appurtenances	DP and LPB	locally fabricated	1	Breakers are obsolete
16	Ground-Fault Circuit Interrupter (GFCI) or ELCB or (RCD)	n/a	n/a	0	Not found
17	Lighting and Lighting Control System	1x40 lighting fixture	Not visble	1	w/ non-functioning fixtures
18	Emergency Generator	Standby Genset	Cumper	1	Rusted enclosure
19	Building Service and Distribution	utility owned	Not visble	1	Open delta connection

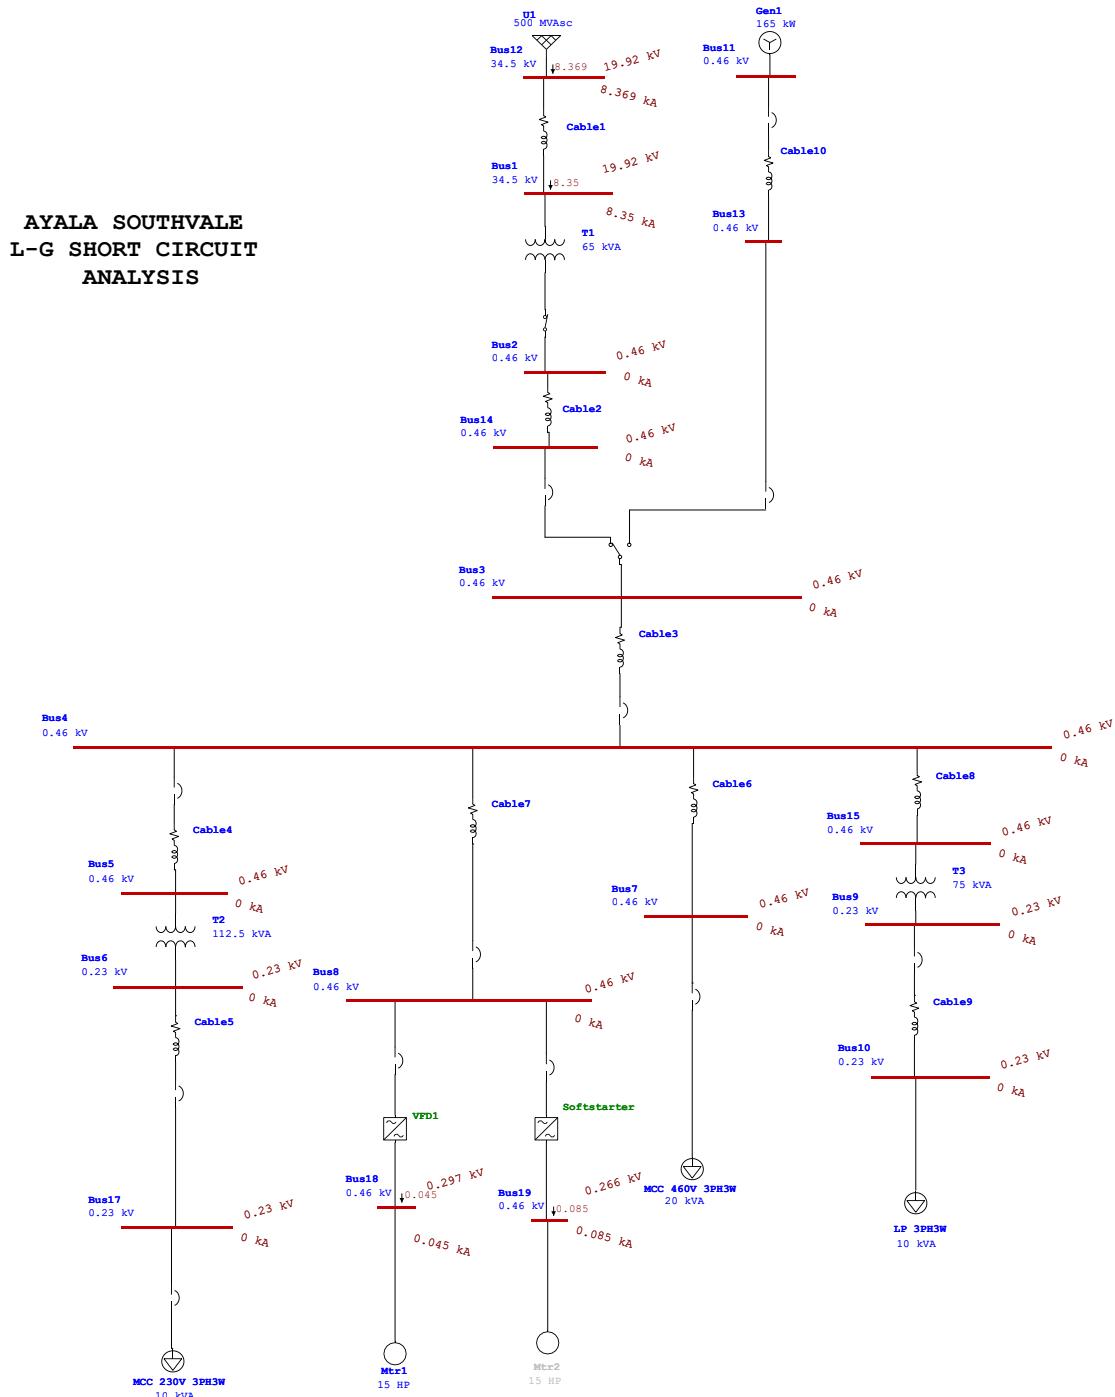
**Figure 2.2: LGfault**

- the values of the FAULT observed to be lower than the values of the protective devices. This infers that the existing protective devices are capable to protect the assets.

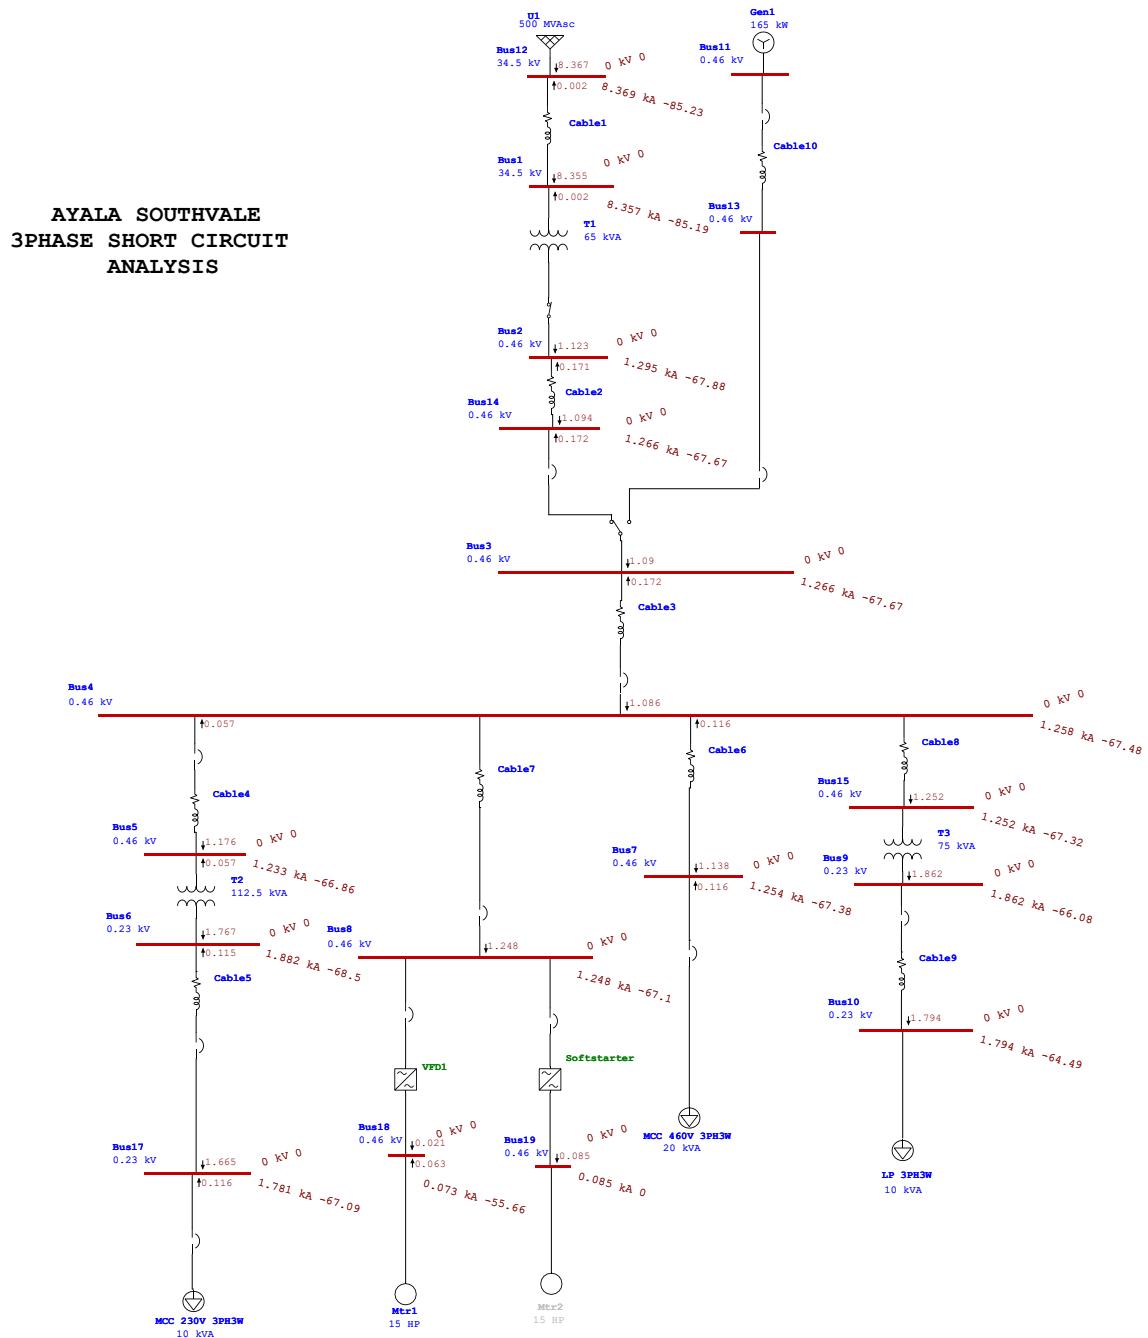
Figure 2.3: Three Phase SCC

It can be interpreted from the results of the SCC that

- the protective devices and bus bars are still provided adequate level of services and performed per applied standards;
- there is no undersized electrical components.

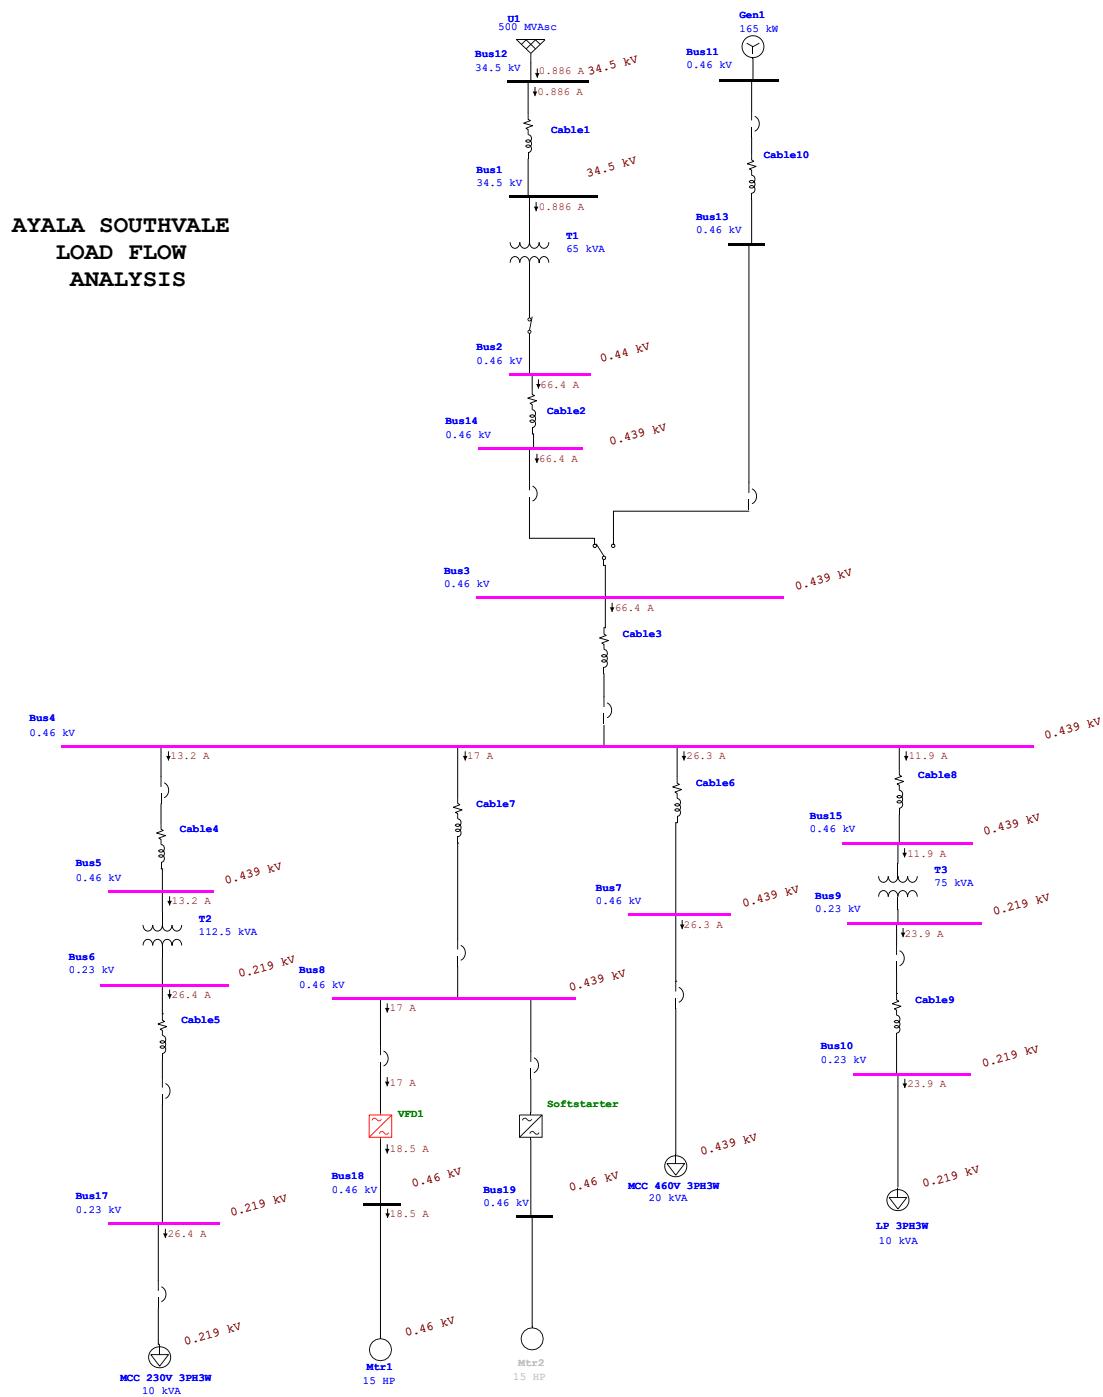
**Figure 2.4:** Load flow analysis

As can be seen from the figure, parameter values are all acceptable. However, there is an indication in pink color for VFD1, inferring that this asset might have reached the marginal setting, but not critical. It is recommended that this asset shall be closely monitored. The conclusion on this asset will be validated together with the analysis on the Power Quality which is in subsection 2.7.

- For the overall system, the maximum loading reached about Phase A :75.1A, Phase B:67.7A, and Phase C: 68.6 (Figure 2.5), which is close to the theoretical values (66.4 A) obtained from ETAB software (Figure 2.4). This indicates that actual parameter values are within the acceptance range;
- For the VFD1, the maximum loading reached about Phase A:18.4A, Phase B: 9.9A, Phase C: 18.5 A (Figure 2.6), which is higher than the theoretical values (16.98 A) obtained from ETAB software (Figure 2.4). This indicates that actual parameter values are not within the acceptance range due to very low phase B value;
- For the softstarter, the maximum loading reached about Phase A: 20.6 A, Phase B: 18.5A, Phase C: (Figure 2.7), which is lower than the theoretical values (33.9 A) obtained from

From this analysis, it is recommended that continuous monitoring on VFD1 shall be implemented to ensure that the loading is not going to exceed the limit. Furthermore, continuity test on VFD shall be conducted to determine the probable issue in phase B.

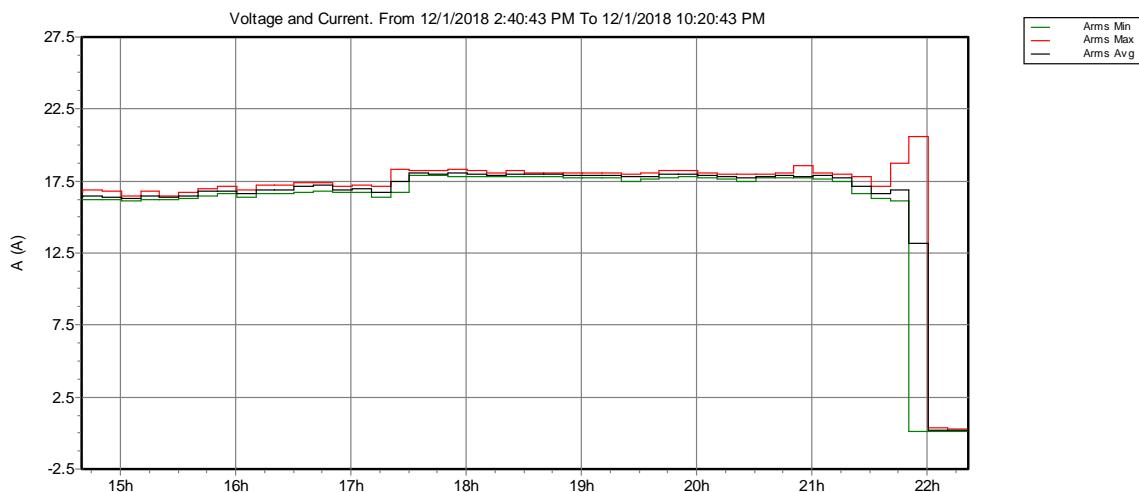
Figure 2.7: soft starter

ETAB software (Figure 2.4). This indicates that actual parameter values are within the acceptance range.

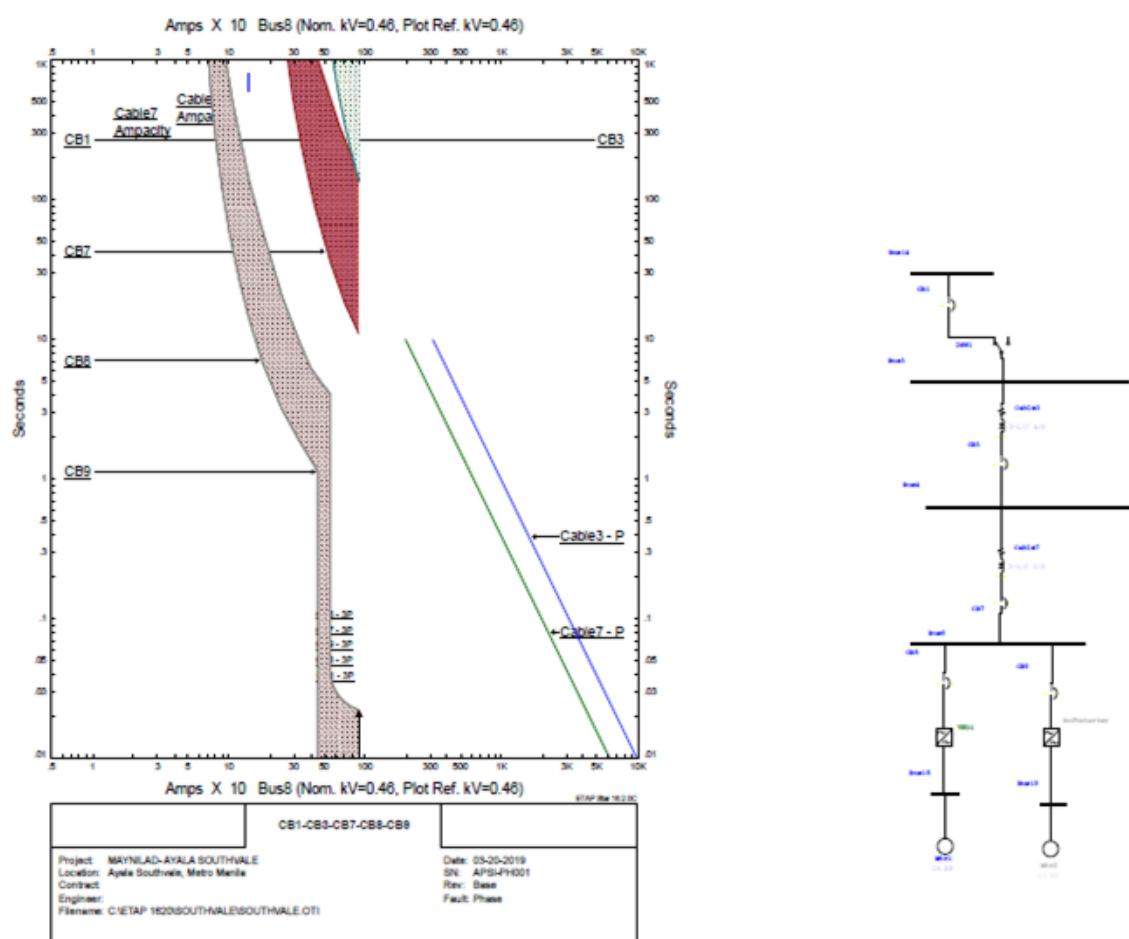
Figure 2.8: Coordination plot

Following remarks/recommendations can be interpreted from values shown in the tables and figure.

- Trip curve is covered by other protective functions or clipped by fault current.
- Some of the Circuit breaker trip devices are fixed and can not be adjusted. Hence coordination is deemed to be partial since some of the branch breaker TCC curves crossed the TCC curve of Main breaker on the instantaneous region.
- L-G fault coordination is not possible. Trip unit of protective device has no ground fault protection provided due to the type of breaker supplied. However , this is allowed under the Philippine Electrical Code.
- For better coordination, main breaker should be of adjustable and electronic type.

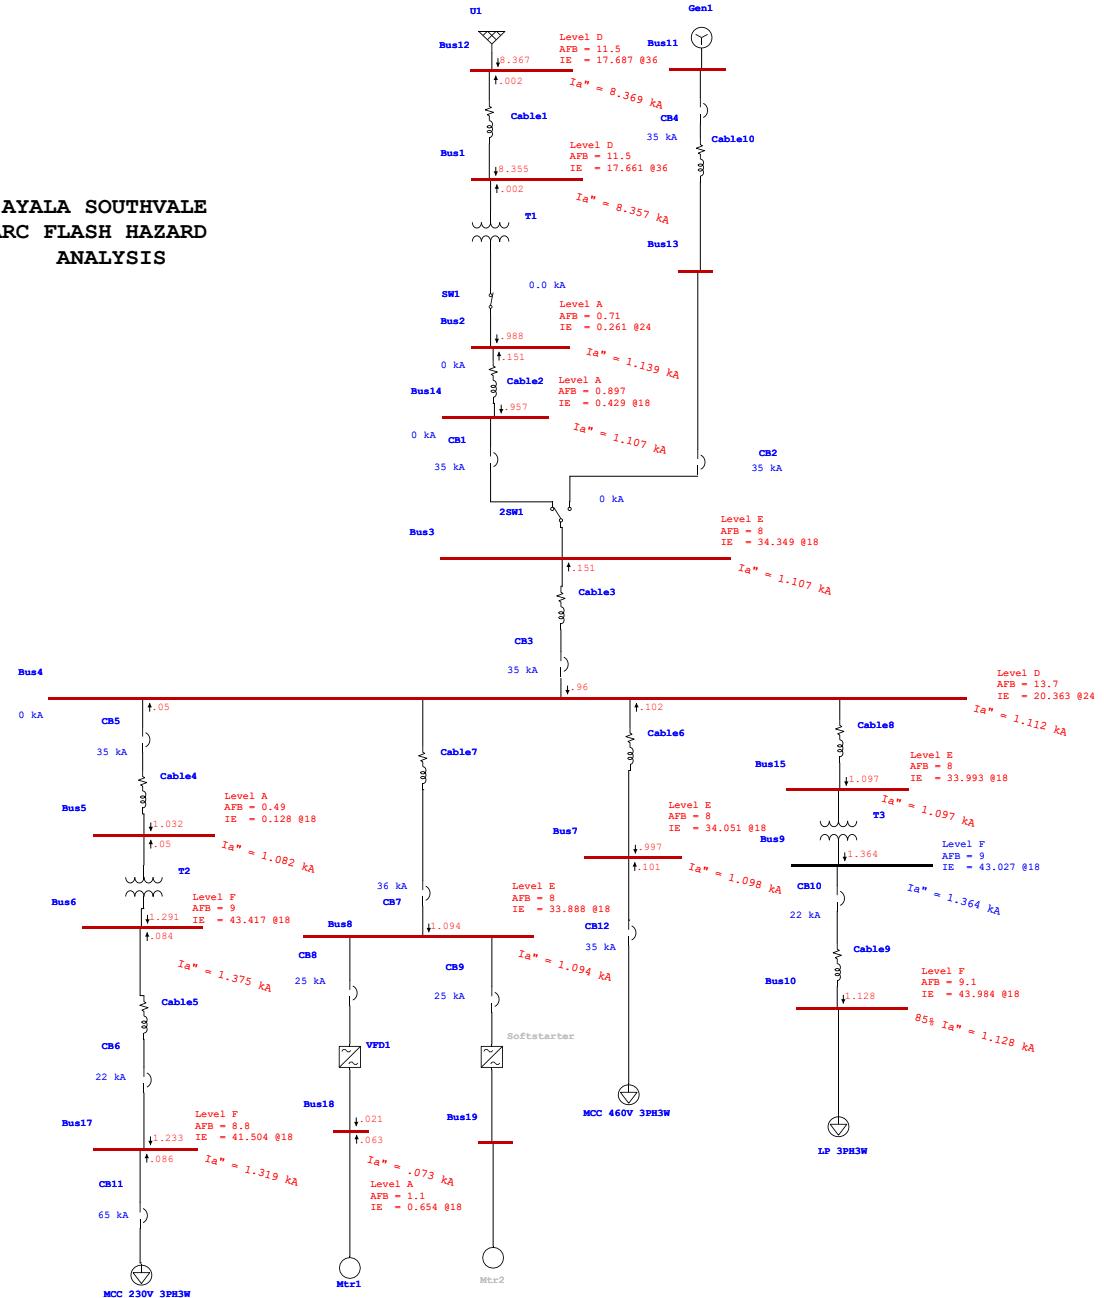
Figure 2.20: ARC flash analysis

The theoretically derived Lee method was used to determine the incident energy and arc flash boundary for this location since the bolted fault current or nominal voltage are outside the empirical method range. ($|I_{bf}| < 0.7 \text{ kA}$ or $|I_{bf}| > 106 \text{ kA}$) and ($0.208 \leq \text{Nominal kV} \leq 15 \text{ kV}$)

According to the results of the Arc Flash Analysis, Cotton underclothing plus FR shirt, pants, plus multi-layer switching suit or equivalent should be worn when opening the cover of the MCC. Arc flash Boundary (AFB) is about 8 feet (2.44 meters). Contributors to the arc flash are the motor loads and the VFD's.

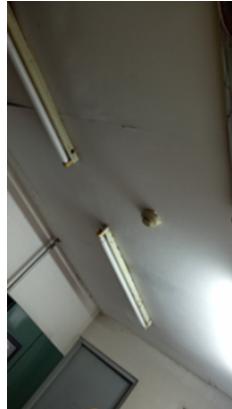
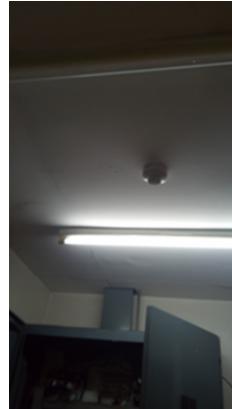
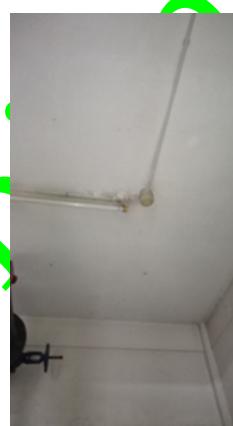
Figure 2.22: As-found devices and panels

Summary of data and information from FDAS audit is presented in Table 2.26 with visual images on as-found devices and panels (Figure 2.22 and Figure 2.23, and Figure 2.24).

No.	Assets	Status	Remarks
A.	VISUAL CHECK OF FIRE ALARM CONTROL PANEL		
1	Panel Status, installed and location area	1	INSTALLED IN THE CONTROL ROOM
2	Power indicator lamp operational	0	NO POWER (NO LIGHT)
3	Devices properly indicated and marked	0	NO MARKINGS
4	Panel clear from trouble indicators	0	NO INDICATOR, NO POWER
5	Lamp test indicator operational	0	NO MARKINGS
6	Zones properly indicated and marked	0	NO MARKINGS
7	Check if it's connected to sprinkler system	0	NO SPRINKLER INSTALLED AT SITE

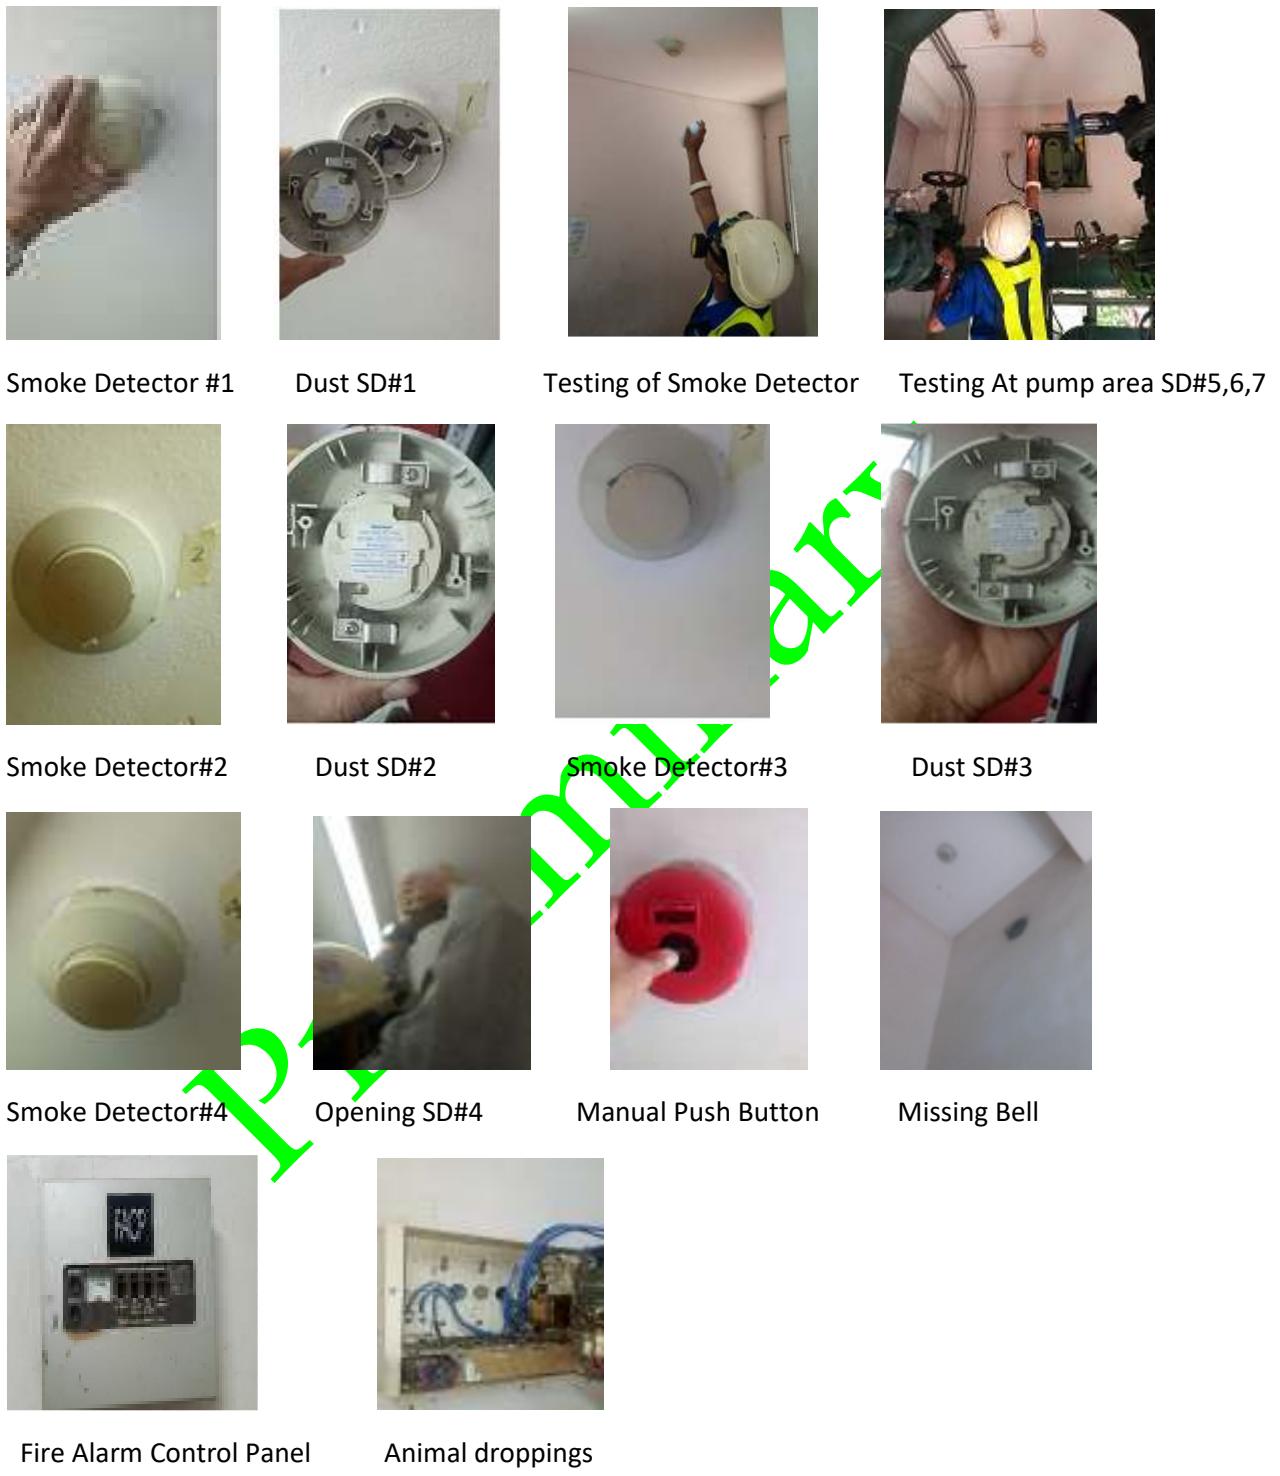
Figure 2.24: Visual inspection on FDAS and safety devices

- Most of the smoke detector devices, manual call point, buzzer and the FACP were not functioning. These were established during the conducted testing of FDAS and devices;
- Manual push button was not functioning when the button was pushed;
- Bell was missing from its original location;
- FACP is with input voltage but was not functioning when tested.

ITEM	DESCRIPTION	YES	NO	Findings During Testing	Test Results
1.	Smoke Detector #1		X	-With dust inside and outside -Spray Smoke Detector Maximum 3 times	-No response on smoke tester -Repeat spray again but no response in the device -Repeat clean -After 3x spray no response on smoke tester
Analysis: After spraying of smoke tester, removal of the device from base to Reset contact point and cleaning did not show any improvement on the device. Hence device is declared not functioning and there is communication failure between device and FACP panel.

6.	Missing Bell		X	- Bell is missing. Only wiring is visible	-No test to be performed
7.	FACP			- with accumulated dust and dirt -with insect and rat "droppings" -No light indicator -No response on sounder, system reset, fire report and battery test when toggle pressed -evidence of rusty enclosure	Measured supply voltage. Value 205 volts Measured output voltage. Value: 0 volts
Analysis : FACP is not functioning

- The smoke detectors are not stand alone type and is dependent on the Fire Alarm control panel for proper operation;
- The FACP, though still have input voltage has no output voltage and is recommended for replacement together with all the devices. All devices in the system should be compatible to be able to operate. Replacement of FACP alone does not guarantee that the existing smoke detectors will operate;
- After replacement of battery, push test/ "hush" button. This will decrease the sensitivity for approximately 8 minutes. During this time, the RED LED will flush every 10 seconds. This will indicate that the device is functioning;
- Owing to the years, the wires and other auxiliaries have deteriorated and must be replaced by a new FDAS system.
